RISK ASSESSMENT[®]

ADDRESS: Los Angeles, CA 90066

<i>CLIENT: 12 Unit Apartment Investor</i>	22 Sep 2008
---	-------------

RISK Assessment[®] Report

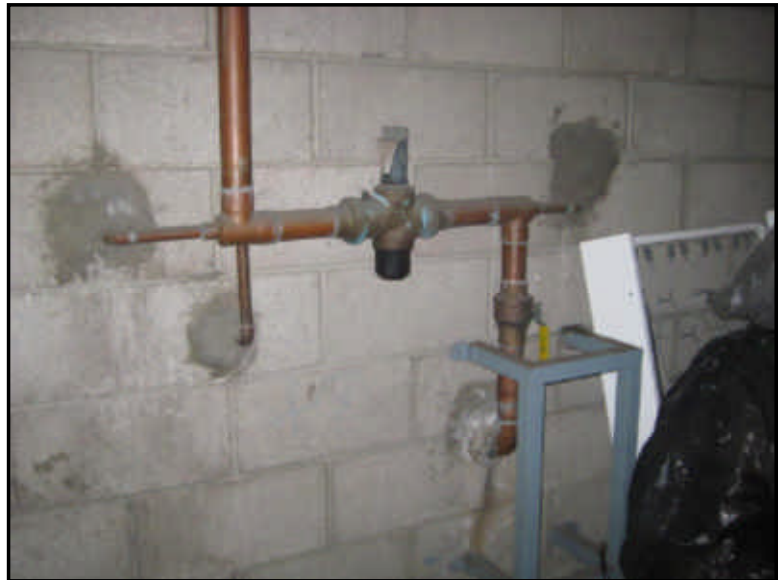
MAIN WATER SHUT
OFF LOCATION:

In the parking area at the front of the building.

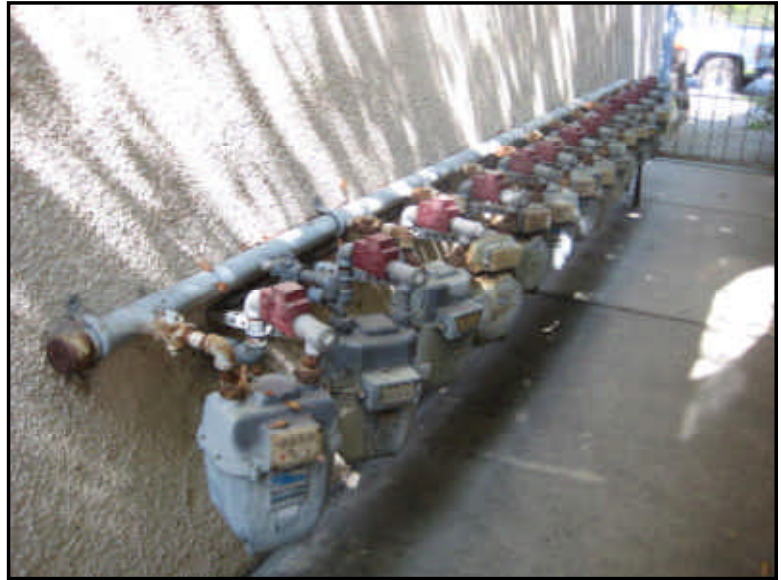
**GAS METER
LOCATION:**

The gas meters are located on the left side of the building.

It is advised to have the gas provider inspect the gas system to determine its condition and check all the gas appliances and fixtures. This is usually a free service.

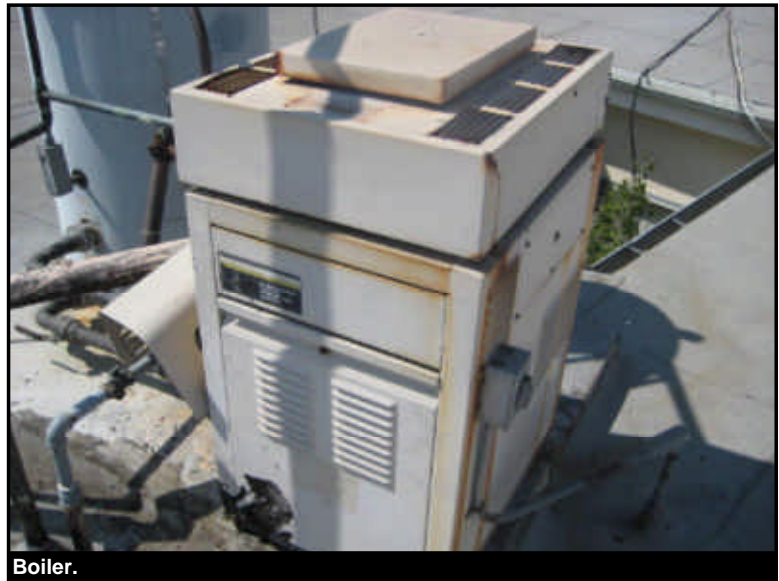
CONDITION:

Needs Attention, the water heater is older and nearing the end of its expected life span. There is rust on the unit exterior and interior.

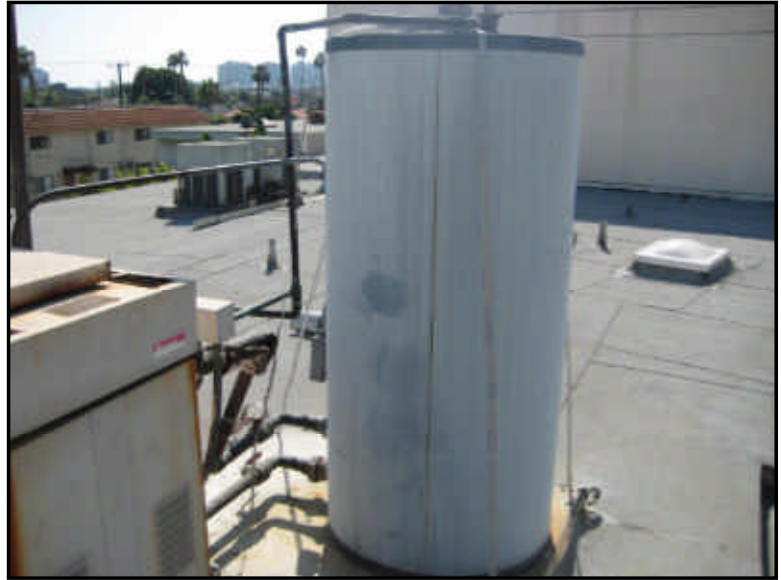
WATER HEATER
STRAPPING AND
SUPPORT:

Not Acceptable, the water heater needs to be properly strapped for earthquake safety in accordance with standards established by state regulations.

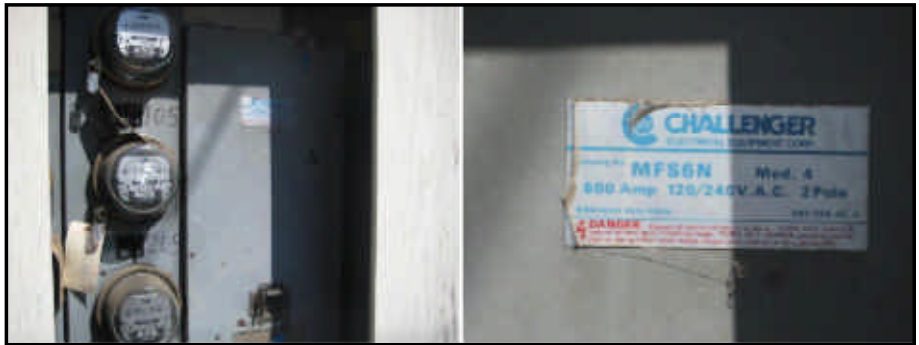
MAIN PANEL LOCATION:

The main electrical panel is located on the rear exterior wall of the building.

MAIN PANEL CONDITION: Serviceable.

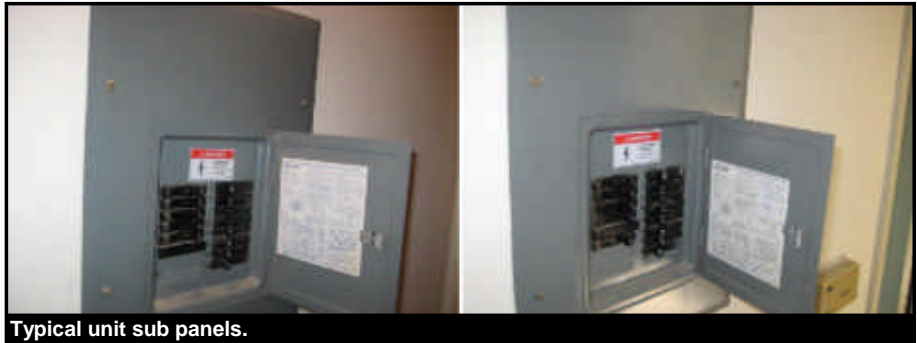
SUBPANEL CONDITION:

Typical unit sub panels.

Serviceable.

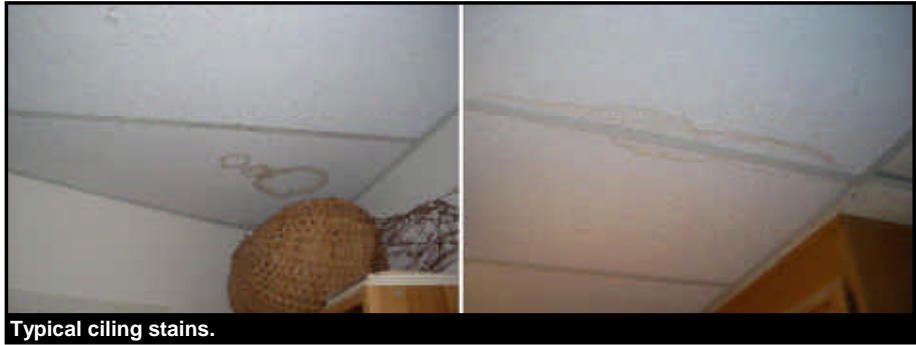
LOCATION
CONDITION:

Typical ceiling stains.

Needs Attention, most of the hallways have moisture stains in the areas.

There are many moisture stains in the areas of the ceiling air handlers. This is usually due to lack of full maintenance in a timely manner.

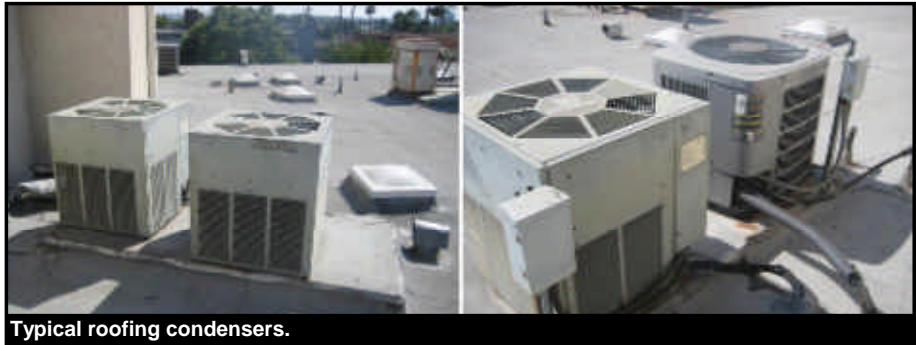
SYSTEM TYPE:

Typical roofing condensers.

The systems are a heat pump type system. This is an all electric system that has a condenser that pumps the refrigerant in one direction to cool the building and then reverses it to heat.

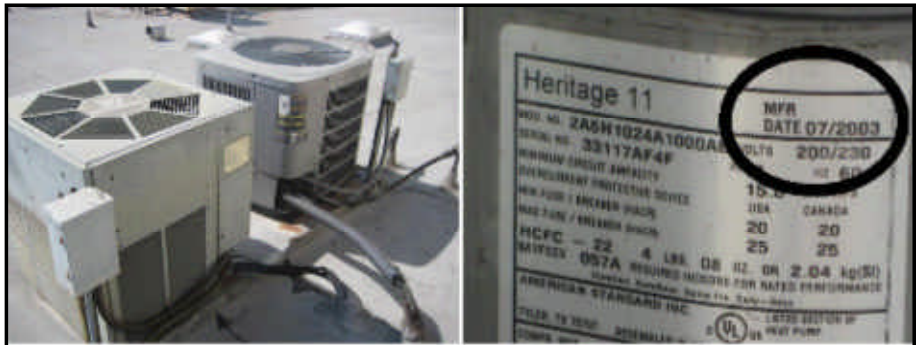
CONDITION:

Needs Attention, The systems are very aged and worn and at or past their expected useful life. Replacement should be considered at this time or in the near future.

Of the twelve units for the building 2 have been replaced in the last five years.

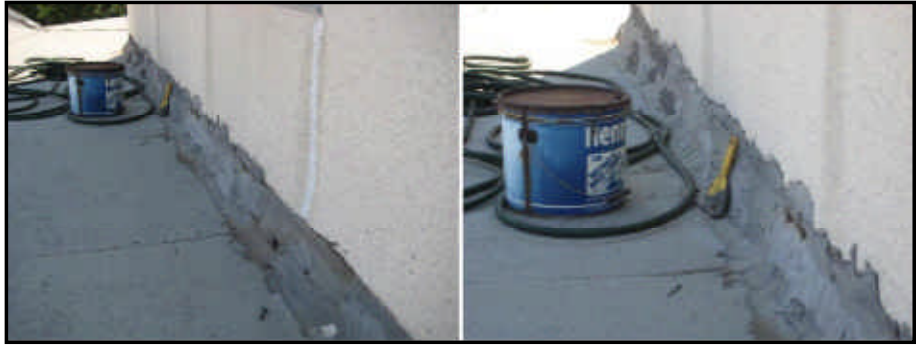
Need Attention: There is an area at the front of the building that the seal at the base of the wall has had patching done to. See building manager as to the history for this.

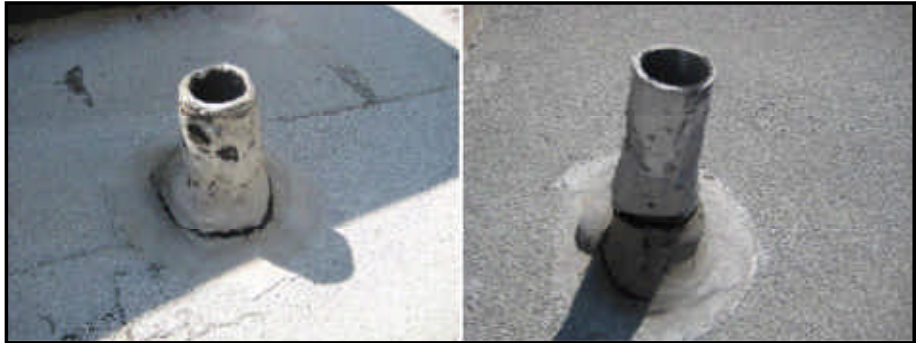
CONDITION:

Needs Attention, the mastic is cracked in areas and is not reliable to ensure a watertight seal.

The roof is in need of maintenance at this time. It is advised to have a roofer examine the entire roofing and drainage system and make any needed repairs or do any maintenance functions needed to help ensure a leak free condition at this time.

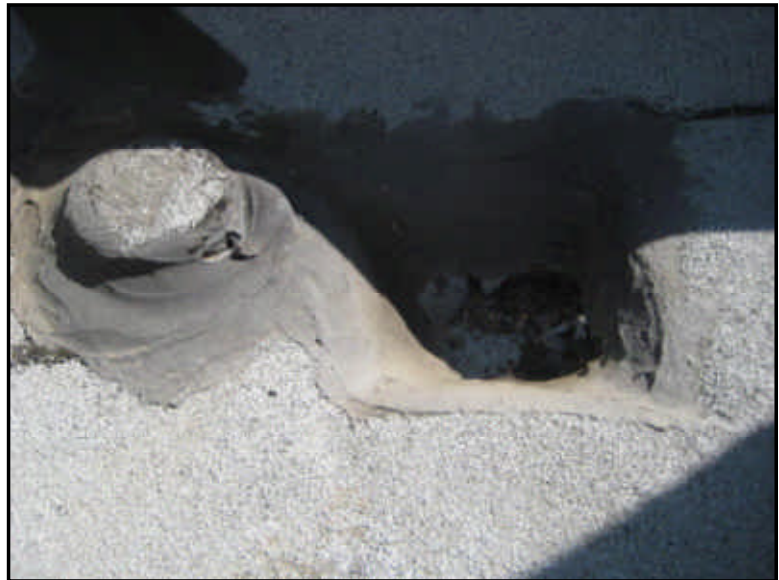
SCUPPER OR GUTTER
CONDITION:

Needs Attention, there is a drain at the front of the roof that appears to be partially clogged. Also It is noted that no secondary drains were observed. This is a standard requirement and is strongly recommended.

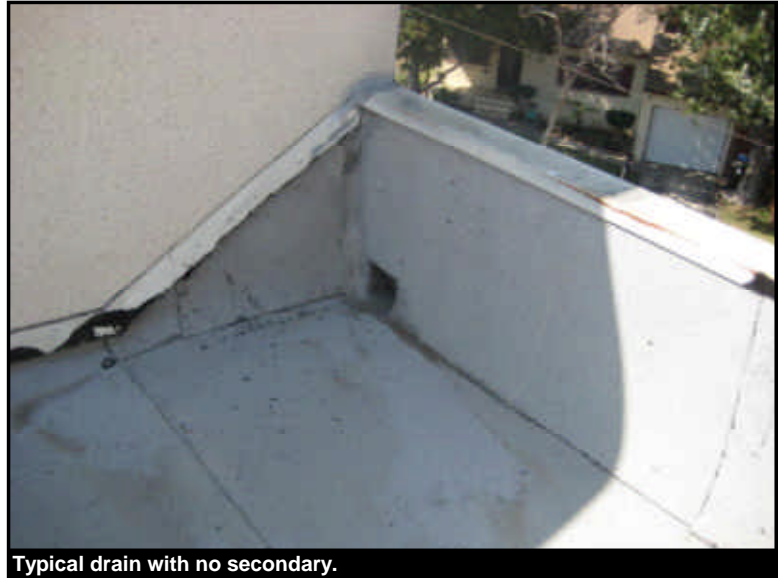
ROOF DRAINAGE:

Needs Attention: There are no secondary drains around the building.

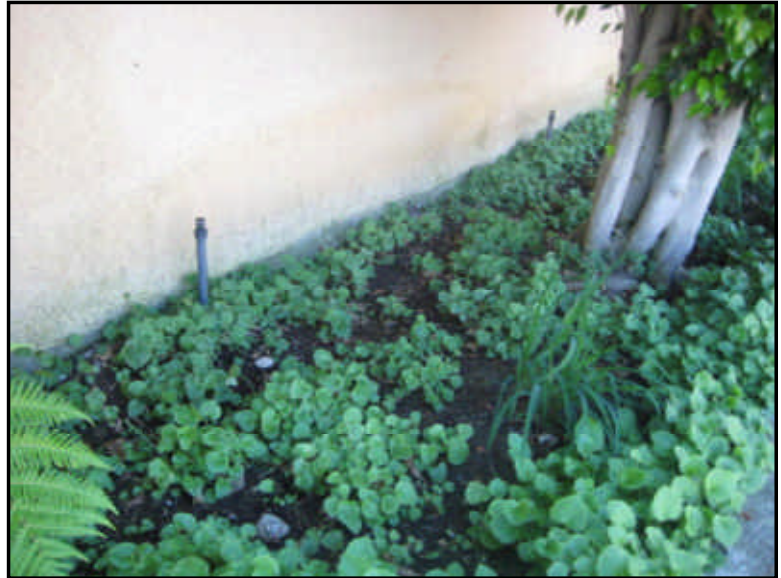
ADDITIONAL NOTES:

The water from the sprinklers appear to hit the exteriors of the building, this can cause deterioration and/or damage and moisture intrusion, water should be directed away from the structure.

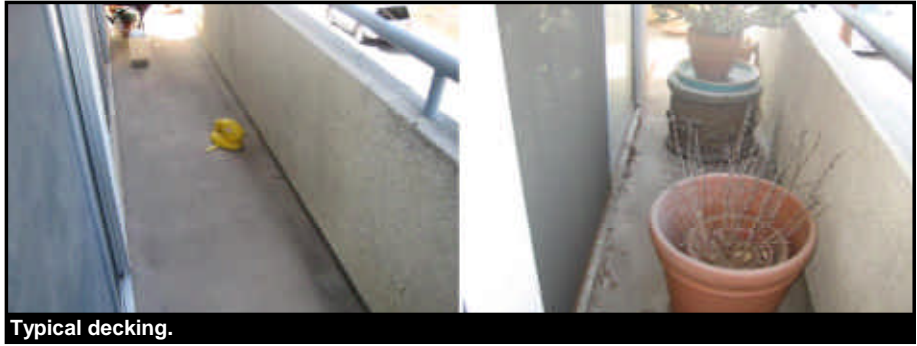
DECK CONDITION:

Typical decking.

Serviceable generally however most had personal items on them that limited the view to a large degree.

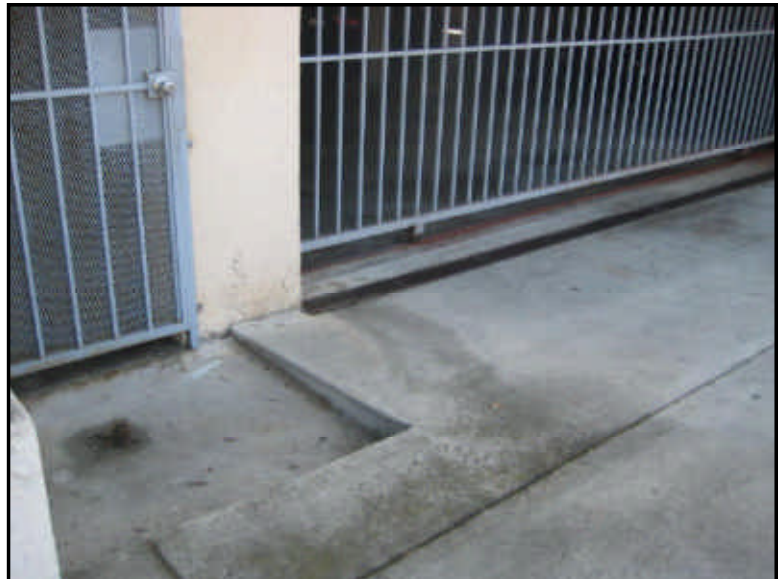
CONDITION:

Serviceable, though it is noted that there are drains in the area that are not tested as part of this inspection.

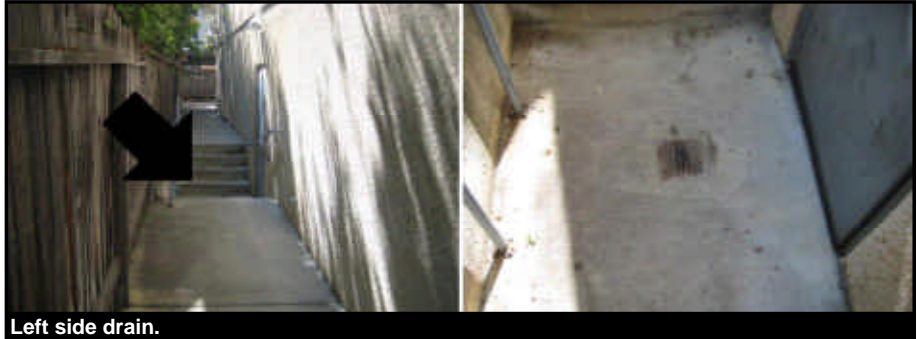
DRAINAGE
CONDITION:

Left side drain.

There were no observable defects in the grading and drainage within six feet of the building. though it is noted that there are area drains at the rear pedestrian door and the main entry garage area door that are not tested. Proper maintenance of these is advised at this time to ensure they function properly.
