RISK Assessment® Report

February 05, 2010.

17 Unit Apartment Building Long Beach, CA

Inspector - Bob Pace & Beau Gordon
Confidential and Proprietary

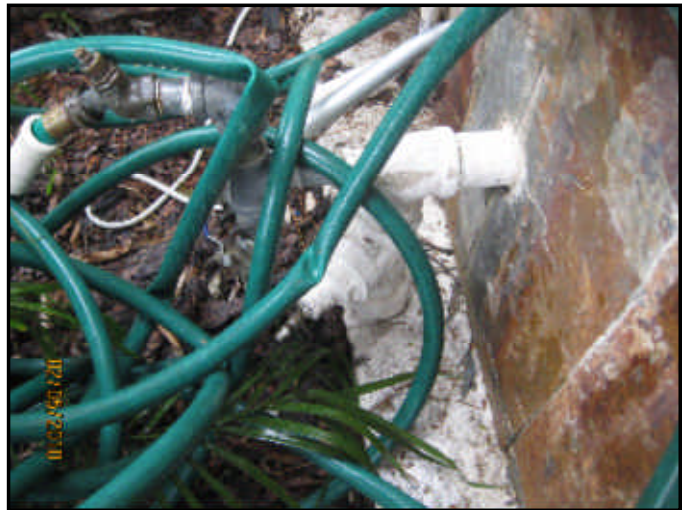
At the front of the building.

Needs Attention: It appears to be the original plumbing.

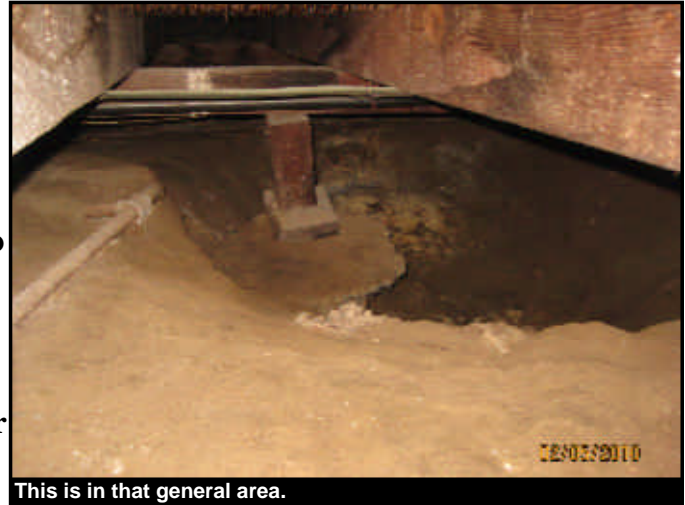
Needs Attention:
There are rusty areas on the exterior of the waste lines. It is not possible to tell when, but they will need replacing in the future as they continue to wear out.

Not Acceptable: There are areas of leaks noted under the building such as at unit 10.

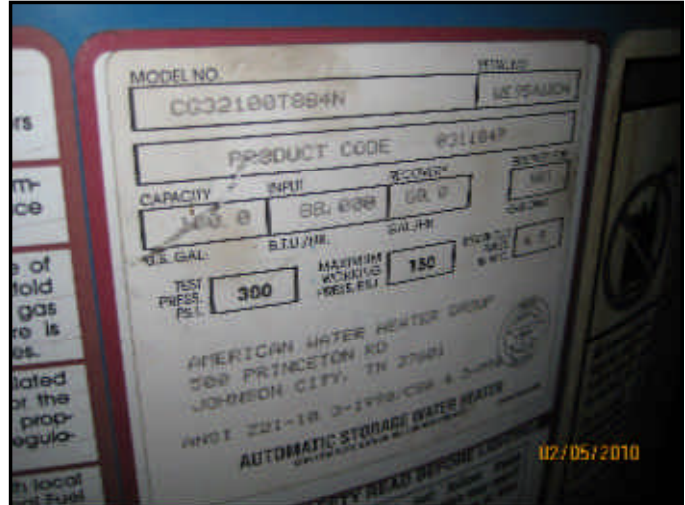
AGE: 15 years old. Water heaters have an expected life of 8 - 12 years.

CONDITION: **Needs Attention: The water heater is very old and past its expected life span. Industry standards indicate that it will need to be replaced in the near future.**

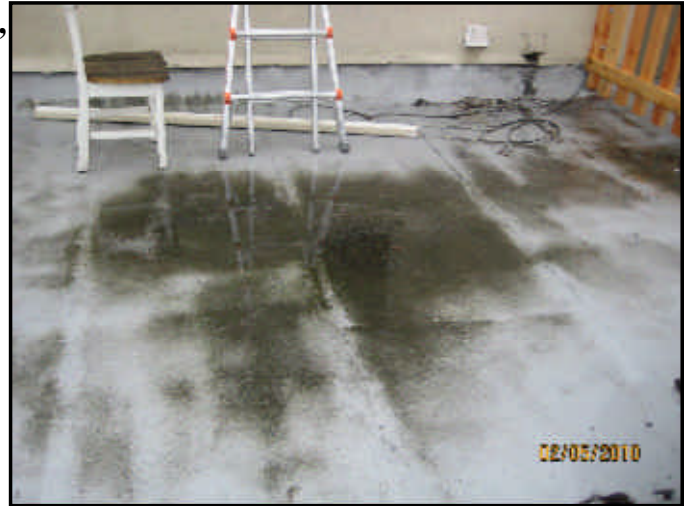
Needs Attention, on the low sloped roof, the roofing material has areas of wear, deterioration and some areas it is losing its granule surface. This sort of wear is usually an indication that the roofing

material is past the half way point of it's expected useful life. there are signs of standing water from the past from discoloration noted in more than one location. It is noted there are areas of the roof that have had patching and or repairs done to them. This is usually an indication that there have been leaks and past issues. It is advised to have full disclosure by the seller as to the history of any roof leaks.

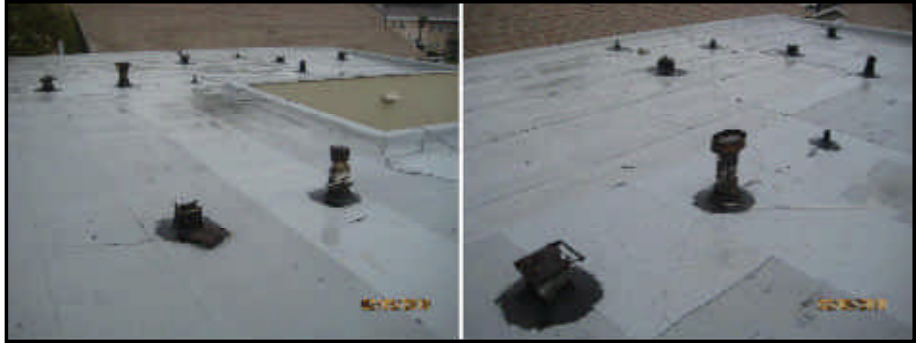
Not Acceptable, there are numerous missing weather cap covers.

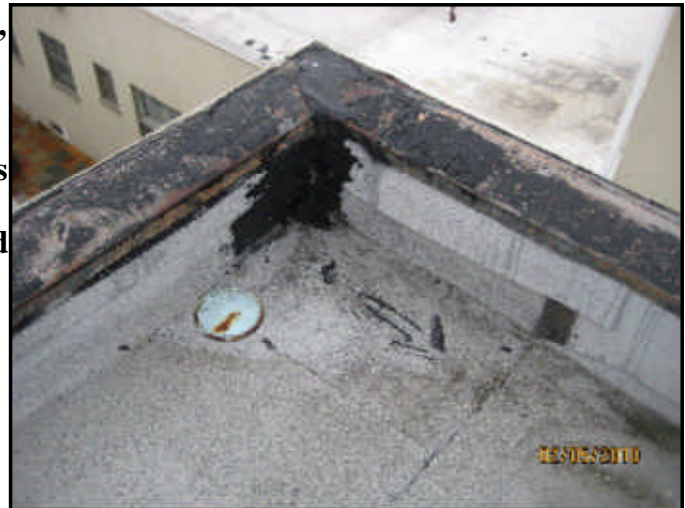
**Needs Attention,
It is noted that
no secondary
drains were
observed. This is
a standard
requirement and
is strongly
recommended.**

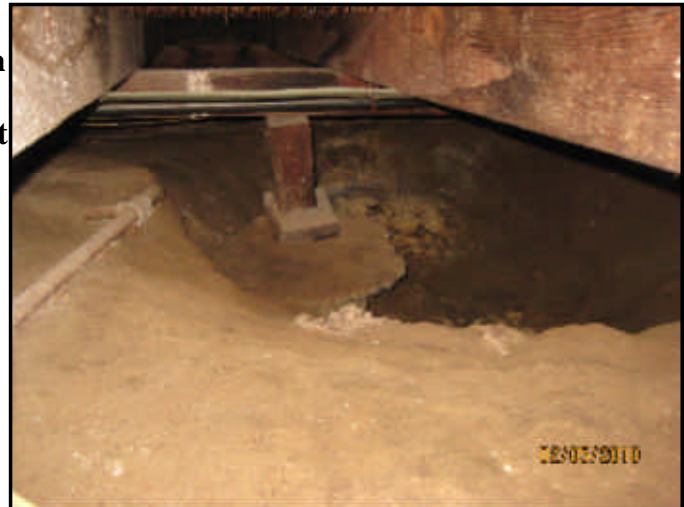
Not Acceptable there is a section under the site near unit 10 that is wet and sunken. Some leaking is noted under unit 10.

<p>Some repairs are needed to areas under the building such as under unit 10 where some of the supports have been undermined. That appears to be best done by a foundation specialist.</p> <p>Further repairs may be recommended during a full review by a qualified foundation specialist however these do not appear to be mandatory at this time.</p> <p>3. What costs are expected over the next five years for the Structural System:</p> <p>Accurate estimates can only be determined after a full evaluation is done by the proper specialist and a detailed recommendation has been completed and reviewed by a qualified contractor. Expected costs for the above mentioned repair is approx. \$2,000 - \$3,000</p>	<p>TOTAL:</p> <p>\$2,000 - \$3,000</p>
--	--

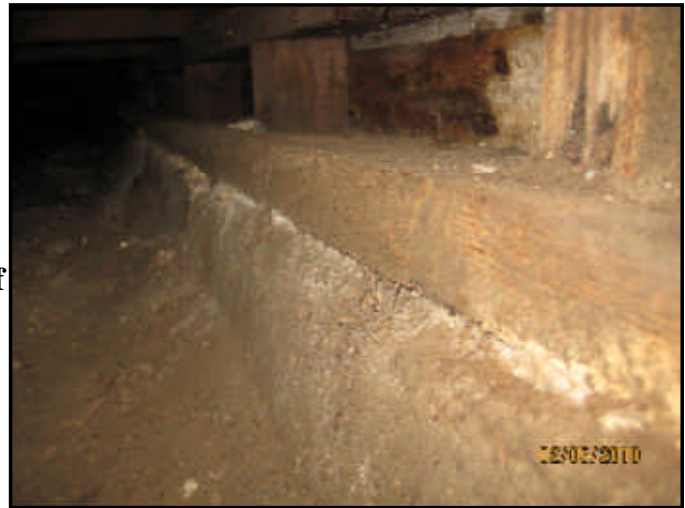
Serviceable, though it is noted that some areas of deterioration are noted such as at the exposed edges of the foundation.

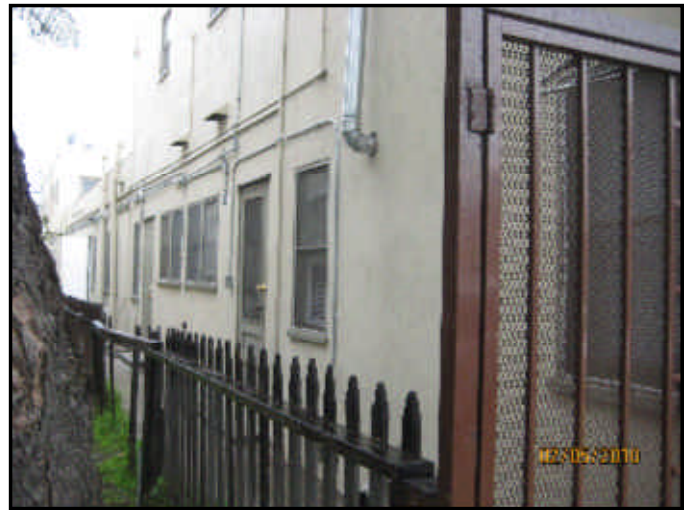
CONDITION: Serviceable overall, There is typical cracking in the exterior walls.

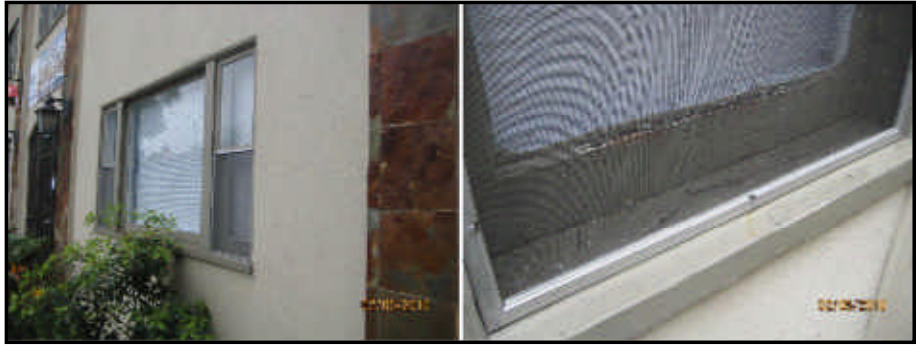
Needs Attention, there are areas of deterioration to the exterior of the windows such as around some of the edges. These are aged and worn for the most part.

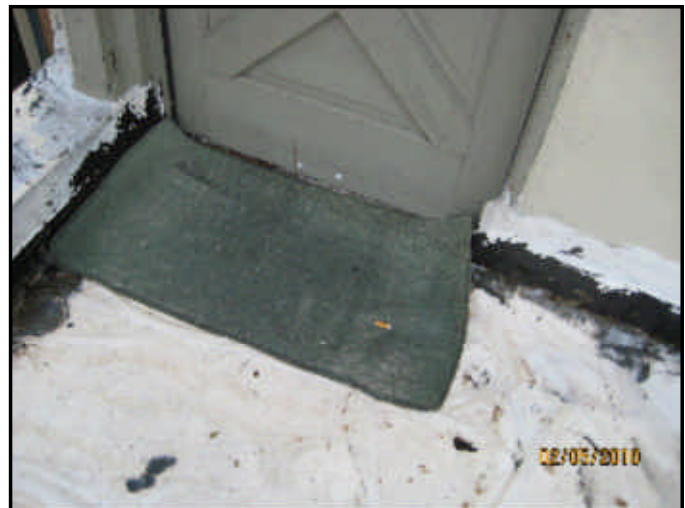
DECK CONDITION: Needs Attention, the deck has roofing material installed that is not suitable for foot traffic.

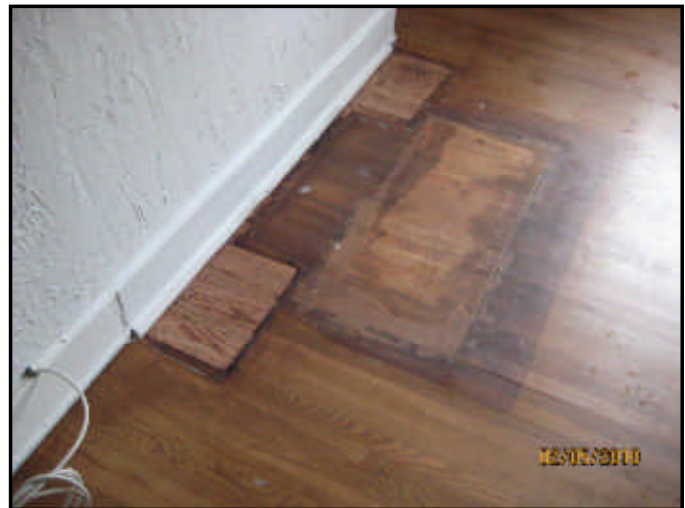
Needs Attention: The wood flooring has been patched in various locations.

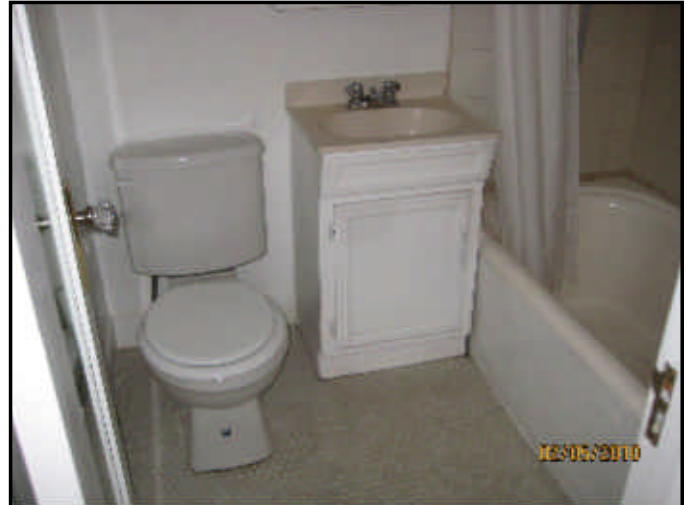
Needs Attention: While the restroom is generally serviceable, there are areas with excessive wear.

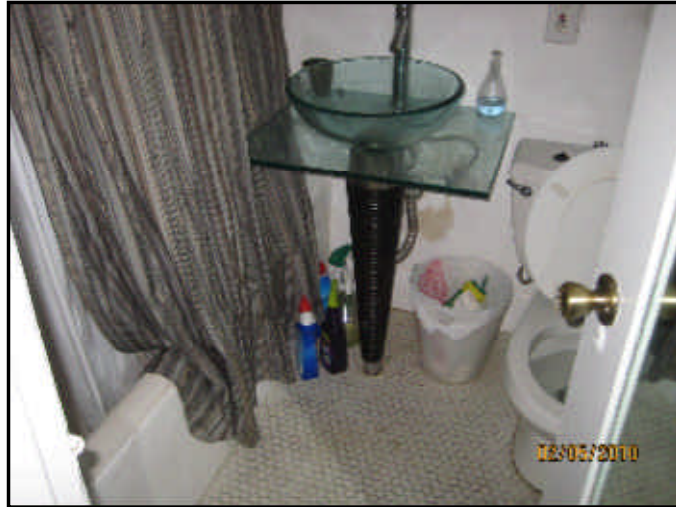
Needs Attention: While the restroom is generally serviceable, there are areas with excessive wear. The sink has been updated.

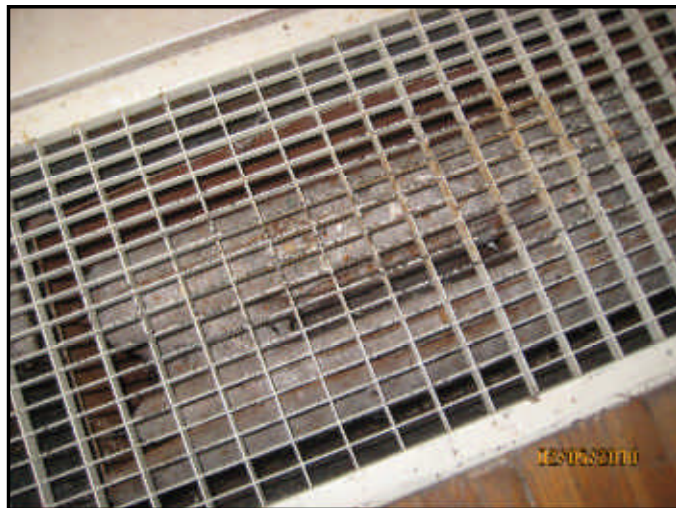
Needs Attention: The gas wall furnace does not appear to be being used. The pilot was off.

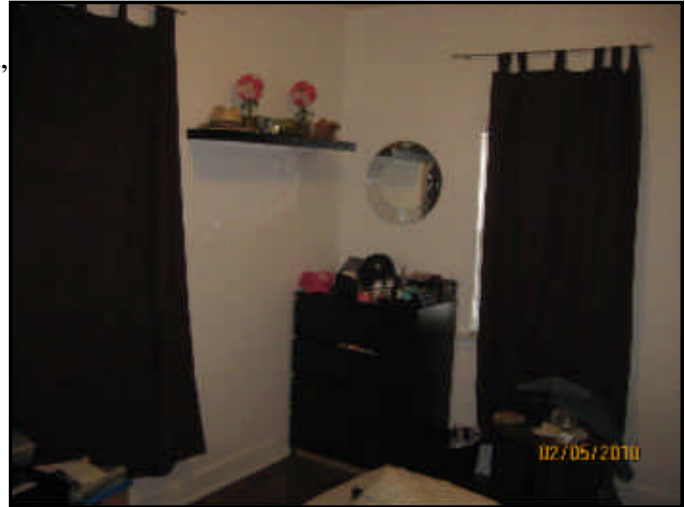
Needs Attention: There are areas of moisture stains and/or damage on the ceiling.

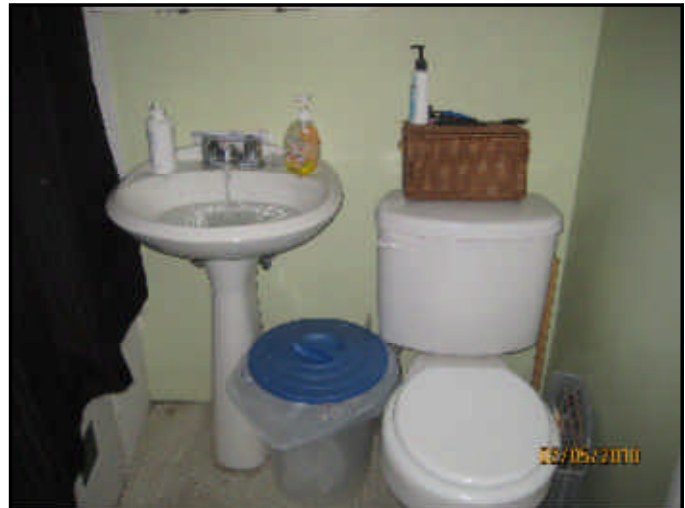
Needs Attention: The sink drains slowly.

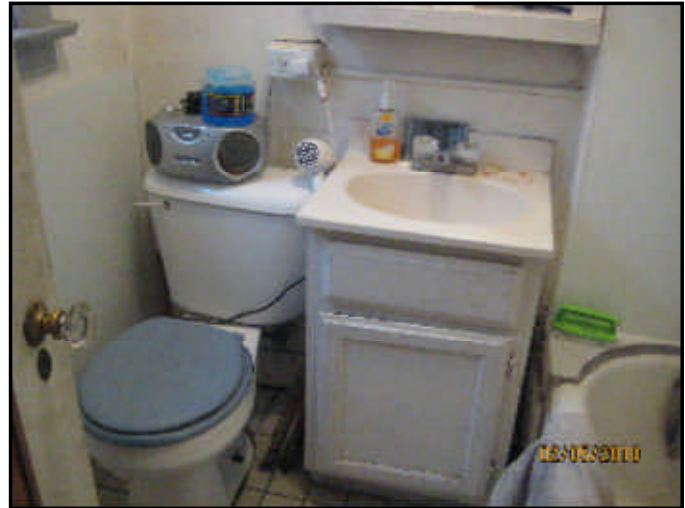
Needs Attention: The sink drains slowly.

Needs Attention: The toilet is damaged.
