# **RISK Assessment® Report**

January 28, 2010.

## **Industrial Customer**

**Moorpark, CA 93021**

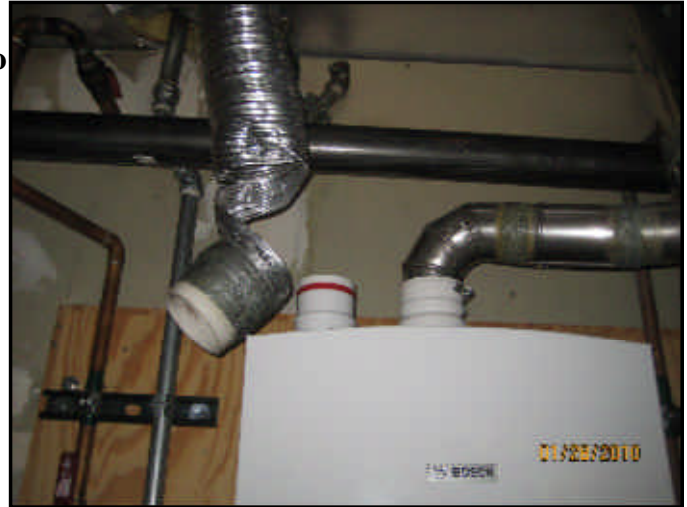
**Not Acceptable:**  
**What appears to be the combustion air line is disconnected.**

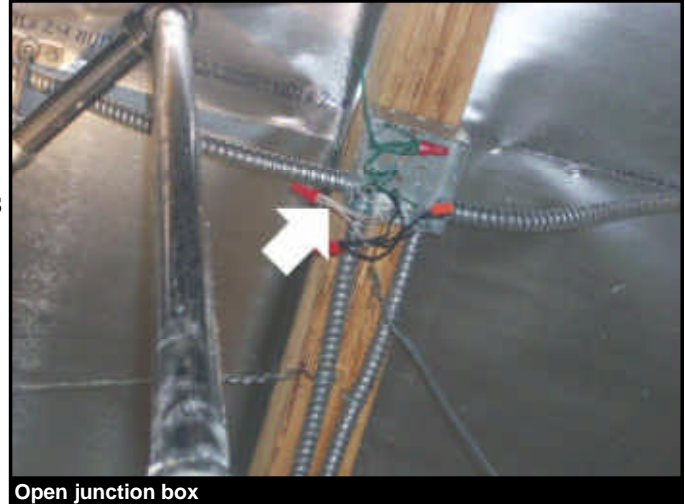
WIRING CONDITION: **Serviceable overall however there are open junction boxes with wires exposed, such as in a small office at the left of reception. These need to have covers installed over them.**

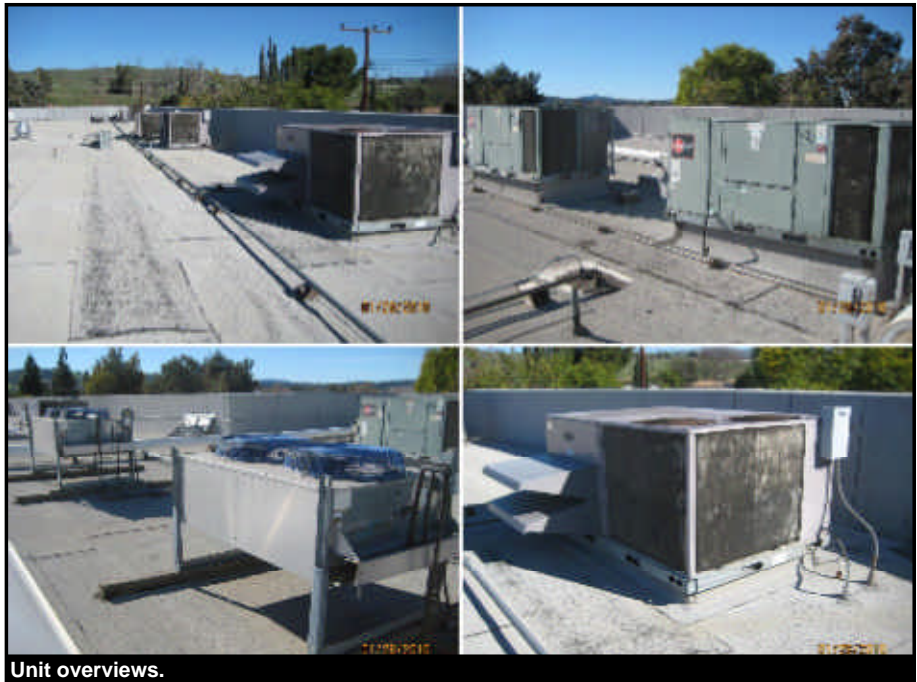
Unit overviews.

**Needs Attention , for sixteen (16) the units are aged and worn. Though they may be nearing the end of their expected useful life and still functional it is noted that this type of unit has a life expectancy of approx. 15 - 20 years, depending on the quality of maintenance , and these units are nearing this age.**

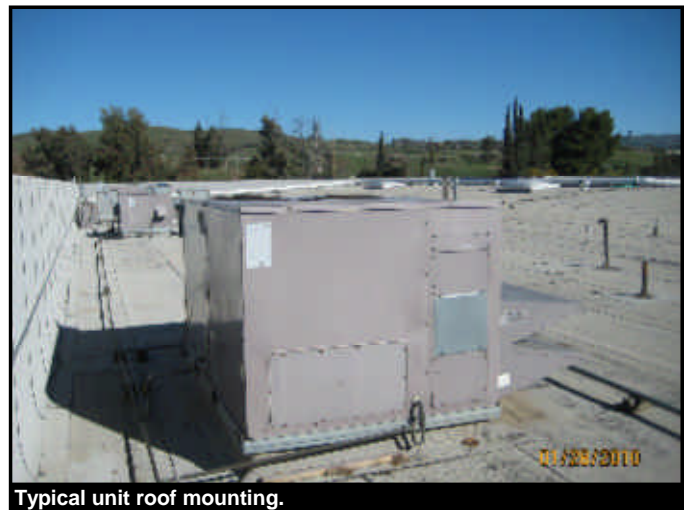
Typical unit roof mounting.

There are two cooling units it is advised to have metal caps installed on approved platforms to help prevent moisture intrusion.

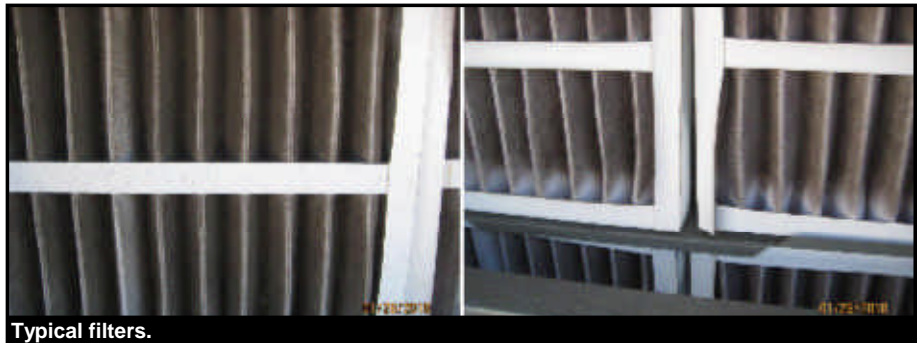
**Needs Attention, four units were opened and the filters examined. Three were found to have filters in need of being changed.**

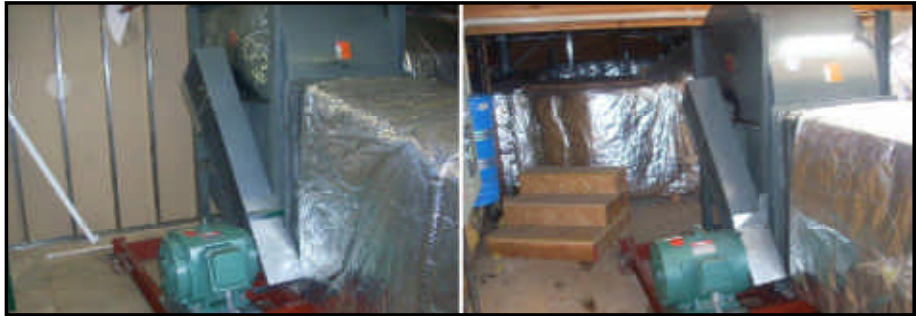
**High volume fans appeared serviceable**

It is noted that there are three high volume fans providing additional air to the air conditioning systems, located on the mezzanine level. These were operating at the time of inspection and appeared to be maintained and generally serviceable.

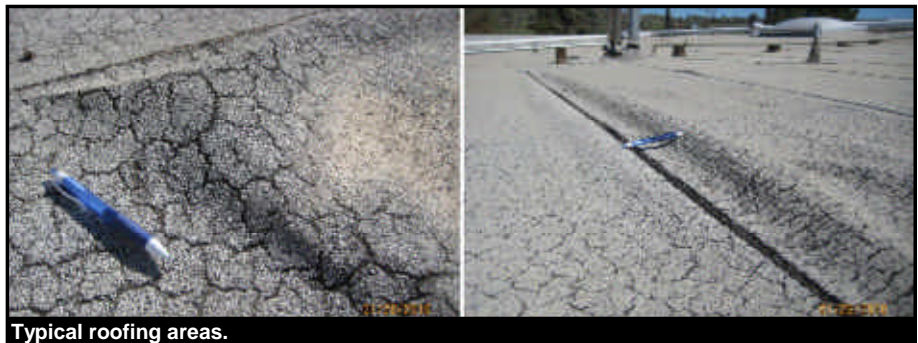
Typical roofing areas.

**The roof is showing excessive bubbling and deterioration. Extensive repairs/replacement is needed at this time to ensure a leak free condition.**

Other than the recommended repairs to the bubbles on the roof expect to pay approx. \$45,000 - \$65,000 for a "Cool Roofing" System. For a complete removal and install of a new roofing system expect to pay from \$100,000 - \$130,000.	<b>TOTAL:</b> <b>\$50,000 - \$130,000</b>
---	--

**A licensed roofing contractor should examine the roof and make all needed repairs (or replacements) to ensure a long lasting leak free condition. The roofing contractor may find more problems with the roof. It is for this reason it is being referred to a specialist, as he can determine all the problems and give an accurate estimate of the costs involved.**

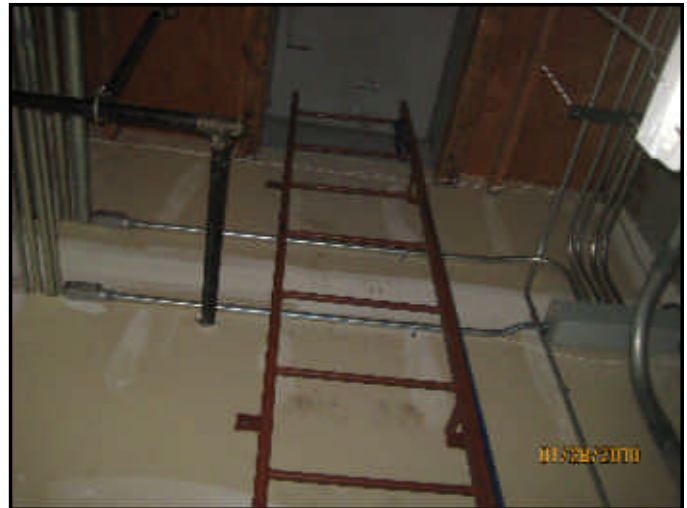
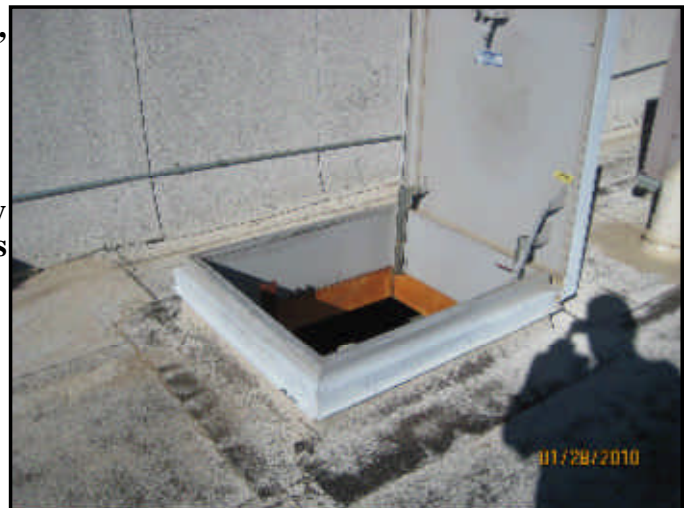
**Needs Attention,  
The roof access is not up to current OSHA standards in regards to safety for such items as proper height and style of Grab Bars.**

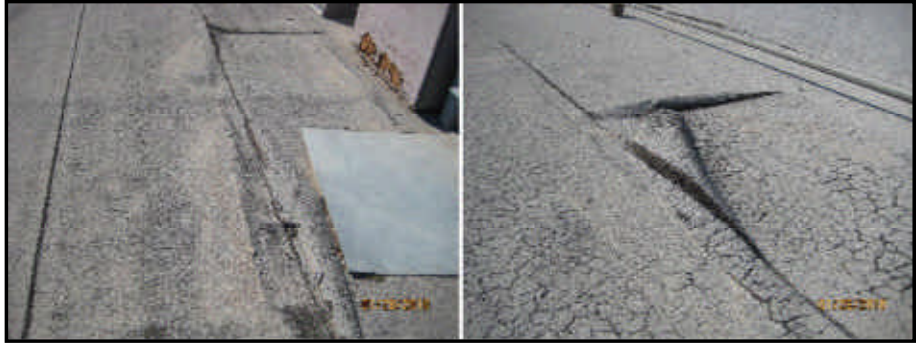
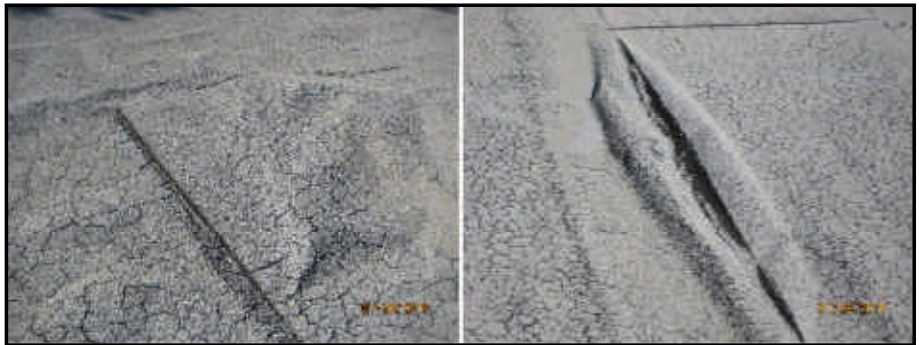
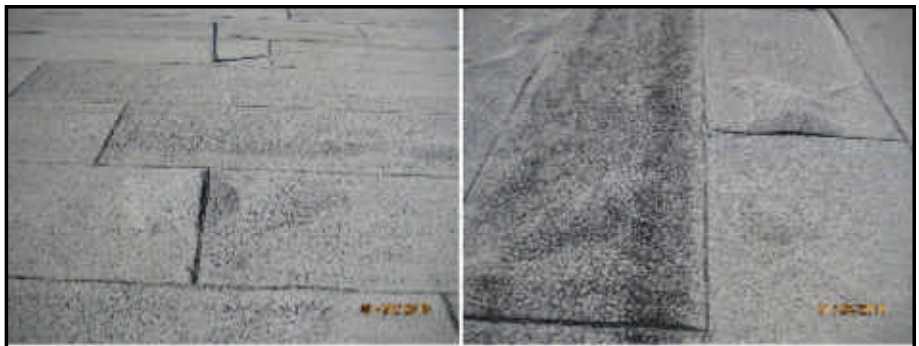
**Not Acceptable, on the low sloped roof, there are excessive bubbled areas of roofing material. This is often an indication that the material was not properly installed or some moisture has gotten under the material.**

**There are sections of the roofing system that are no longer a reliable moisture barrier.**

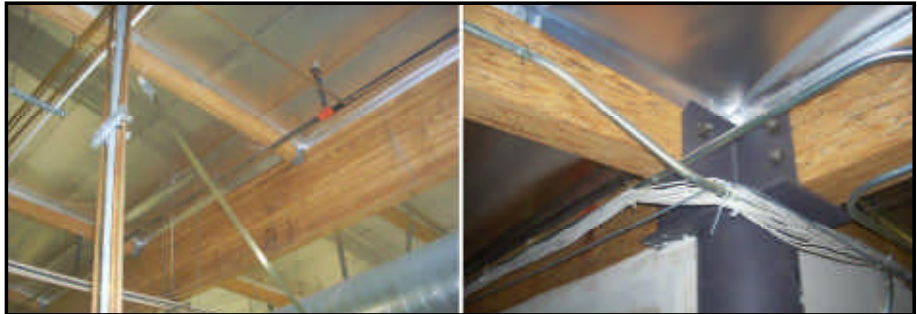
View of beams and cross supports

Serviceable, however the view is limited, and there are areas of past stains to the wood members.

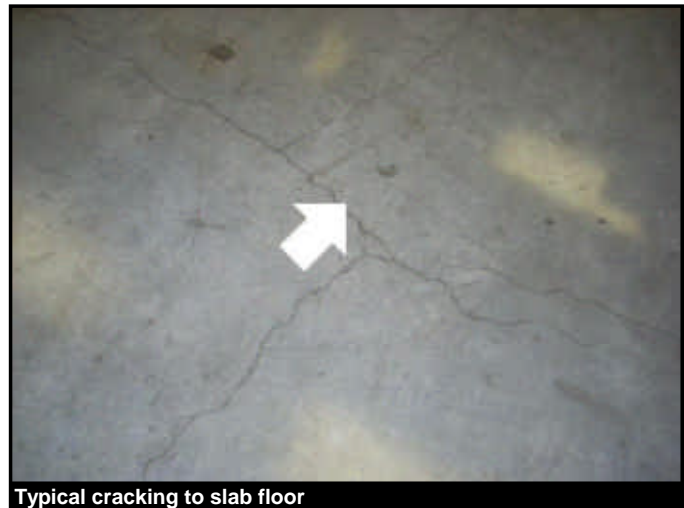
There are cracks in the slab that appear to be typical for the age and style of construction. However if you need a more detailed evaluation it is advisable to contact a structural engineer or a foundation specialist.

Typical cracking to slab floor

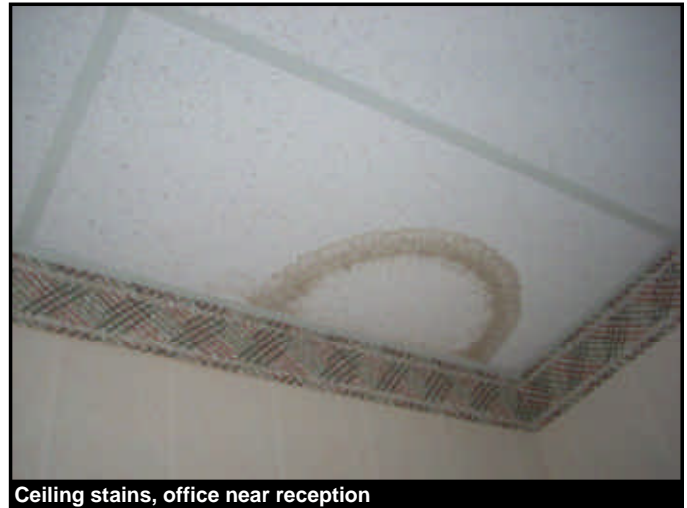
Needs Attention:  
There are a number of office areas in the building with evidence of moisture intrusion at the ceilings, such as the office on the left side right off the reception area.

Ceiling stains, office near reception

GENERAL COMMENTS: **There are several signs of moisture intrusion in the building. This is viewed as a concern and should be pursued so that all active sources of moisture entry are corrected.**

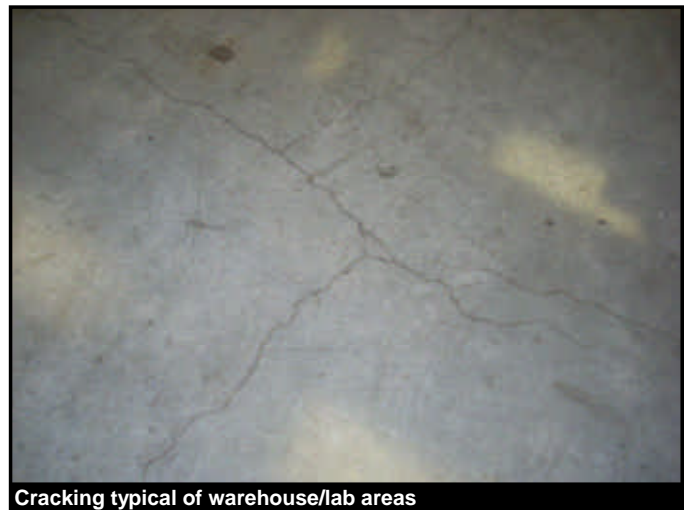
It is noted that warehouse and lab areas have no finish flooring and these areas show typical signs of cracking and minor wear.

**Cracking typical of warehouse/lab areas**
