RISK ASSESSMENT[®]

ADDRESS: Cerritos, CA

CLIENT: TFP Investments

RISK Assessment[®] Report

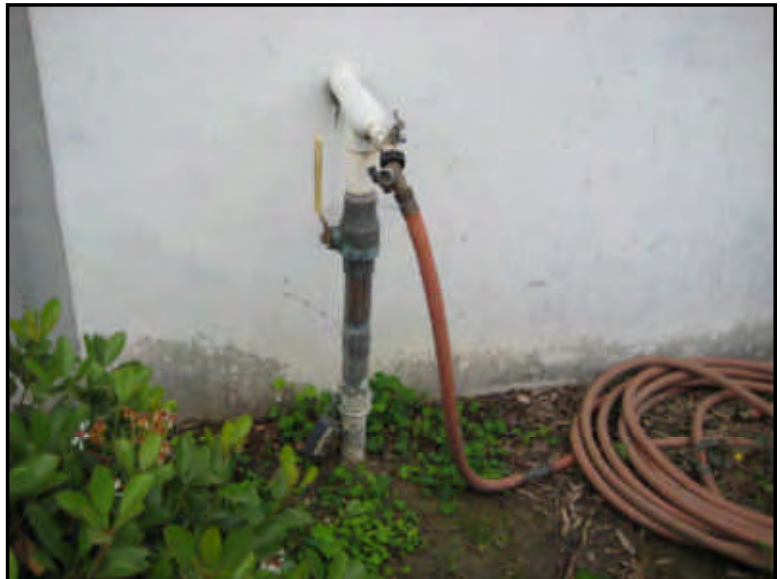
MAIN WATER SHUT
OFF LOCATION:

In the front of the building.

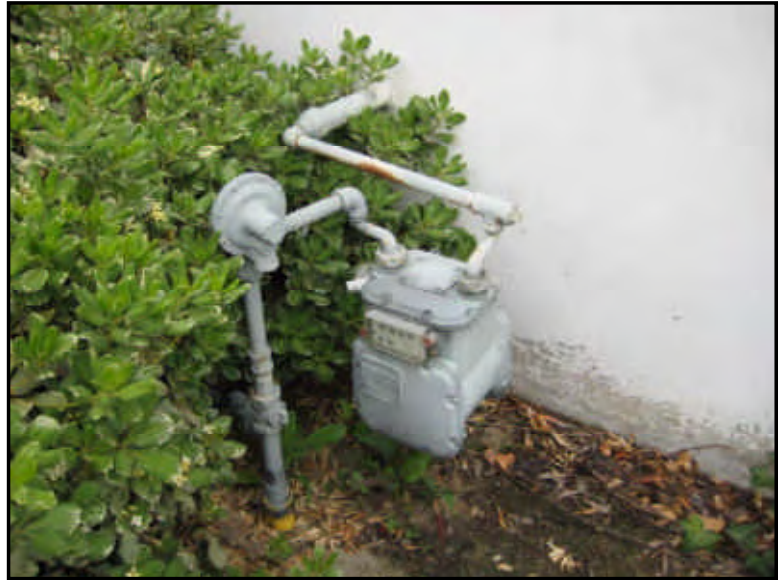
**GAS METER
LOCATION:**

The gas meter was located on the right side of the building near the front.

It is advised to have the gas provider inspect the gas system to determine its condition and check all the gas appliances and fixtures. This is usually a free service.

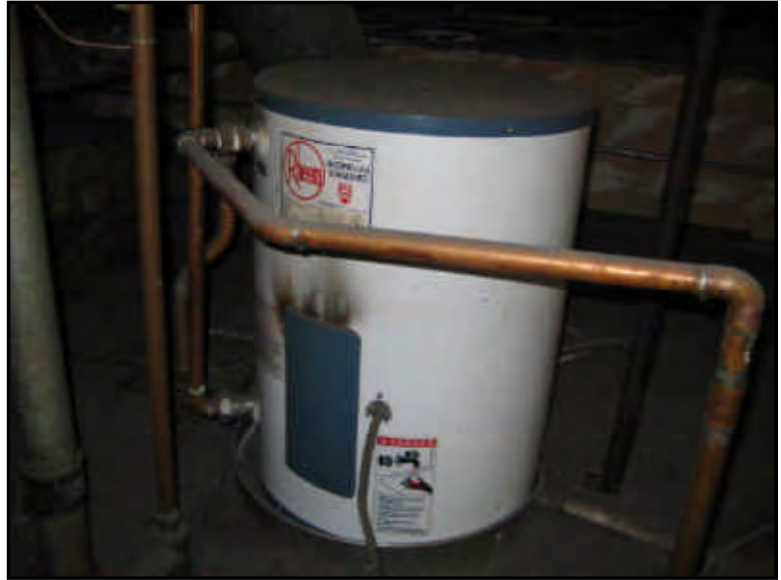
LOCATION:

Over the bathroom near the roof access ladder.

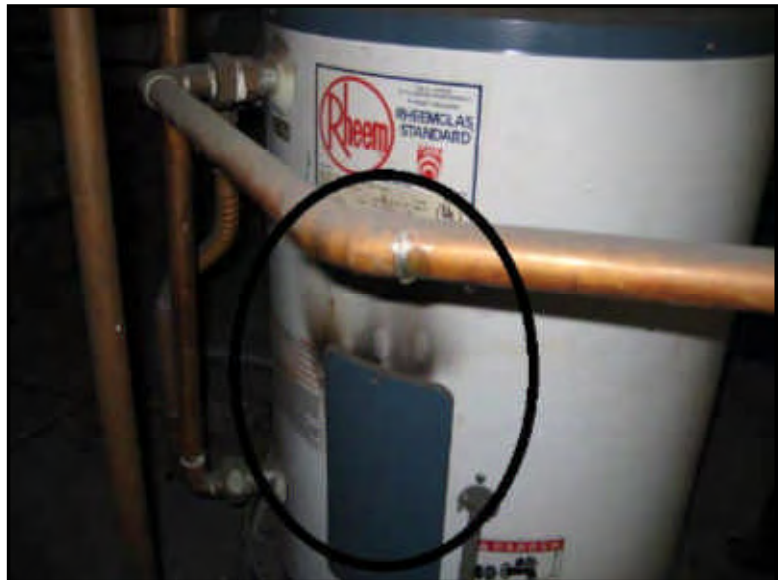
CONDITION:

17 years old. Water heaters have an expected life of 8 - 12 years.

Needs Attention, there is scorching on the exterior of the water heater. The reason this occurred is not known as it was not doing it during this inspection but it has occurred in the past. Also the water heater is very old and past its expected life span. It may need to be replaced soon.

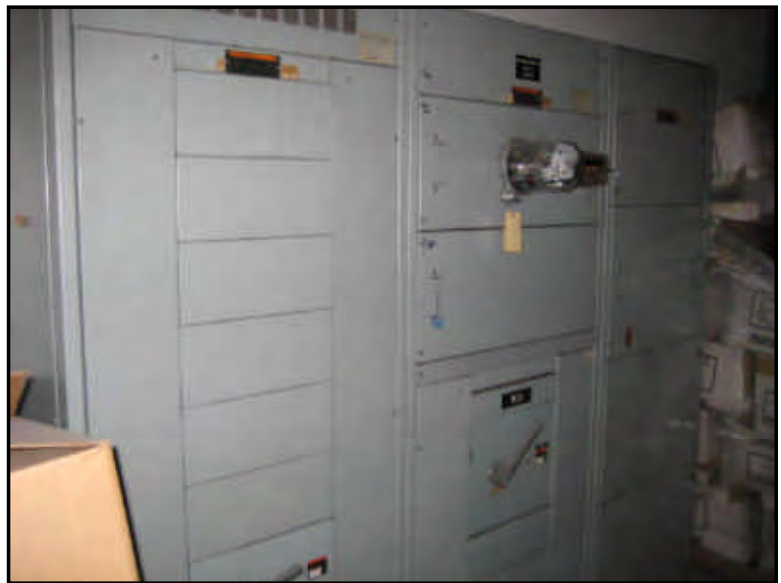
TYPE OF ELECTRICAL SERVICE:

400 Amp. This is a 3 Phase 4 Wire system. The electricity is supplied by an underground line.

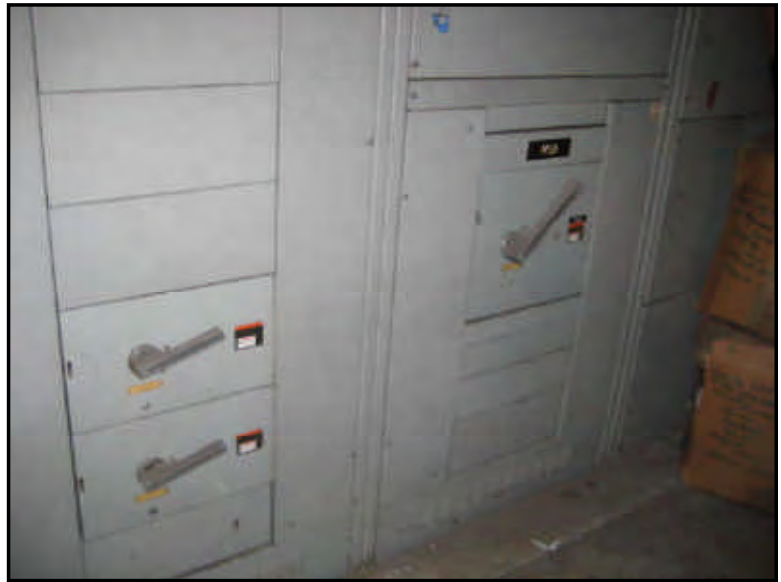
TYPE OF CIRCUIT
PROTECTION DEVICE:

The shut off device is a disconnect lever.

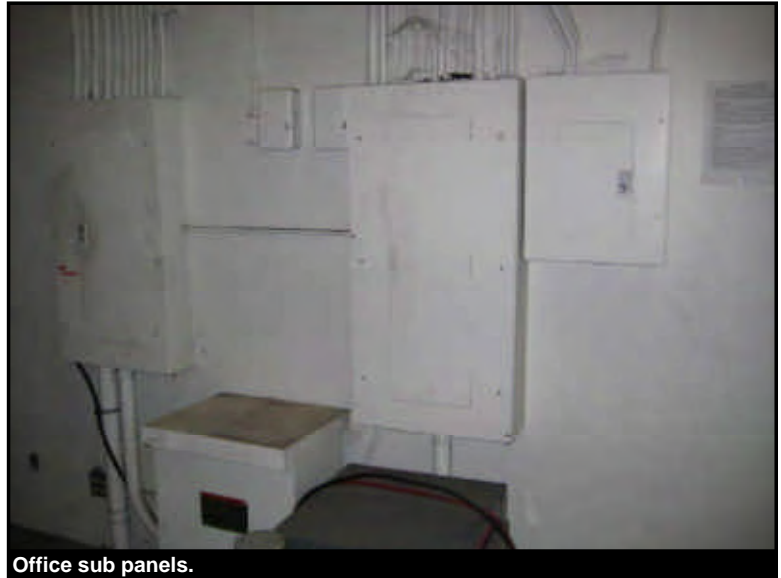
SUBPANEL
LOCATION:

There is an electrical subpanel in more than one location such as at the rear of the office space.

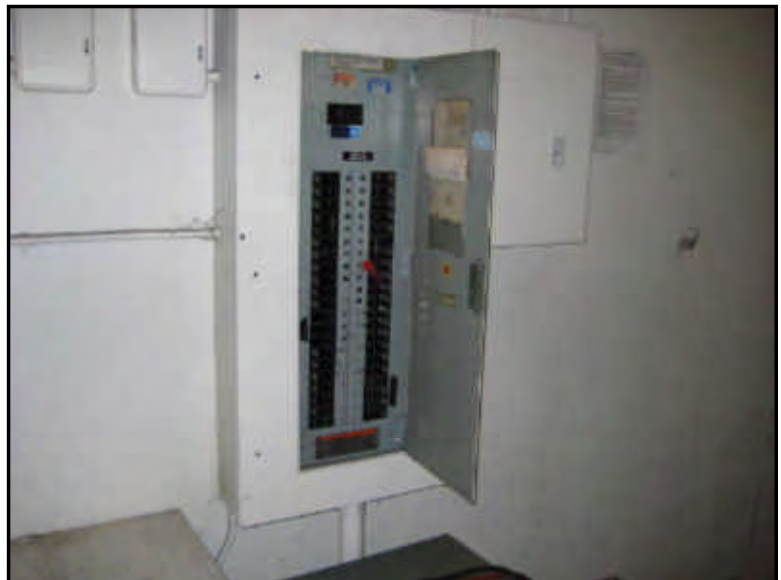
SUBPANEL
CONDITION:

Serviceable.

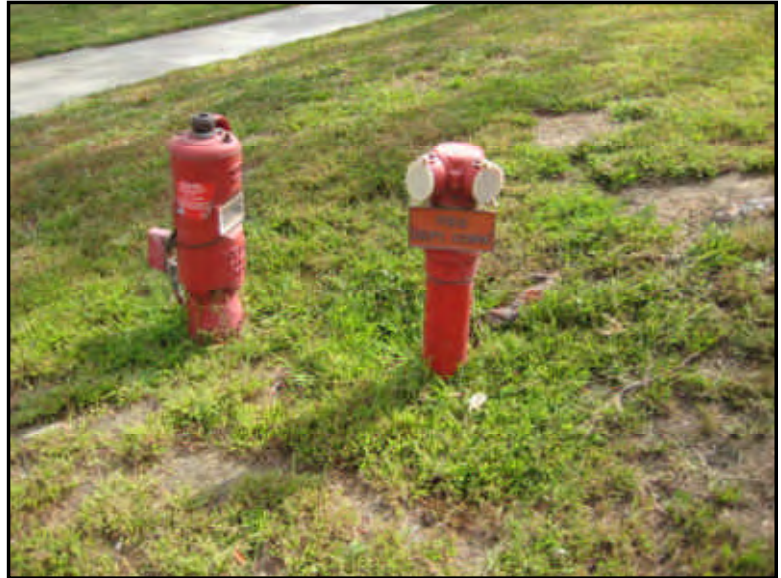
FIRE SUPPRESSION SYSTEMS:

There is an interior fire suppression system in the unit. This is not tested as part of a general visual property inspection.

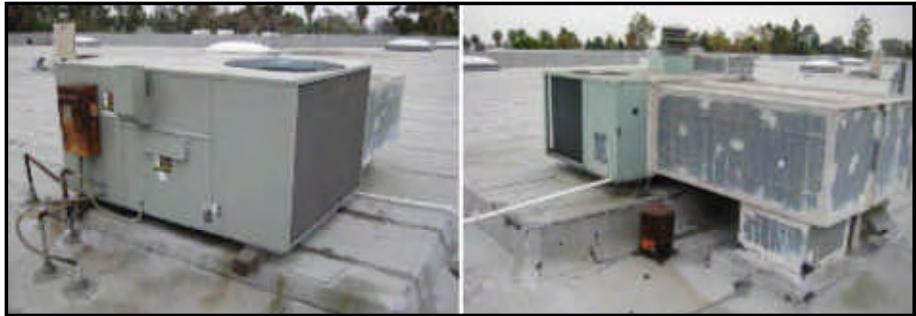
LOCATION
CONDITION:

Typical units on blocks.

Needs Attention, Three of the 6 units are sitting on wooden blocks. This is not a reliable method regarding moisture intrusion. It is advised to have platforms with metal caps installed to help ensure a leak free condition.

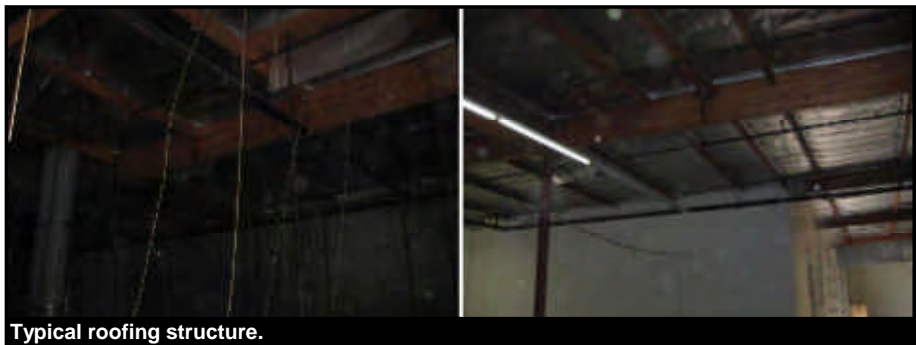
TYPE OF ROOF
FRAMING:

The roof is supported by structural beams and cross supports.

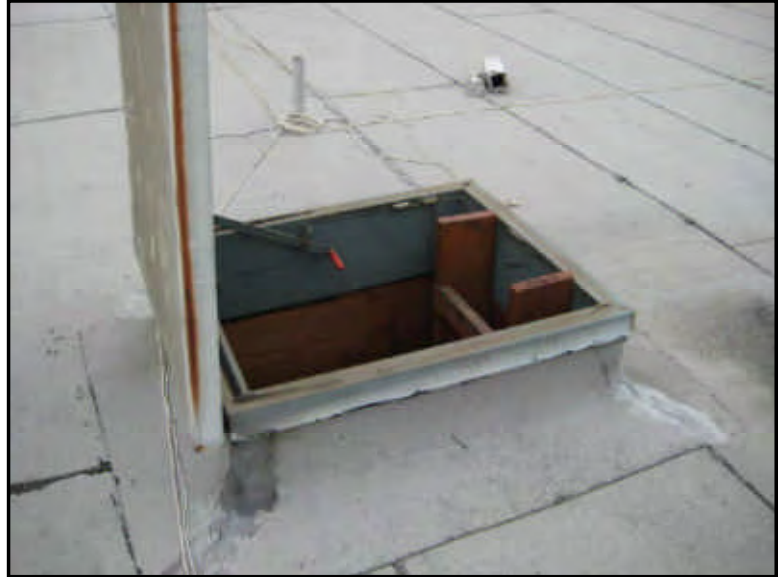
ACCESS TO ROOF:

Access to the roof is via a ladder that is accessed inside the building.

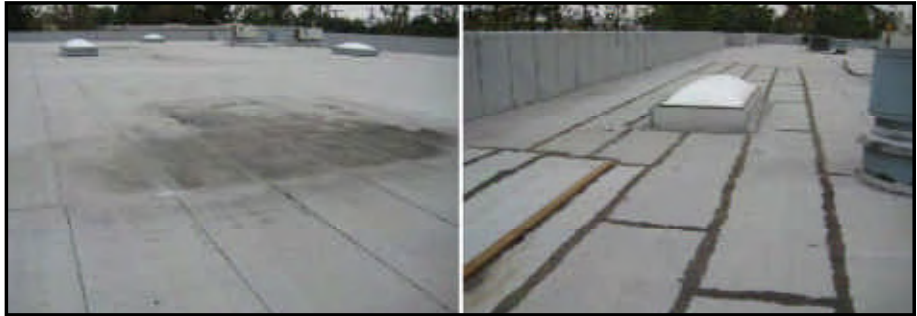
**ROOF COVERING
STATUS:**

Flat area left and patched area right

Needs Attention, on the low sloped roof, The roof does not have the recommended 1/4" per foot slope in it to allow water to run off properly during rains in all areas. It is advised to increase the slope on the roof to the recommended 1/4" per foot in those areas however this may not be practical do to expense. Review by a roofer at this time is advised. It will be very important that the roof has regular maintenance to help ensure a a leak free condition. This is noted mainly in the center of the roof.

Also on the low sloped roof, It is noted there are areas of the roof that have had patching and or repairs done to them at the right front corner. This is usually an indication that there have been leaks and past issues. It is advised to have full disclosure by the seller as to the history of any roof leaks.

The roof is in need of maintenance at this time. It is advised to have a roofer examine the entire roofing and drainage system and make any needed repairs or do any maintenance functions needed to help ensure a leak free condition at this time.

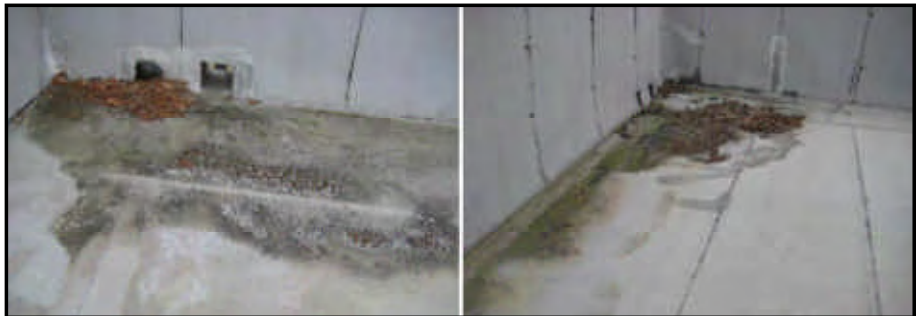
Debris around drains.

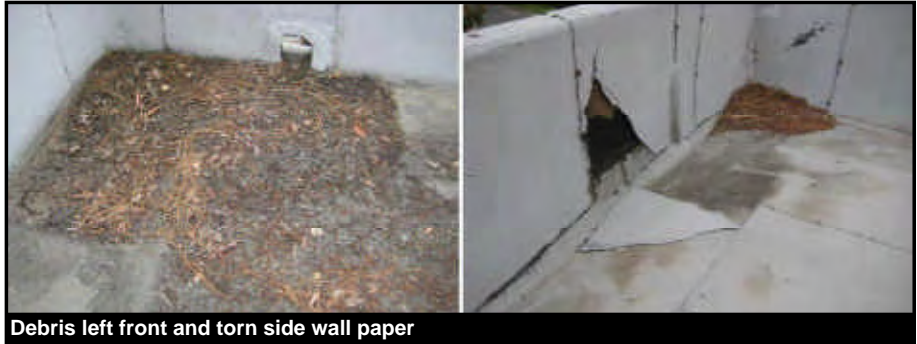
Debris left front and torn side wall paper

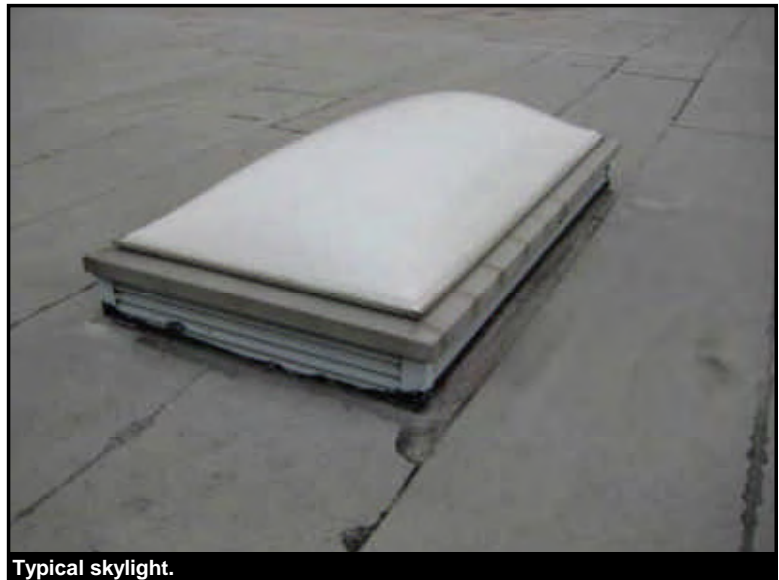
SKYLIGHTS:

Typical skylight.

Serviceable.

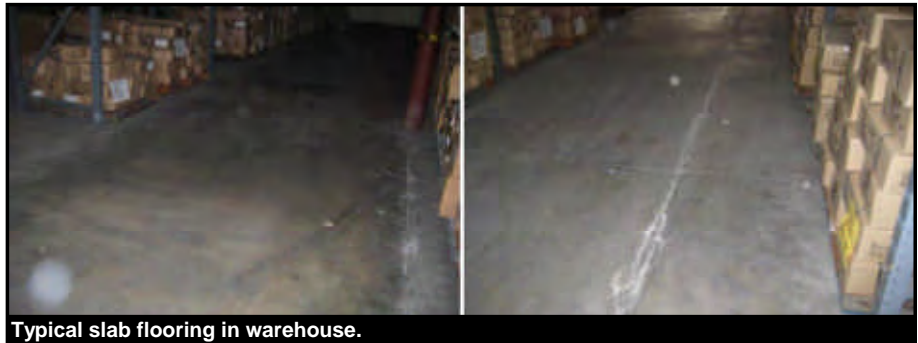
SLAB ON GRADE COMMENTS:

Typical slab flooring in warehouse.

There are cracks in the slab that appear to be typical for the age and style of construction. However if you need a more detailed evaluation it is advisable to contact a structural engineer or a foundation specialist.

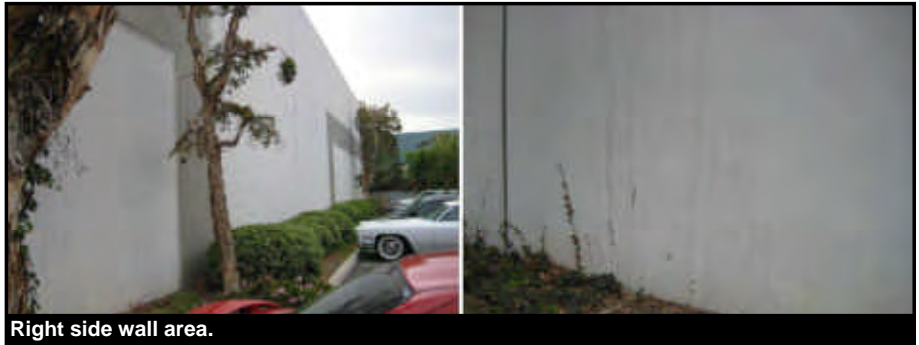
Right side wall area.

Serviceable however there is typical cracking in the exterior walls.

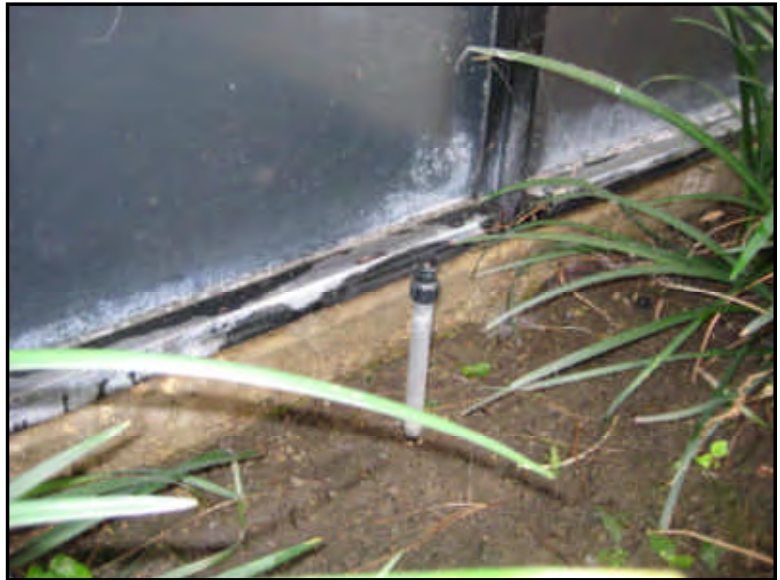
ADDITIONAL NOTES:

The water from the sprinklers appear to hit the exteriors of the building, this can cause deterioration and/or damage and moisture intrusion, water should be directed away from the structure.

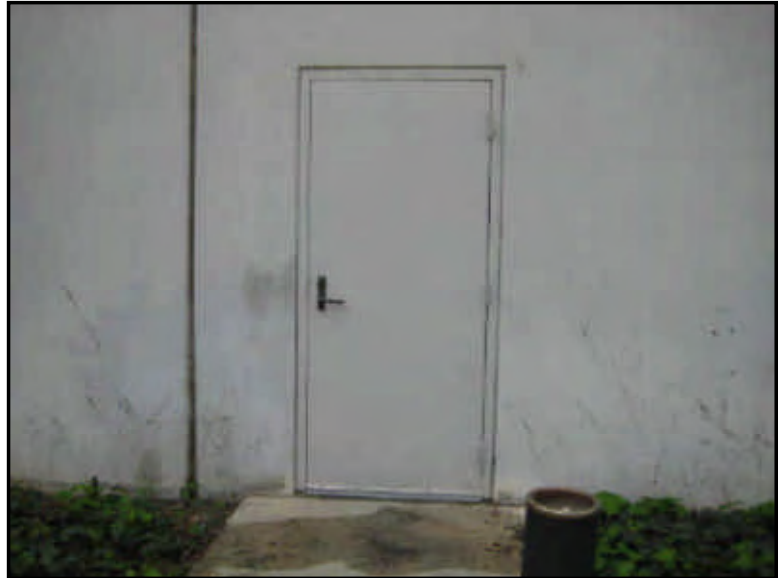
Serviceable overall.

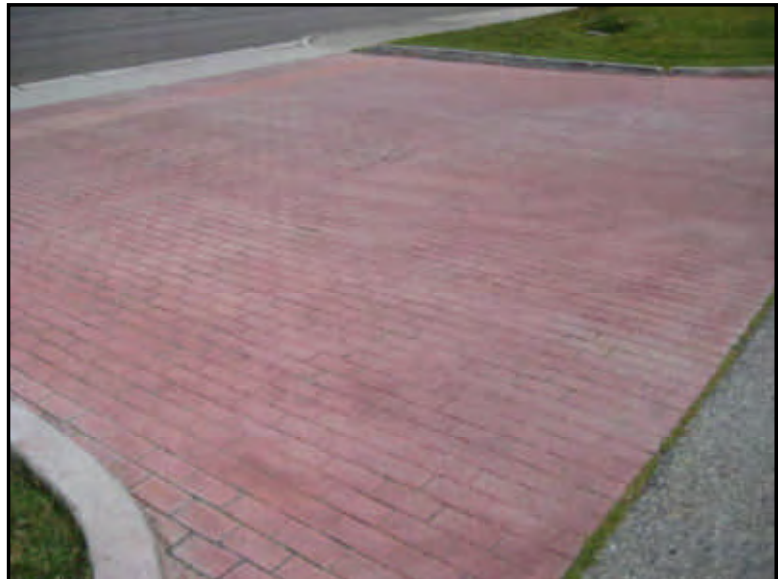
DRIVEWAY:

Serviceable.

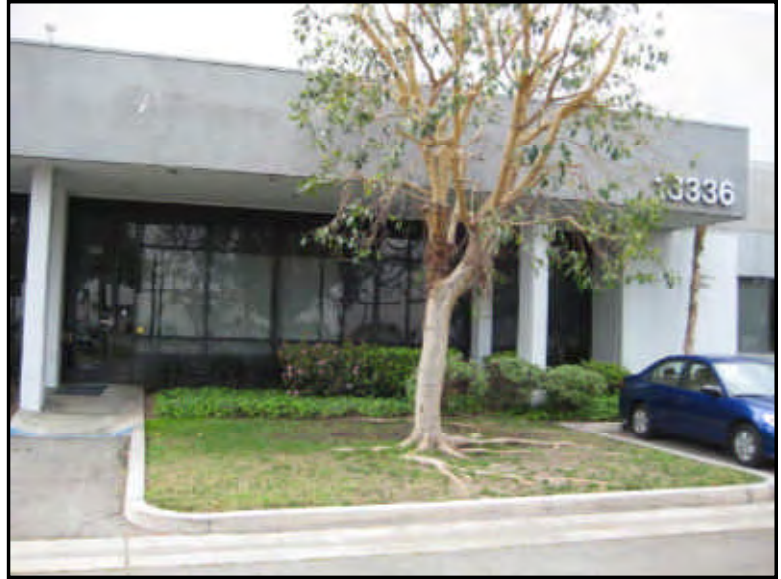
FRONT ENTRY:

Serviceable.

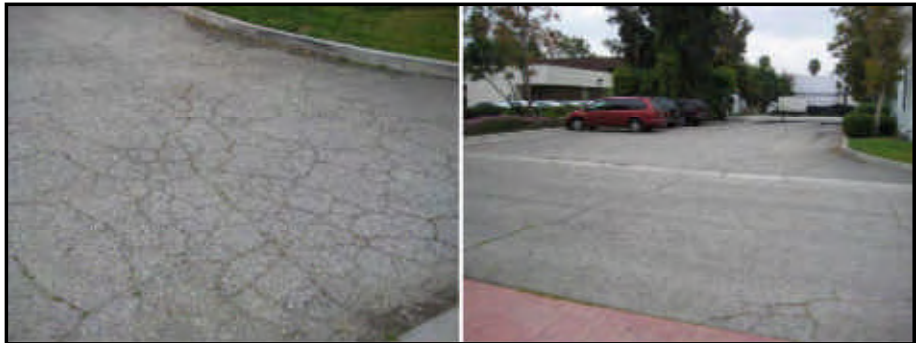
DRIVEWAY:

Needs Attention, The parking areas are in need of being resealed and restripped in the front and left sides. The left side rear area is concrete and appears to be serviceable for the most part.

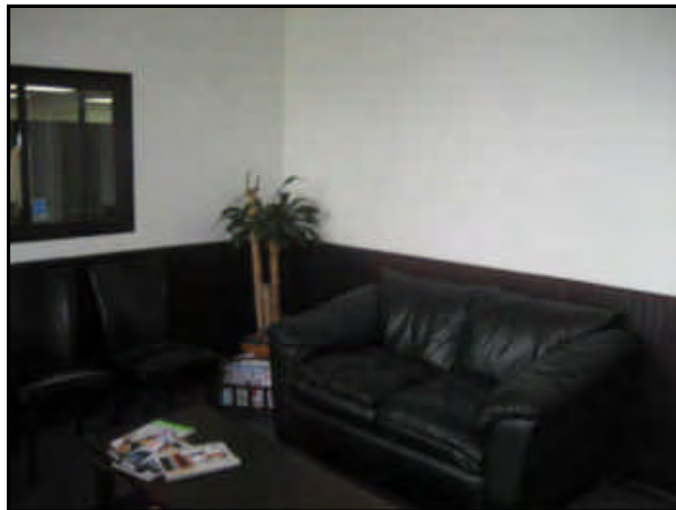
LOBBY

Serviceable.

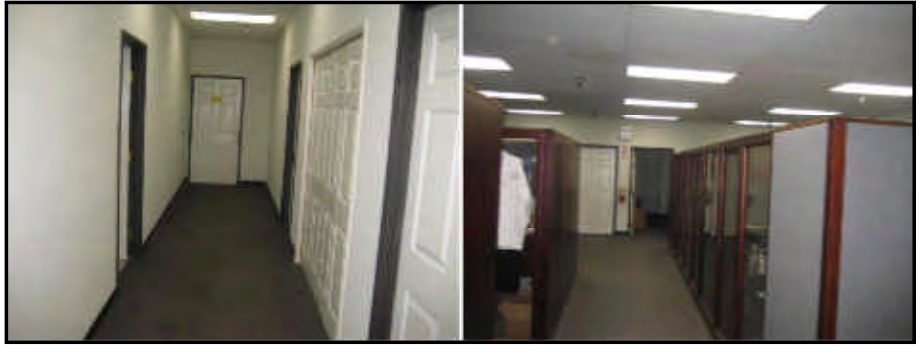
HALLS:

Serviceable.

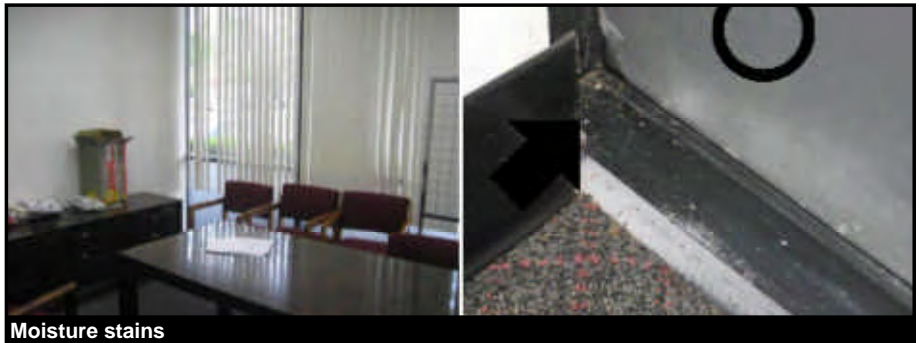
Moisture stains

Needs Attention: There are moisture stains at the base of the window in the conference room in the office area near the front door.

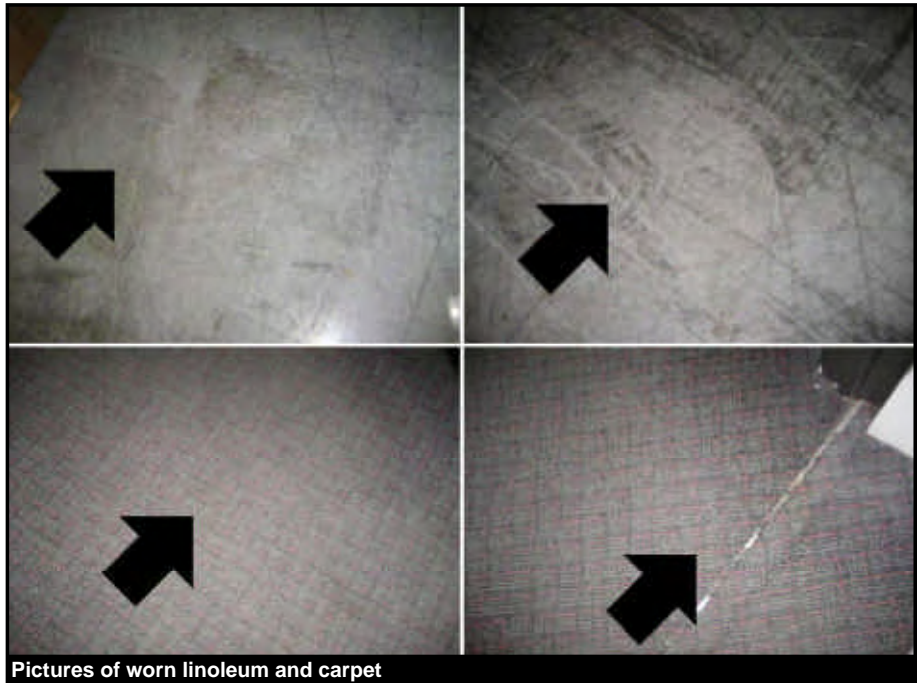
Pictures of worn linoleum and carpet

Needs Attention, there are areas of worn linoleum and the worn and stained carpet.

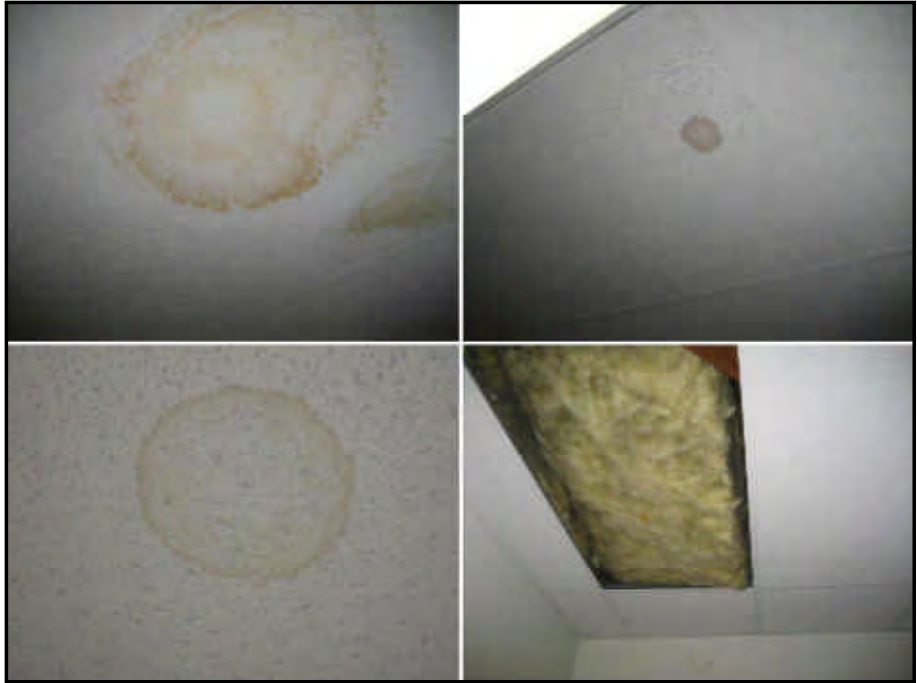
CEILING: There are areas of moisture stains on the ceiling, There are areas of damage to the ceiling.

Picture of the moisture stains and damage to the ceiling.

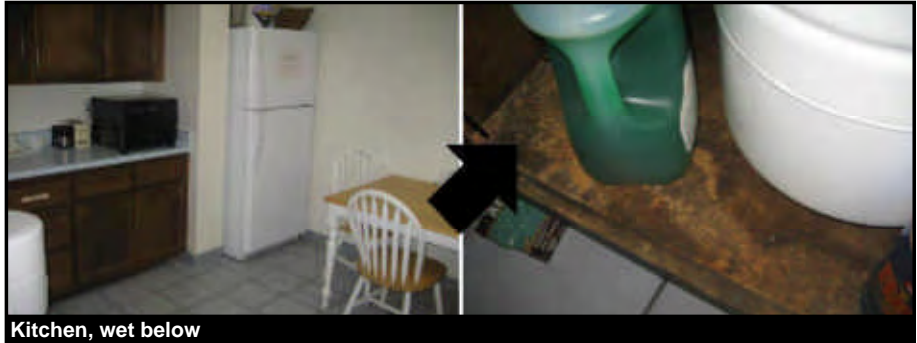
Kitchen, wet below

Needs Attention: While generally functional there are areas of wear and deterioration.

FAUCET: The faucet drips continuously, and needs repair. There is no hot water at the sink

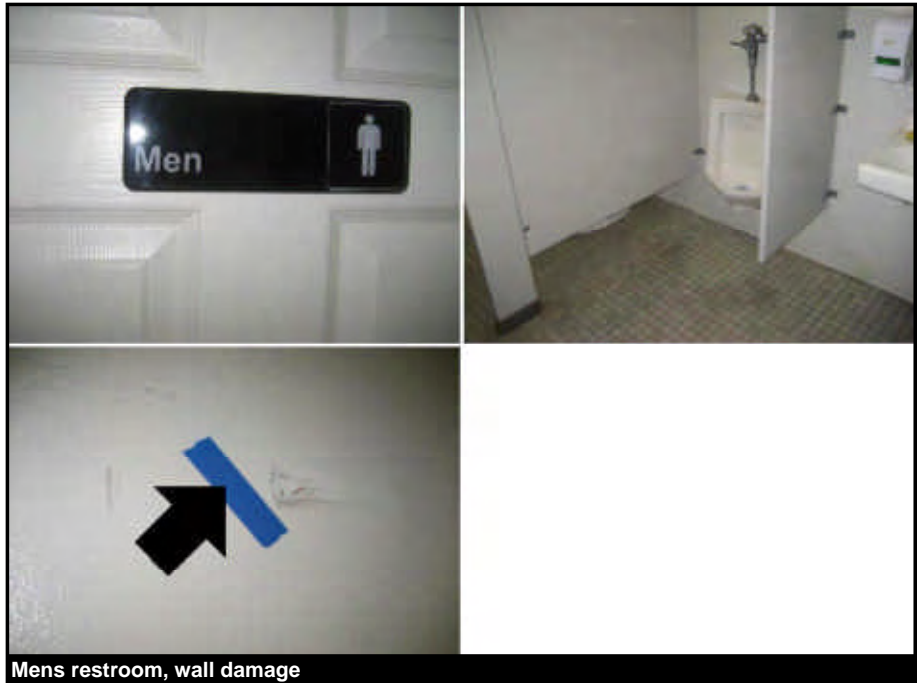
Mens Restroom

Needs Attention: While generally functioning there are areas with noticeable wear that could use servicing and maintenance.

WINDOW / VENTING: The bath vent fan is not working correctly,

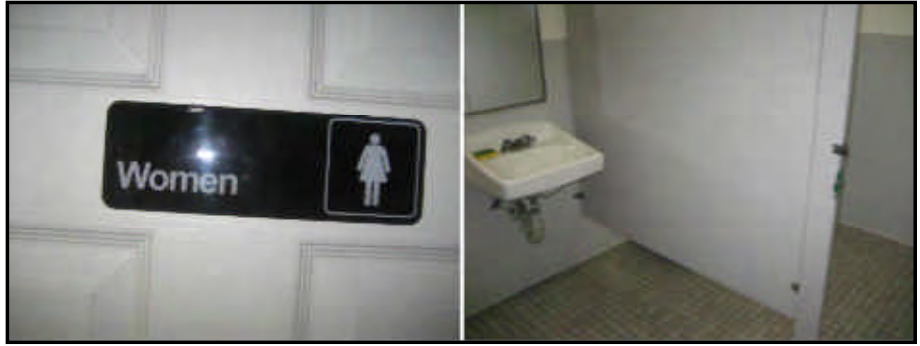
Womens Restroom

Needs Attention: While generally functioning there are areas with noticeable wear that could use servicing and maintenance.

TOILET: The toilet leaks at the base of the handle.

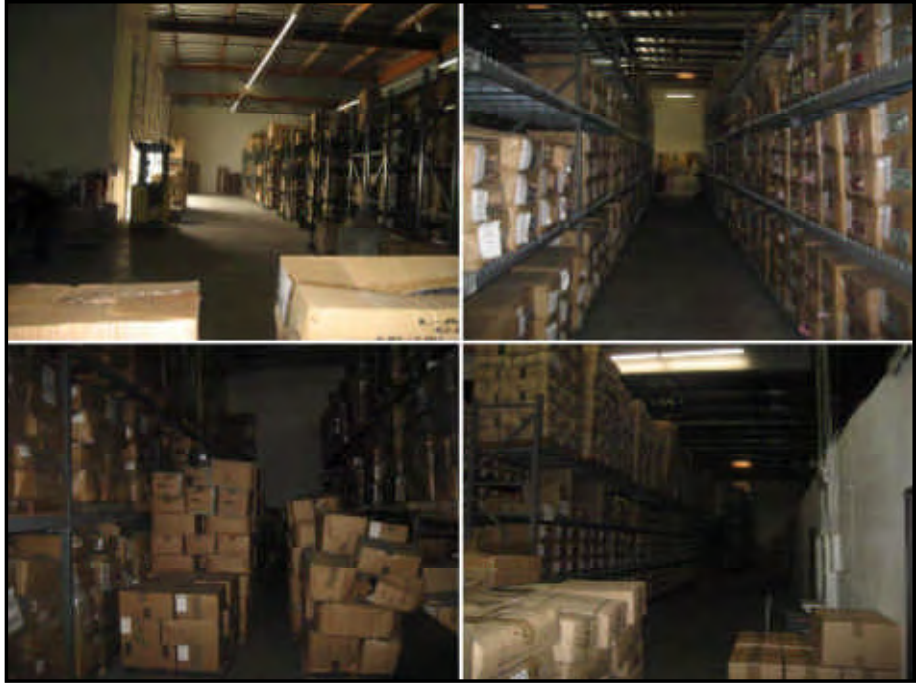
Warehouse area

WALLS: There are areas of damage to the walls

It is noted that multiple loading dock did not function at the time of inspection.

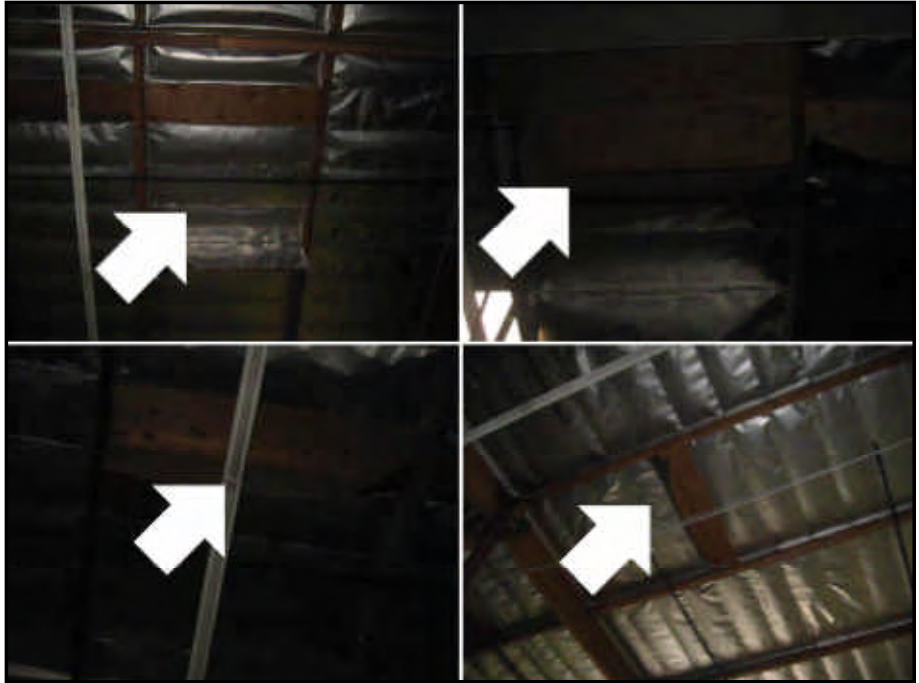
Pictures of the ceiling insulation falling down from the ceiling.

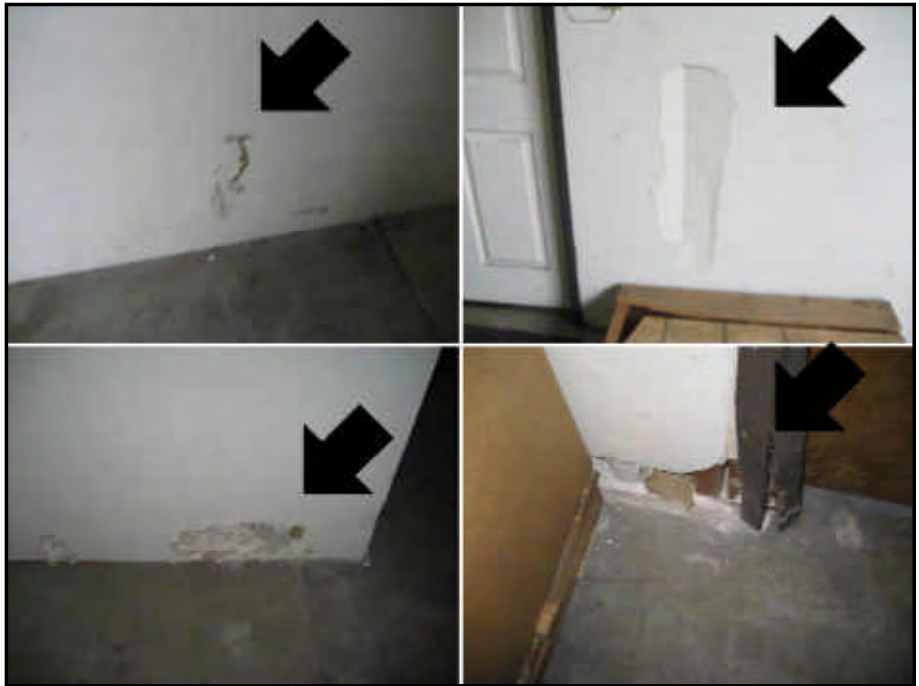
Pictures of the wall damage in the warehouse area.

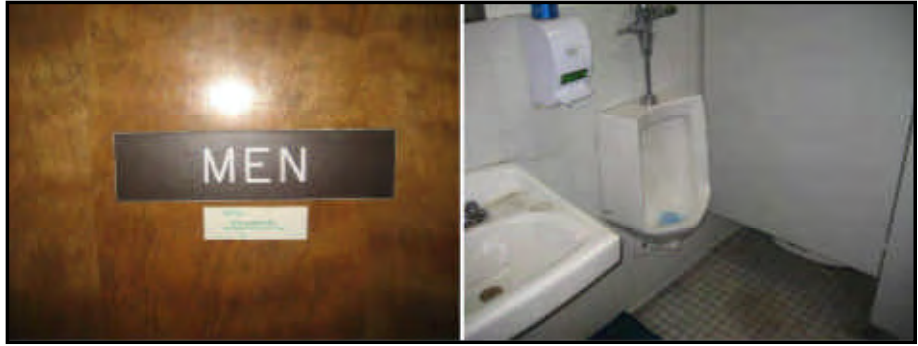
Mens Restroom

Needs Attention: While generally functioning there are areas with noticeable wear that could use servicing and maintenance.
