RISK Assessment® Report

February 03, 2010.

Warehouse Client

City of Industry, CA

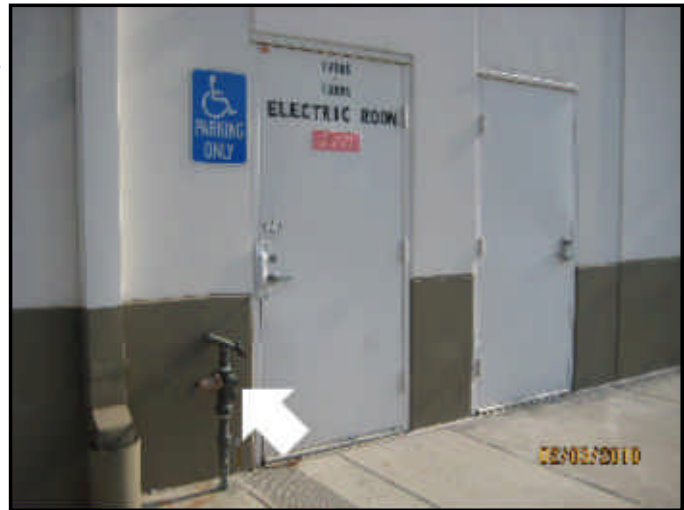
MAIN WATER SHUT OFF LOCATION:

On the left side of the building as you face it from the street.

Serviceable.

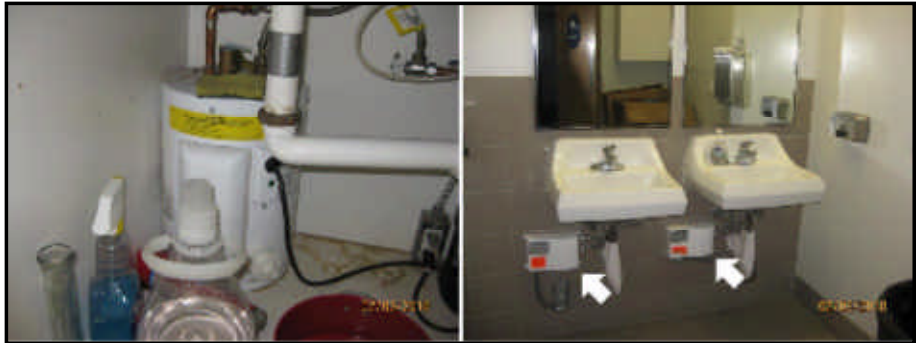
LOCATION:

The hot water in the restrooms are provided by point of use, insta-hot. None of the water heaters were functioning at the time of inspection.

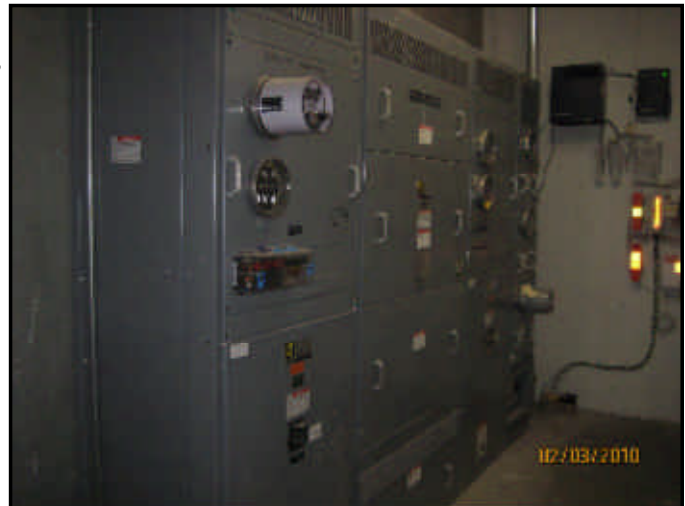
PANEL LOCATION:

The main electrical panel is located in the utility area of the left side space.

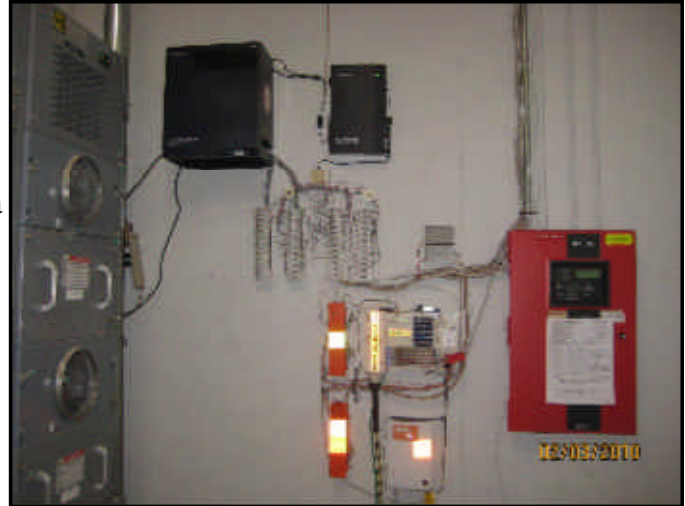
FIRE SUPPRESSION SYSTEMS:

There is an interior fire suppression system in the unit. This is not tested as part of a general visual property inspection.

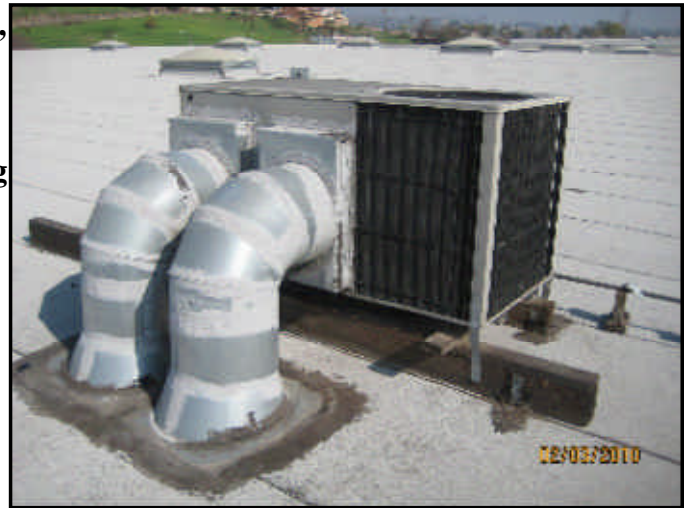
LOCATION
CONDITION:

Needs Attention, one of the units, the smaller of the two on the left side is sitting on wooden blocks. This is not a reliable method regarding moisture intrusion. It is advised to have platforms with metal caps installed to help ensure a leak free condition.

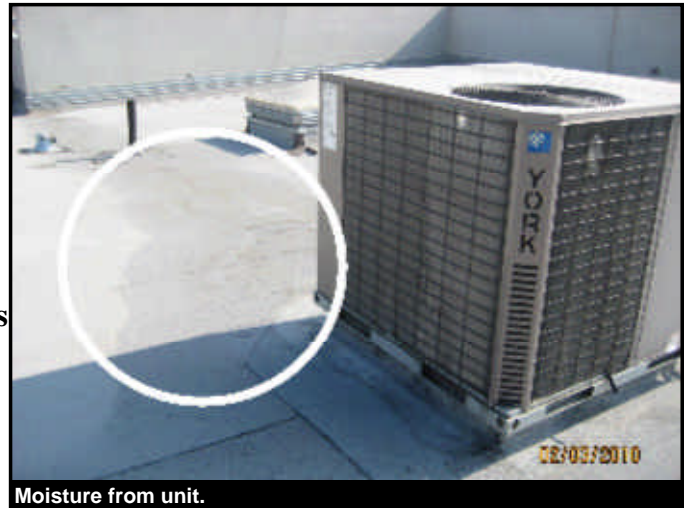
CONDITION:

Not Acceptable two of the three units are leaking. Corrections are needed at this time.

Overall the units appear to be serviceable.

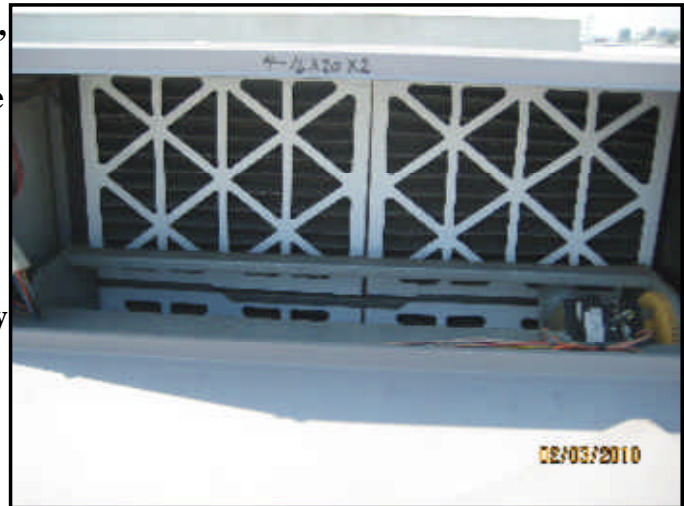
RETURN AIR AND FILTERS:

Needs Attention, the larger unit over the left side office space had the filter cover off. It was reinstalled however the filters were dirty and in need of being changed.

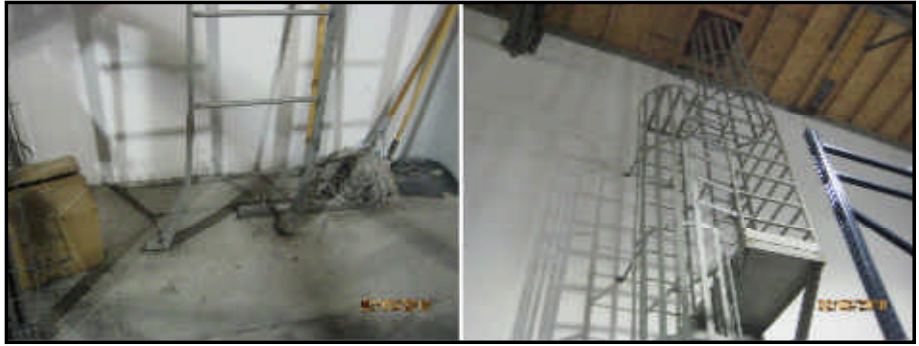
ACCESS CONDITION:

Needs Attention, the bottom of the ladder has been damaged and is leaning to the side. Also The roof access is not up to current OSHA standards in regards to safety for such items as proper height and style of Grab Bars.

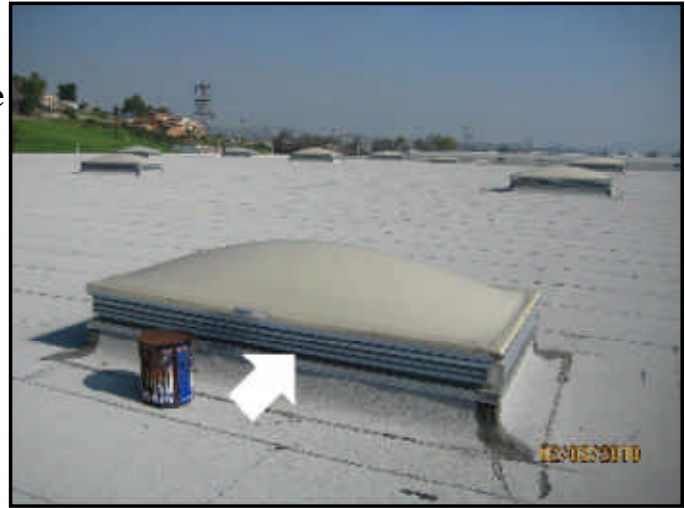
**Serviceable
however the
vents on the side
can allow
moisture to
enter during
heavy rains.**

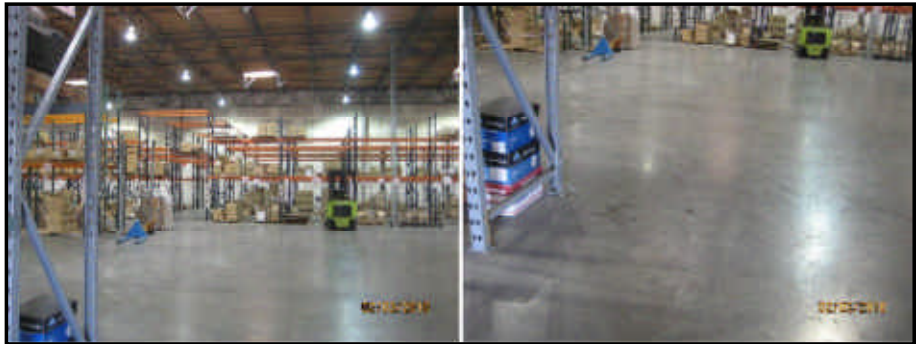
SLAB ON GRADE COMMENTS:

There are cracks in the slab that appear to be typical for the age and style of construction. However if you need a more detailed evaluation it is advisable to contact a structural engineer or a foundation specialist.

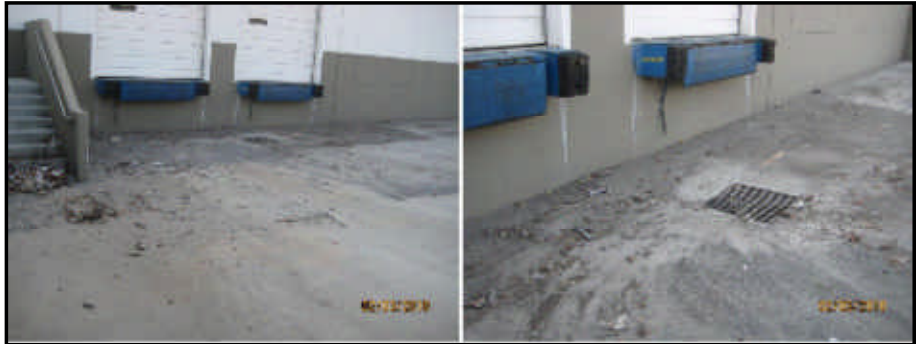
DRAINAGE
CONDITION:

There were no observable significant defects in the grading and drainage around the immediate building areas however there are some signs of past standing water in the rear around the drains by the docks. It is noted that the site is a "flat" or very low slope site and it is expected that there will be some areas where water will pool or pond during rainy periods.

It is advised to consult the current owner to determine if there have been any history of adverse conditions in the past after rains.

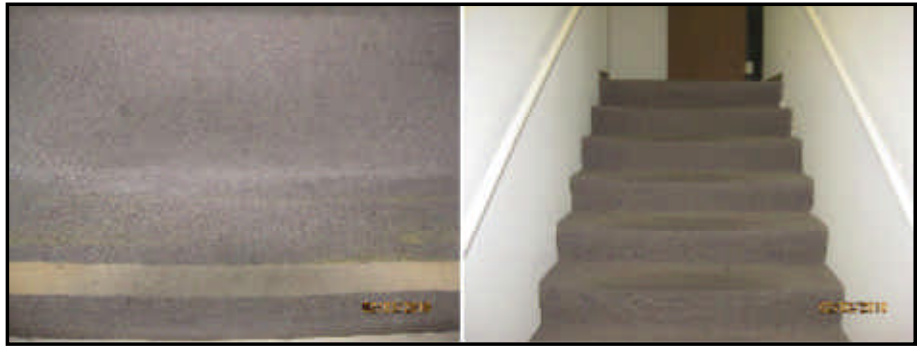
STAIR CONDITION:

Needs Attention: The covering of the stairs is worn and deteriorated.

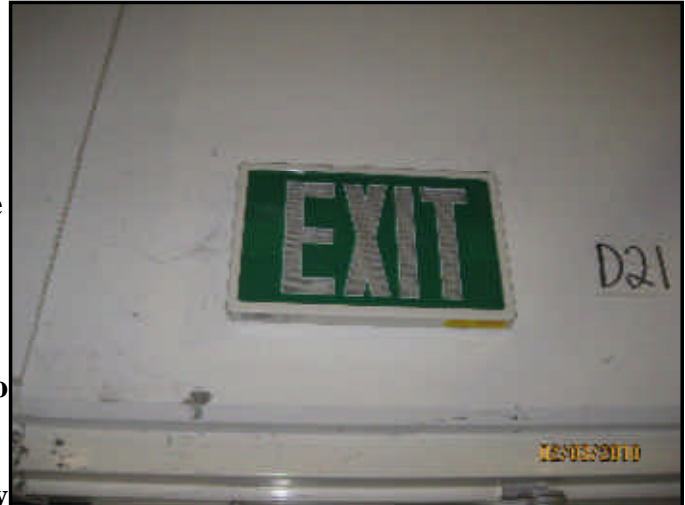
EXIT SIGNS:

Needs Attention: Although there are signs present, they do not appear to be in sufficient number and/or are improperly placed. A examination into the current requirements of this municipality

would reveal what the current requirements are as to placement and types of signage required.

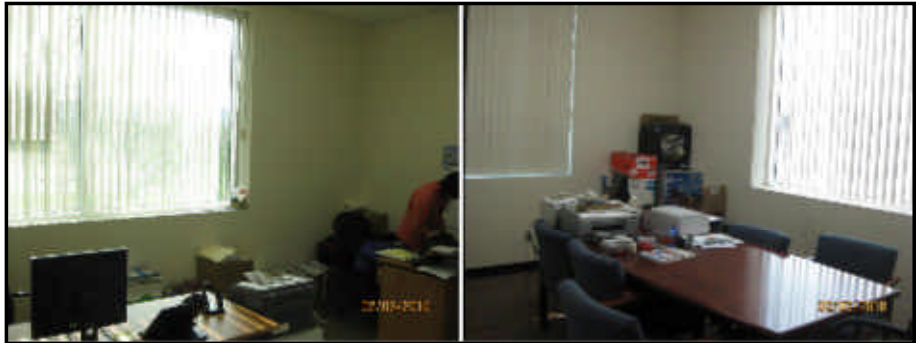
OFFICE AREAS:

Serviceable overall with typical wear within 19885.

Needs Attention: There are areas of moisture stains and/or damage on the ceiling, primarily noted within 19985 on the second floor. Only one minor instance of moisture staining was observed in the other unit.

It was reported that the major moisture staining within the large office occurred in the last rain storm, with the balance being due to moisture that appears to be originating from the roof mounted air conditioning units. See the heating section of the report for additional information.

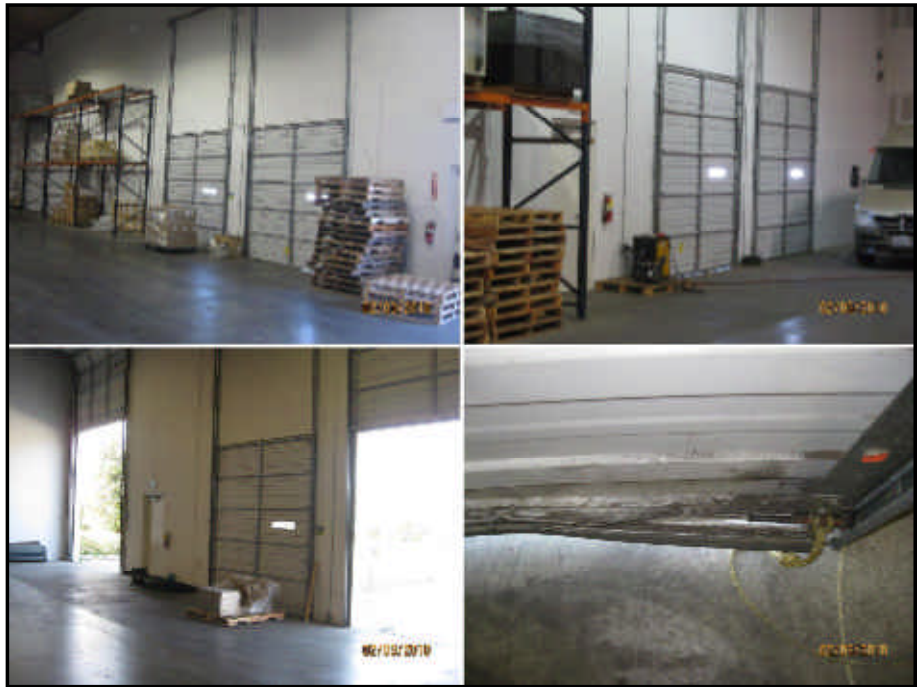
EXTERIOR DOORS
ROLL UP DOORS:

Serviceable, with typical wear, though it is noted that there is minor damage at two of the ten doors. Three of the ten doors were lock and could not be tested.

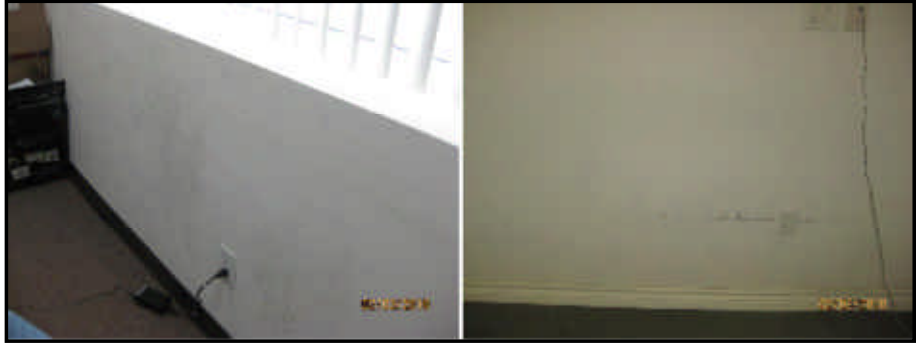
WALLS:

Serviceable overall, though dirty and needing paint in some areas, primarily within 19885.

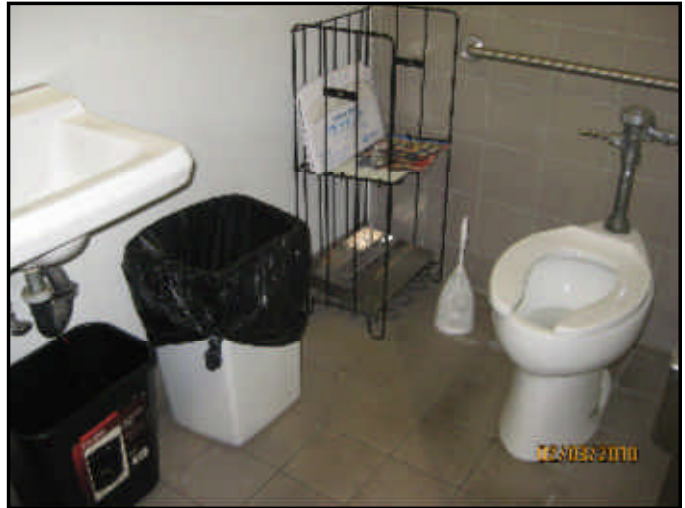
Warehouse Unisex Restroom

**Sink
Needs
Attention:
There is no or
insufficient hot
water to the
sink. This is
required for
hygienic
reasons.**
