RISK ASSESSMENT[®]

ADDRESS: Thousand Oaks, CA 91360

CLIENT: Restaurant Investor

RISK Assessment[®] Report

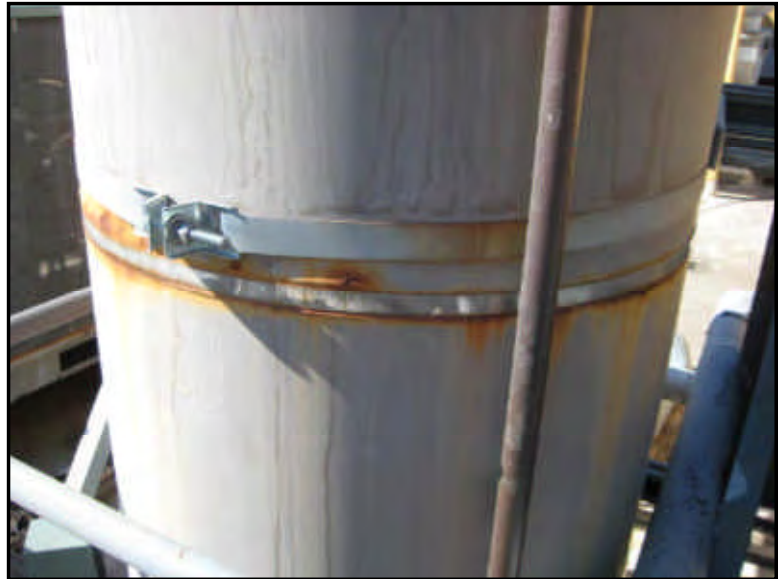
The age of the water heater is unknown but it appears newer however the storage tank is aged and rusted.

Needs Attention, the exterior of the water heater storage tank is rusty in areas.

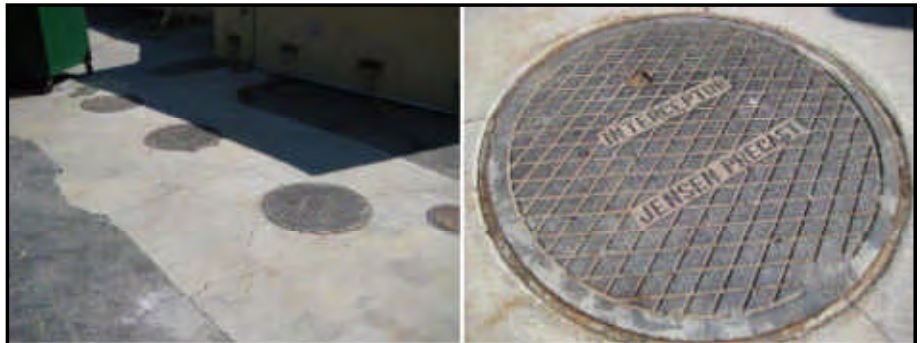
There are what appear to be grease interceptors in the rear. These are not part of this inspection. Further review by a qualified plumber is advised at this time.

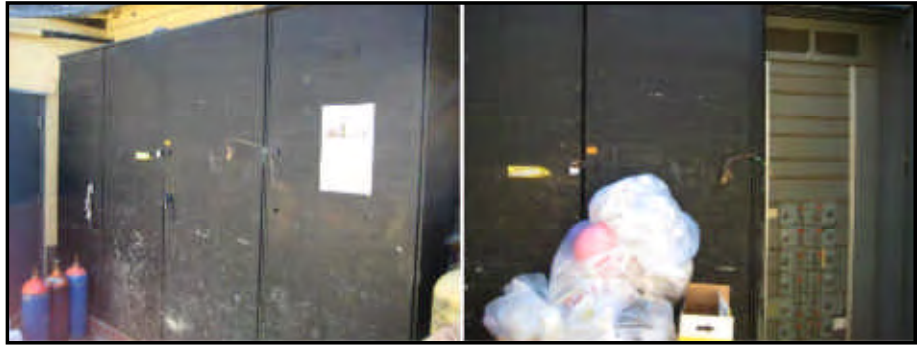
The main electrical panel is located on the rear exterior wall of the building.

Needs Attention, Zinsco panels have been observed on the site. These panels have been known to have breakers that did not cut the power as designed.

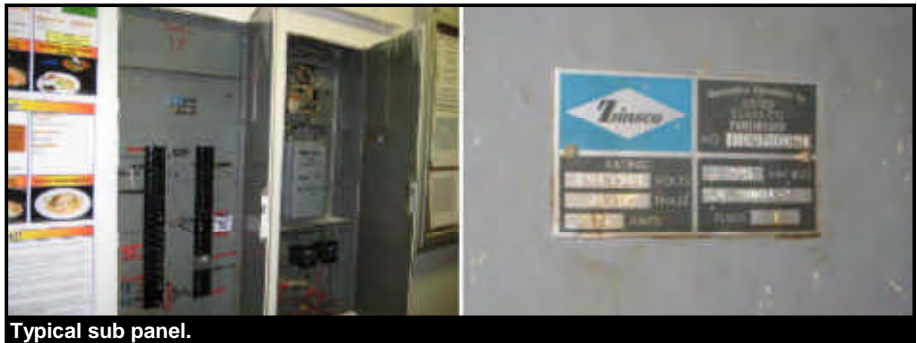
Typical sub panel.

Needs Attention: There are Zinsco panels on the site. These are known to not operate with all the safety aspects other designs of panels have. Further review is advised at this time by a qualified electrical expert to determine the status.

It is advisable to have an electrician examine the system and make all needed repairs to ensure a properly installed and correctly operating electrical system. This investigation of the system should be done prior to the expiration of the contingency period so the repair or replacement costs are known and unwanted expenses are avoided. It is expected that when the electrical specialist checks out the system they will find more problems as this is a general inspection and not designed to list every fault but to isolate areas in need of further detailed inspections.

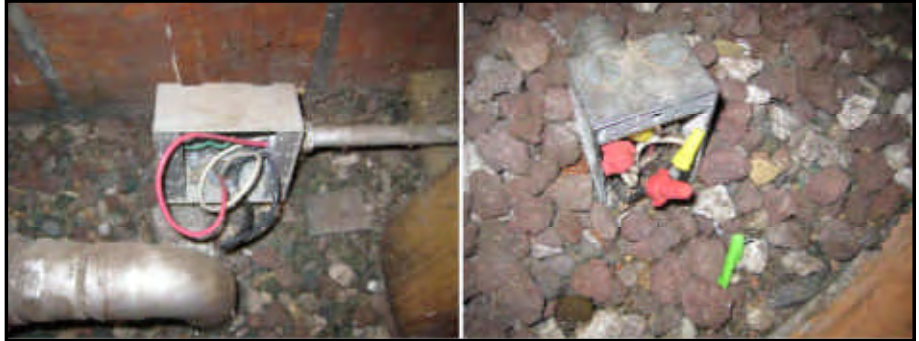
Serviceable overall however there are some open boxes such as by the main water line in the front to the right of the entry that should be properly covered.

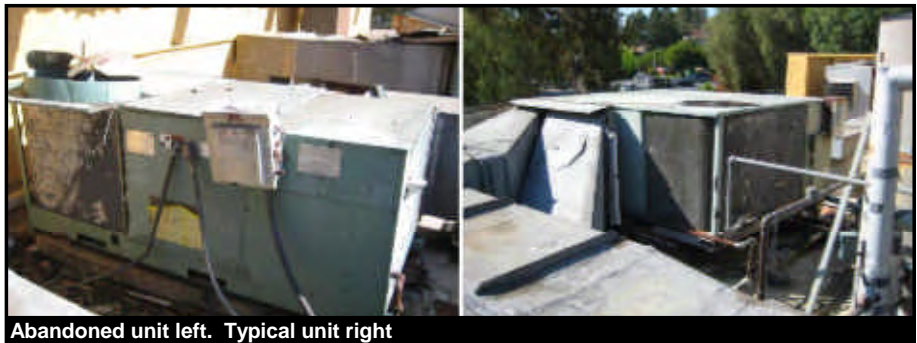
The heating and cooling systems are located on the roof.

There are two systems that appear to be abandoned.

There are four systems that are aged and worn and appear to be from 1984. Typical life for this type of system is approx. 15 - 17 years when exposed to the elements. These units are past their expected useful life.

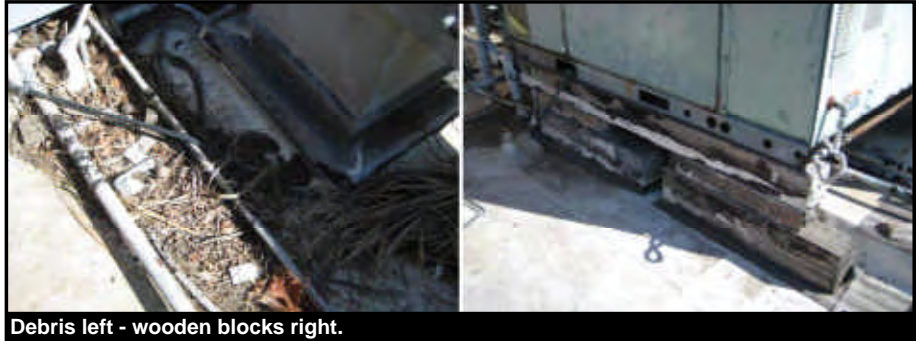
Debris left - wooden blocks right.

Serviceable generally however due to the excessive debris the base of all units was not able to be seen fully.

Needs Attention for one of the units at the rear center part of it is sitting on wooden blocks. This is not a reliable method regarding moisture intrusion. It is advised to have platforms with metal caps installed to help ensure a leak free condition.

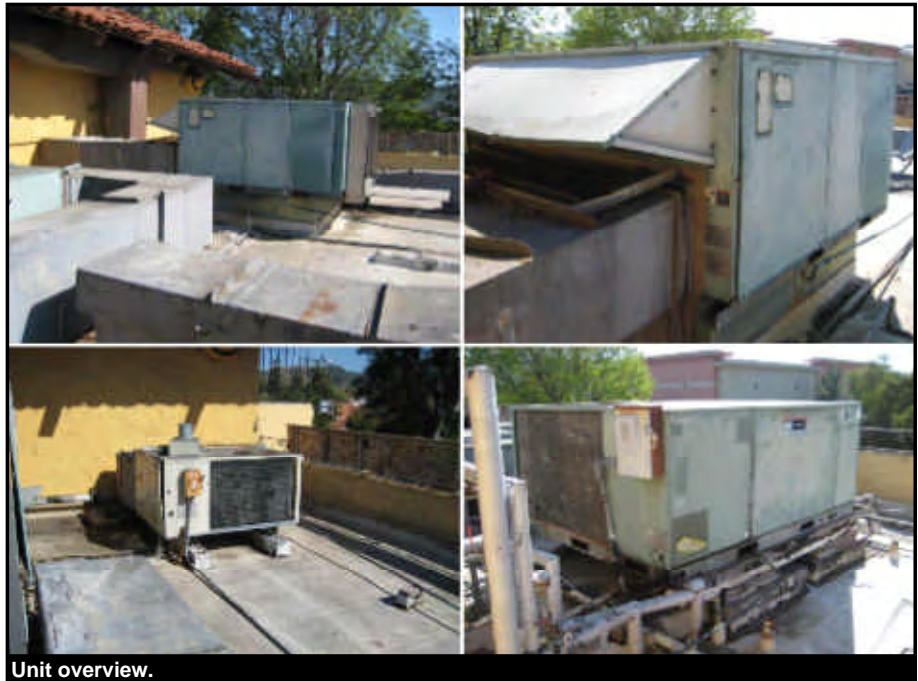
Needs Attention of the 4 systems that are in operation all of these systems are very aged and worn and past their expected useful lives. They appear to be in need or replacement at this time due to age and overall condition.

There are two smaller, approx. 5 ton units, that appear to be abandoned and no longer in use.

It is advised to have a licensed heating and cooling contractor examine the heating and cooling systems and make all needed repairs to ensure safe and properly operating systems. It is expected that the heating and cooling specialist may find additional items that need repair as the general inspection is designed to turn the investigation over to the specialist for a more detailed inspection.

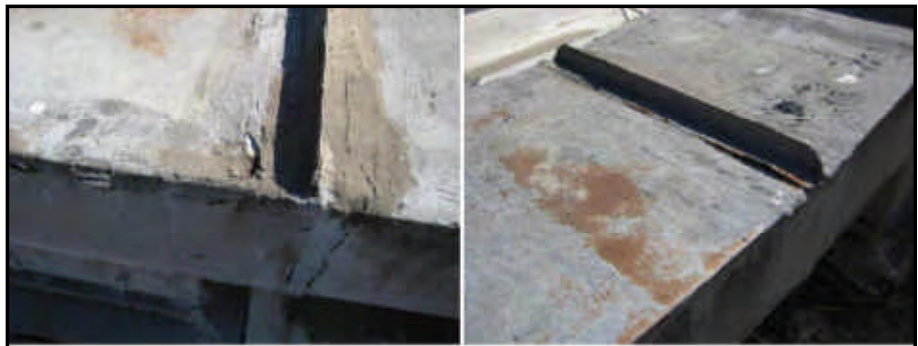
Not Acceptable, there is ducting on the roof that is old and worn and deteriorating. These are exposed to the weather and the exterior on them is rusting and not fully sealed.

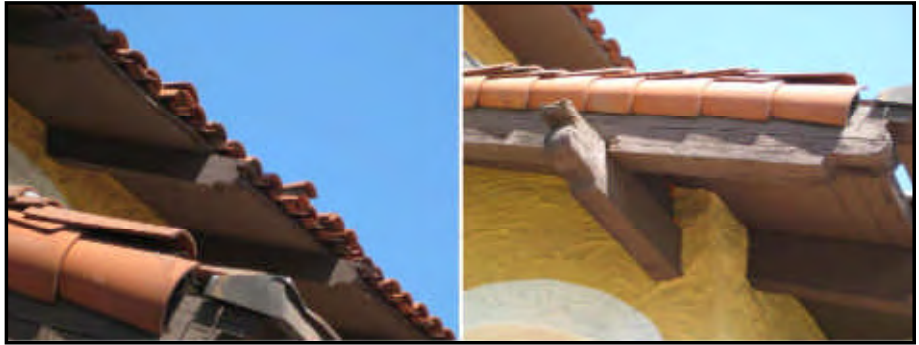
Needs Attention the ends of the beams are deteriorated in multiple locations at the exterior.

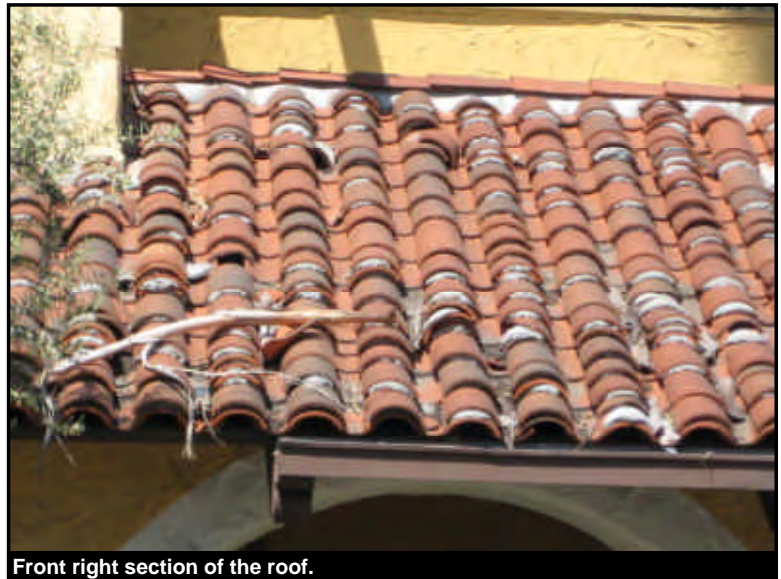
Needs Attention, on the tile roof there are areas of cracked tiles, there are displaced tiles that have slipped down and are no longer in the correct location. This allows sunlight to deteriorate the exposed underlayment

on the low sloped roof, The roof does not have the recommended 1/4" per foot slope in it to allow water to run off properly during rains. It is advised to increase the slope on the roof to the recommended 1/4" per foot however this may not be practical do to expense. Review by a roofer at this time is advised. It will be very important that the roof has regular maintenance to help ensure a a leak free condition.

Both the roof is in need of maintenance at this time. It is advised to have a roofer examine the entire roofing and drainage system and make any needed repairs or do any maintenance functions needed to help ensure a leak free condition at this time.

A licensed roofing contractor should examine the entire roof and make all needed repairs (or replacements) to ensure a long lasting leak free condition. The roofing contractor may find more problems with the roof and this is why it is being referred to a specialist so they can determine all the problems and give an

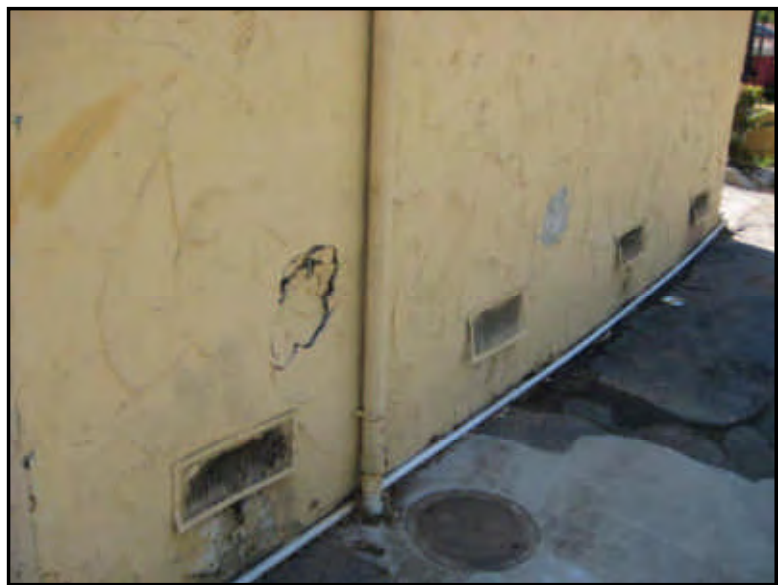
Serviceable, there is typical cracking in the exterior walls.

It is noted that there is some damage in the rear.

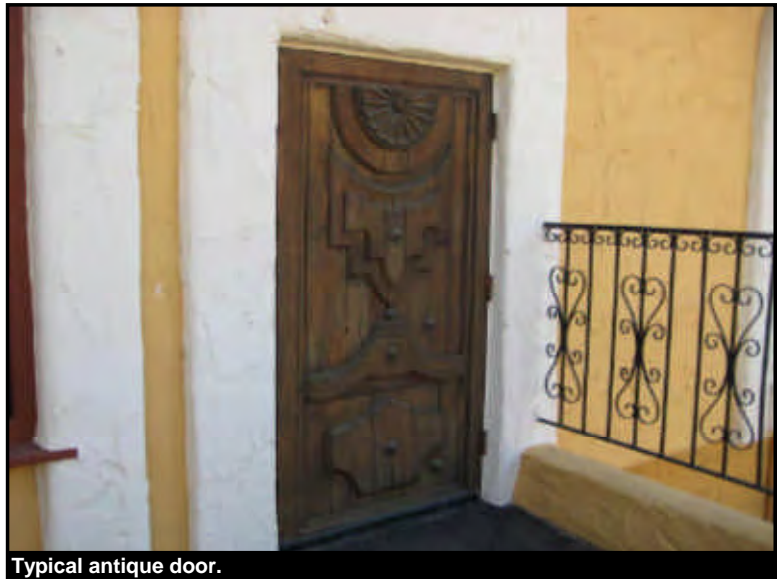
Typical antique door.

Needs Attention there are antique doors such as at the upper left and rear that are aged and worn and sagging.

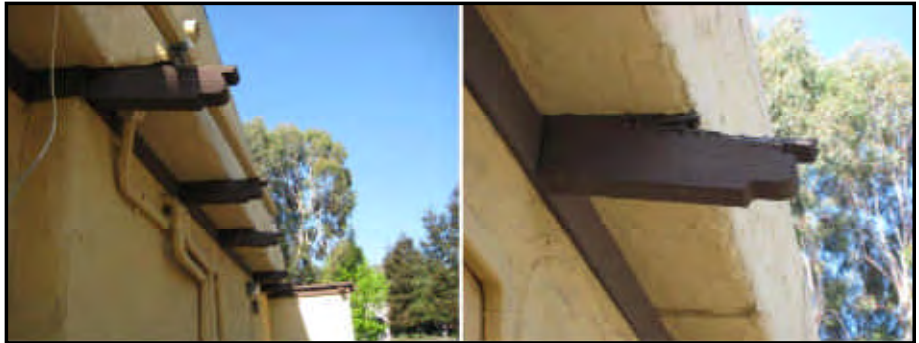
Needs Attention, the trim is deteriorated in areas in many locations. See pest control report for further details.

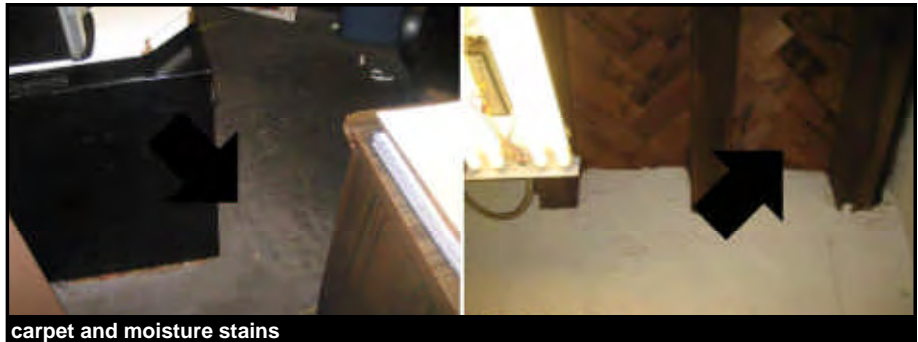
Needs Attention, there are areas of moisture stains, on the ceiling

The carpet is stained and damage in multiple areas.

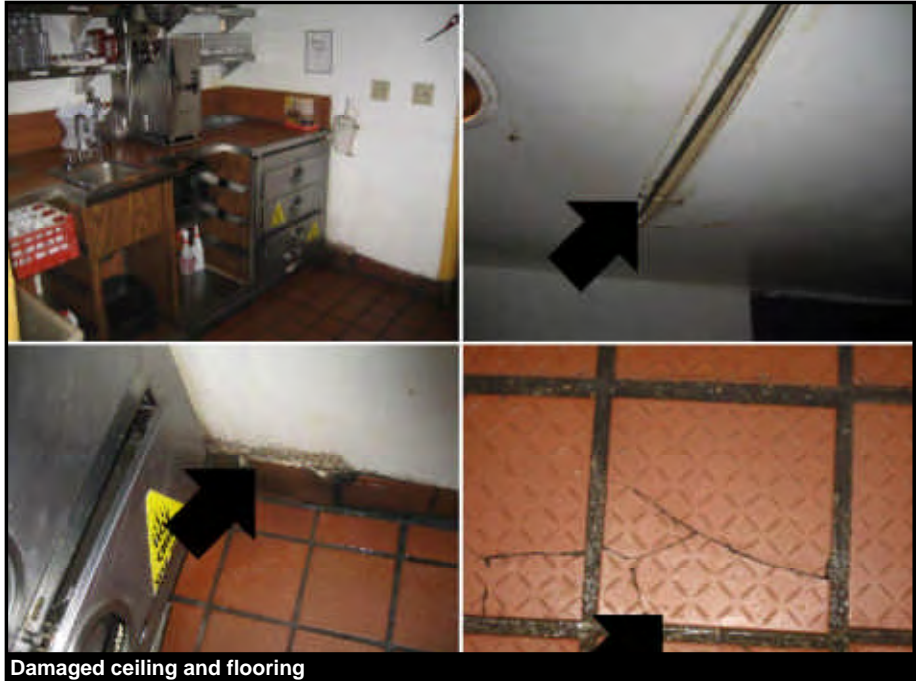
Serving station left side

Damaged ceiling and flooring

Needs Attention : the ceiling is falling down. There are moisture stains on the flooring and cracked tiles.

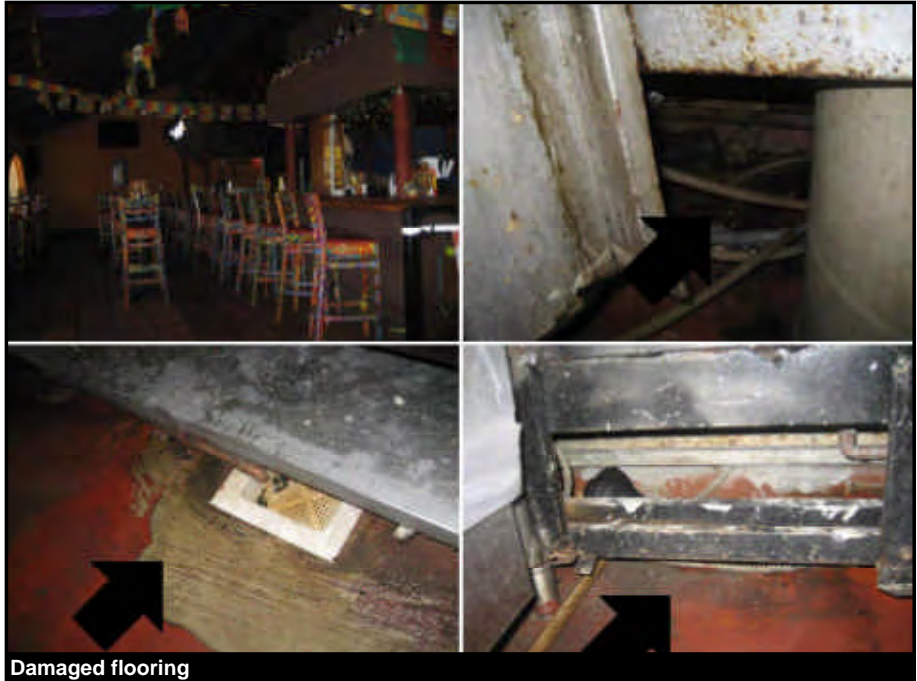
Bar Area

Needs Attention : The flooring is damaged in multiple areas. There appears to be a mold like substance on the flooring.

This is not a mold or fungus inspection, it is advised to have a mold specialist examine the property and structure and do a complete inspection to determine the presence or absence of any mold that may affect the health or safety of the occupants.

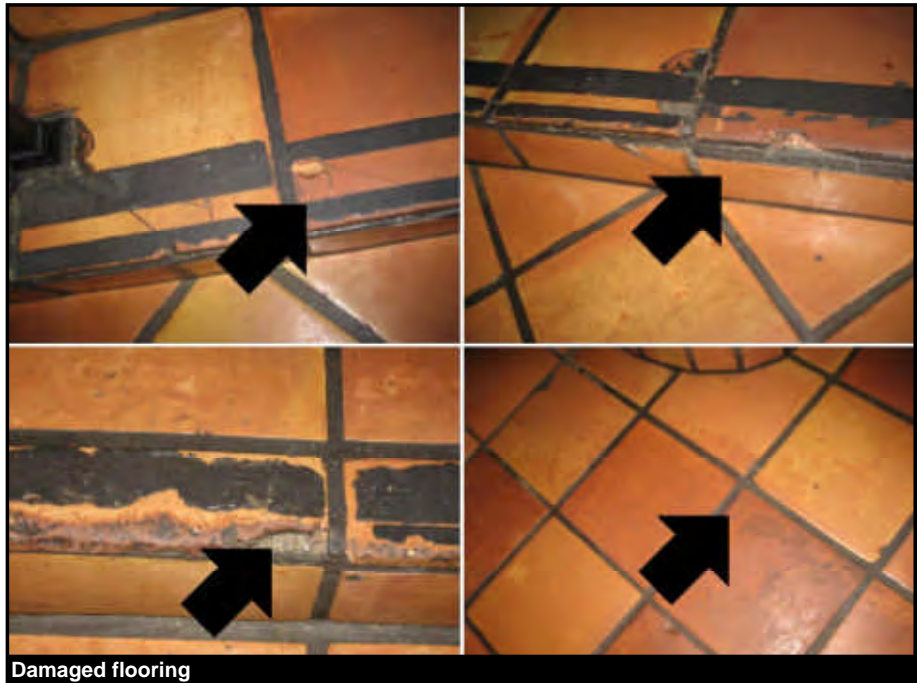
Damaged flooring
Needs Attention, there are areas of cracked and damage floor tiles.

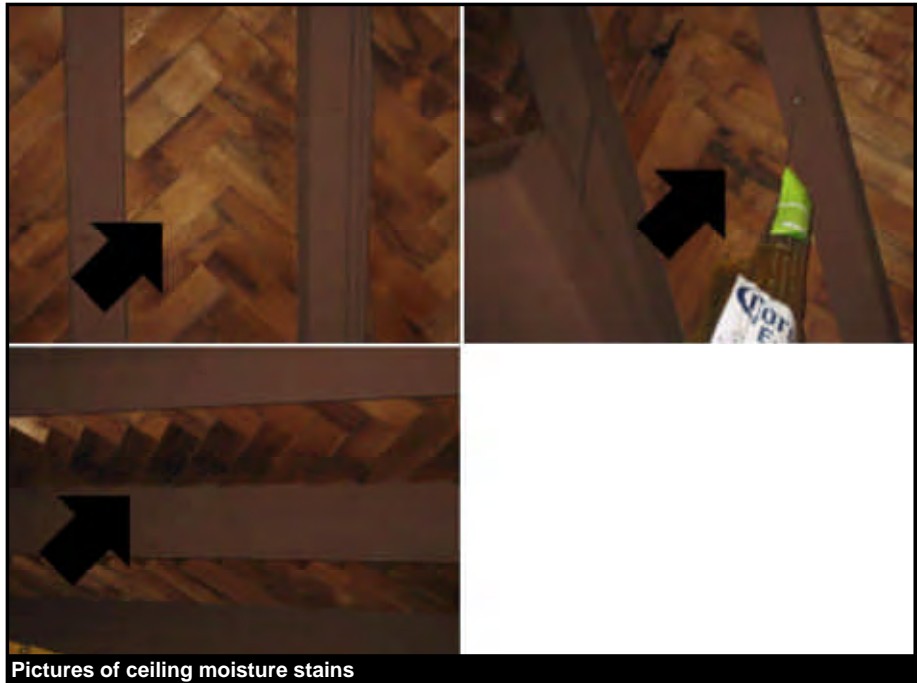
Pictures of ceiling moisture stains
Needs Attention:

WALLS: There are areas of moisture staining on some walls

CEILING: There are areas of moisture stains on the ceiling, There are areas of damage to the ceiling.

FLOOR: The floor has areas of chipped / cracked tile and deteriorated grout.

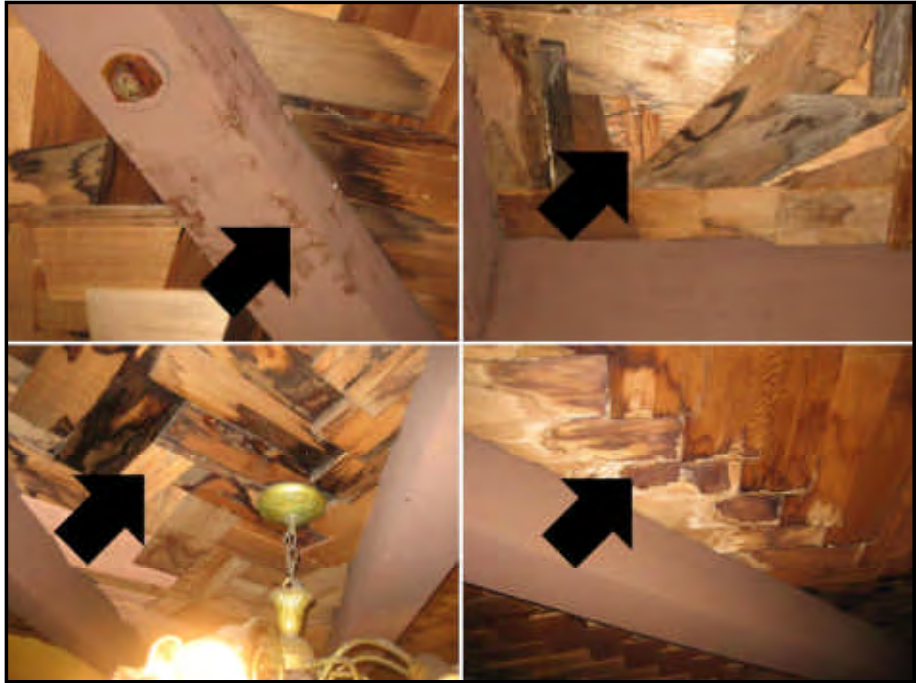
Pictures of the moisture stains on the ceiling.

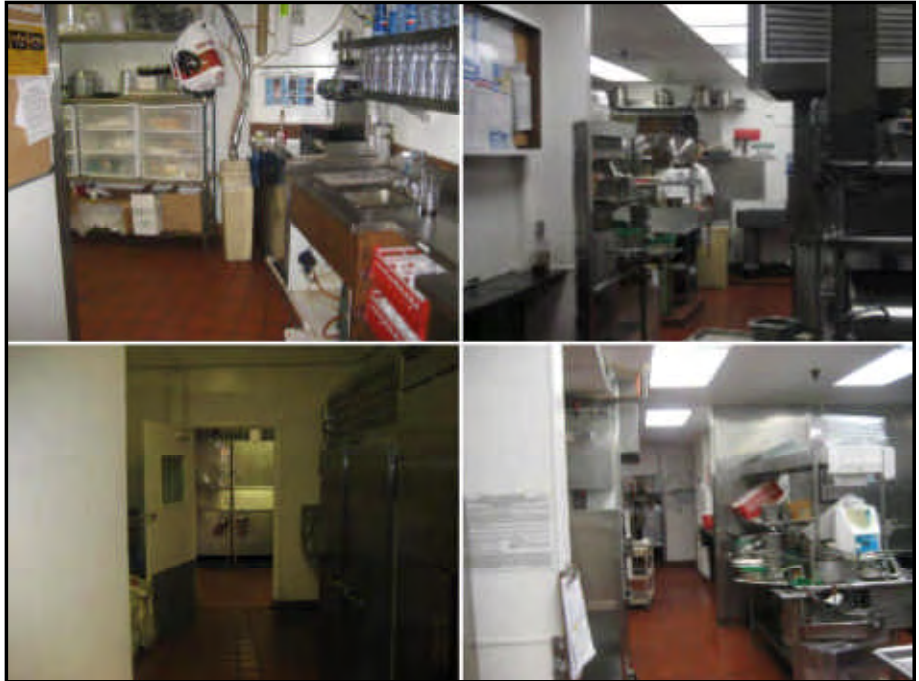
Needs Attention: While generally functional there are areas of wear and deterioration.

WALLS / CEILING: There are areas of stress cracks or damage in the walls / ceiling.

FLOOR: The flooring has areas of deterioration and damage.

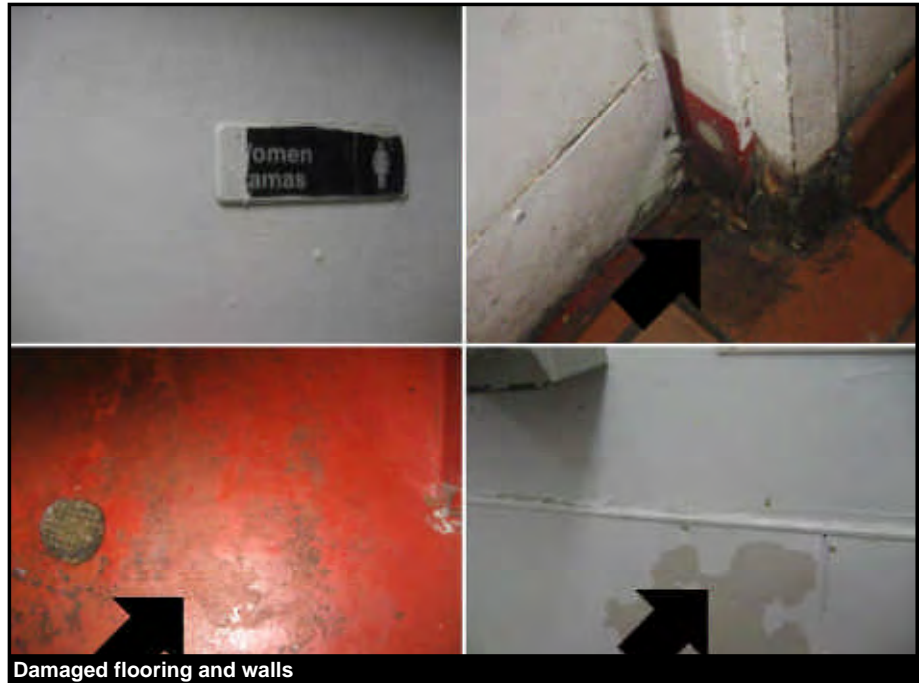
Womens Restroom in the kitchen

Damaged flooring and walls

SINK: The sink stopper is missing or not working.

TOILET: The toilet is not working properly and needs repairs.

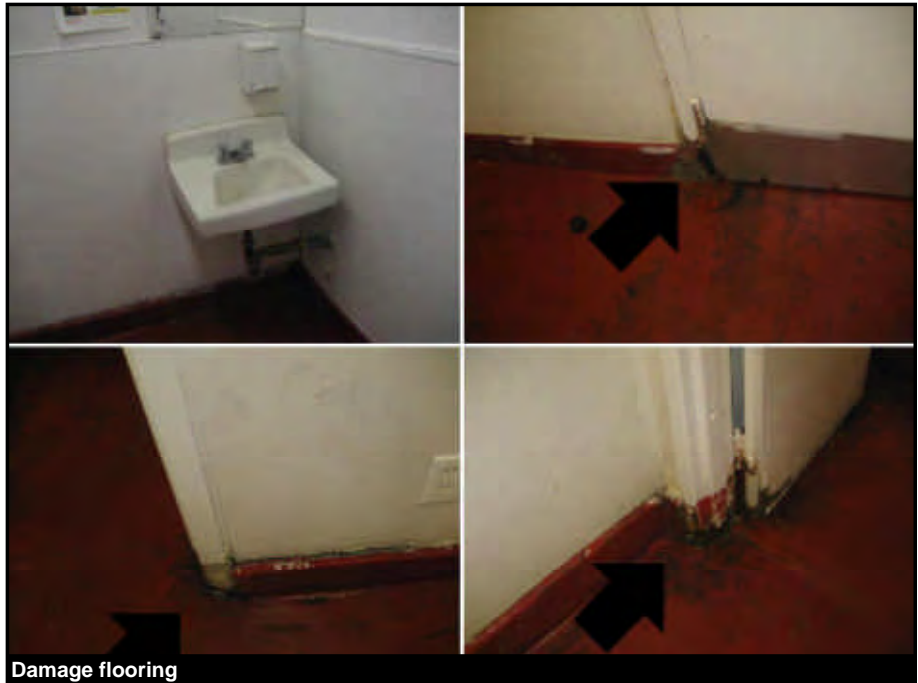
Mens Restroom in the kitchen

Not Acceptable:

TOILET: The toilet is not working properly and needs repairs. The toilet has a broken handle or flush parts and needs repair.

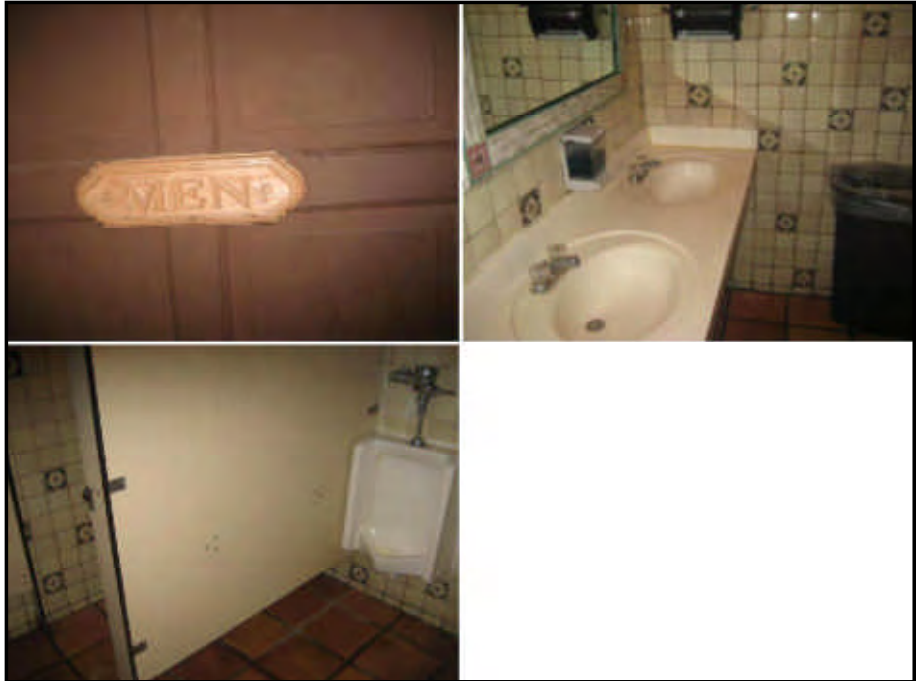
Mens Restroom 1st floor

Needs Attention: While generally functioning there are areas with noticeable wear that could use servicing and maintenance.

SINK: The sink stopper is missing or not working. The sink is cracked.

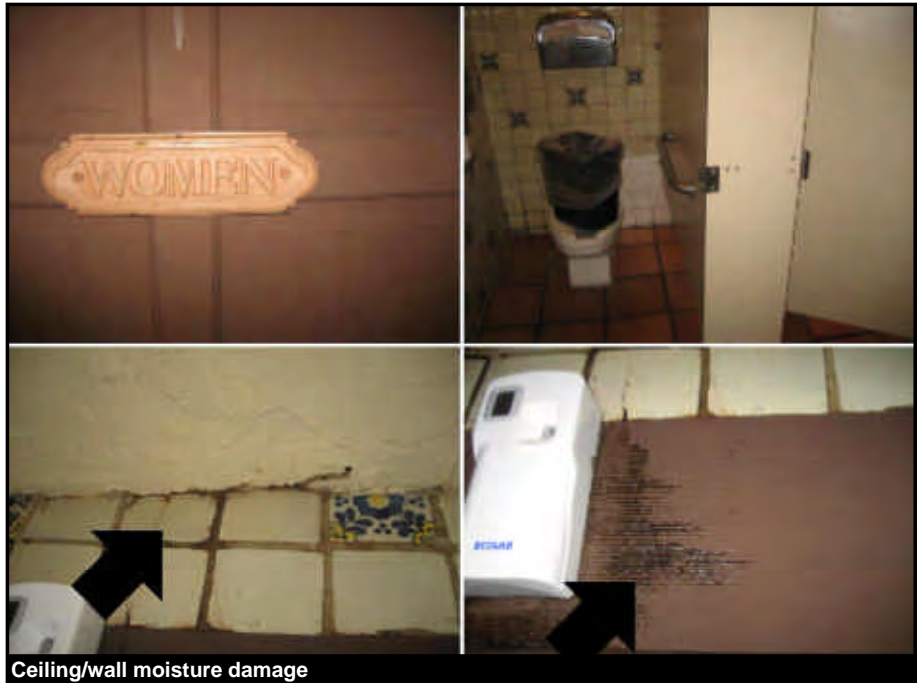
Needs Attention: While generally functioning there are areas with noticeable wear that could use servicing and maintenance.

WALLS / CEILING: There are areas of moisture stains / damage on the walls and ceiling such as above the door into the bathroom.

SINK: The sink stopper is missing or not working.

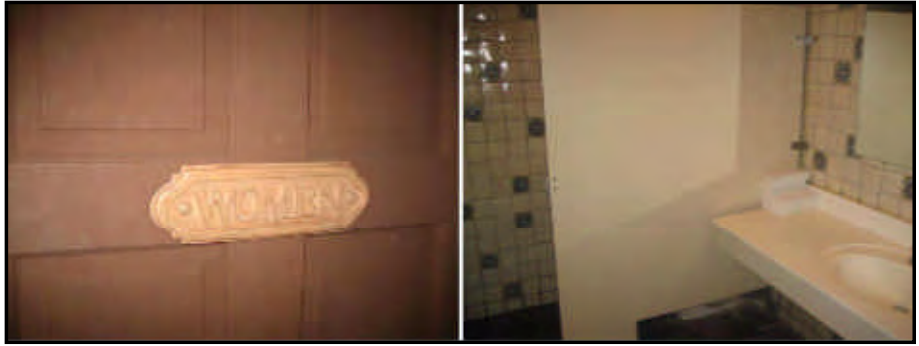
Womens Restroom upstairs

Needs Attention: While generally functioning there are areas with noticeable wear that could use servicing and maintenance.

FLOOR: The floor is worn and damaged in areas. There is moisture staining and damage to the floor covering and it may need repair / replacement.

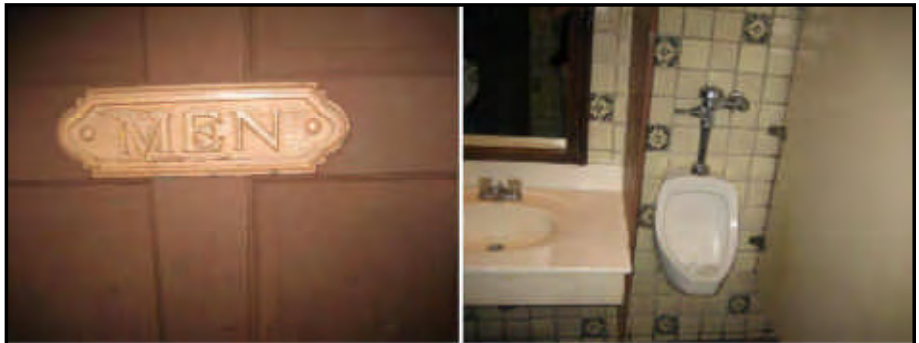
Mens Restroom upstairs

Needs Attention: While generally functioning there are areas with noticeable wear that could use servicing and maintenance.

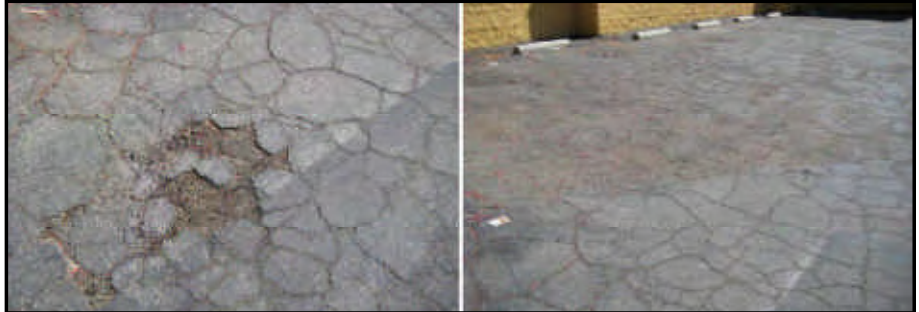
Typical sections of the parking area.

Needs Attention, The parking for the site is in an asphalt parking lot. There are striped spaces. The parking areas are in need of being resealed and restripped. The parking areas are worn and aged.
