RISK ASSESSMENT[®]

ADDRESS: Paramount, CA

CLIENT: City Investment

2 Apr 2008

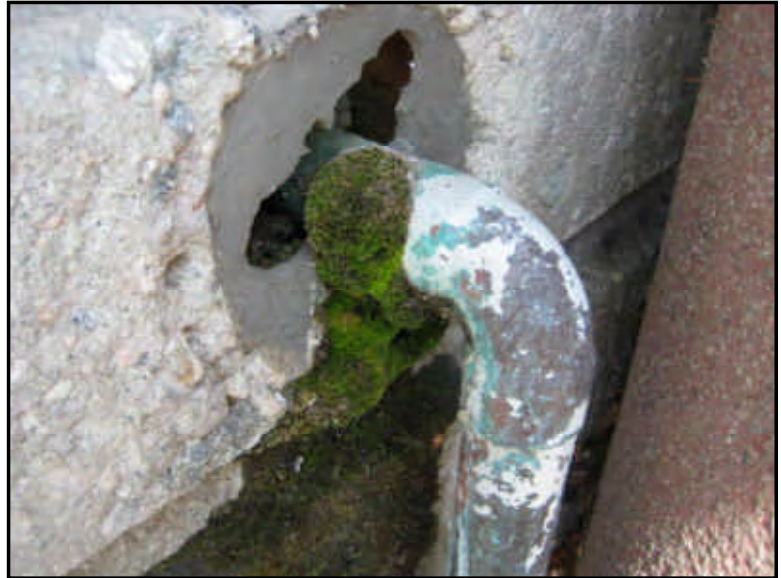
Not Acceptable, there is a leak outside at the building connection.

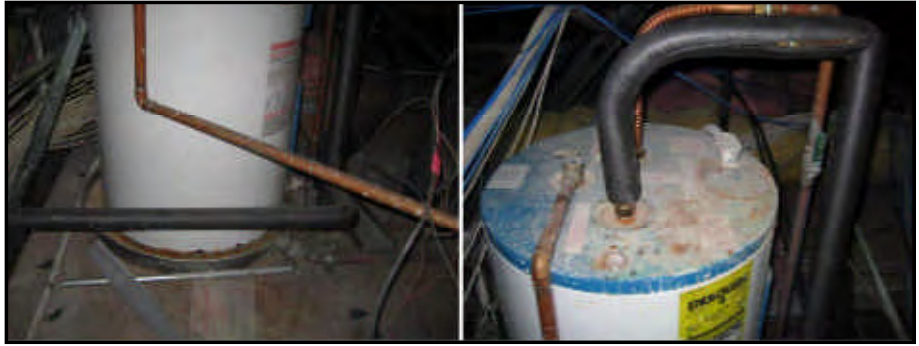
Appears to be original from 1991 or 17 years old. Water heaters have an expected life of 8 - 12 years.

Needs Attention, the water heater is very old and past its expected life span. It may need to be replaced soon. Also the exterior of the water heater is rusty in areas.

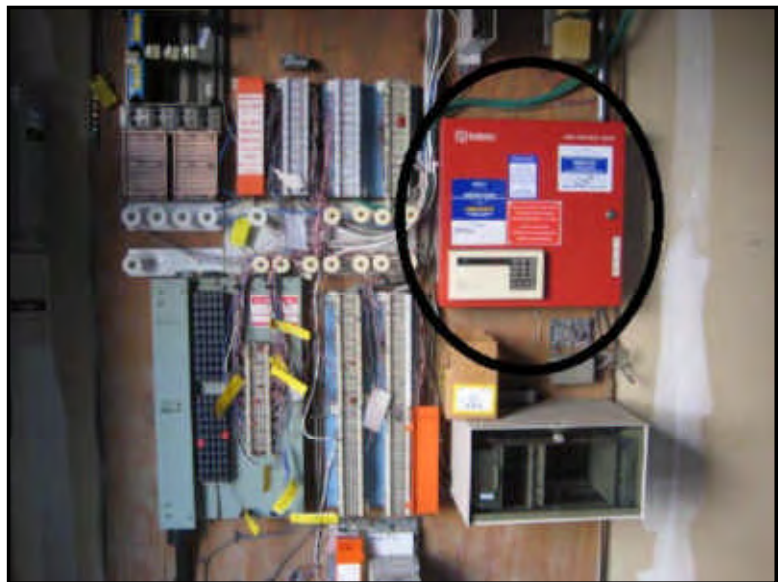
There is an interior fire suppression system in the unit. This is not tested as part of a general visual property inspection.

An updated 5 year sprinkler inspection is advised at this time for health and safety.

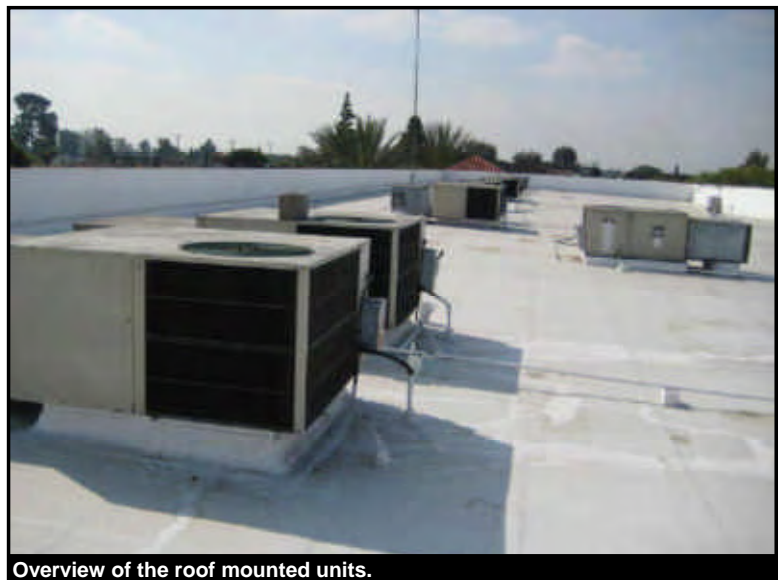
Overview of the roof mounted units.

There are a total of 11 roof mounted units on the site. All are the same type and style and all appear to be original and in similar condition generally.

It is advised to have all the units serviced and cleaned at this time to ensure safe and properly functioning systems. It is beyond the scope of this general visual inspection to inspect the inner workings of the systems. This can and should be done by a licensed Heating and Cooling specialist at this time. Due to the age of the units within the next five years expect extensive repairs or replacement of most of the units.

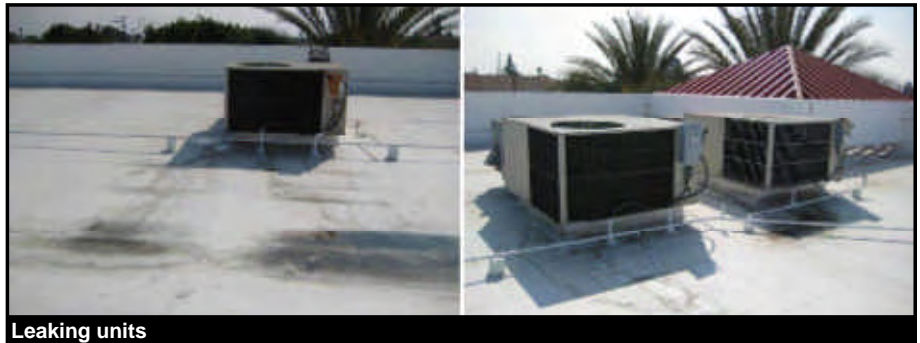
Needs Attention, The units are aged and worn. Though they may be at or near the end of their expected useful life and still functional it is noted that this type of unit has a life expectancy of approx. 15 - 17 years and these units are at or near this age.

Not Acceptable, it is noted that three of the units, the left three as you face the building from the street are leaking at the base. This appears to be from condensate leaks.

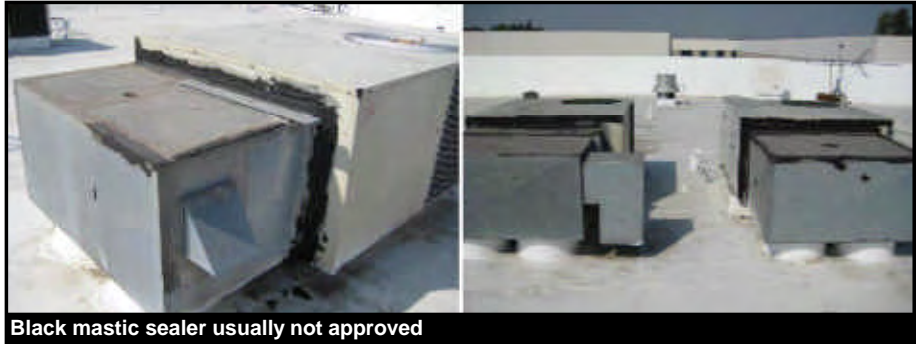
Needs Attention, there is ducting on the roof that has improper sealing material applied to them. This type of sealer is not designed for exposed roofing ducts. This has been done to 6 of the 11 units.

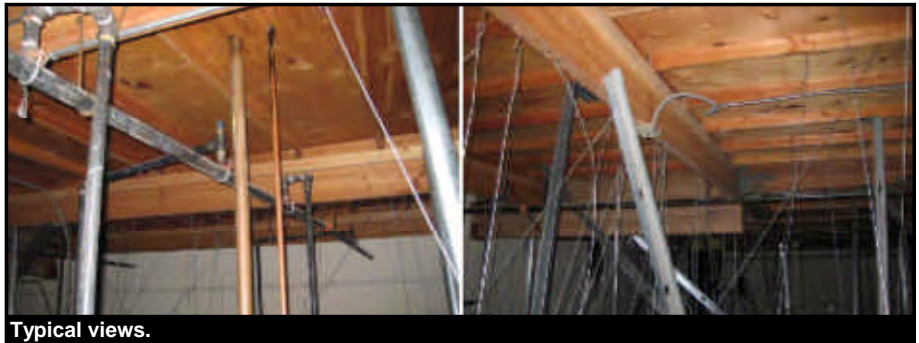
Typical views.

Serviceable, where visible however there are areas of stains on the framing lumber as from former roof leaks

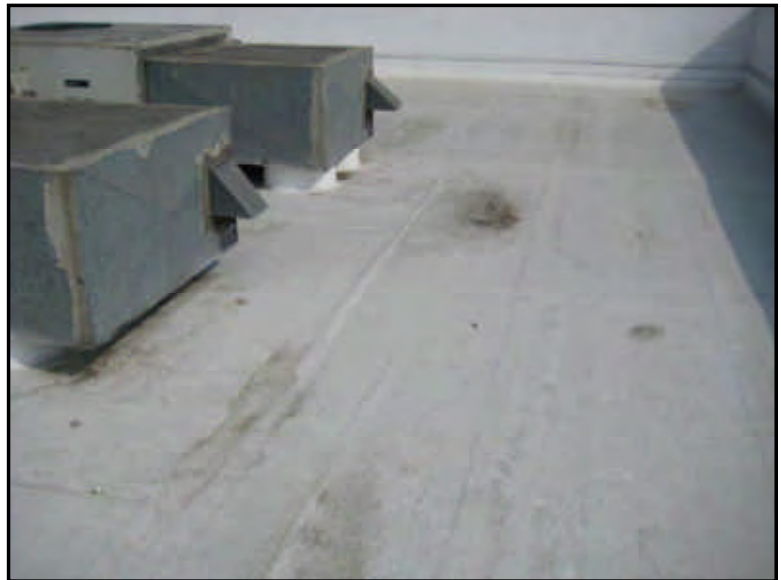
The roof appeared generally serviceable.

It is noted some wrinkles were noted on the roofing material at the right front near the HVAC units. This is usually is an indication that the roof was not properly installed. This may be due to installing roofing material over other roofing materials. The only way to fully determine the true condition is to do a roof coring which is beyond the scope of this inspection.

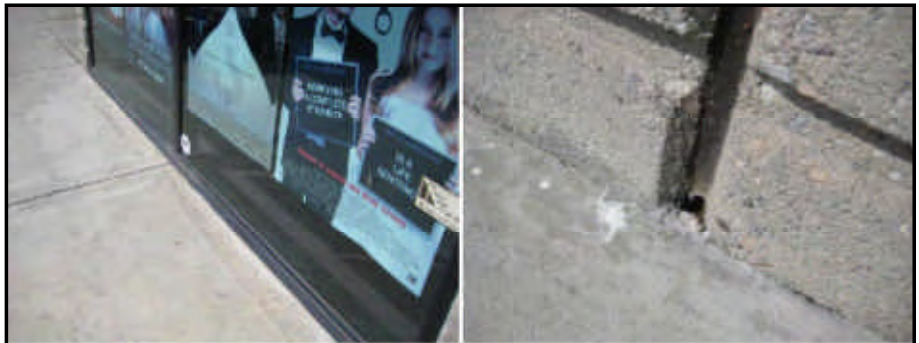
Serviceable overall.

Needs Attention, the metal window seals are aged and worn with some areas that no longer appear to be a weather tight seal. This is noted to areas such as at the corners of some windows in front of the Sheriffs area.

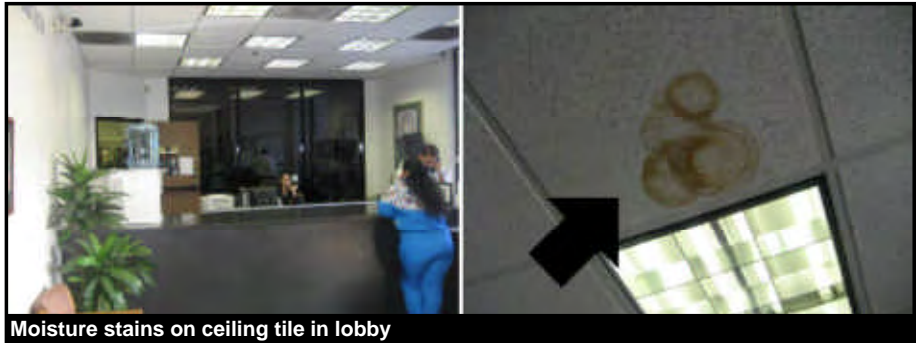
Moisture stains on ceiling tile in lobby

Needs Attention: There are moisture stains on the ceiling.

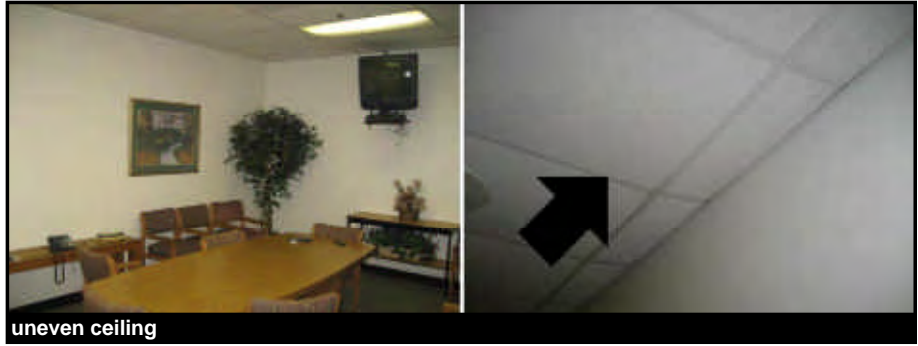
uneven ceiling
Conference Room

Needs Attention The ceiling is uneven in areas.

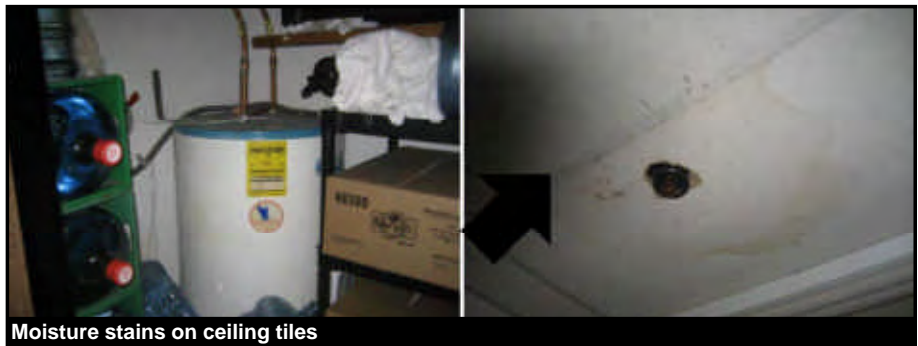
Moisture stains on ceiling tiles
Mop closet

Needs Attention There are moisture stains on the ceiling.

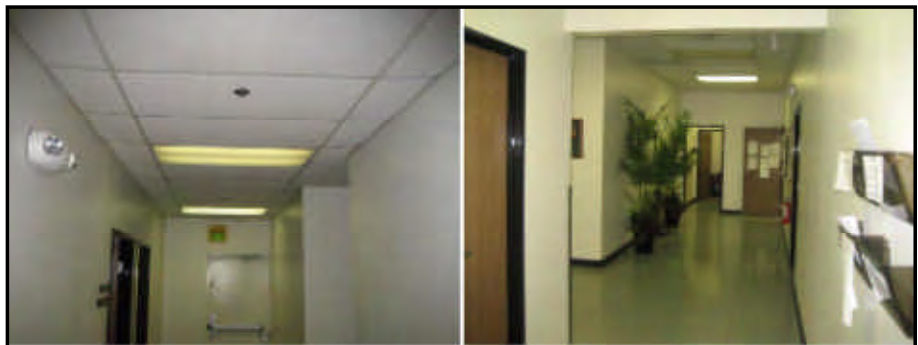
Needs Attention: There are areas of worn linoleum floors and carpet in the hallways.

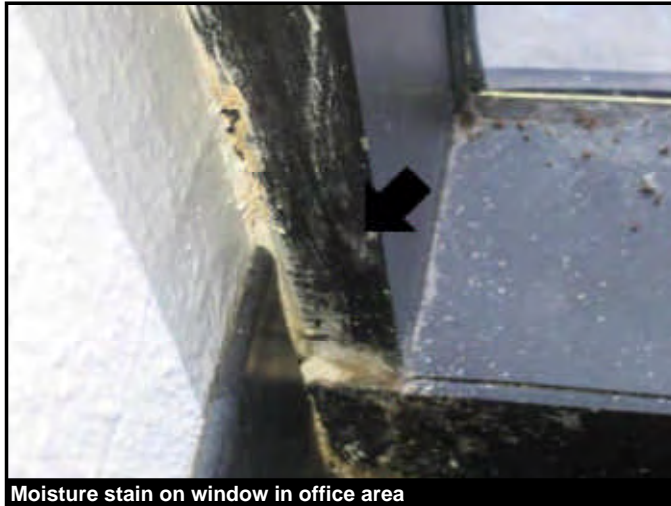
Moisture stain on window in office area

Needs Attention There is bubbling paint on the window sill in Fred Bertsche office & in Lt. Armalin office .

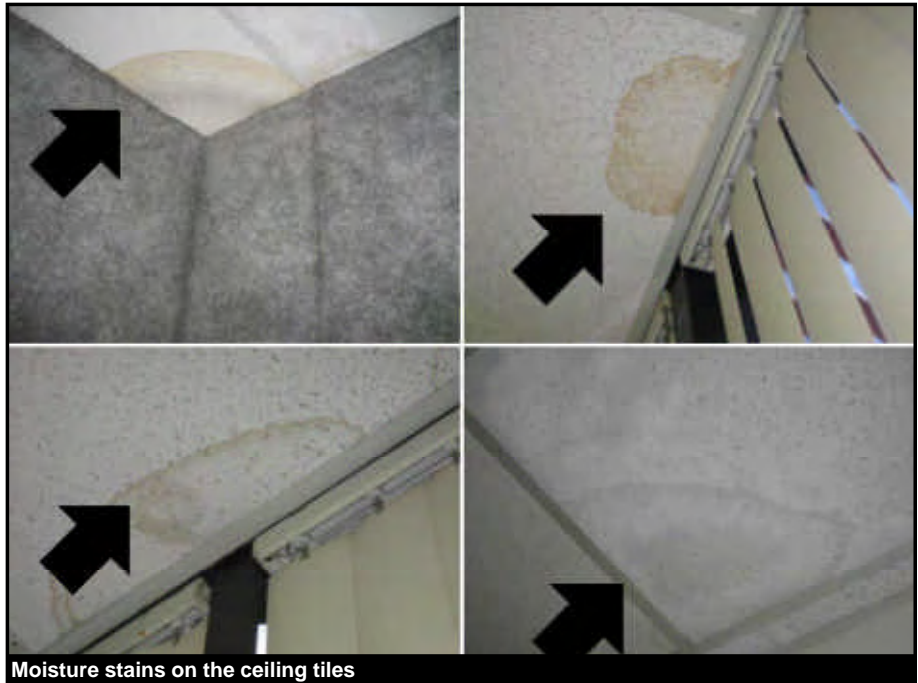
Moisture stains on the ceiling tiles

Needs Attention: There is typical wear to the unit,

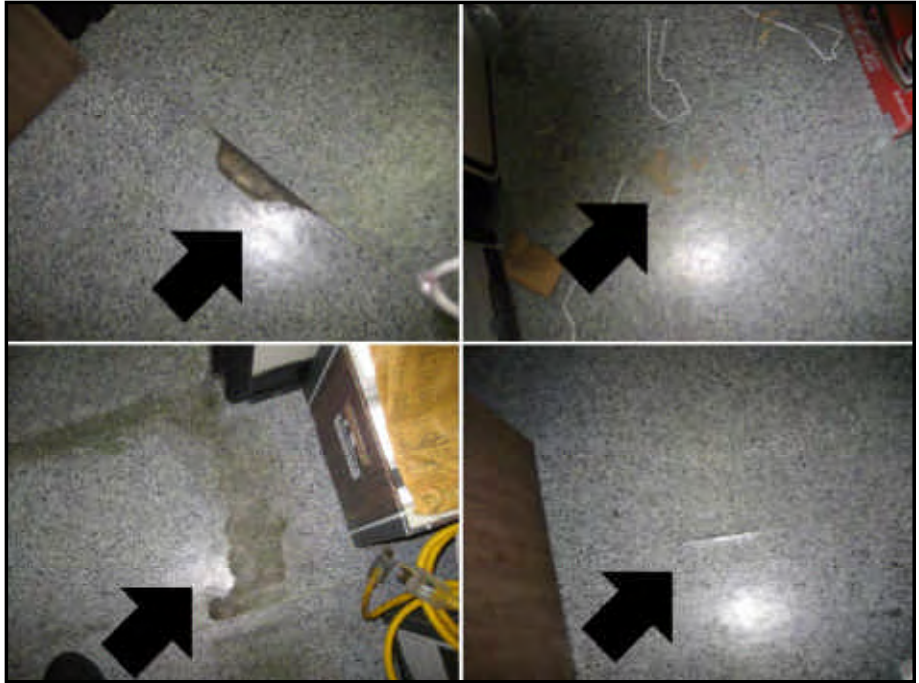
FLOOR: There are areas of worn and damaged linoleum. The carpet has areas of wear, staining.

Pictures of the worn, damaged and aged linoleum.

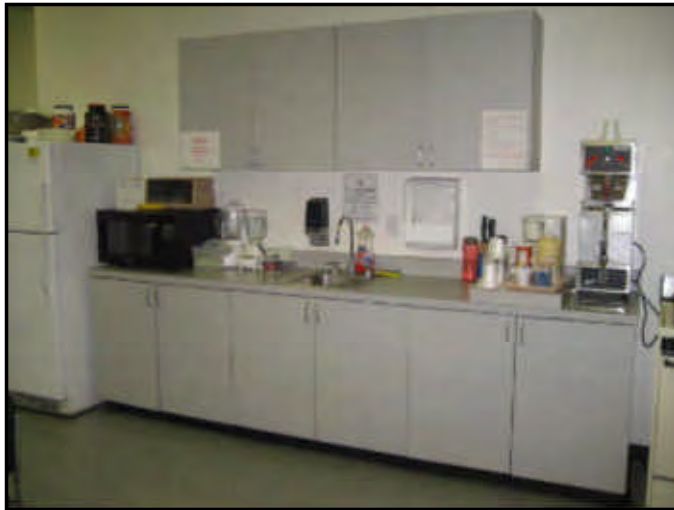
Needs Attention: While generally functional there are areas of wear and deterioration.

COUNTERS: The counter tops have areas of wear,

CABINETS: The cabinet surfaces are worn

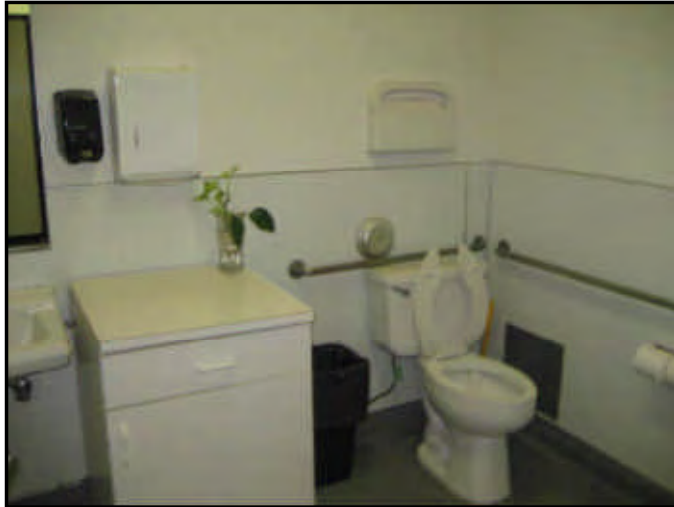
Restroom in left side corner of building

Needs Attention: While generally functioning there are areas with noticeable wear that could use servicing and maintenance.

The sink is not properly attached to the wall

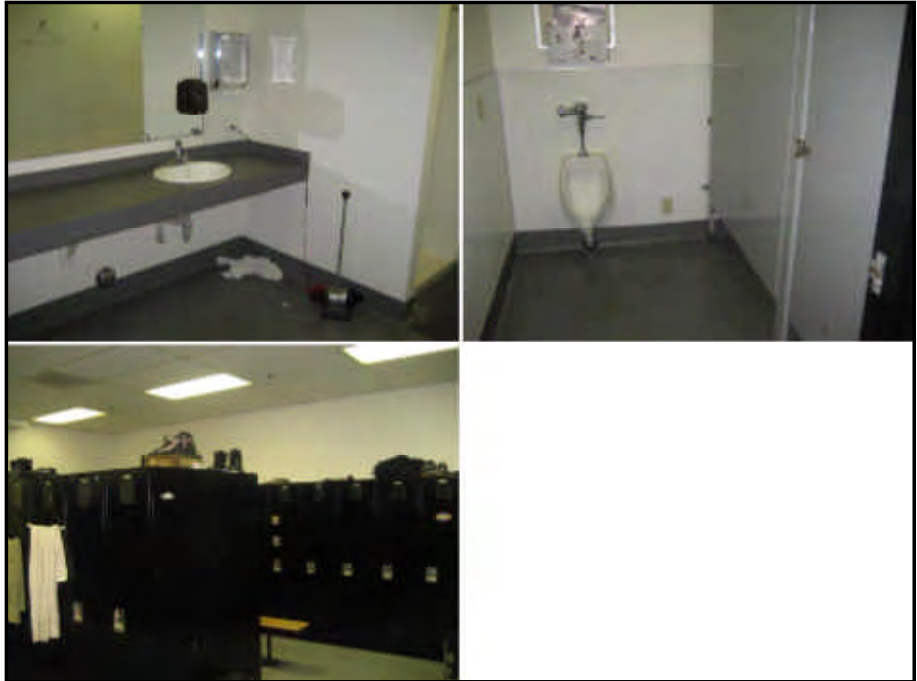
Mens Locker Room

Needs Attention: While generally functioning there are areas with noticeable wear that could use servicing and maintenance.

TOILET: The toilet is loose and not correctly attached to the floor.

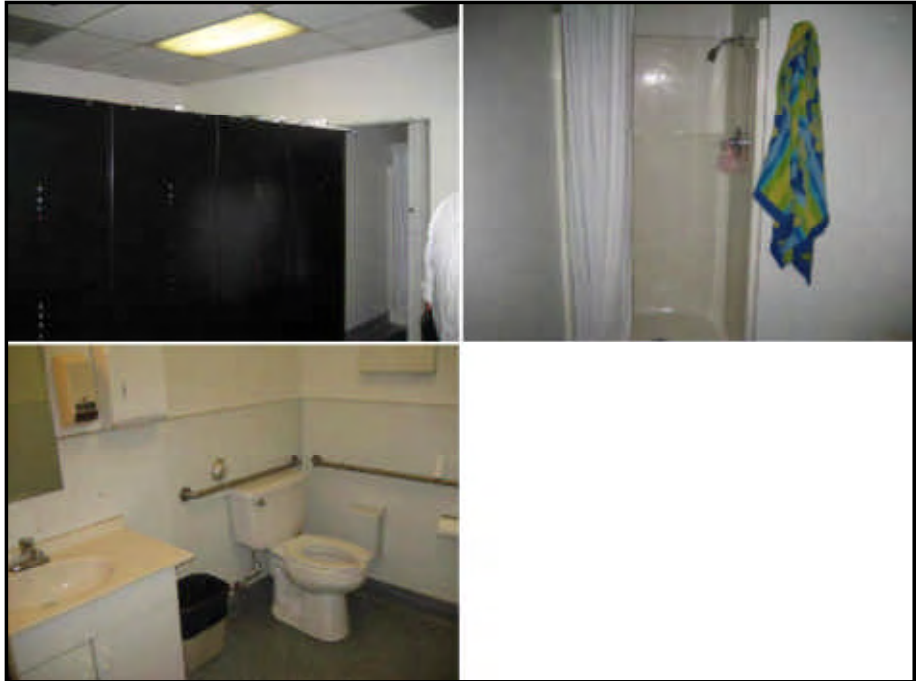
Needs Attention: While generally functioning there are areas with noticeable wear that could use servicing and maintenance.

FLOOR: The floor is worn and damaged in areas. Womens Locker Room

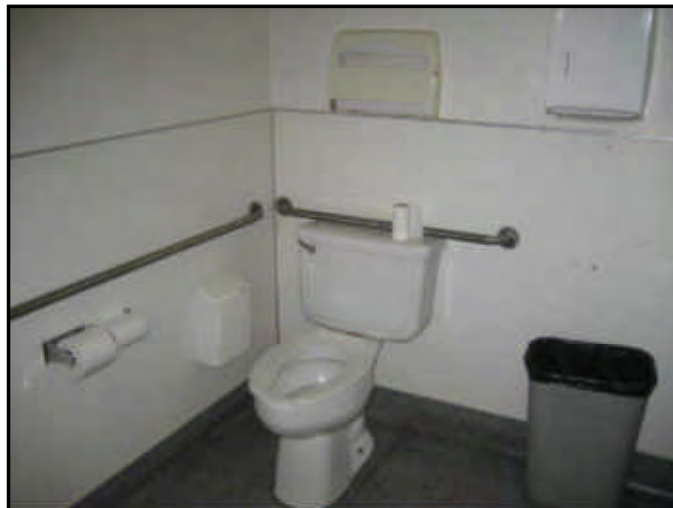
Restroom right side rear

Needs Attention: While generally functioning there are areas with noticeable wear that could use servicing and maintenance.

The sink is not properly attached to the wall

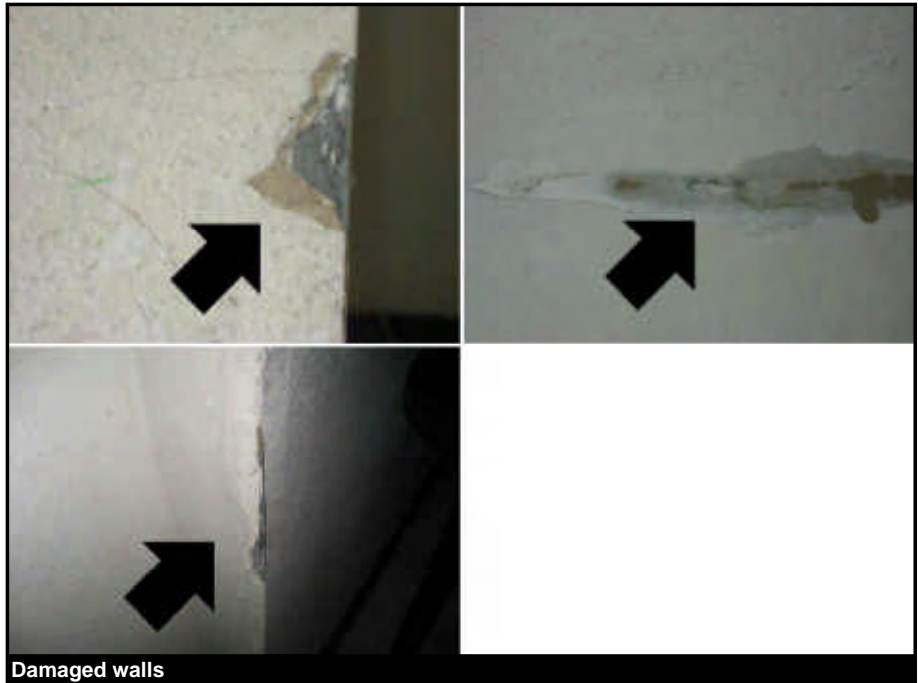
Not Acceptable: This unit is showing excessive wear and in need of maintenance and repairs,

WALLS: There are areas of damage to the walls

FLOOR: The linoleum flooring is damaged in multiple areas. The carpet has areas of wear, staining, tears / damage

It is noted that the rear door handle is damaged and that there are multiple moisture stains on the floors and under the sinks.

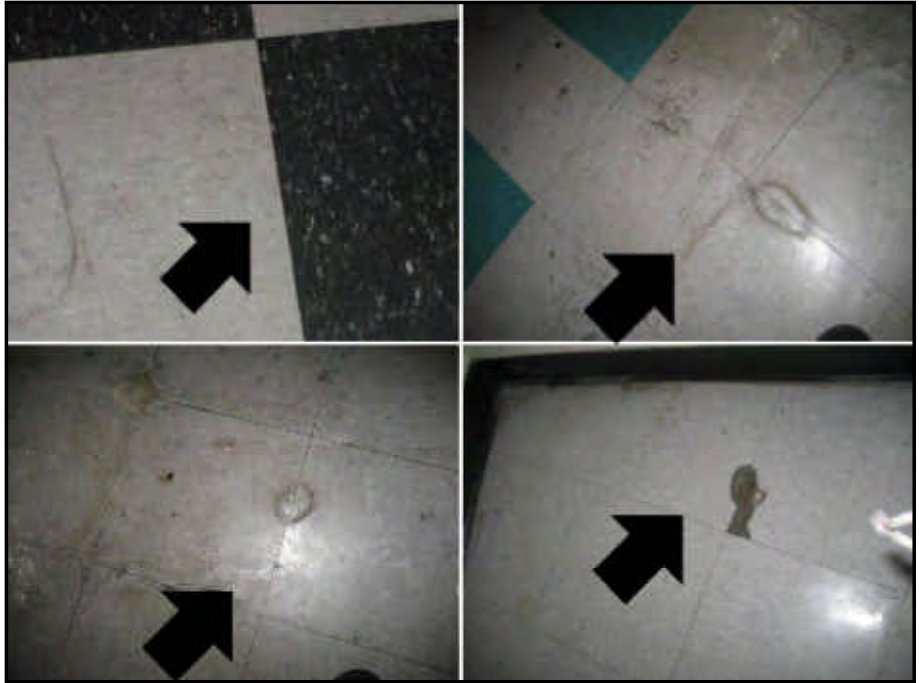
Pictures of the worn and damaged floors.

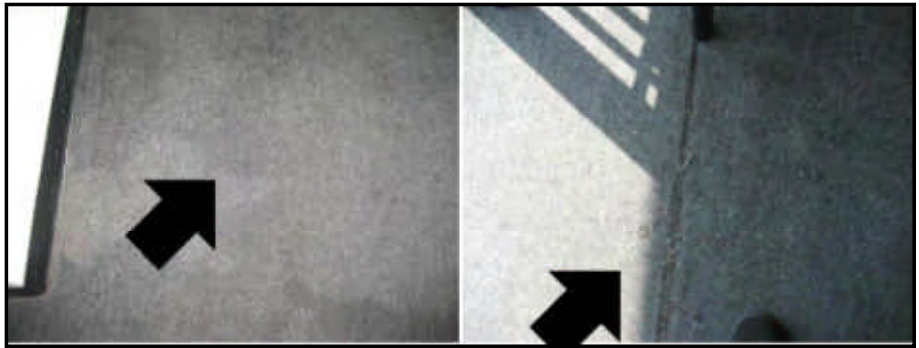
Pictures of the worn and damaged carpet.

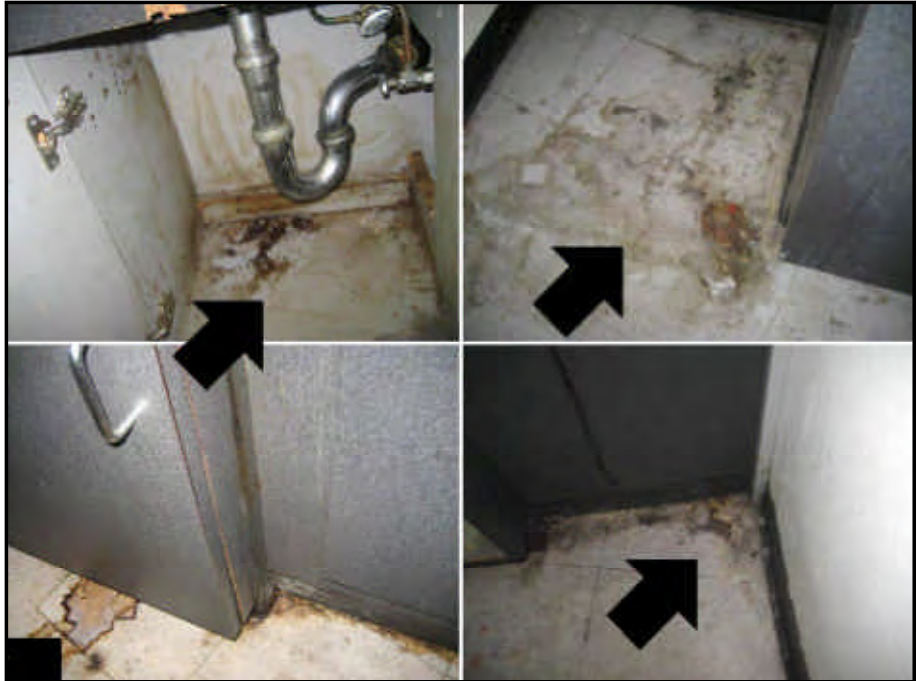
Pictures of the moisture stains on the flooring.

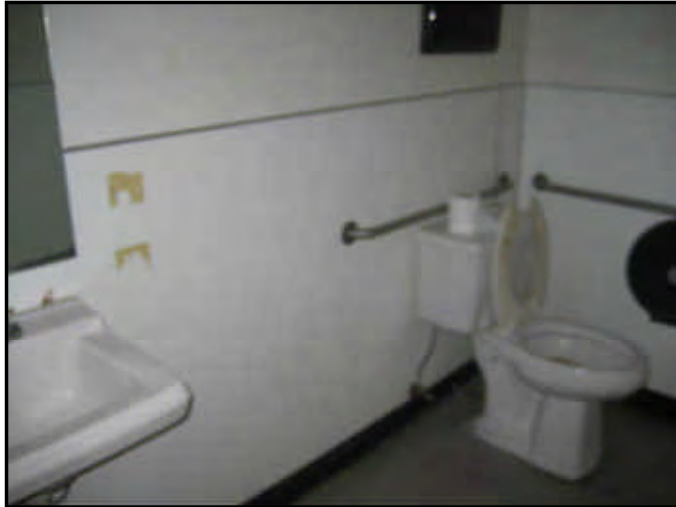
Mens Restroom

Needs Attention: While generally functioning there are areas with noticeable wear that could use servicing and maintenance.

SINK:There was no hot water in the sink.

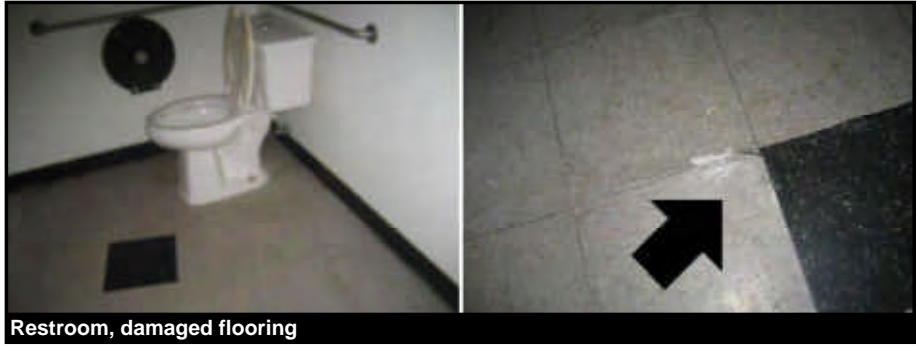
Needs Attention: While generally functioning there are areas with noticeable wear that could use servicing and maintenance.

WALLS / CEILING: There are areas of damage that will need repair

SINK: The sink is cracked. There was no hot water in the sink.

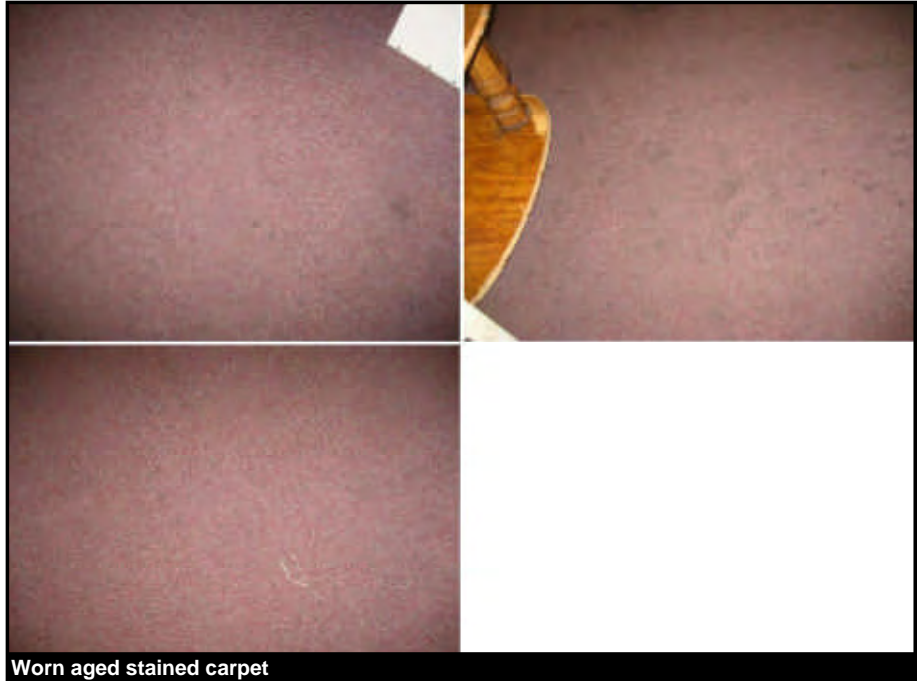
Worn aged stained carpet
Needs Attention: There are areas with significant wear, this unit may be ready for maintenance.

WALLS: There are areas of damage to the walls

CEILING: There are areas of moisture stains on the ceiling, There are areas of damage to the ceiling.

FLOOR: The carpet has areas of wear, staining, tears / damage. The linoleum is worn and aged in multiple areas

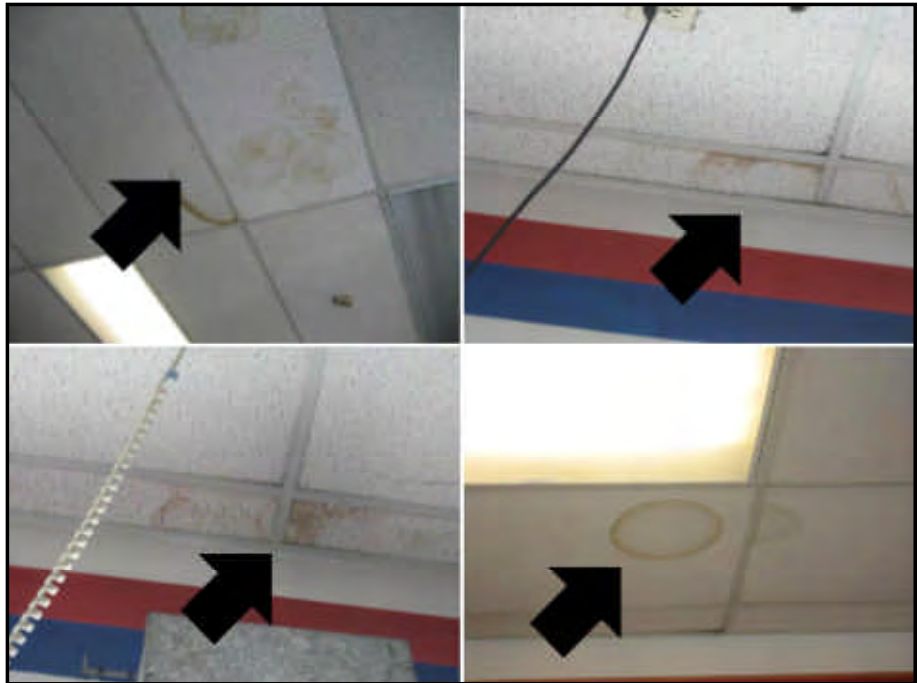
Pictures of the moisture stains on the ceiling.

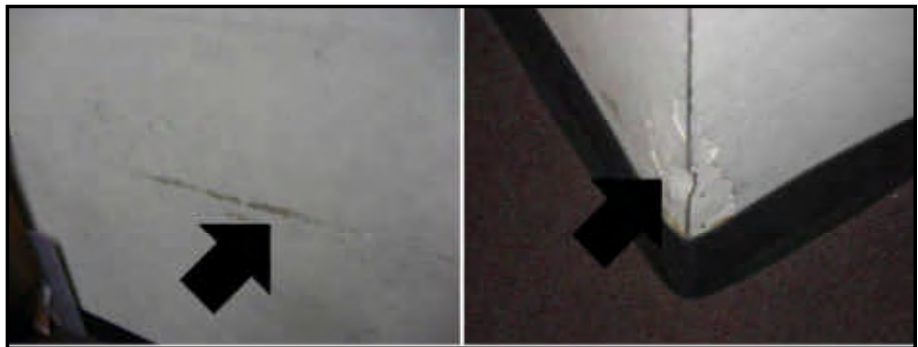
Picture of the damaged walls.

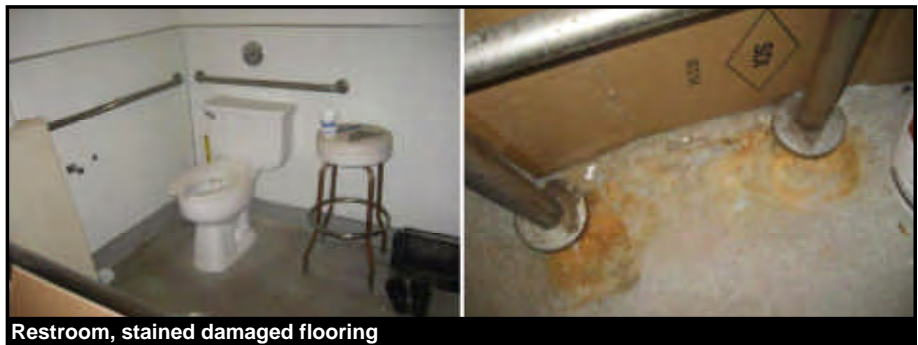
Restroom, stained damaged flooring

Needs Attention: While generally functioning there are areas with noticeable wear that could use servicing and maintenance.
