RISK ASSESSMENT[®]

ADDRESS: La Quinta, CA 92253

<i>CLIENT: Shopping Mall Investor</i>	28 Apr 2008
---------------------------------------	-------------

RISK Assessment[®] Report

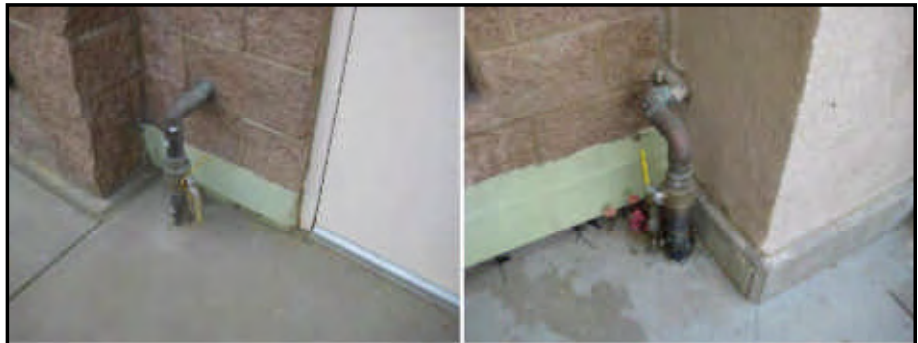
MAIN WATER SHUT OFF LOCATION:

On the back of the buildings.

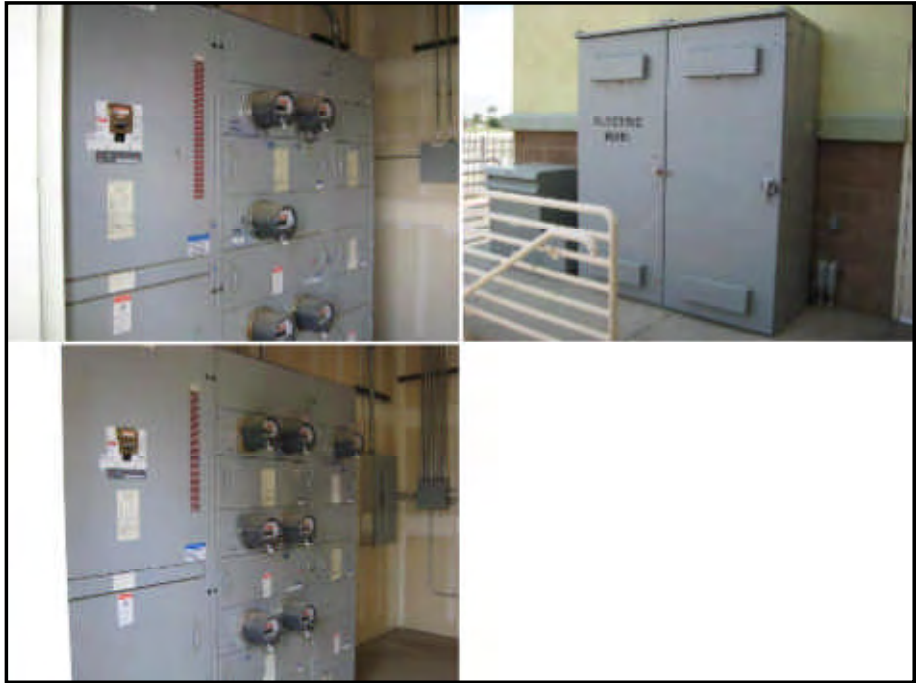
MAIN PANEL
LOCATION:

In the rear of each unit.

A, & C have electrical rooms. Unit B has a stand up panel at the exterior.

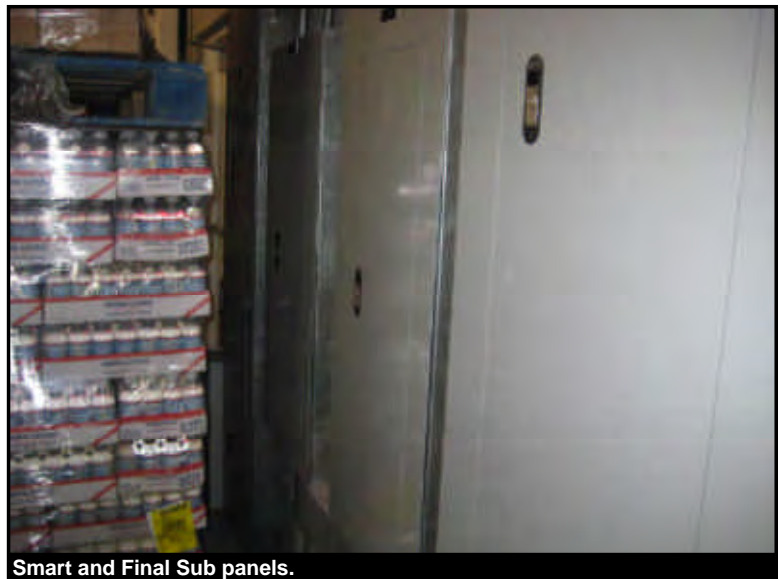
Smart and Final Sub panels.

Serviceable overall in appearance however it is noted that the sub panels in Smart & Final have articles in front of them. At Smart and Final there are sub panels on the site that do not have the recommended 36" of clearance for safety.

Also It is noted that there are no protective bollards (heavy metal posts) in front of the sub panels to protect from damage due to

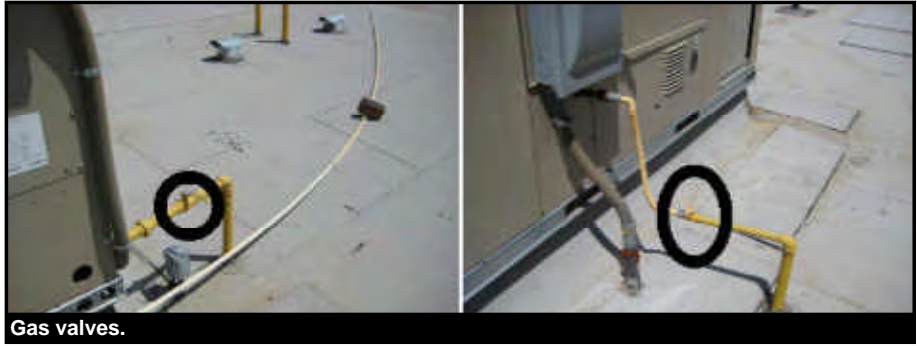
Gas valves.

Serviceable, however it is noted that the gas was off to all three units.

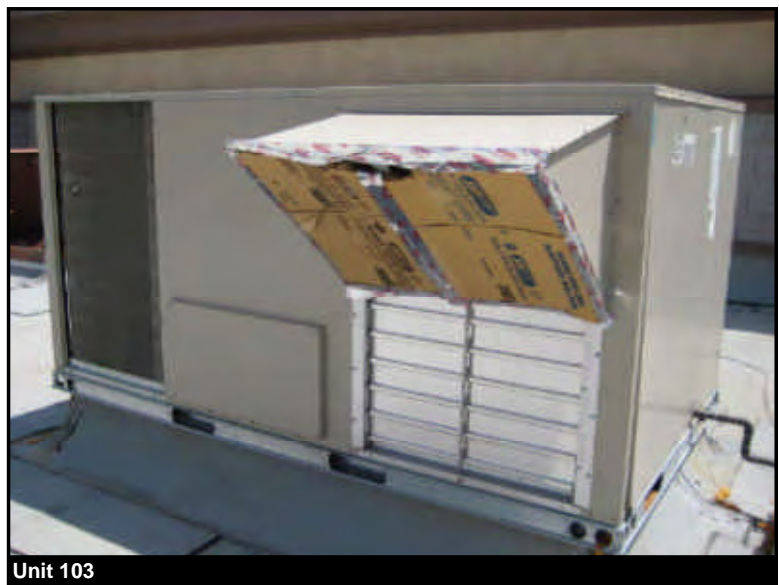
Unit 103 has cardboard over the intake vents. This is normally not recommended. Full review by a qualified professional is advised at this time to determine the status of this unit.

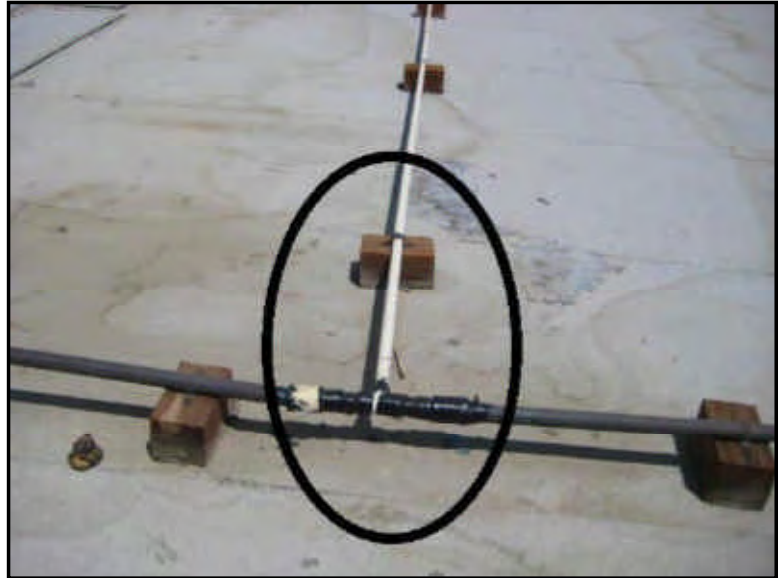
Serviceable overall however the gas was off to unit TRU-4.

Needs Attention, The condensate lines are made of plastic material. Generally the required material is metal.

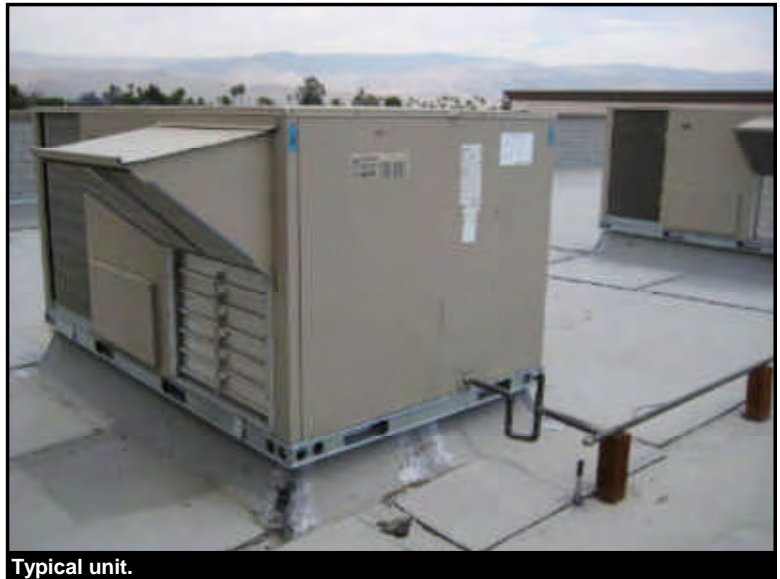
Typical unit.

Serviceable.

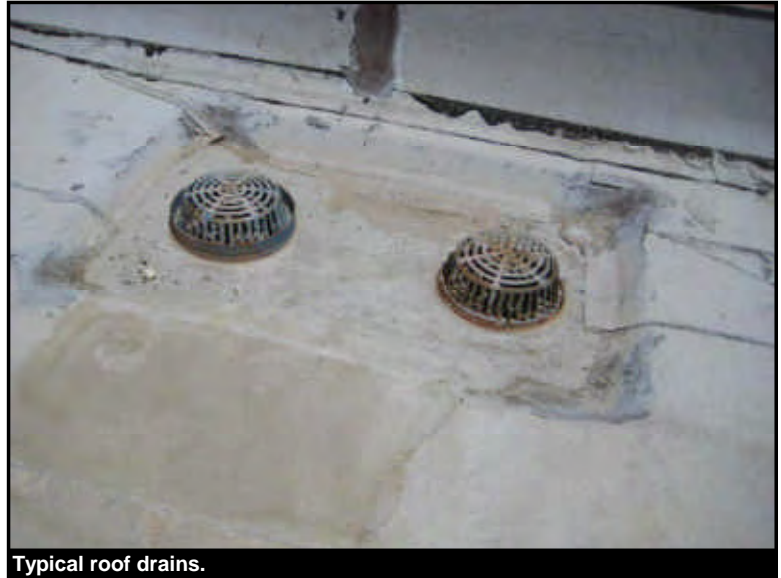
Typical roof drains.

This building contains roof drains. The majority of the piping for these drains is contained in the walls or ceilings of the building. The piping is concealed for the most part. Visual inspection of these drains is limited to the areas visible on the roof and at the exit locations. If further investigation is needed it is advised to have the drains examined by a qualified specialist with an internal camera.

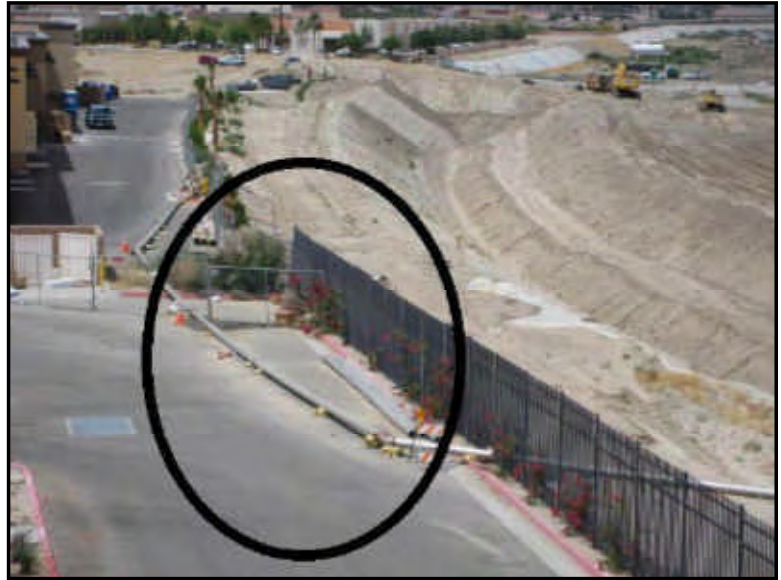
There were no observable defects in the grading and drainage within six feet of the building, though it is noted that The site is a relatively flat site, it is expected that there will be some areas where water will pool during rainy periods.

Also it is noted there is piping in the rear that was disclosed as being temporary. It is advised to obtain full disclosure of this from the seller.

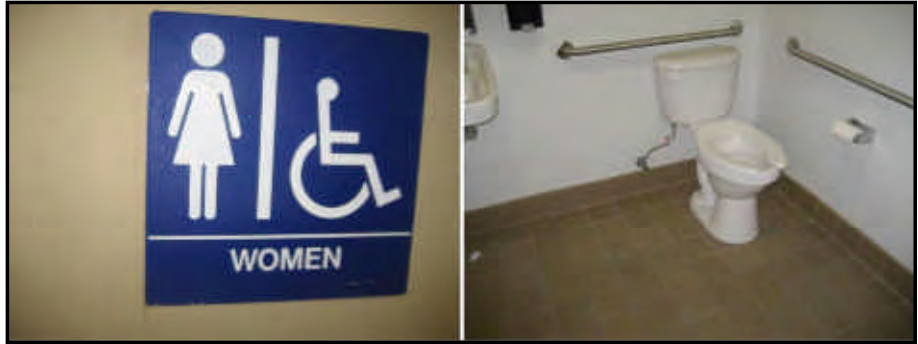
Womens Restroom

Serviceable: The bathroom surfaces and fixtures appeared to perform correctly when operated briefly.

However there was no hot water in the sink.

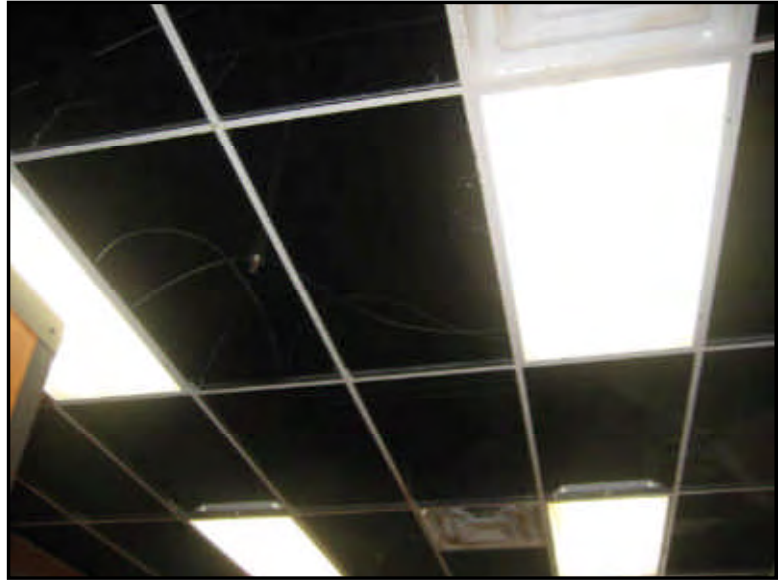
Serviceable - however there are ceiling tiles missing.

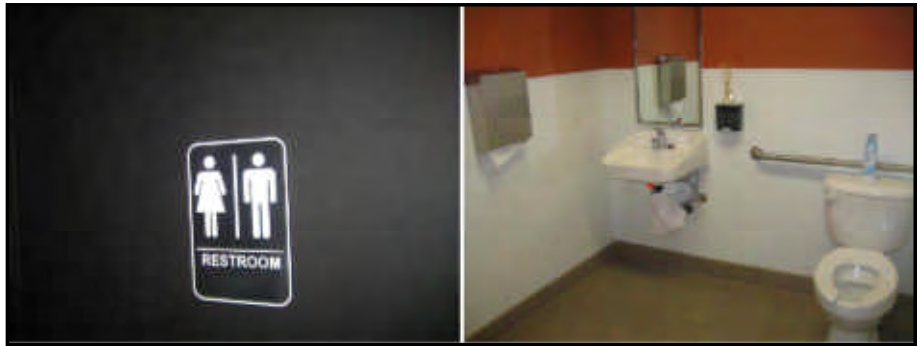
Needs Attention:

TOILET: The toilet is loose and not correctly attached to the floor.

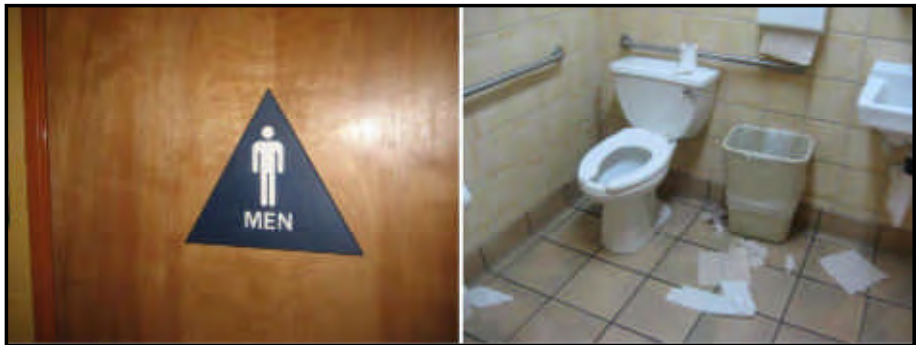
Needs Attention:

TOILET: The toilet is loose and not correctly attached to the floor. Mens Restroom

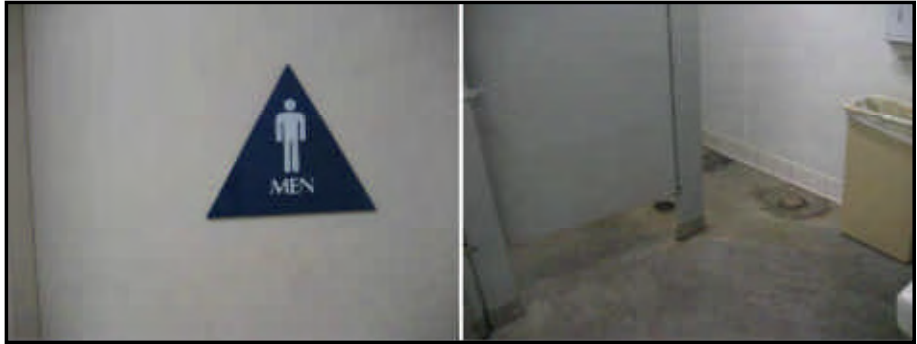
Mens Restroom

Needs Attention: While generally functioning there are areas with noticeable wear that could use servicing and maintenance.

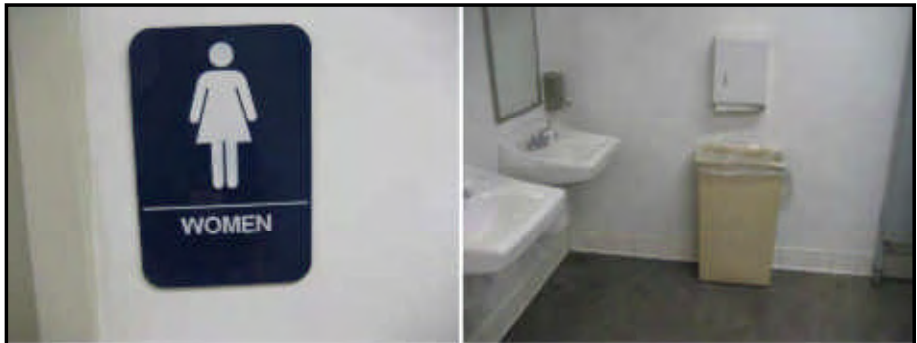
Womens Restroom

Needs Attention: While generally functioning there are areas with noticeable wear that could use servicing and maintenance.

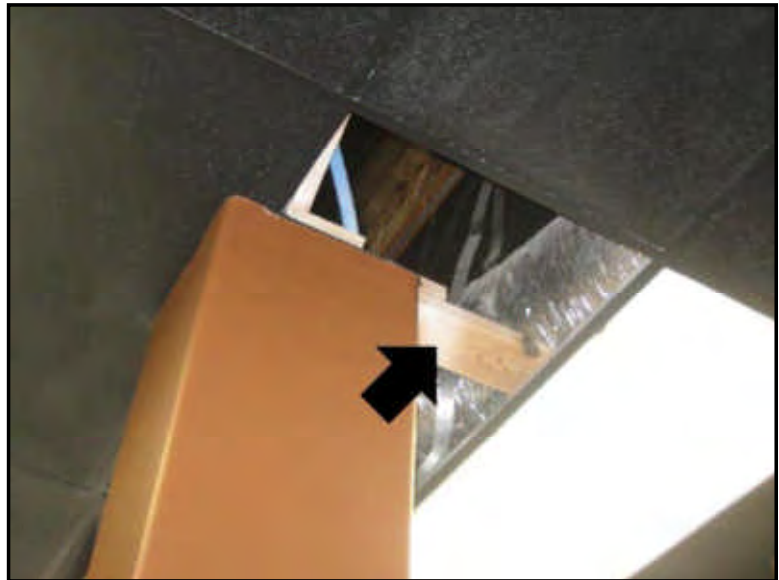
Serviceable, there is typical wear to the surfaces however there are some missing ceiling tiles.

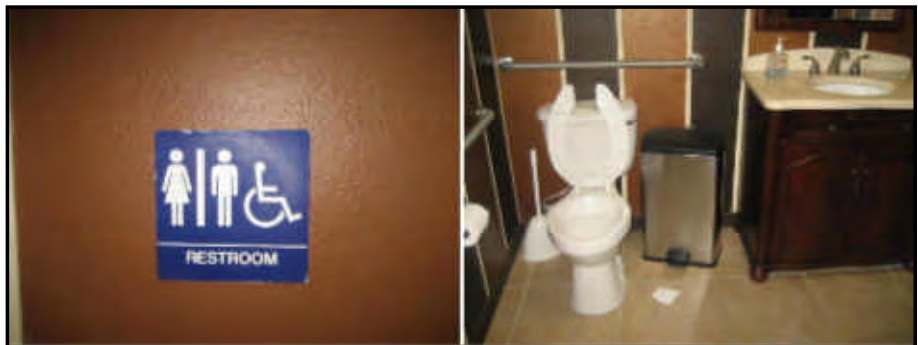
Needs Attention:

TOILET: The toilet is loose and not correctly attached to the floor.

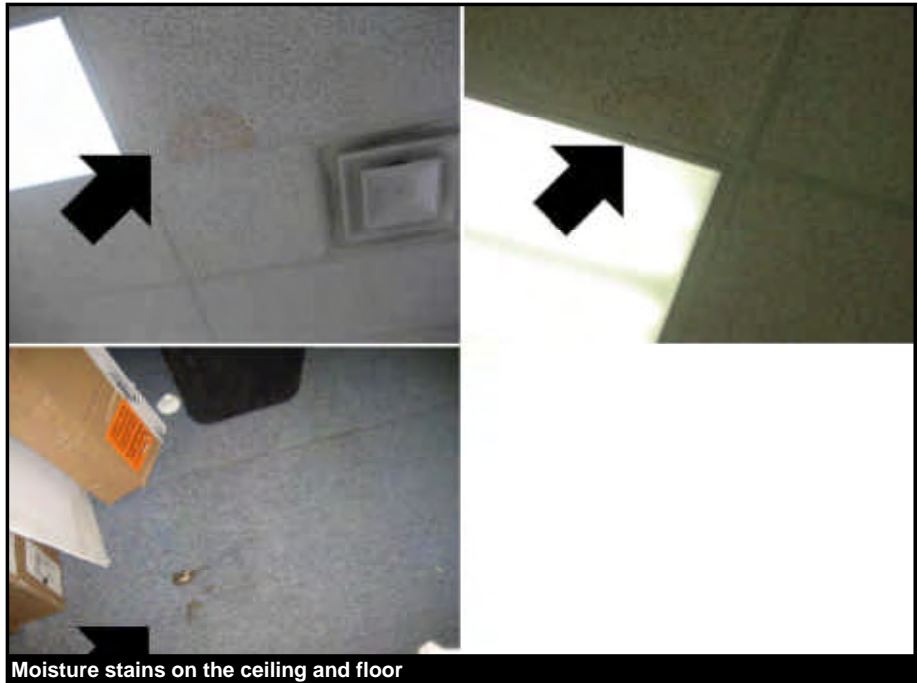
Needs Attention:

CEILING: There are areas of moisture stains on the ceiling,

FLOOR: The carpet has areas of wear, staining, tears / damage.

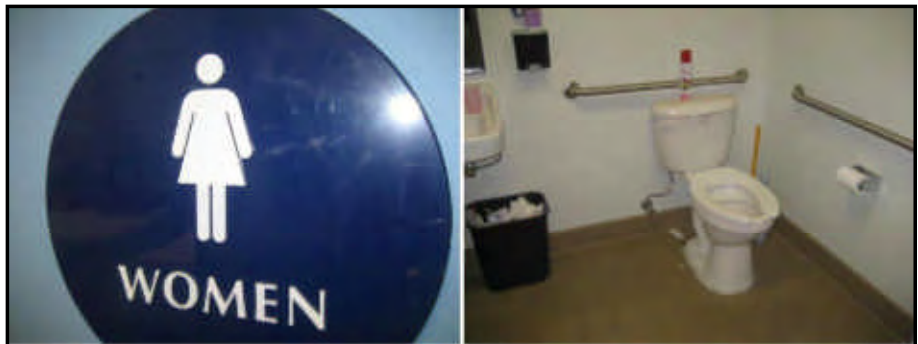
Womens Restroom

Needs Attention:

TOILET: The toilet is loose and not correctly attached to the floor.

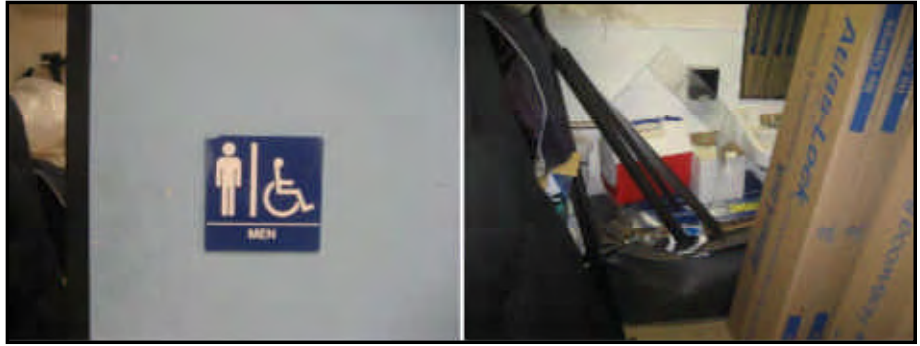
Mens Restroom

Needs Attention: There are multiple personal items in the restroom area. It is noted that the walls are not finished in the restroom.

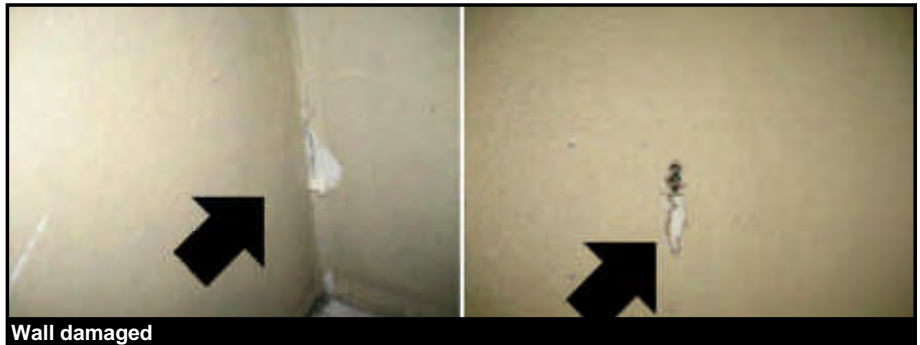
Needs Attention:

WALLS: There are areas of damage to the walls

CEILING: There are areas of moisture stains on the ceiling.

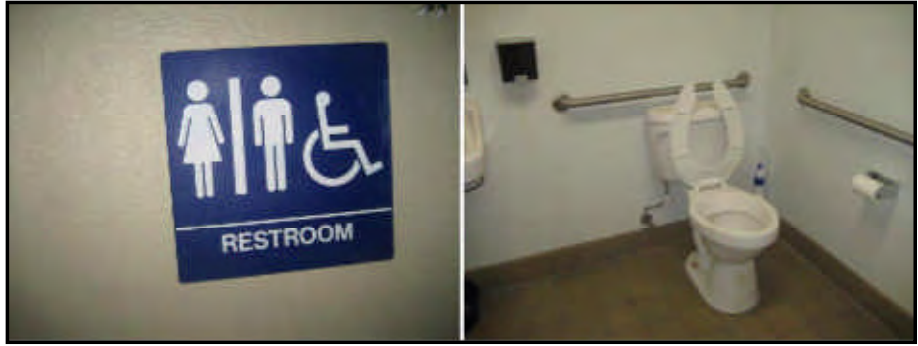
Needs Attention:

SINK: The sink is Not properly attached to the wall.

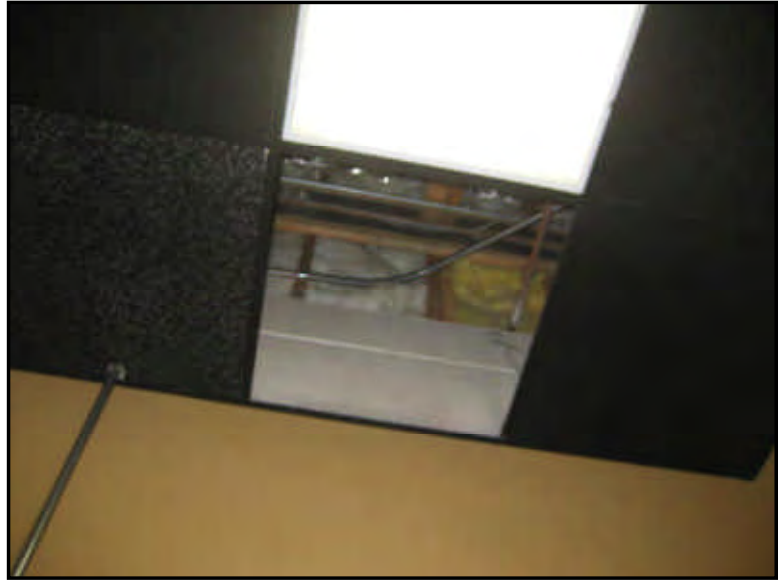
Needs Attention: There are ceiling tiles missing.

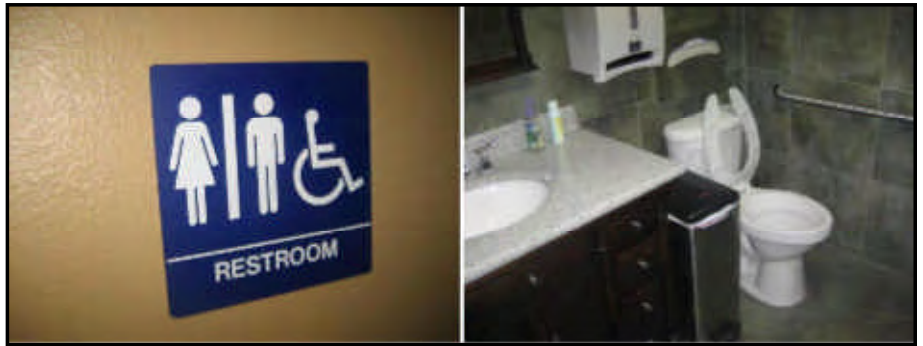
Needs Attention:

TOILET: The toilet is loose and not correctly attached to the floor.

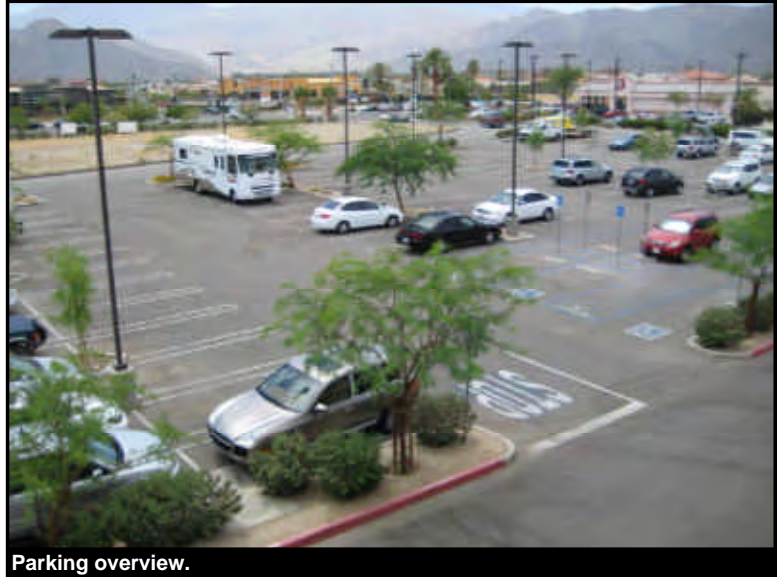
Parking overview.

Needs Attention, The parking areas are worn.
