# RISK Assessment® Report

**Pomona, CA 91767**

# RISK ASSESSMENT<sup>®</sup>

This is an assessment of the five major systems - Plumbing, Electrical, Heating and Air Conditioning, Structure and Roofing along with an assessment of any other current deferred maintenance issues for the site.

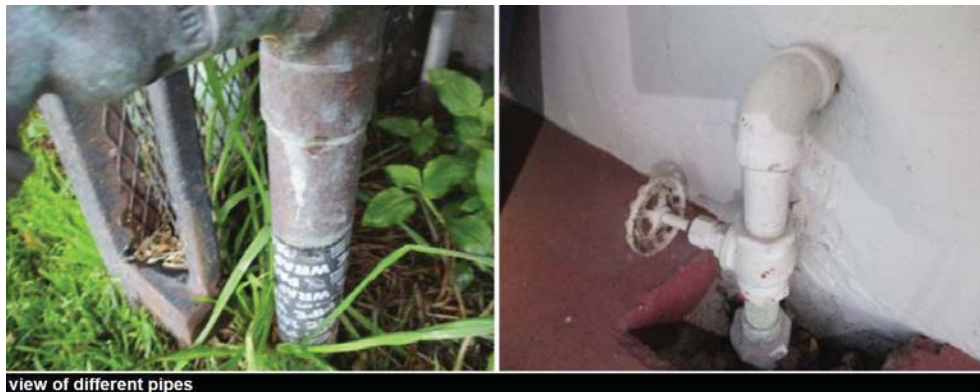
Copper to the church

Galvanized iron to the house.

**It appears to be the original plumbing with aged galvanized iron piping which is at or near the end of it's expected useful life.**

**It is recommended to replace all original galvanized iron piping in the system.**

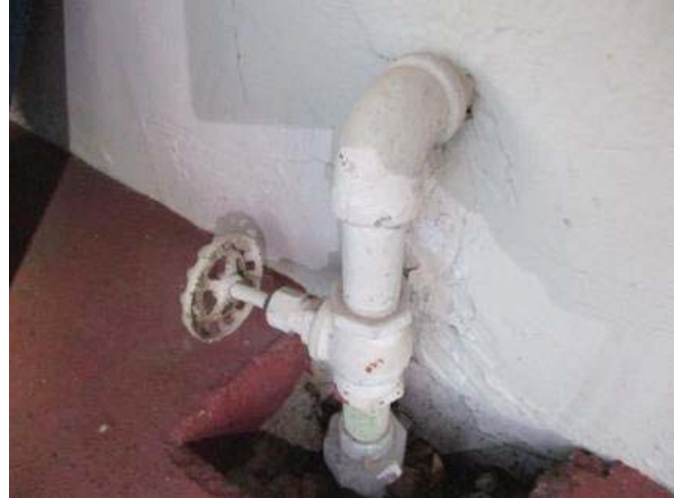
**No pressure regulator was observed at the main line where it enters the structure. They are sometimes installed in other locations that are not readily discoverable.**

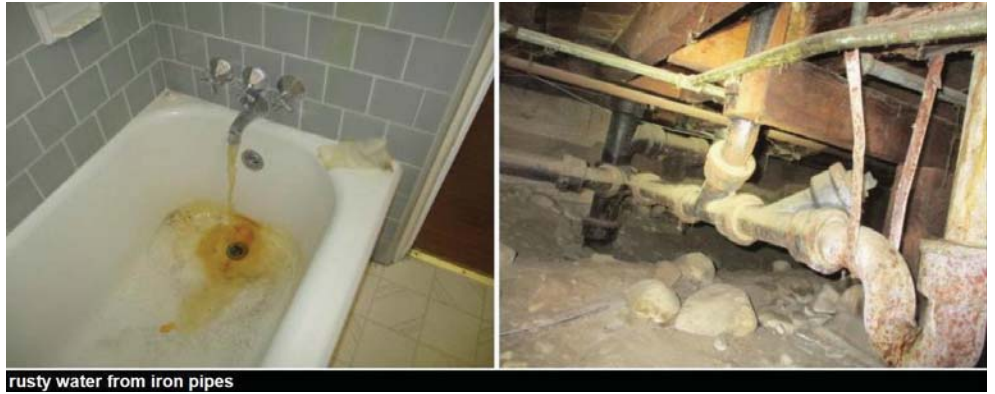
**The original galvanized steel piping that is left in the system has rust and is showing deterioration. These will need to be replaced as they continue to wear out.**

**Rusty water comes out of the tub and sink in the bathroom.**

rusty water from iron pipes

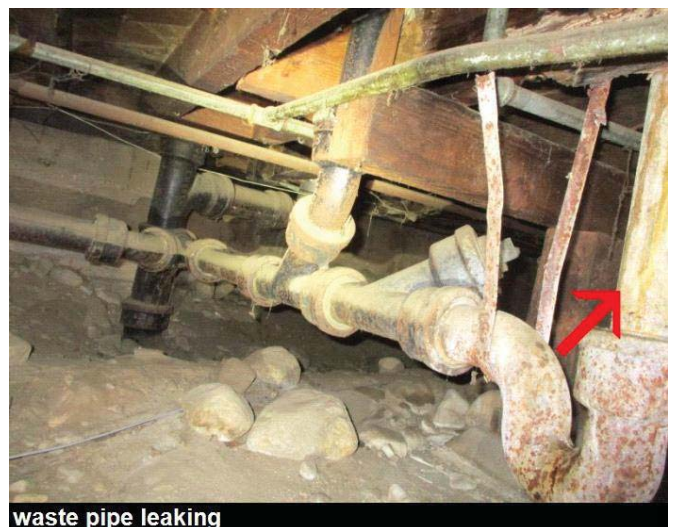
**Waste leak is seen  
under the bathroom  
of the house.**

waste pipe leaking

**The interior of the waste lines are not visible. A detailed investigation can only be performed by the use of an internal camera by a specialty contractor. Such an inspection is recommended at this time as only by this kind of inspection can the actual condition of the waste lines be determined.**

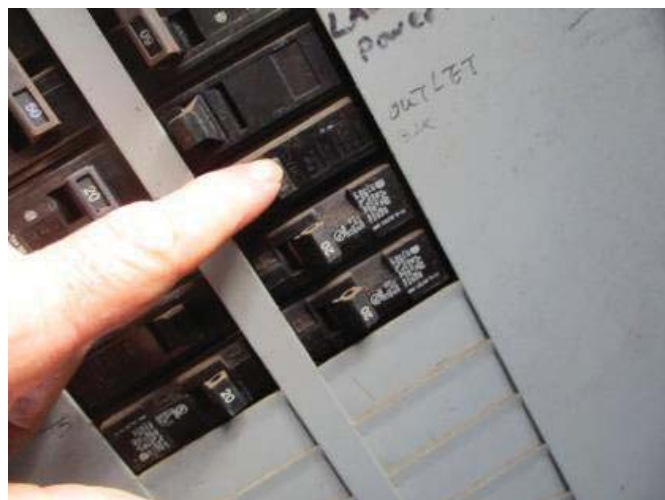
**Church panel cover is missing a hinge.**

**Some breakers are in the off position for an unknown reason ( Church)**

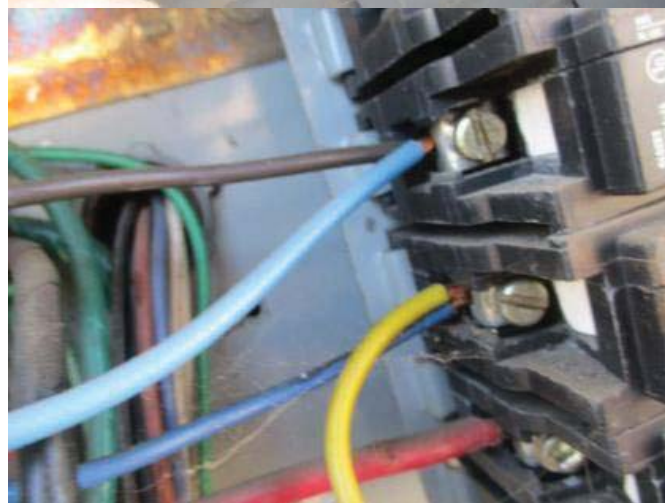
**There is more than one wire connected to a single circuit breaker, where only one wire should be connected to each breaker. This can sometimes cause overloading of the wires or breakers. It also can cause the wires to have improper contact with the breaker and arc between the wire and breaker connection. Seen at house panel.**

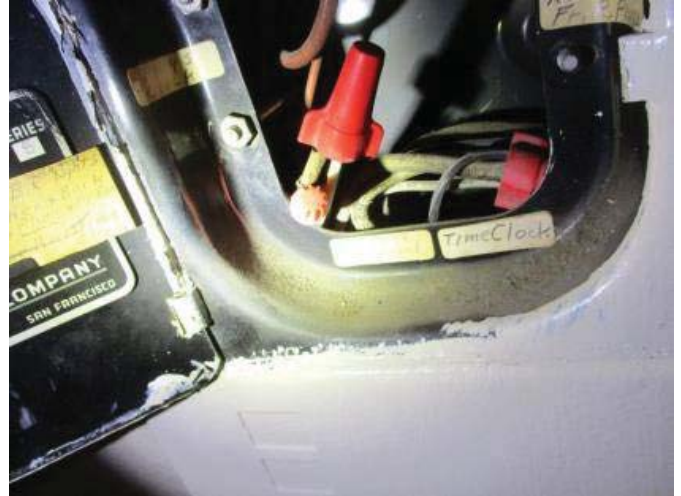
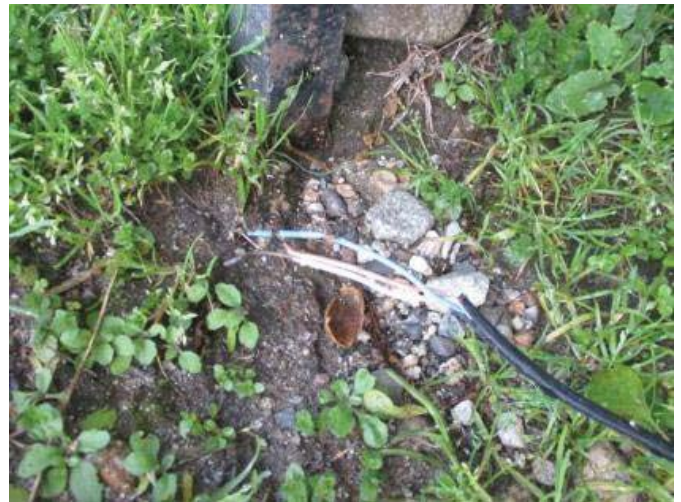
The wiring is a combination of the original cloth covered wiring and plastic coated wiring. The cloth covered wiring is older but may continue to generally function unless it is disturbed or overloaded. The cloth covering will continue to wear out and have to be replaced at some time in the future when it can no longer serve its purpose of insulating the wires.

Exposed or disconnected wire seen in front planter area.

**It is advised to have all original portions of the wiring removed and to have modern wiring installed by a qualified professional for health and safety.**

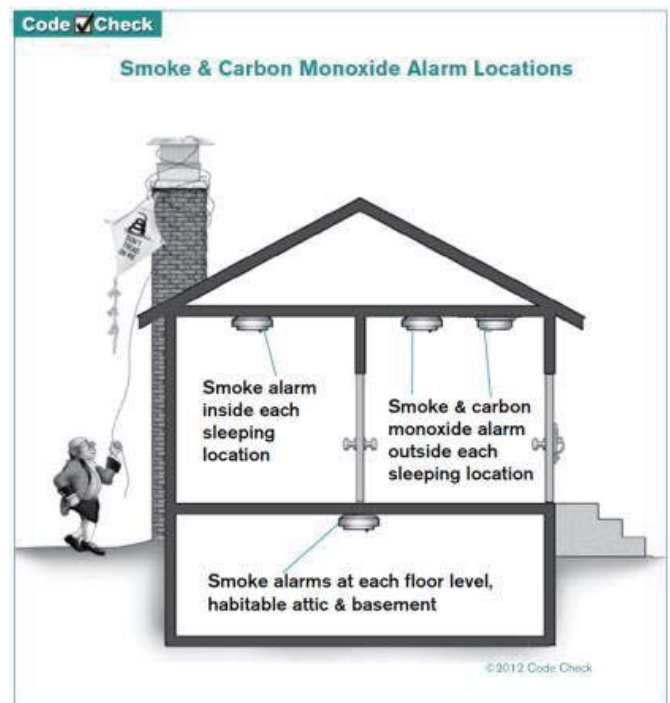
**There are missing smoke detectors in some areas.**

**Smoke detectors are needed to comply with local safety regulations and escrow instructions. Most local cities require detectors in each sleeping area and the adjoining living area, within twelve feet of the door of the sleeping areas. It is advised to check with the local municipality to determine their requirements.**

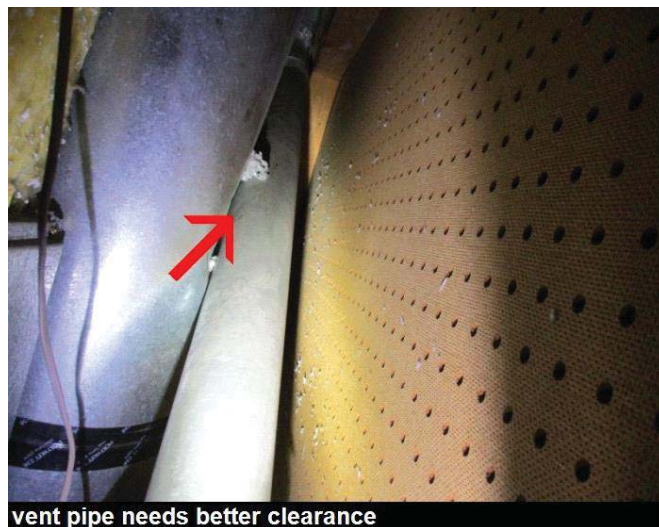
**Clearance from combustibles appears inadequate.**

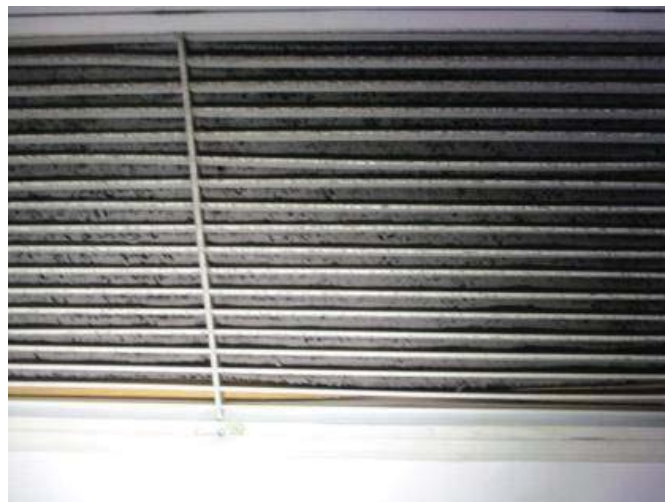
**The air filters are dirty and need to be replaced.**

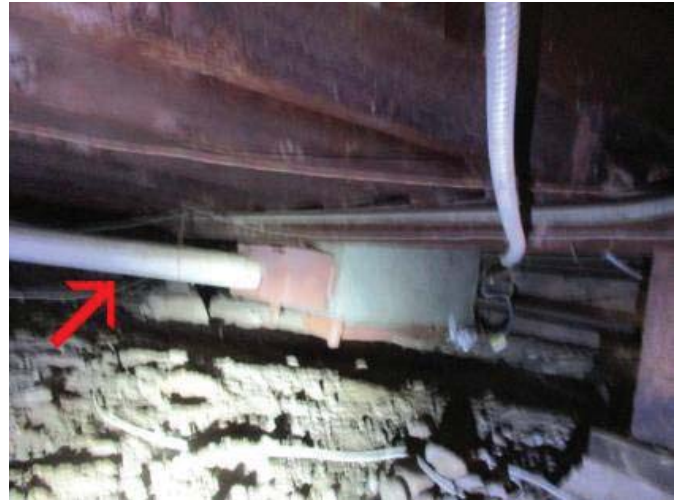
**The furnace vent line goes into piping made of older materials. Many manufacturers specify that a new metal vent pipe be installed when the new furnace is installed. This older piping can allow condensation to run back into the furnace causing it to rust prematurely or not vent properly.**

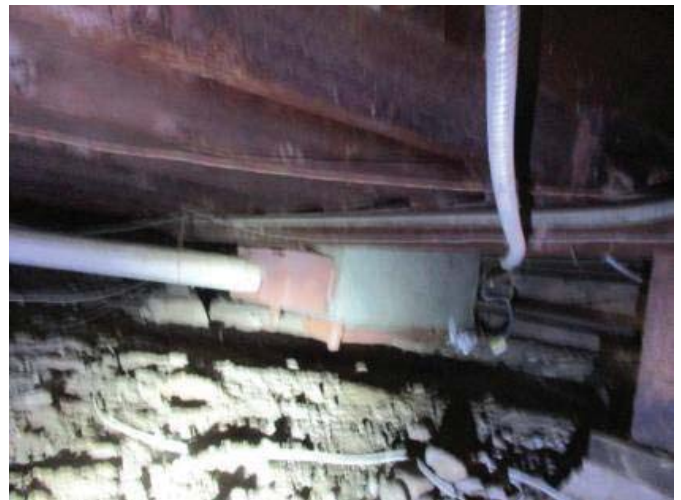
**Floor furnace is operating but is aged and rusted.**

**Advise unit be cleaned and serviced by a Heating expert.**

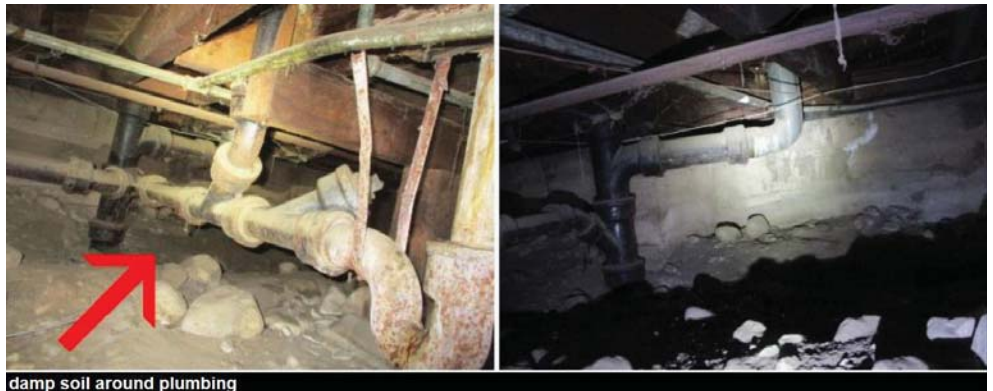
The crawl space has debris in it, it is advisable to have it removed and the area cleaned up. Wood / cellulose especially should be removed to help prevent future infestations.

There are areas of damp soil under the building.

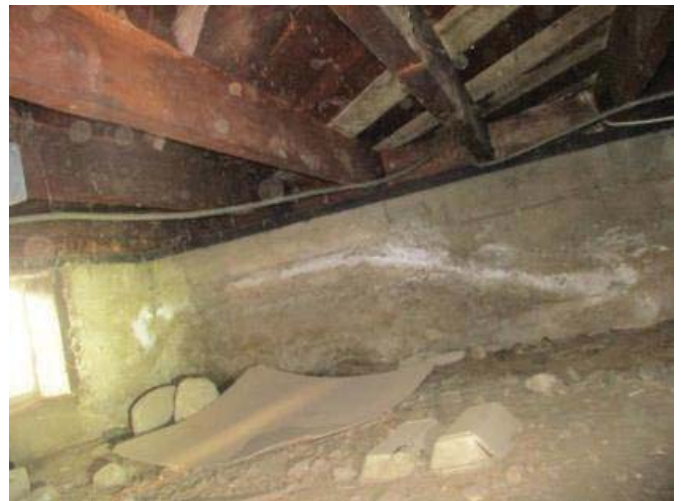
There are areas of the foundation that show signs of moisture intrusion. This is evidenced by the presence of efflorescence. This is the white chalky substance on the concrete that are mineral salts pulled through the concrete due to moisture being present on the exterior. Typically this is not a structural concern.

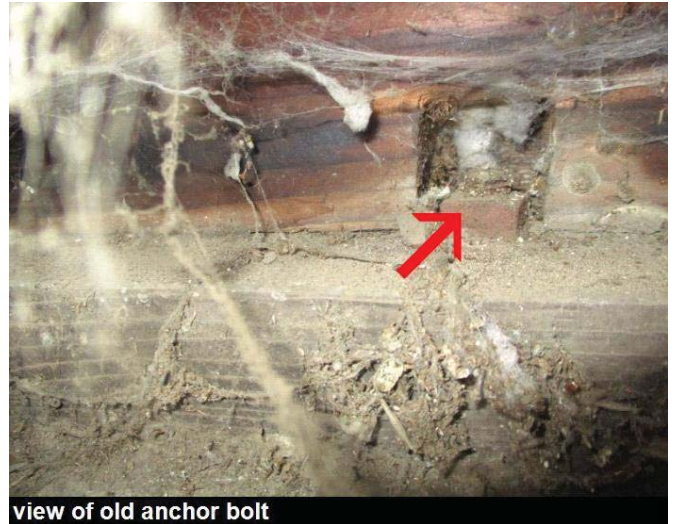
**The structure has some original anchor bolts. There are not many of these bolts and it does not meet today's standards that have been established for bolting. This would be evaluated by a foundation expert if additional work was to be undertaken to bring it up to these standards.**

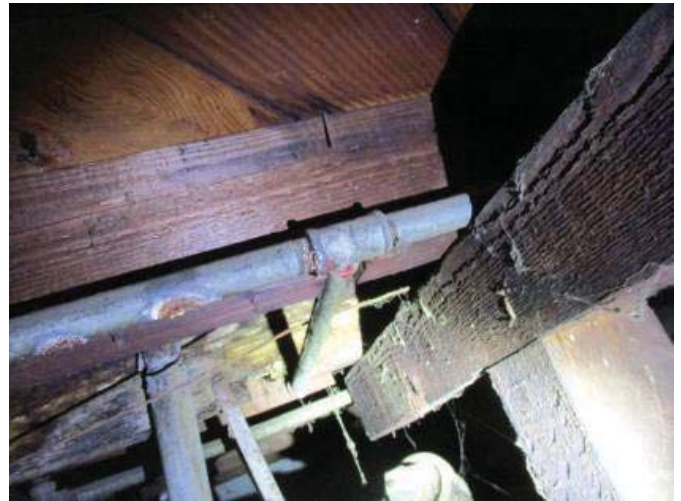
**There are areas of moisture stains and deterioration.**

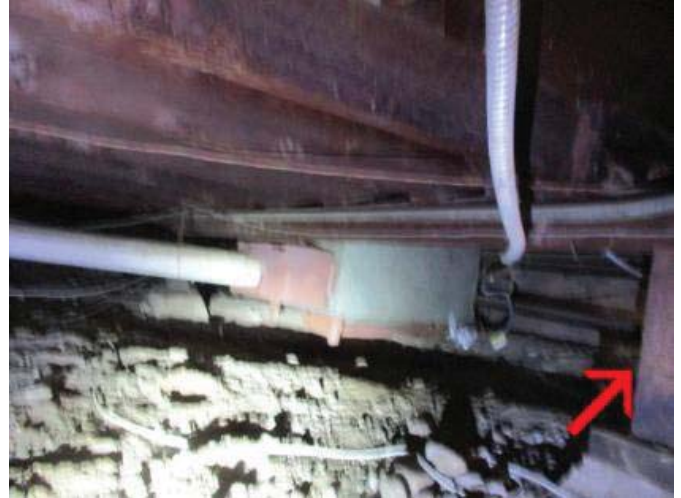
The existing system is aged and worn and not up to modern standards.

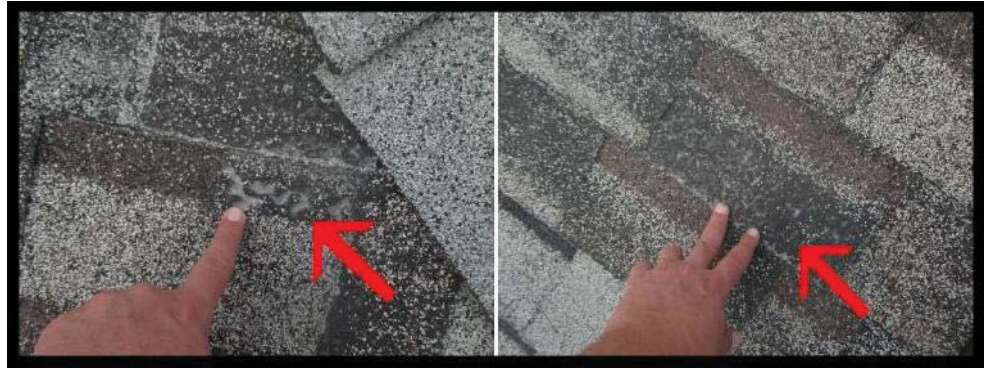
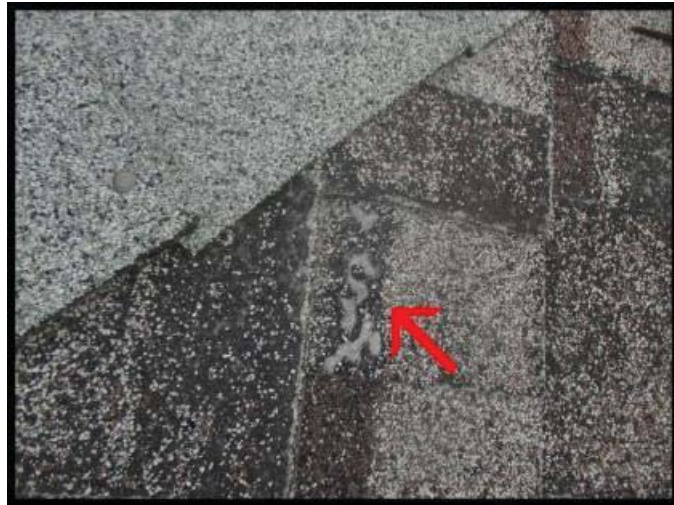
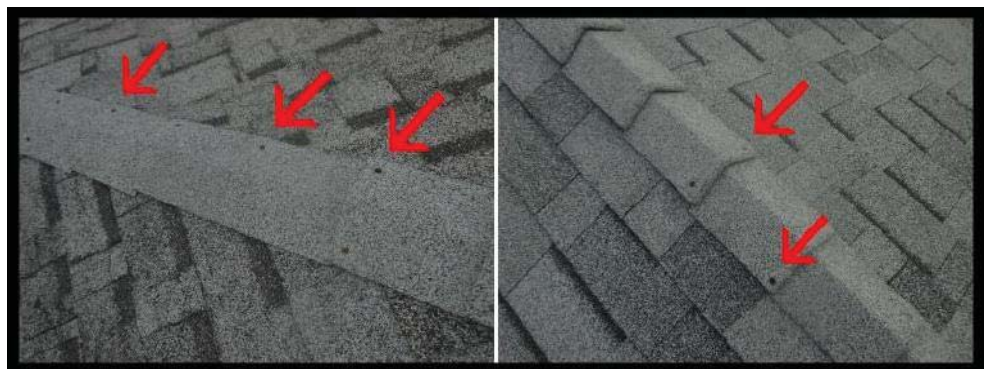
**On the composition roof over the bathroom building, the shingles are older, deteriorating and losing their surface granules. It is nearing the time to replace this roof.**

**On the composition roof, the ridge caps installed at the peak of the roof installed incorrectly with exposed nails showing.**

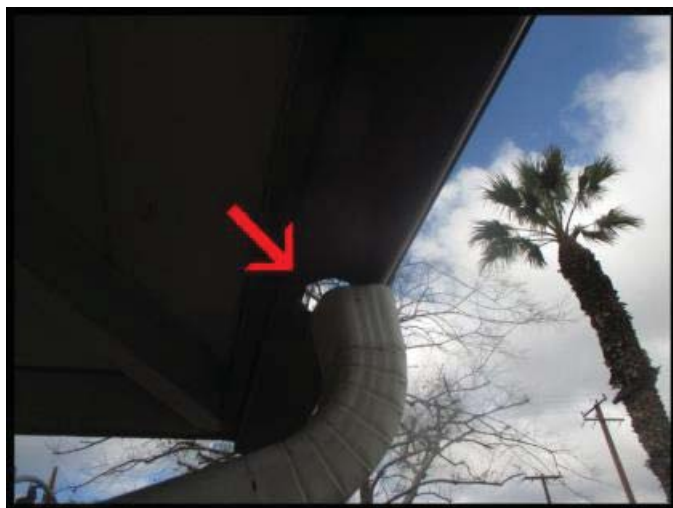
**There are areas where the gutters are not properly connected and they may leak.**

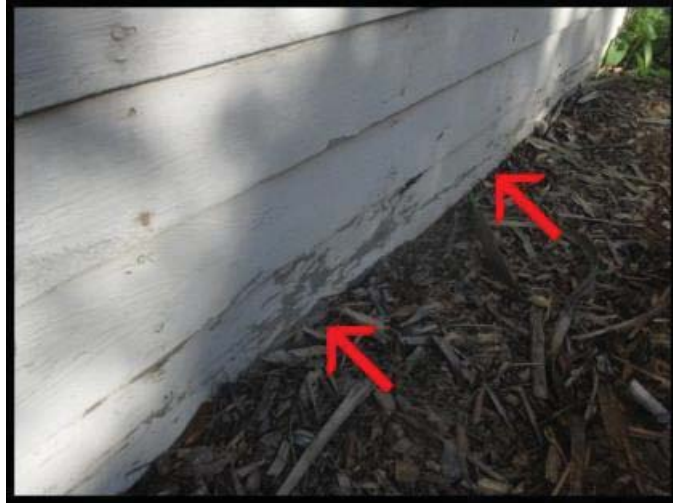
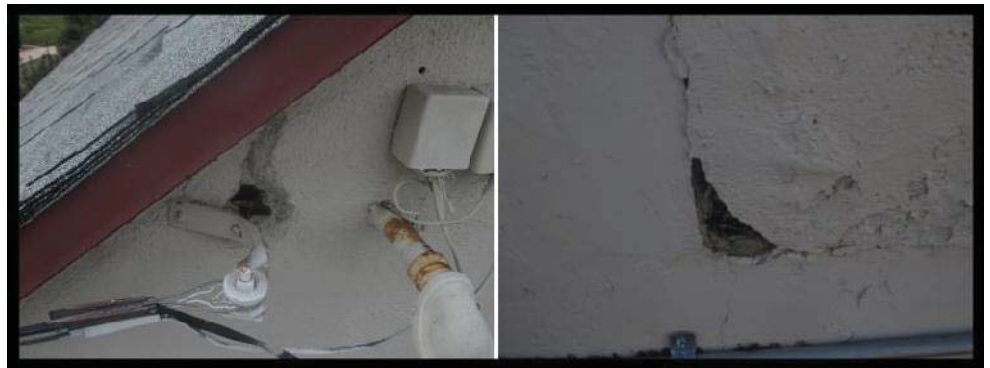
**There are areas of weather beaten and peeling paint to the exterior of the building.**

**There are areas of damage to the exterior walls.**

It is advised to have the exterior of the building fully patched and painted to help ensure longer lasting life and help minimize moisture intrusion.

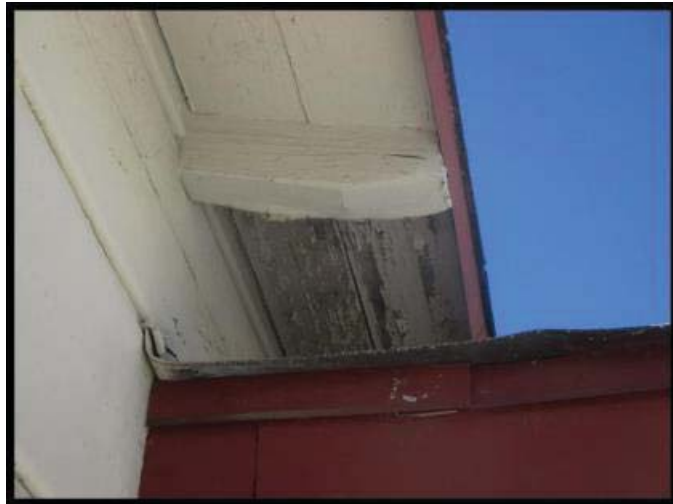
The trim has areas of weather beaten surface and peeling paint.

It is advised to repair or replace deteriorated areas of the exterior wood trim and then have them repainted to help ensure a longer lasting condition.

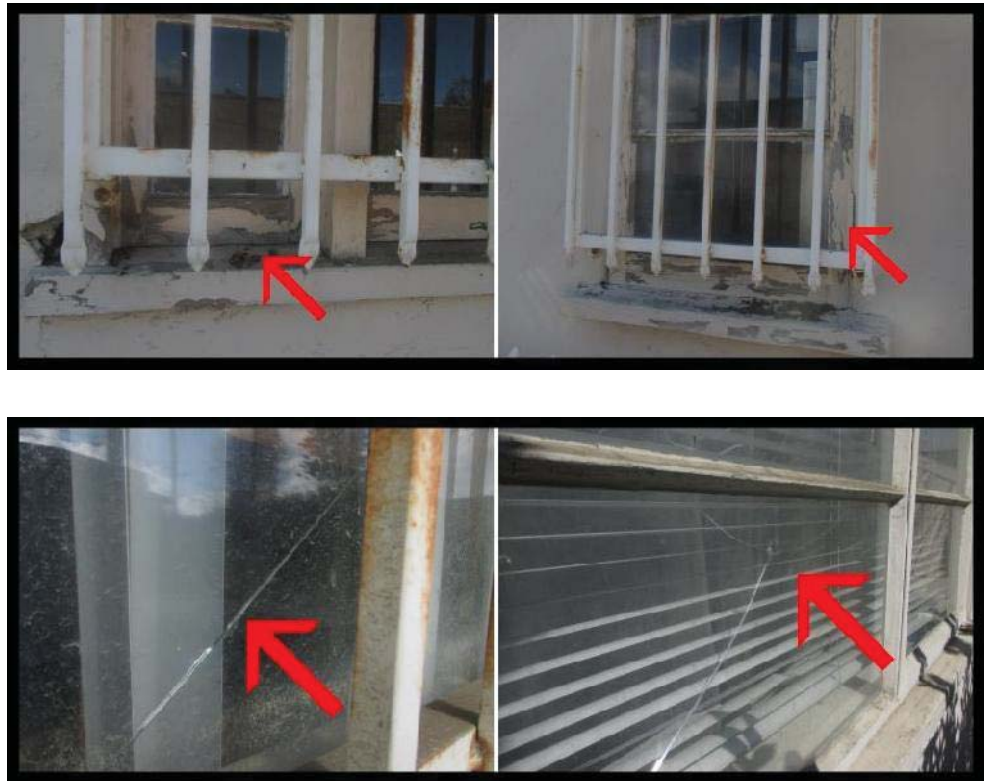
**The windows are aged wooden windows. They have areas that are pulling apart at the seams and showing some areas of excessive deterioration. Some are at the end of their life and replacement is advised at this time.**

**There are cracked window panes.**

It is advised to have all openable windows examined and any maintenance or repairs done at this time for ease of use and proper function.

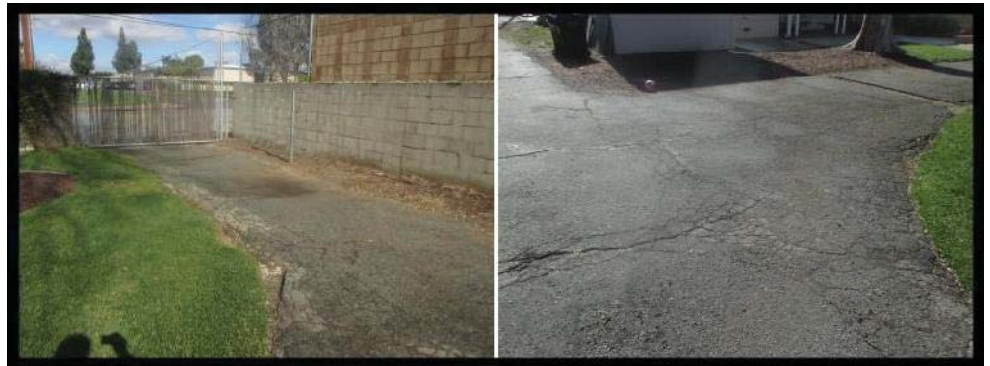
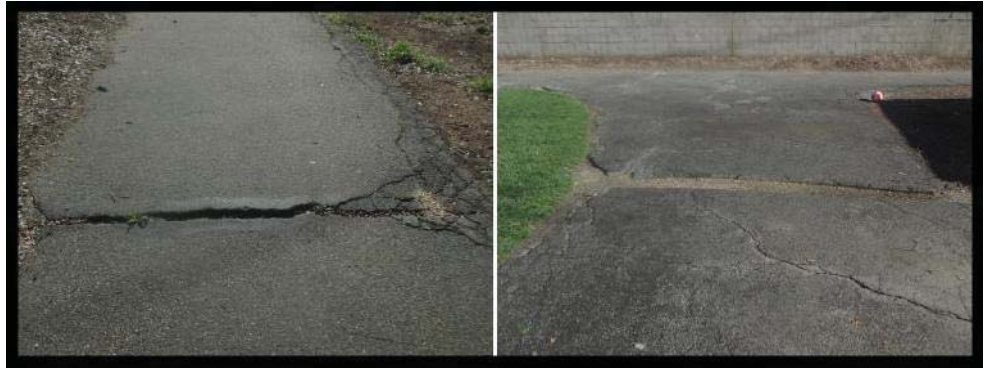
**The asphalt driveway has areas of wear and deterioration and in need of being resealed.**

Some repairs to the parking areas are needed then it is advised to have the parking areas fully resealed and restriped at this time.

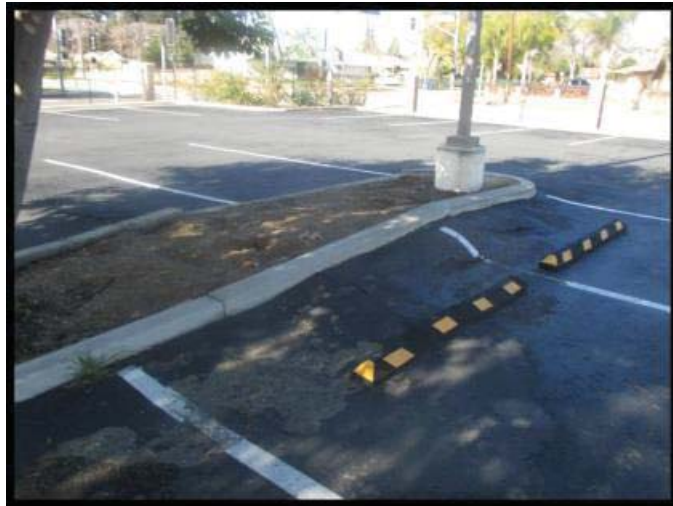
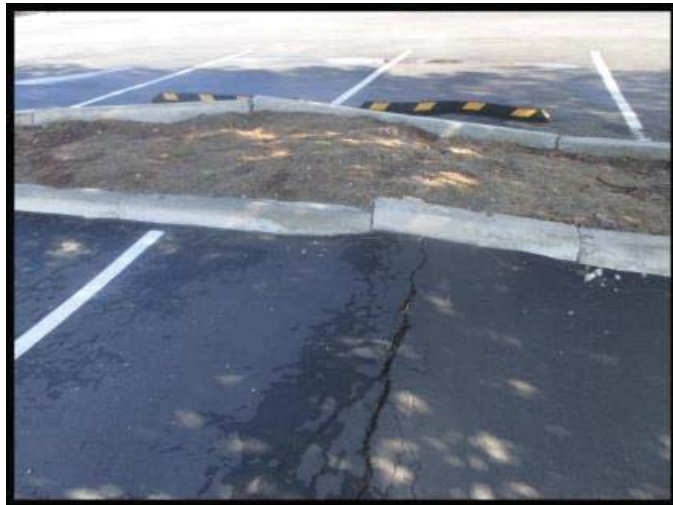
**There are tree root systems causing shifting and cracking of the parking area.**

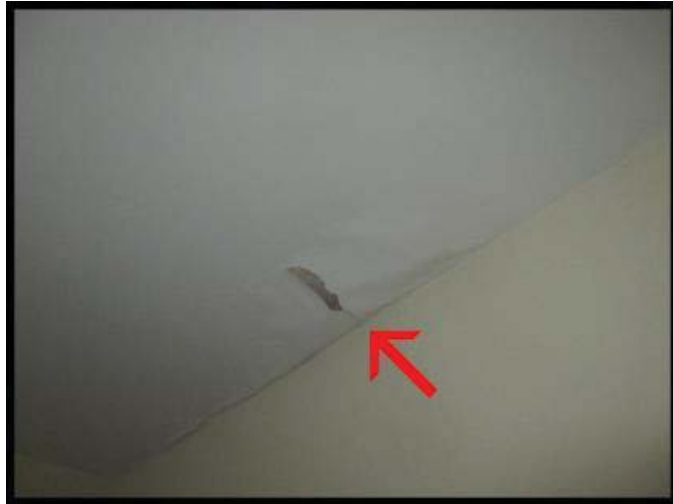
**The ceiling has a texture material that may contain asbestos.**

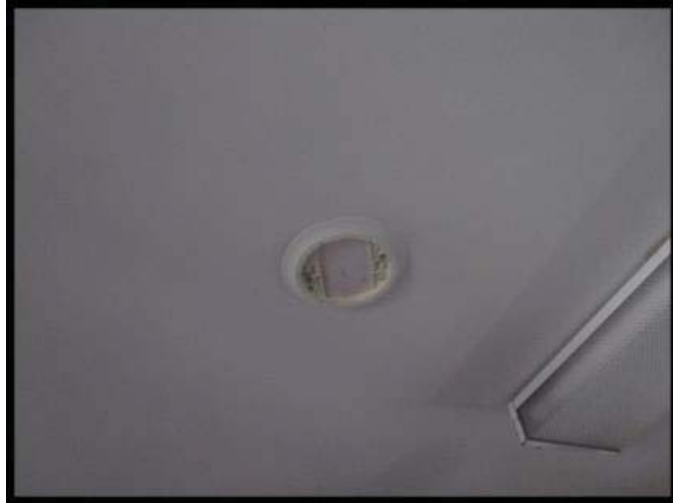
There is a removed / missing smoke detector noted.

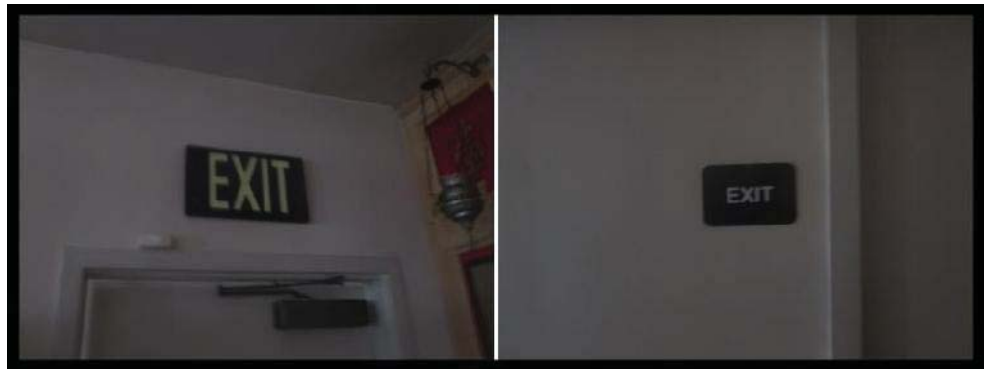
**Although there are signs present, they are not of the type that are required by current standards.**

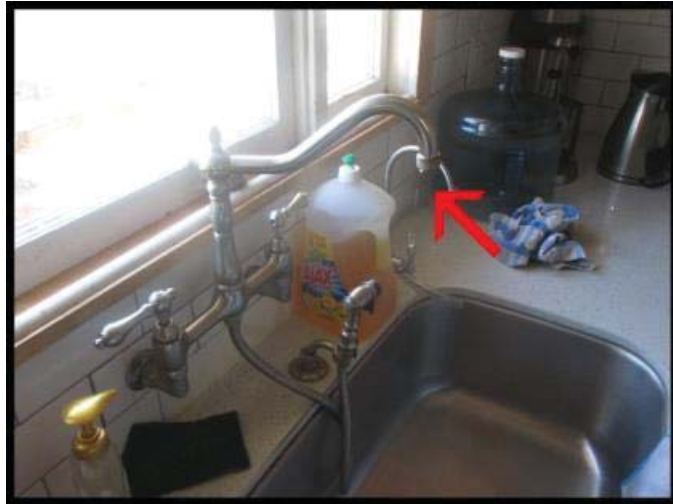
**The faucet drips in the kitchen area.**

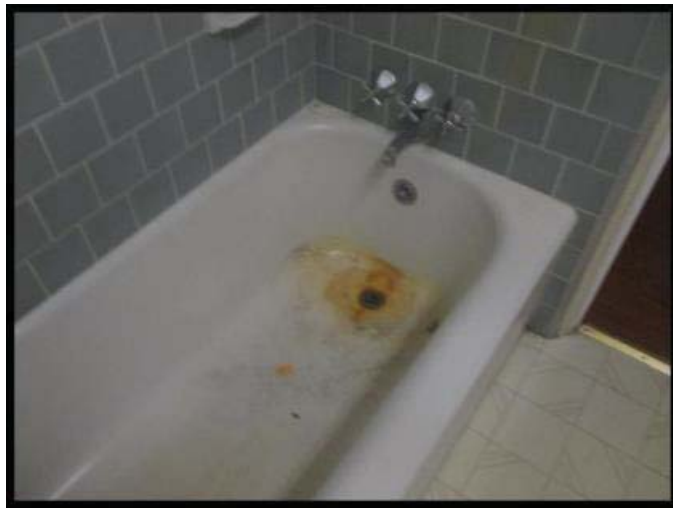
**The surface of the tub is worn/damaged.**

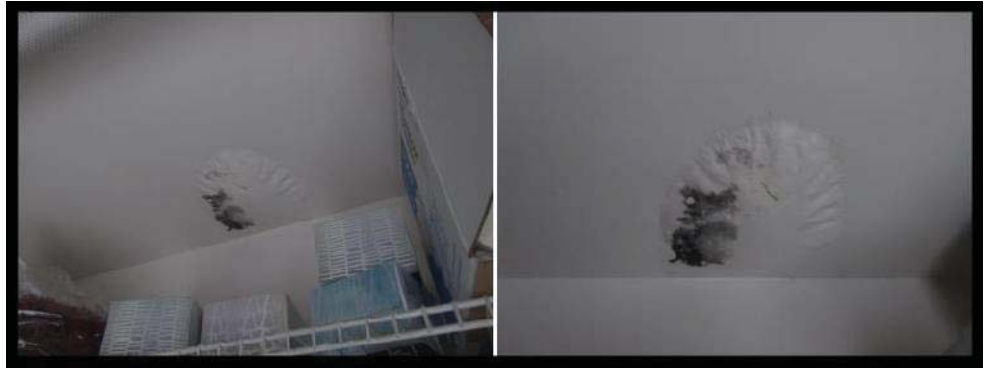
**There is a mold-like substance on the ceiling of the mop closet areas of the outside bathroom area.**

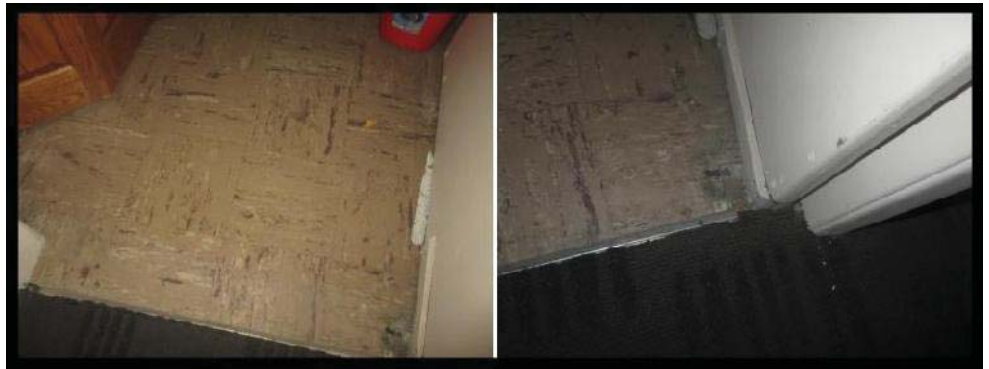
**There are flooring tiles, similar to standard linoleum, but are smaller 9" tiles in the building. These tiles have been known to often times contain asbestos material. It is advised to have some properly tested at this time to determine the true status.**
