RISK Assessment® Report

Venice 90291

Inspector - Mike Howson
Confidential and Proprietary

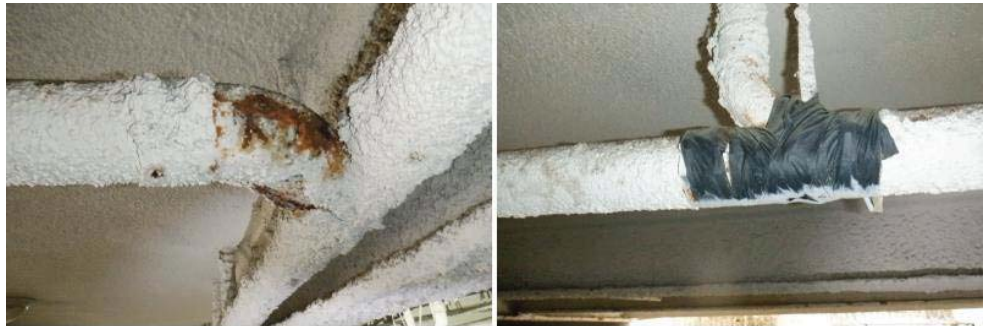
Needs Attention:

There are rusty areas on the exterior of the waste lines. It is not possible to tell when, but they will need replacing in the future as they continue to wear out.

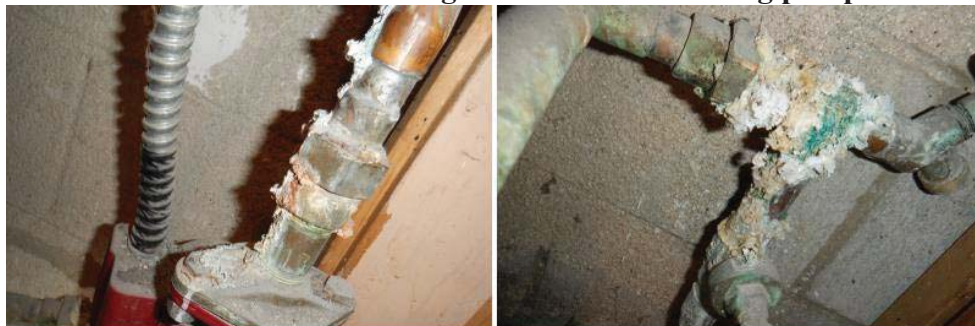
Needs Attention:

Corrosion is noted around fittings near the recirculating pump.

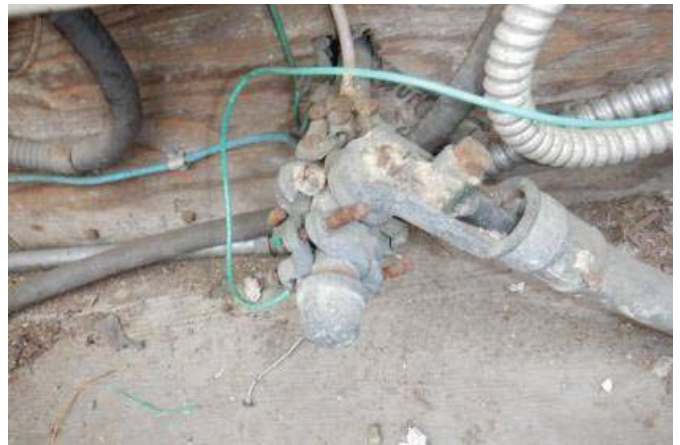
Needs Attention:

Grounding cable appears to be connected to older galvanized iron pipe. This may not be an active system since water pipes have been upgraded to copper. An Electrician should review the grounding and ensure there is proper grounding.

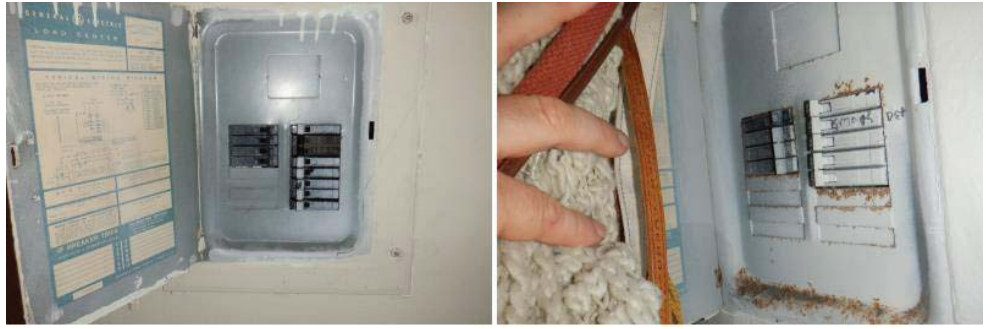
Needs Attention:

The circuit breakers of the subpanels of the units, or some of the subpanels, have been coated with paint. This condition can cause the breakers to fail to perform as designed and therefore prevent proper reaction to conditions of overloading or overheating. It is recommended to have an electrician inspect the affected breakers and make

recommendations regarding correcting this condition.

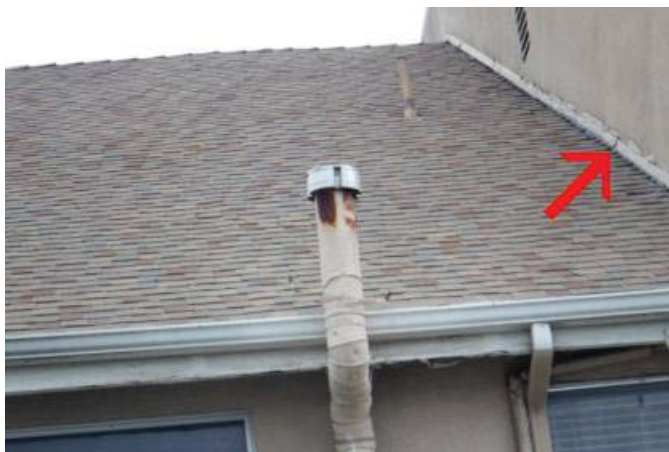
Needs Attention:

The flashings have been covered over with mastic which is a temporary solution and will require regular maintenance to help ensure a leak free condition.

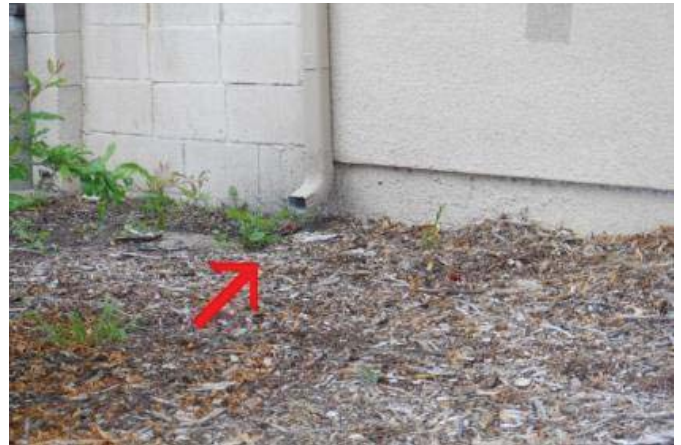
Needs Attention:

**The downspouts do
not all route the water
away from the
building but instead
deposit it next to the
structure which
commonly causes
problems to the
foundation over time.**

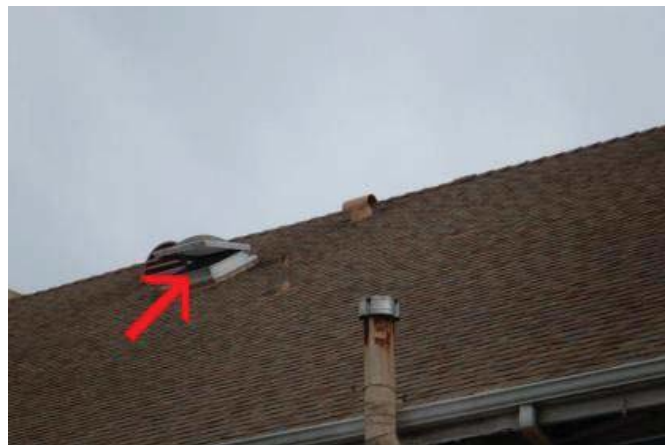
One looks partially open at center of building.

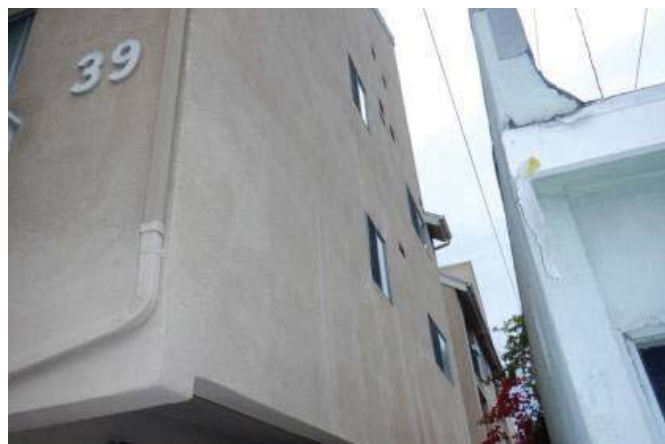
Needs Attention:

There are cracks and damages noted to stucco

Crack fill lines are seen around the building. These should be painted.

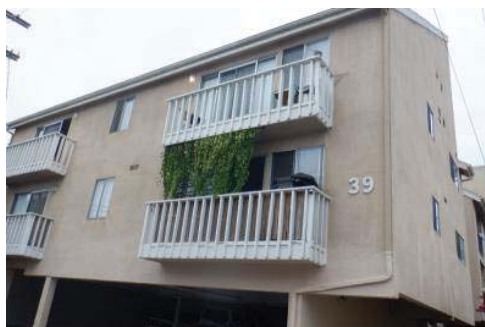
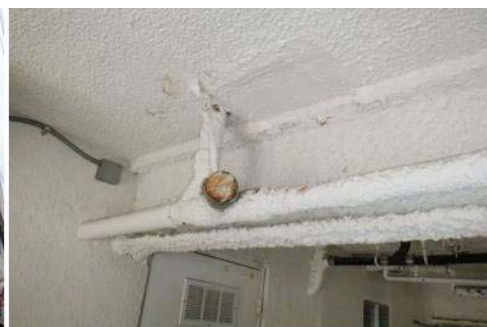
PARKING STRUCTURE
BELOW LIVING SPACE

The building appears to have a soft story condition over the carport area or garage. This is typically a condition where there is living space over a garage or parking area and the area below may not have sufficient structure to support the upper floor (this is most common over an open parking structure) in case of lateral movement. It is advised to have this examined by a Structural Engineer to determine if this is the case with this structure and what remedial actions would be taken to correct it, if necessary.

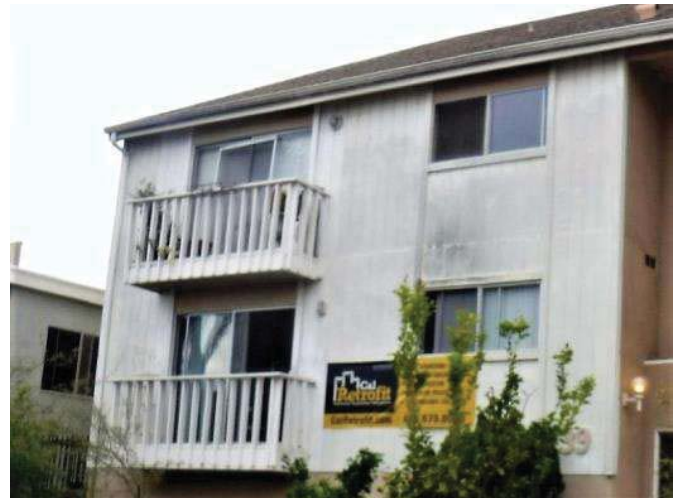
Needs Attention:

There are areas of cracking, peeling or bubbling paint to the exterior of the building.

The wood exterior surface is Aged and Worn overall.

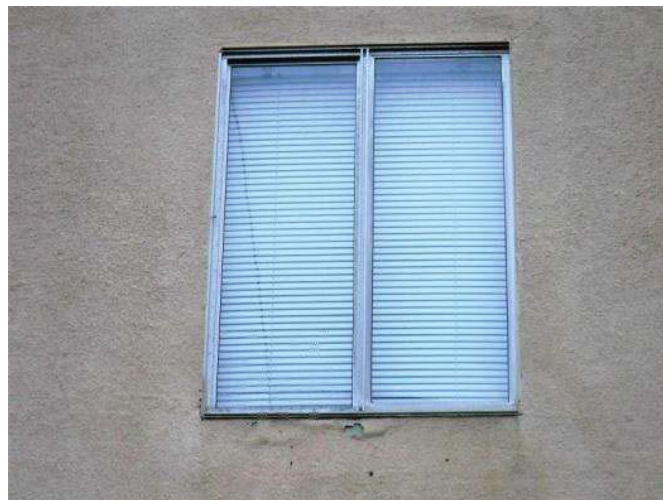
Needs Attention:

The windows appear to be the original aluminum windows. They are aged and worn and at the end of their expected useful lives. Maintenance and some repairs are needed at this time if proper function is desired.

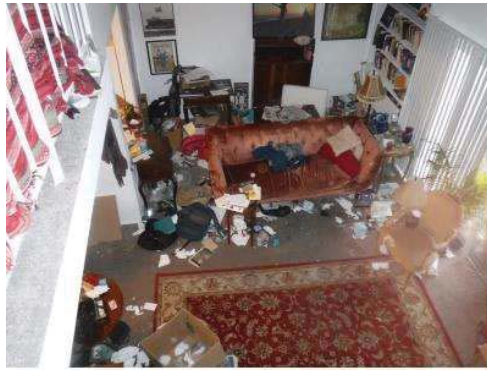
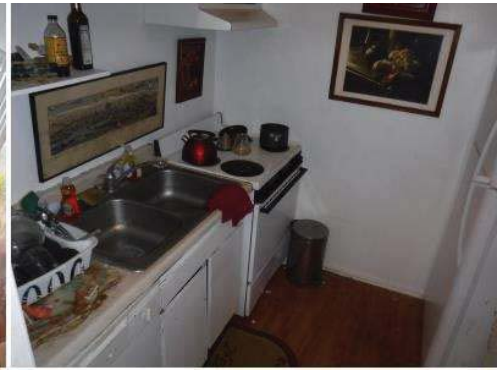
Needs Attention:

Excessive wear is noted in unit 10

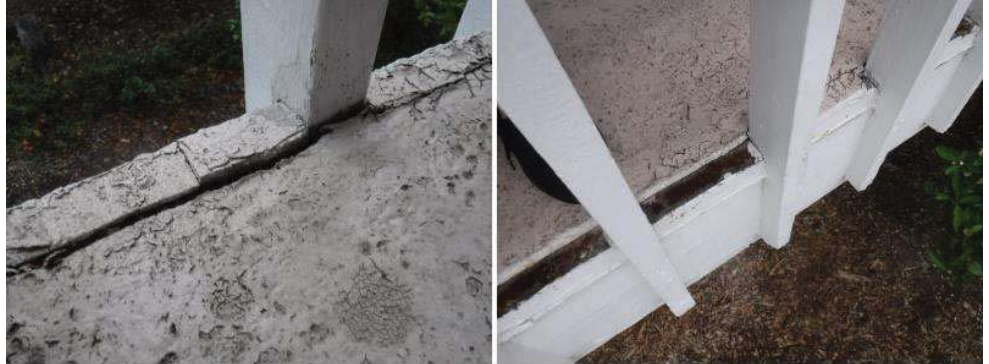
NEEDS ATTENTION:

Most of the deck / balcony surfaces have areas of wear and/or damage such as in units 14, 8, 12, 4.

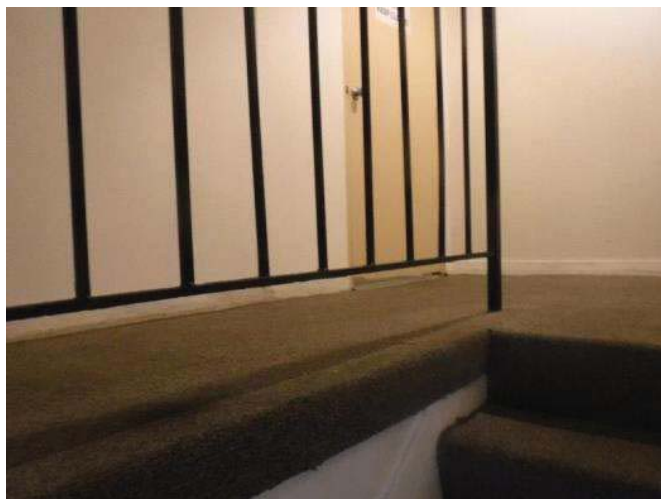
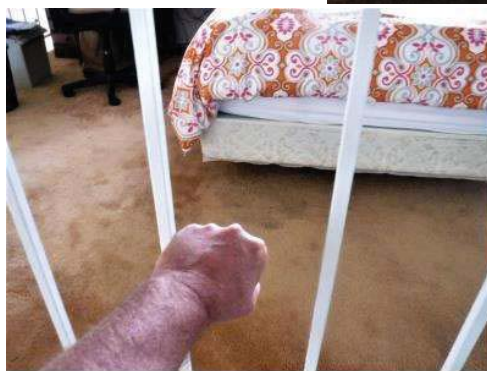
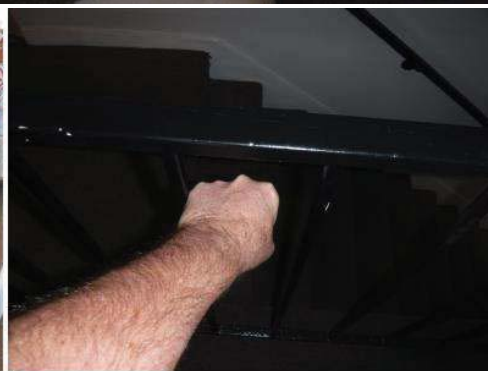
Needs Attention:

The handrail is loose and not well secured to the floor in the exit to the car port.

The space between the rails is greater than is currently recommended for child safety. The railings should not have any space greater than four inches in any portion of them.

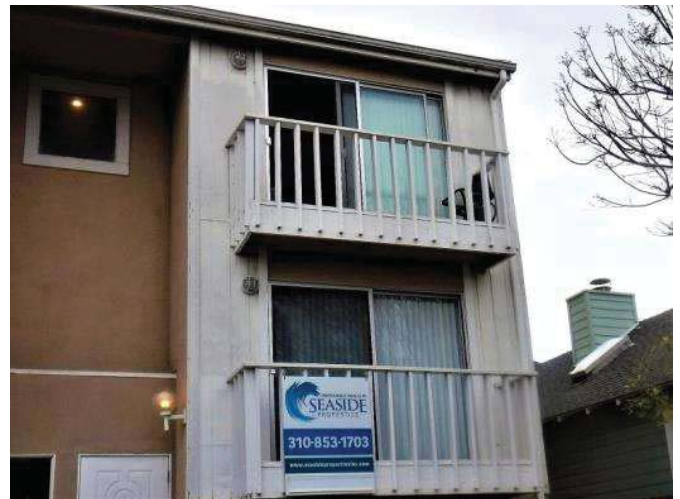
**The windows and
glass sliding doors
are generally aged
and worn and
hard to operate.**

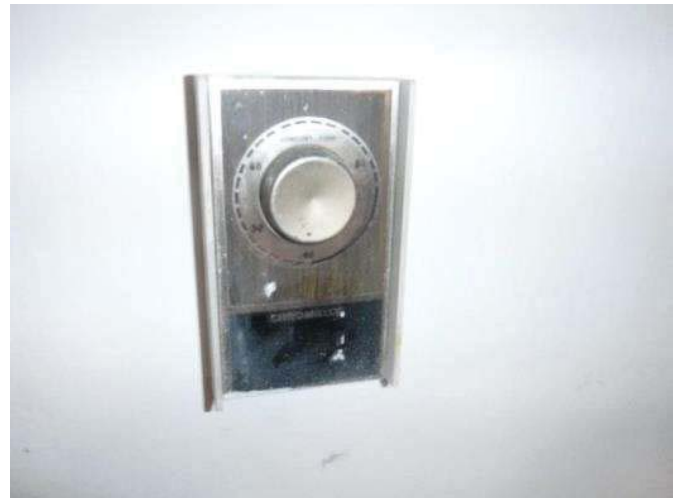
Some of these systems are not operating. Such as in unit # 13, 4.

Some residents have never used it and don't know if it worked. None were tested.

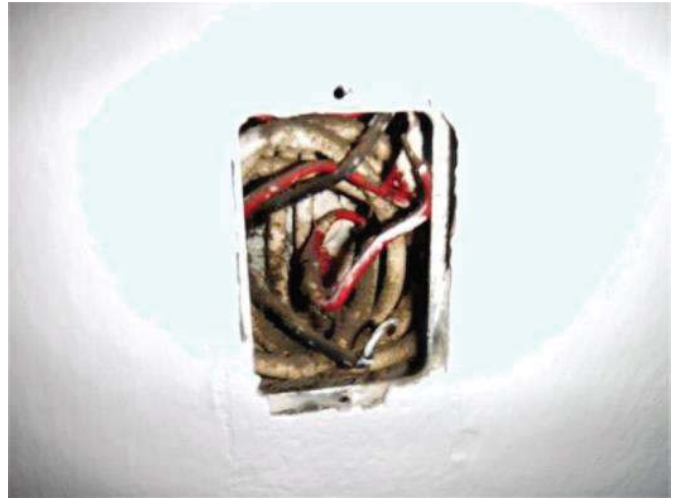
NEEDS ATTENTION:

**Apartment # 13
has exposed wires
which are for the
radiant ceiling
heat elements .**
