RISK Assessment® Report

Studio City, CA 91604

RISK ASSESSMENT®

This is an assessment of the five major systems - Plumbing, Electrical, Heating and Air Conditioning, Structure and Roofing along with an assessment of any other current deferred maintenance issues for the site.

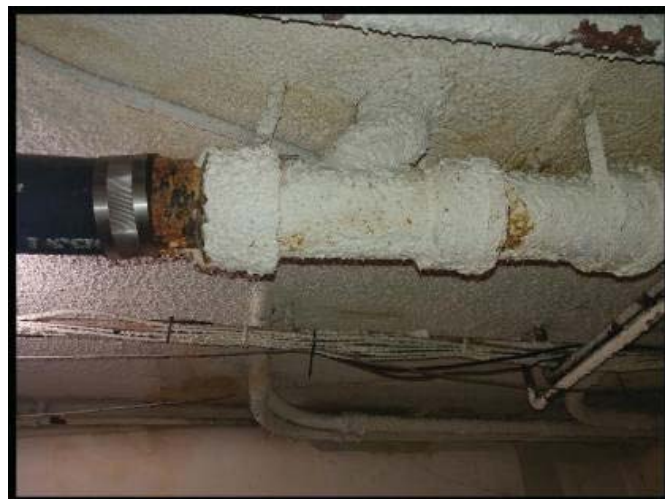
There are rusty areas on the exterior of the waste lines. It is not possible to tell when, but they will need replacing in the future as they continue to wear out.

Some of the waste lines have been Replaced. This is a typical sign that the original waste lines remaining in the system are wearing out and at or near the end of it's service life.

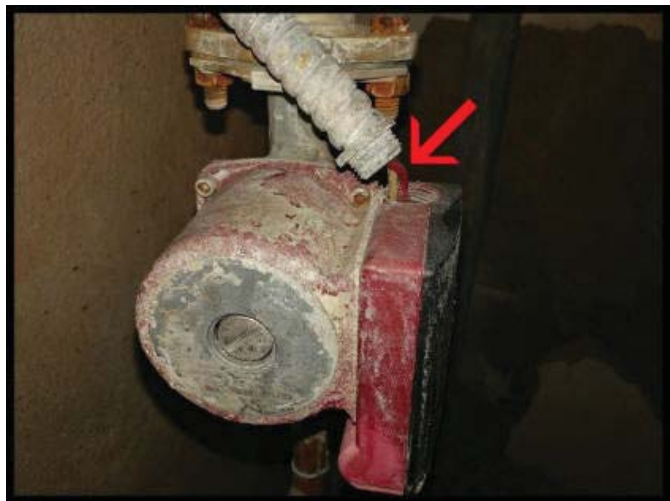
Needs Attention:

Open wires were observed at the unit.

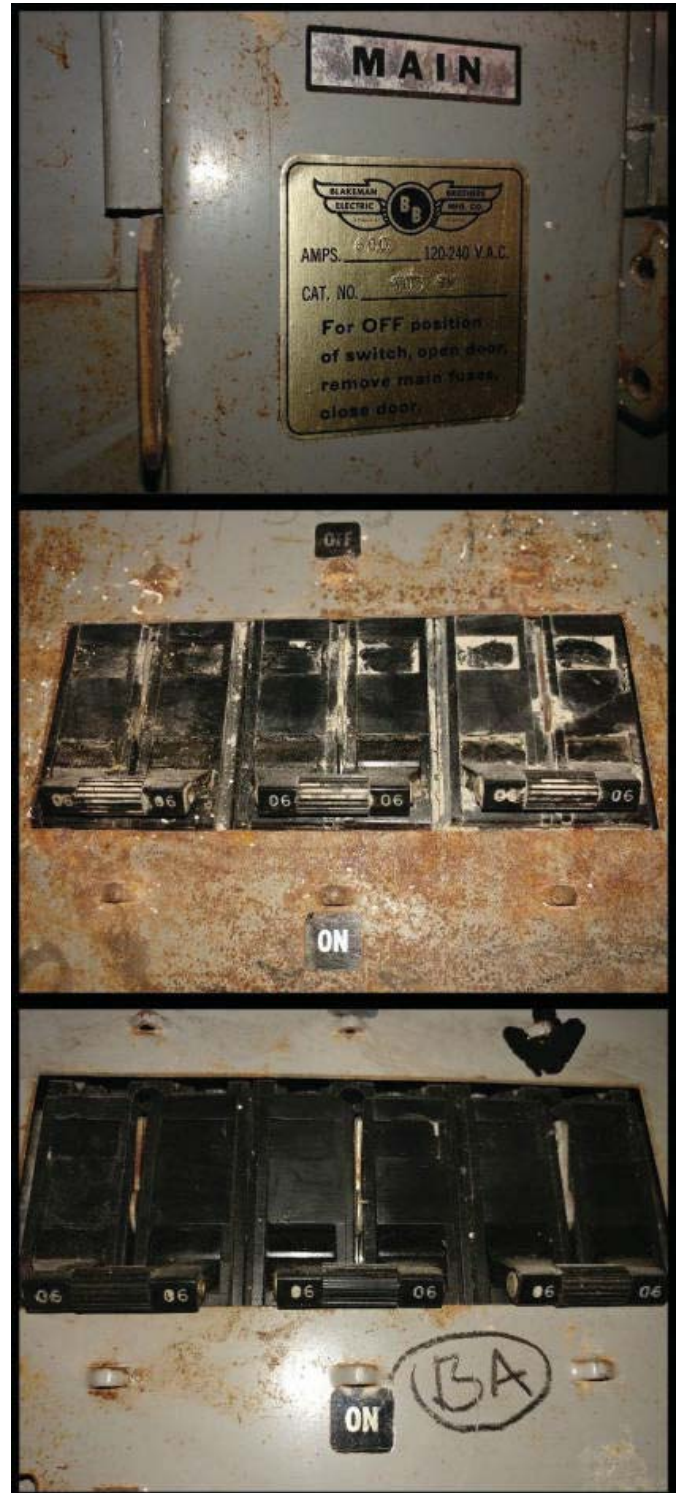
Service Amperage
rating - 600 amp stand
up panel.

This panel and circuit breaker system is an old system. It is nearing the end of its expected life span. As with all older systems it will be more prone to failure due to its age and design. Some of these older systems have a reputation for unreliability, failing to trip, jamming, or overheating. Some electricians may recommend the panel be replaced and upgraded for safety.

The main service to the site is aged and worn and at or near the end of its expected useful life. Review is advised by a qualified electrical contractor for safety at this time.

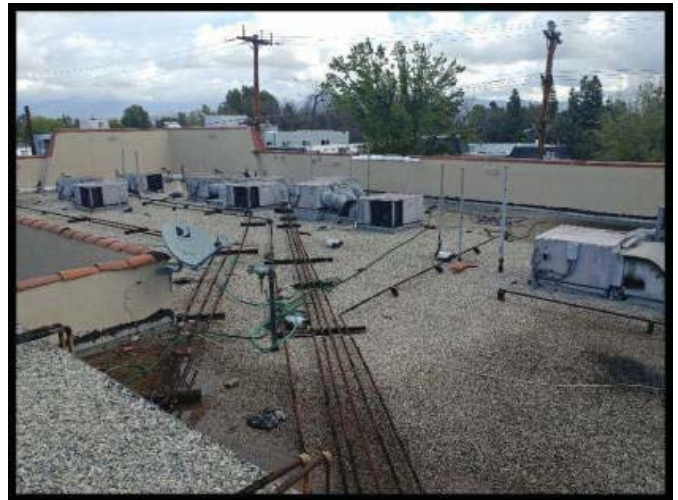
Due to the age of the units, approximately 10 years or more since the date of manufacture, the presence of the coolant known as R22 is typical. This coolant is no longer allowed to be used and if repairs are needed that involve installing more coolant for any reason, replacement of the unit is usually warranted.

Most of the HVAC systems are aged and worn.

Replacement should be expected in the near future per industry standards due to age.

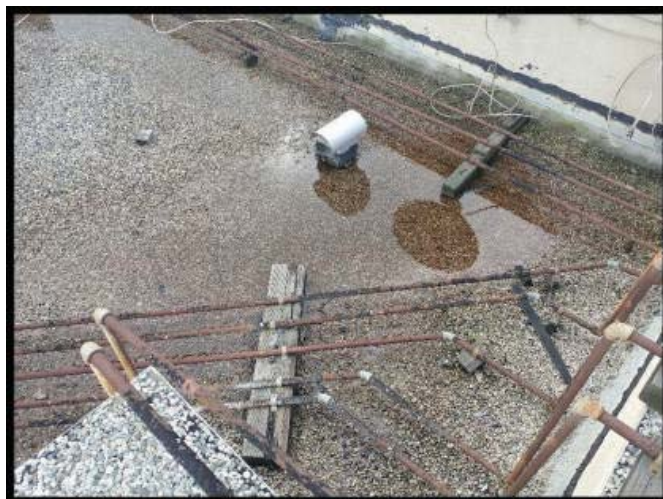
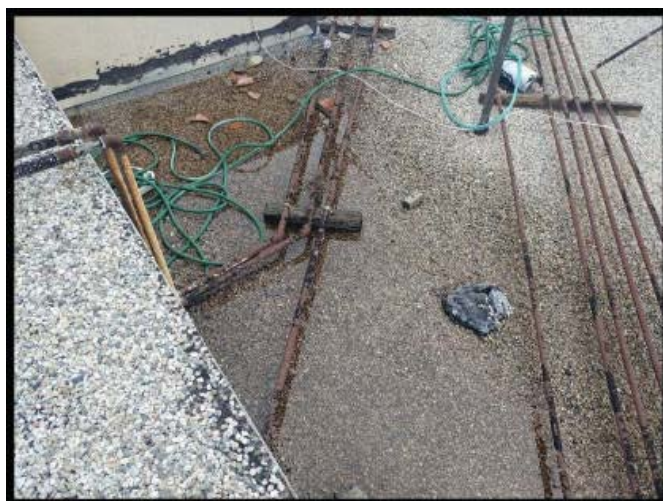
There are areas of standing water on the roof during the inspection. Standing water will accelerate the deterioration of roofing materials affected. It is advised to eliminate these areas of ponding by improving the slope of the roof wherever needed, or to reinforce affected areas where slope improvement is impractical.

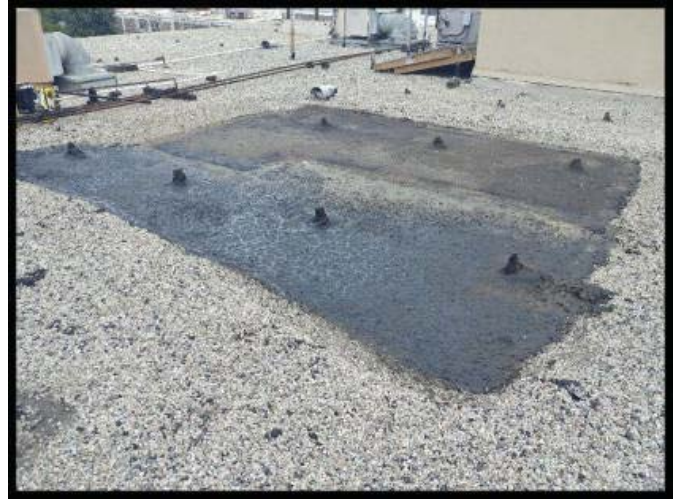
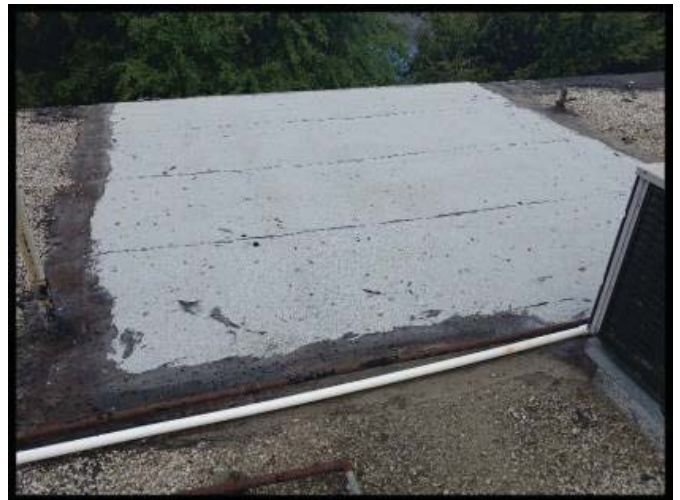
There are areas of the roof that have been patched. This is normally done to correct past moisture intrusion issues. Full disclosure regarding these is advised at this time from the building's past history.

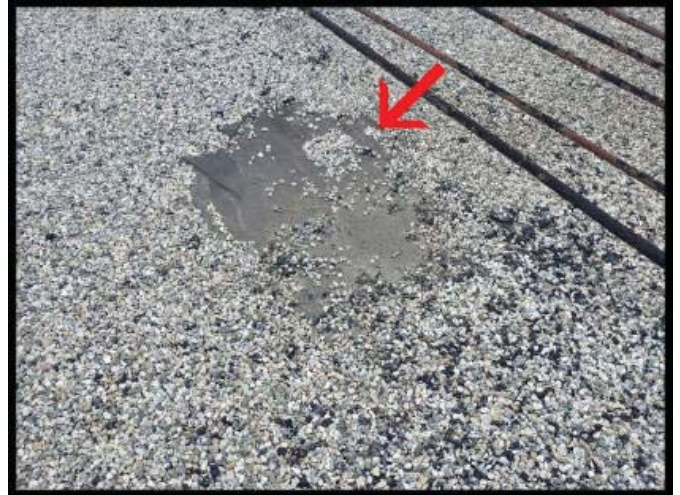
There are sections of exposed underlayment. This roof no longer is a reliable moisture barrier. Extensive repairs/replacement are needed at this time.

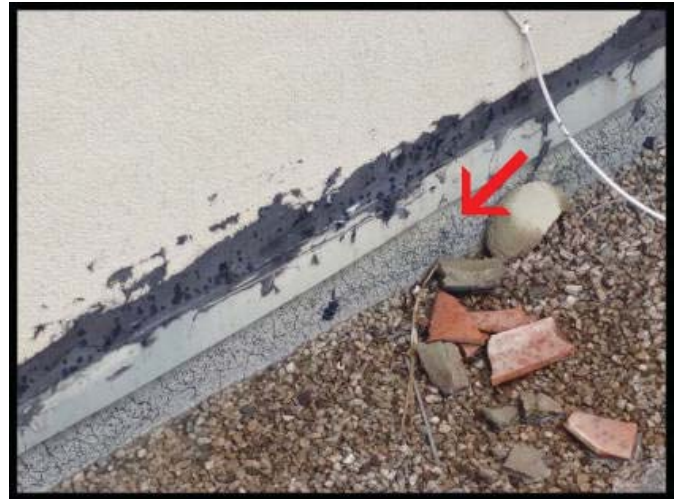
The roofing system is showing signs of general wear and age.

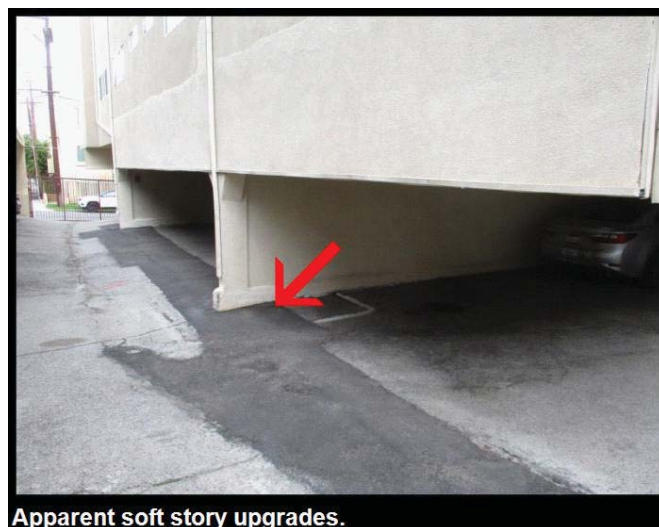
Seismic retrofit work has been done to the building since the original construction. This work appears to have been done professionally and to professional standards. No significant defects were observed. Due to the nature of this type of work and it requiring engineering specifications the ability to determine if it has been done to these specifications is beyond the scope of this general visual inspection. If further review or a more detailed inspection is desired then it is advised to have the work reviewed by a qualified seismic retrofit specialist.

Apparent soft story upgrades.

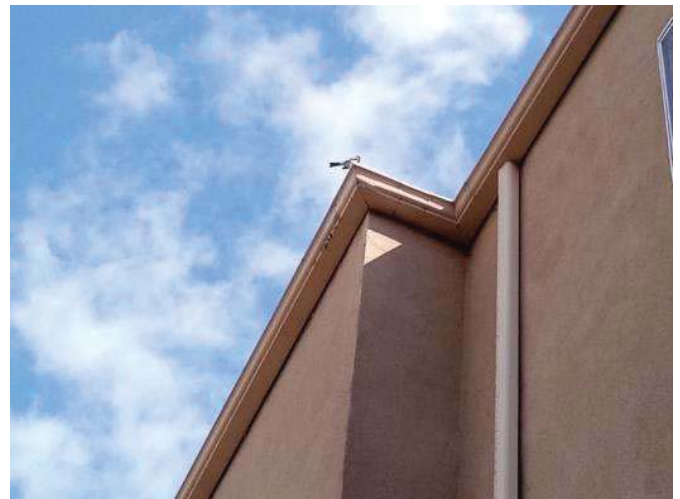
The Roof gutter is deteriorated to the point that it needs replaced.

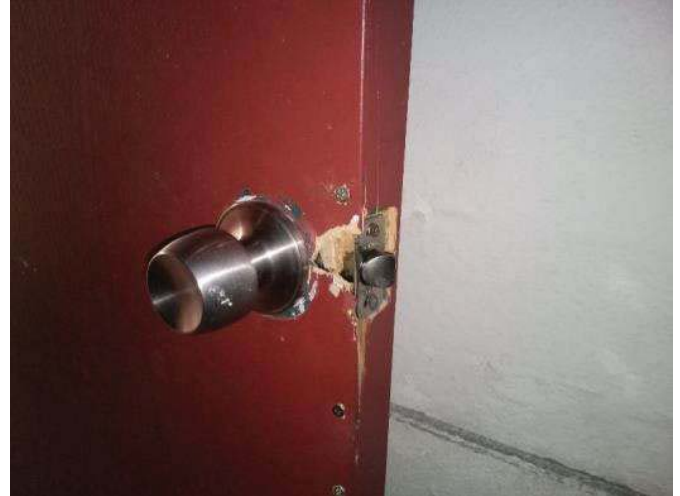
Damage to a door in
the basement
service room.

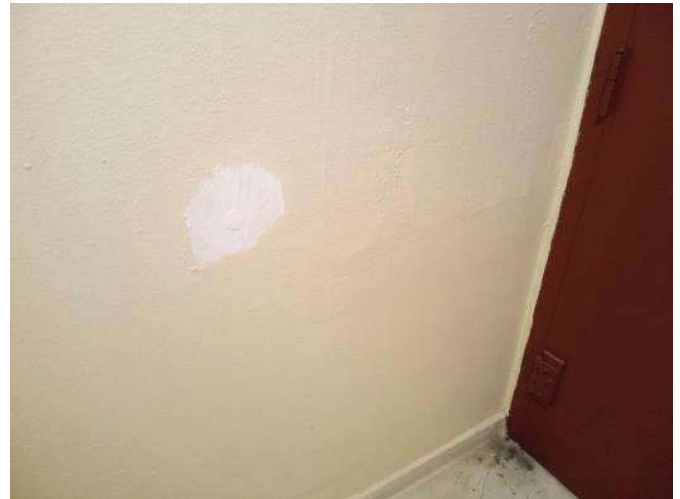
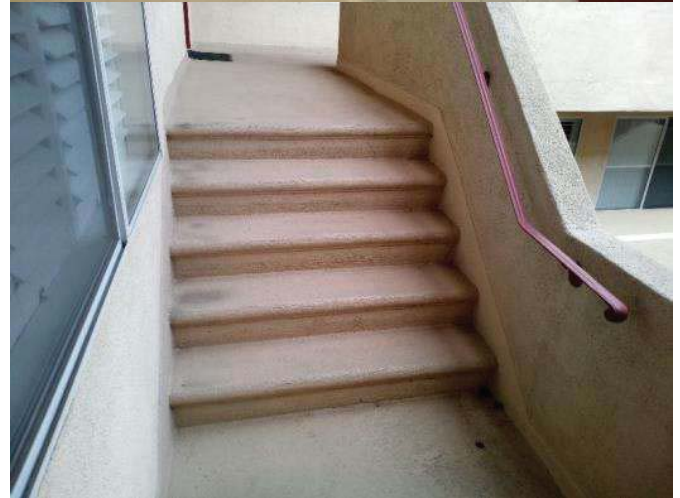
Some minor painting and patching needs to occur

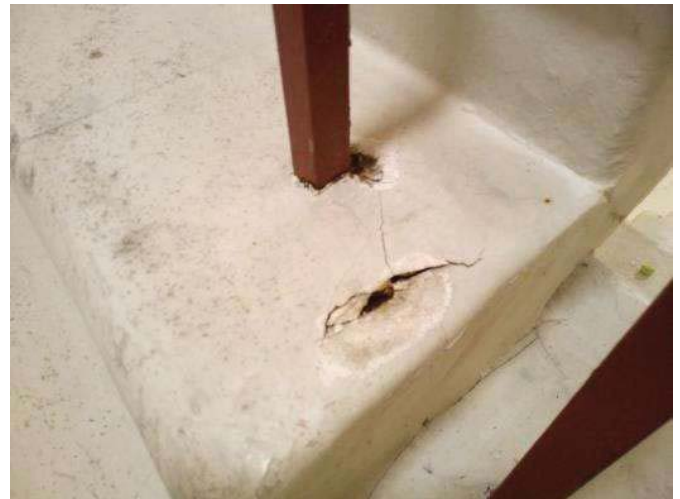
Some of the railing base connections to the deck show signs of deterioration and this can promote moisture intrusion and hidden damage.

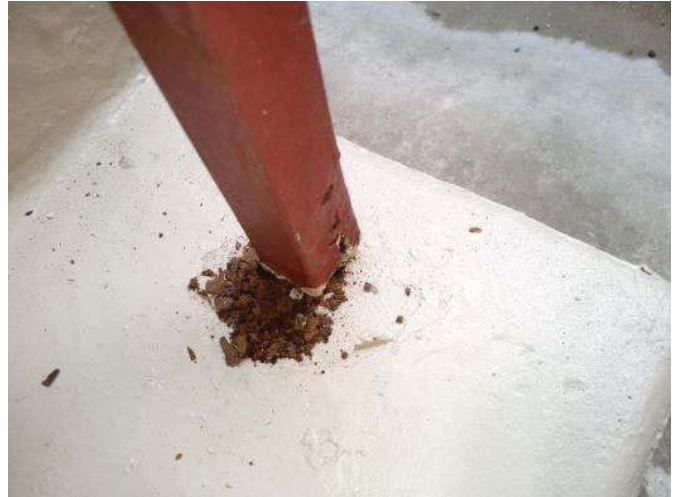
The railings are damaged.

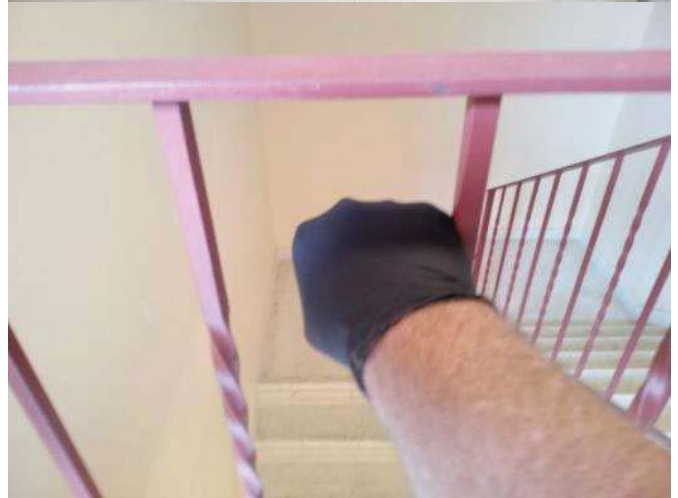
The railings do not meet current safety standards - it is recommended that there is no space greater than four inches in any portion of the railing for safety.

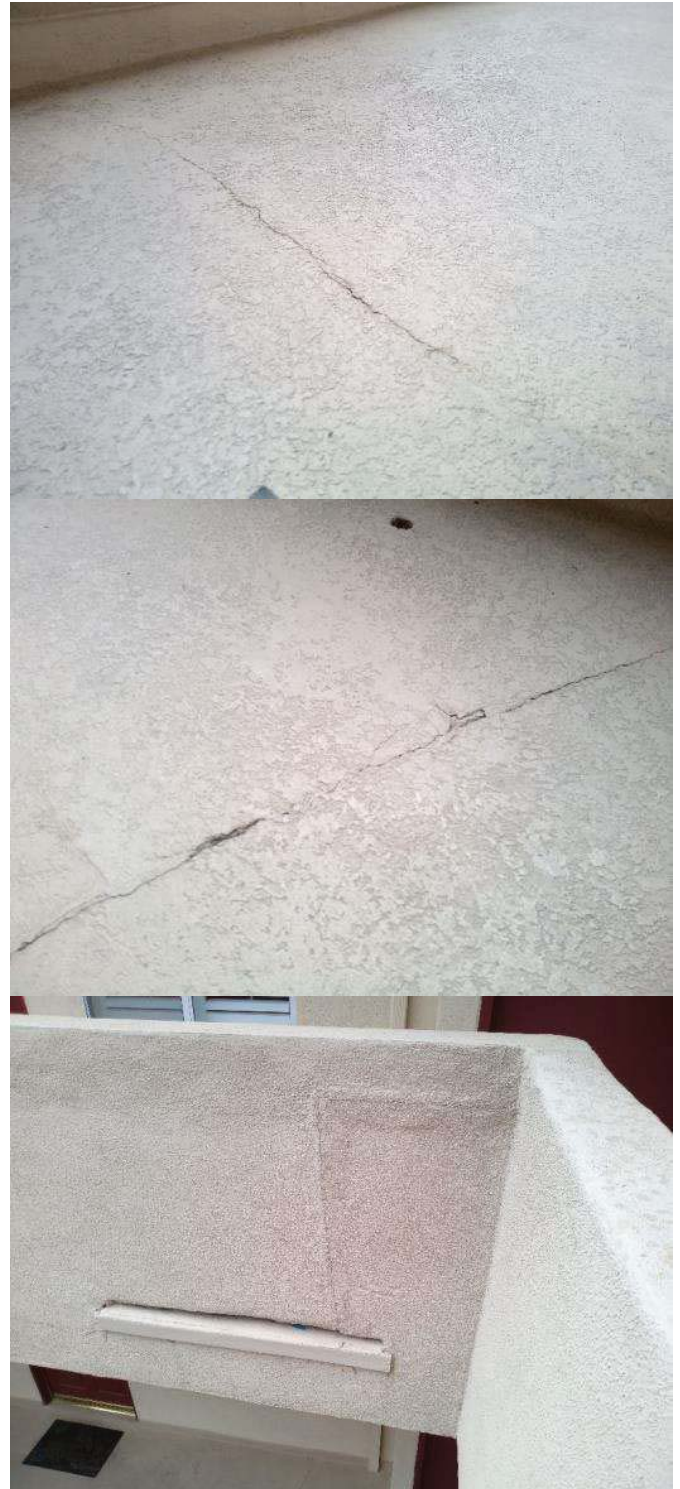
The second story deck area needs more attention than the third

Cracks need to be sealed

It is advised to have the decking fully cleaned, and any needed repairs made then sealed to help ensure a leak free moisture barrier.

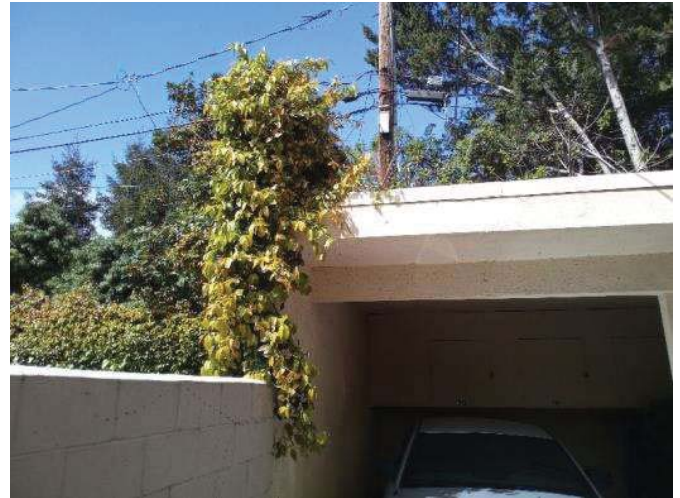
The exterior of the garage has vegetation growing on it. While this may be attractive it can deteriorate the covering of the building over time.

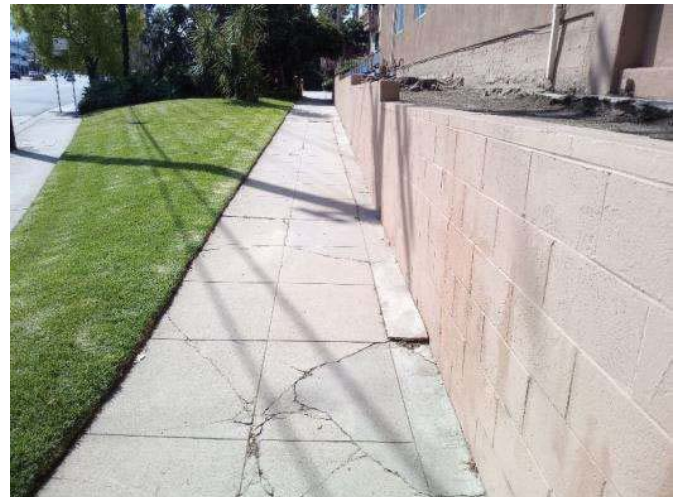
There are cracked in
areas of the public
concrete walkways.

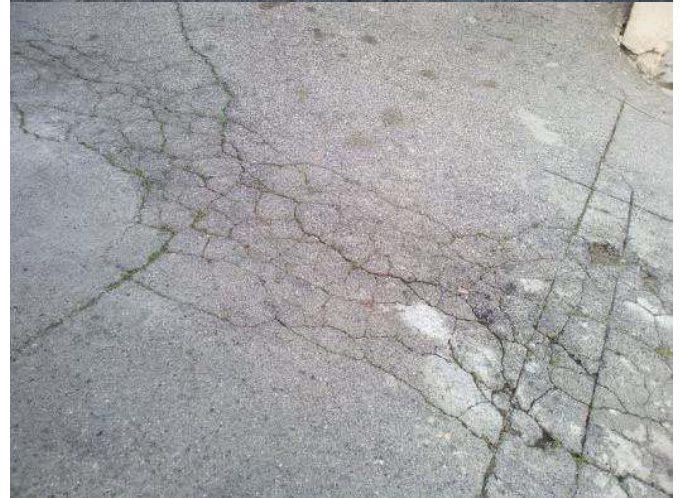
The driveway area surfaces are deteriorated and in need of being resurfaced at this time.

The parking area is worn and aged and there are sections that are deteriorated to the point that resurfacing of the asphalt is advised at this time.

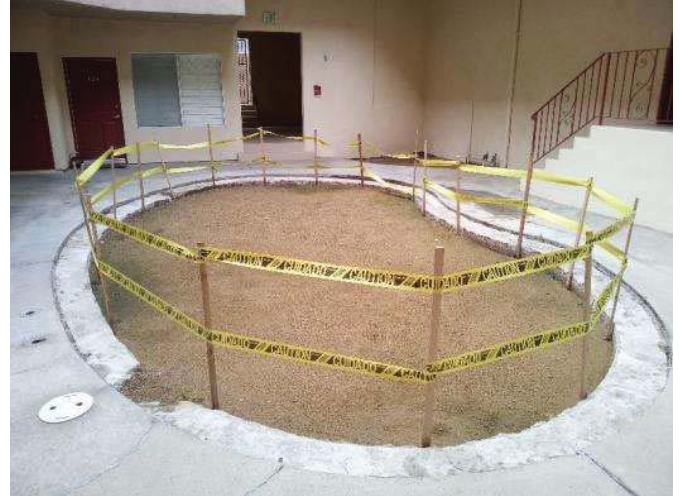
The site appears to have previously had a pool installed in the courtyard and filled in. Further review by qualified general contractors is advised to determine that all proper procedures have been followed.

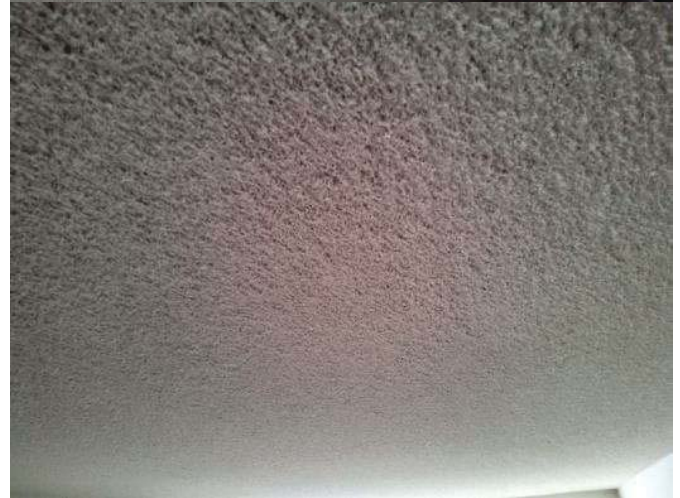
There is ceiling texture material that may contain asbestos in the un-renovated units. According to the property manager this has already been tested

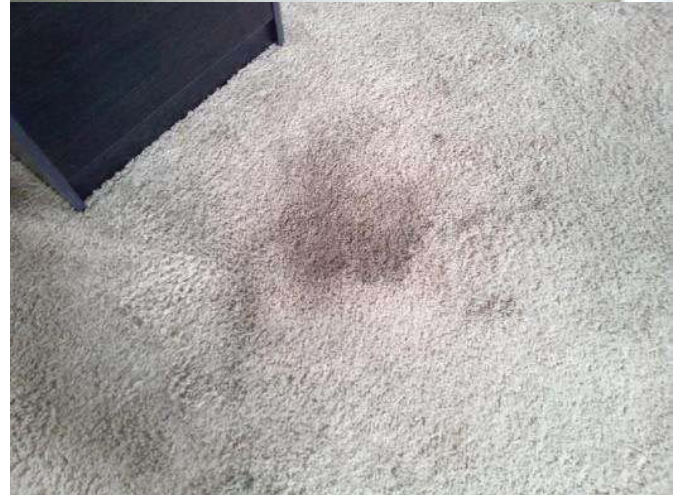
The carpet has areas of wear and/or damage in unit stains and wear in unit 308, 205.

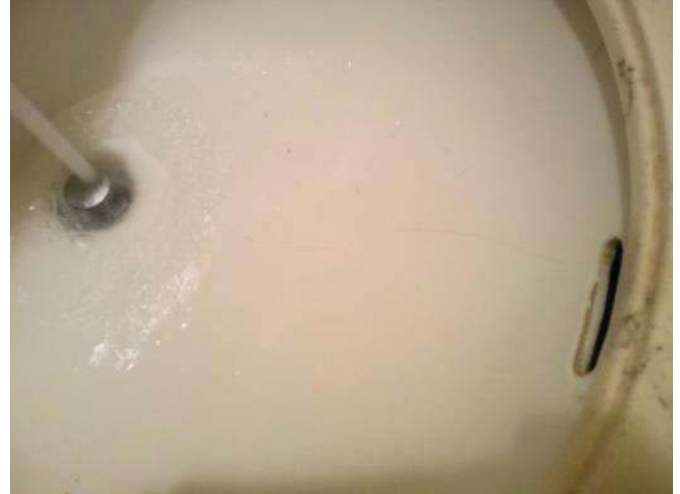
Cracked sink, 205

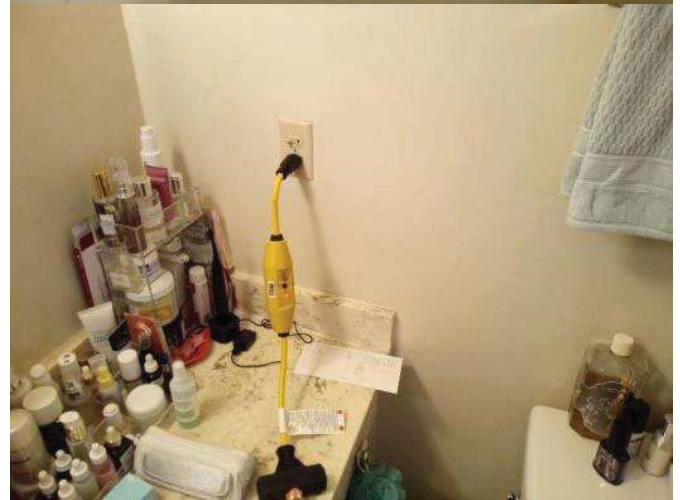
No GFIC's in the non-renovated units.

It is recommended that Ground Fault Circuit Interrupter (GFCI) safety outlets be installed at the exterior, restrooms, & any kitchen outlets. Not all the outlets may have these at the proper locations. This is advised for health and safety.

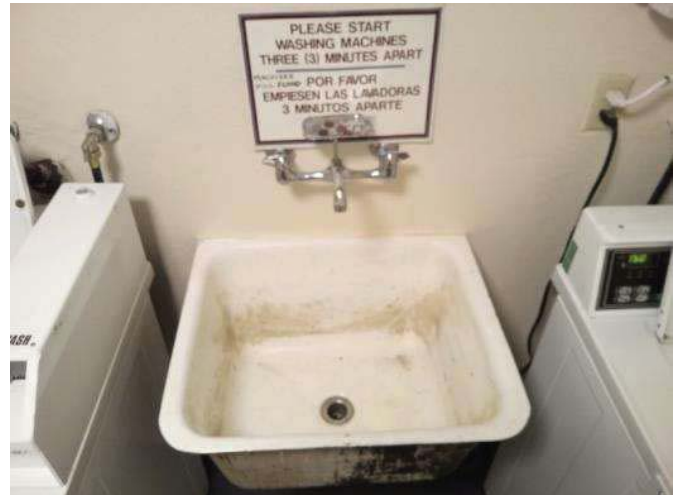
The laundry sink is generally worn.
