RISK Assessment® Report

RISK ASSESSMENT®

Commercial Real Estate Inspectors

This is an assessment of the five major systems - Plumbing, Electrical, Heating and Air Conditioning, Structure and Roofing along with an assessment of any other current deferred maintenance issues for the site.

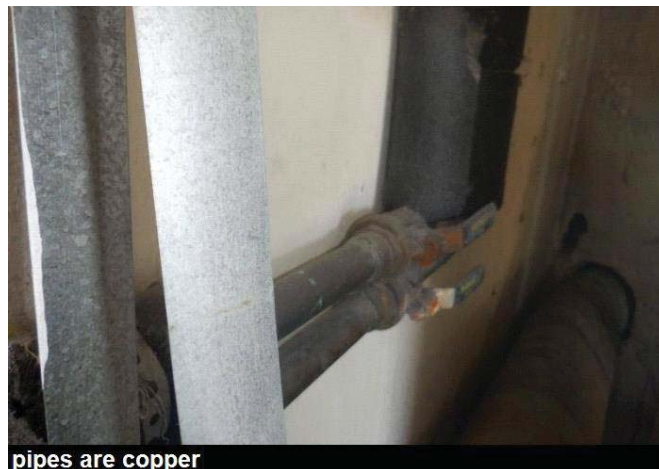
Needs Attention:

While copper pipe is visible in most areas, old rusted galvanized pipe was seen in wall cavity at the back which may not be active ,however it is not a certainty that all old iron pipe has been replaced with copper. It would take further intrusive inspection by a Plumber to determine this.

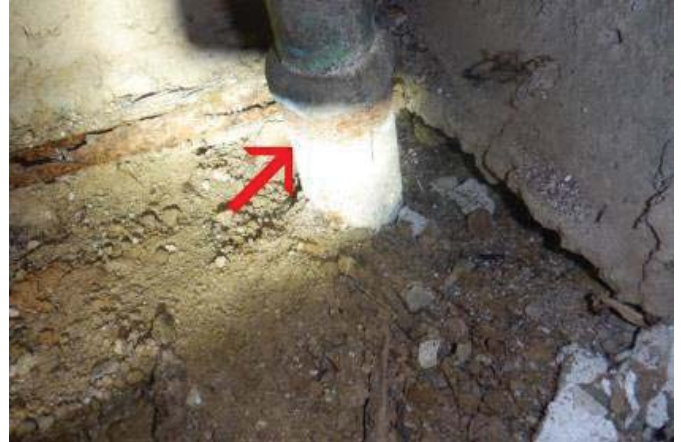
Needs Attention:

There are rusty areas on the exterior of the waste lines. It is not possible to tell when, but they will need replacing in the future as they continue to wear out.

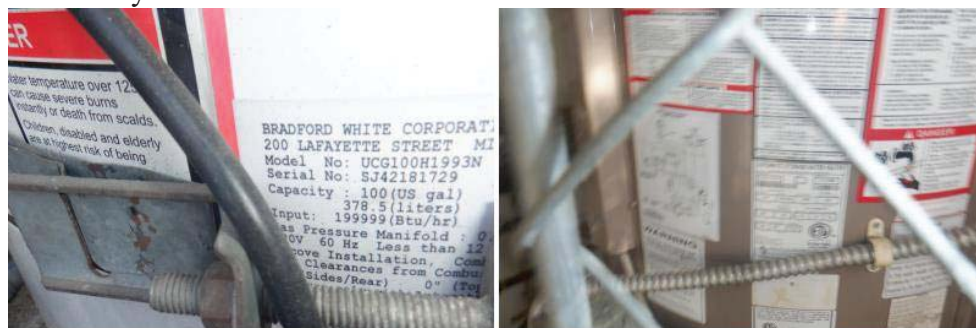
one is 6 years old

one is 22 years old.

older water heater in back, is past it's expected serviceable life.

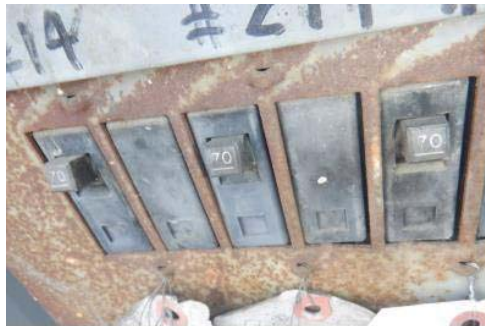
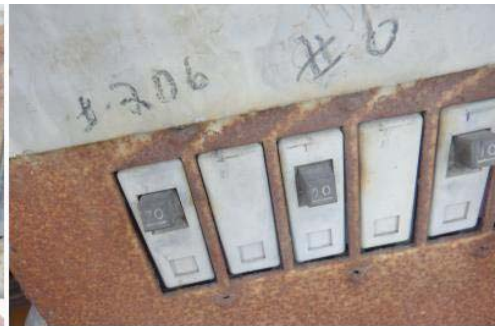
Needs Attention:

The panel is missing some required labels. This is a safety issue. Each panel and breaker is required clearly visible label as to its size and what area it serves.

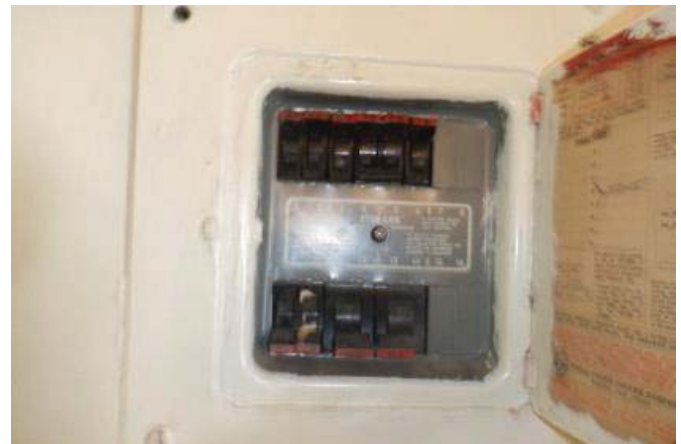
Needs Attention:

Panels identified as having been manufactured by the company Federal Pacific have been observed on the property.

Below is information on Federal Pacific subpanels. An electrician viewing this panel may recommend replacement due to the manufacturer alone. Other electricians after inspection and testing may determine the panel does not need to be changed out. Consultation with a qualified electrician is advised.

**Replacement of these
panels is often the
recommendation for
health and safety.**

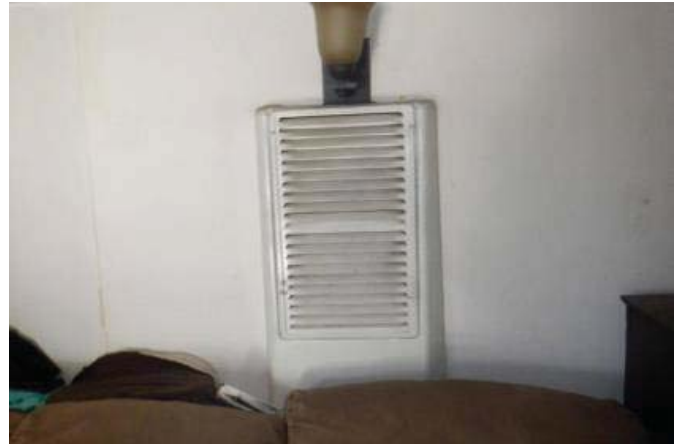
Needs Attention:

The original heating units are aged and worn. Though they may still be functional and working, it is noted that this type of unit has a life expectancy of approx. 15 - 20 years. Depending on the quality of maintenance, these units are at or near this age.

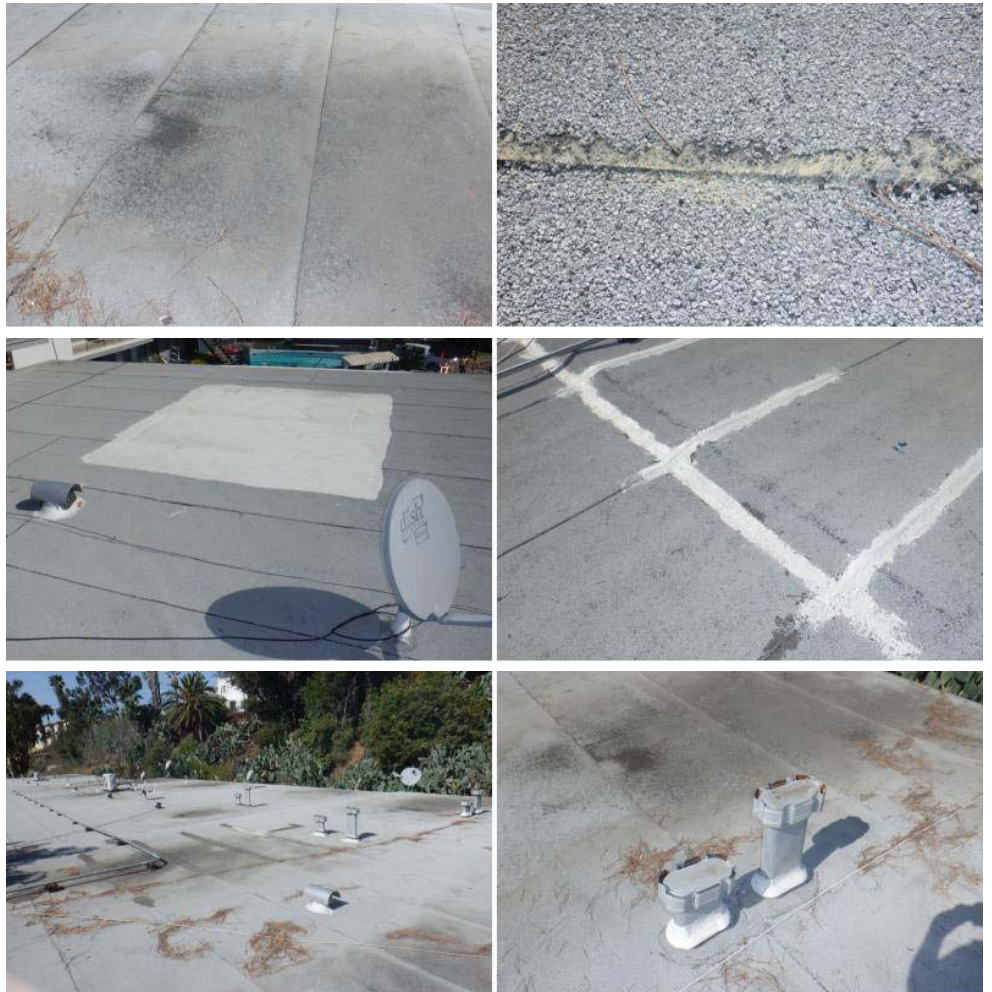
There is debris on the roof. It is advised to have this removed.

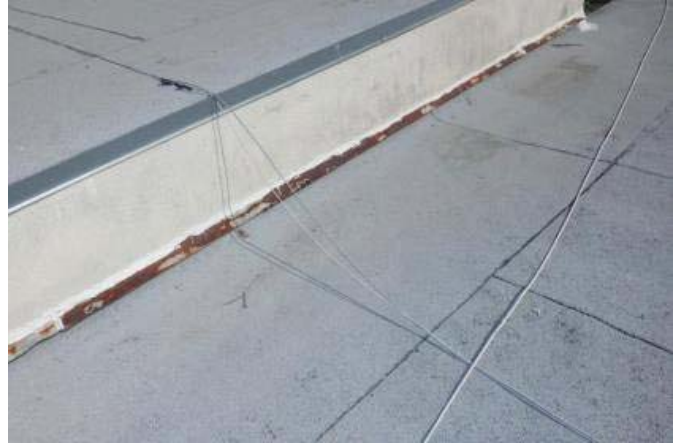
The metal flashing is rusting and corroded in areas.

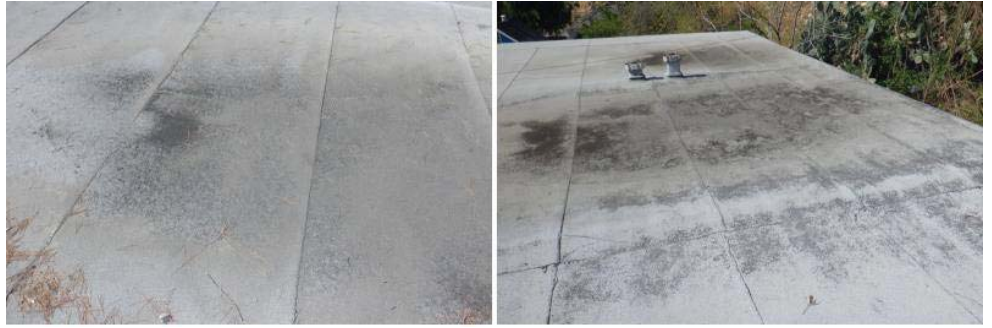
There are areas of the roof where water is ponding and not flowing freely off the roof, as evidenced by discoloration of the roofing surfaces or accumulations of dirt and debris.

If improving the slope of the roof is not practical, it is advised to have the roofing specialist examine these areas and make recommendations, such as adding additional material to the affected areas to improve their ability to withstand the deteriorating effects of ponding water.

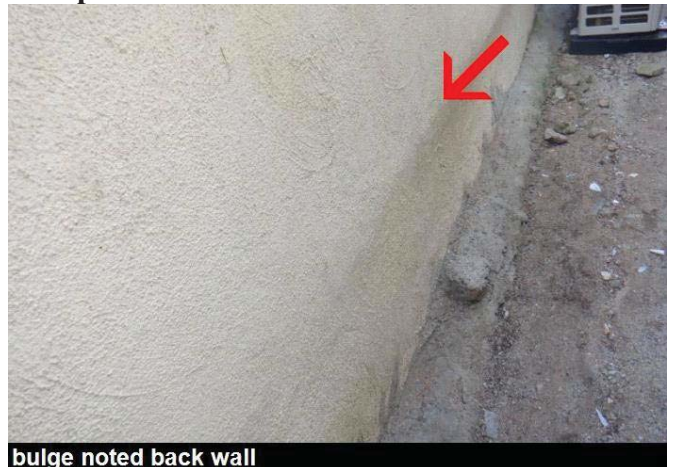
**Back exterior walls
have bulging in areas.
These should be
evaluated by a
Structural expert.**

bulge noted back wall

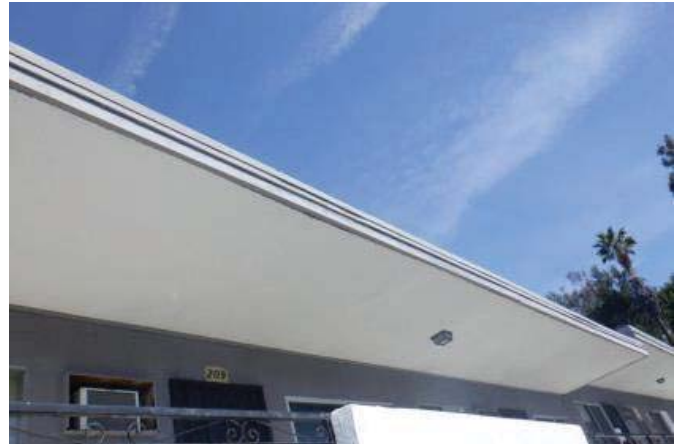
The trim has areas of weather beaten surface and peeling paint.

It is advised to repair or replace deteriorated areas of the exterior wood trim and then have them repainted to help ensure a longer lasting condition.

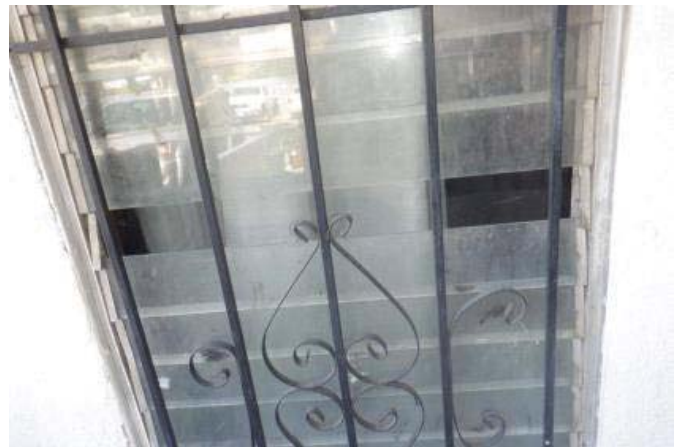
Needs Attention:

Older jalousie (slat) windows are seen. Some damages or missing pieces are noted.

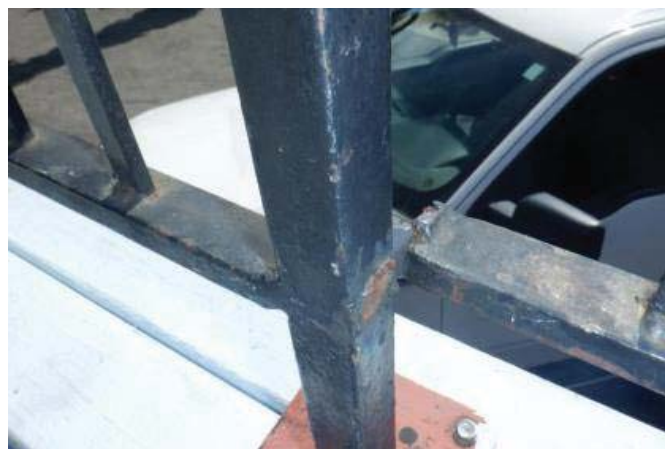
The railings do not meet current safety standards - it is recommended that there is no space greater than four inches in any portion of the railing for safety.

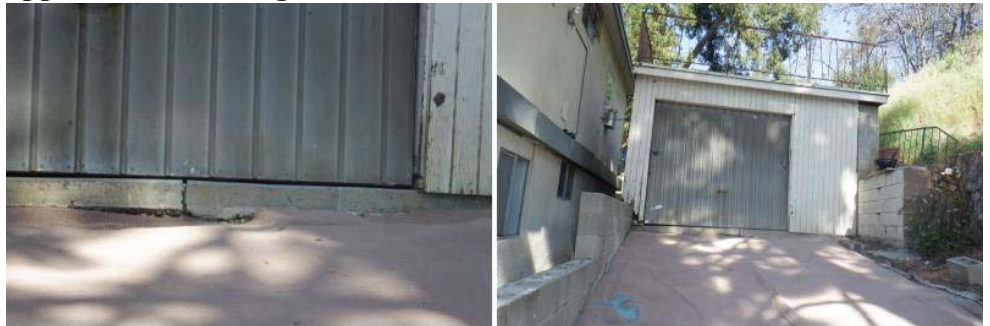
There is a separate storage building on the right side of the property. It appears to be damaged in areas. It was not viewed inside.

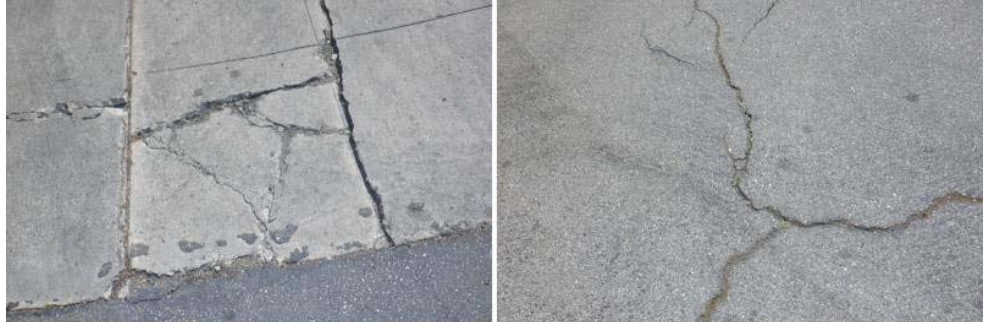
There are areas of wear and deterioration. It is advised to have some repairs made to areas exhibiting excessive wear, then reseal and restripe the entire parking lot.

Some repairs to the parking areas are needed then it is advised to have the parking areas fully resealed and restriped at this time.

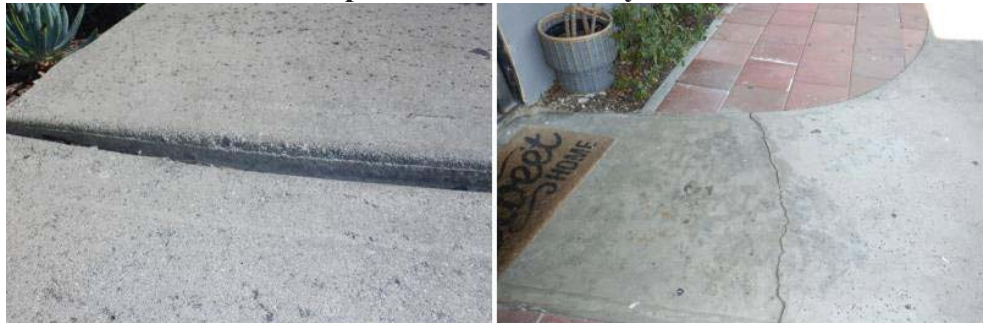
There are cracks and trip hazards in walkways.

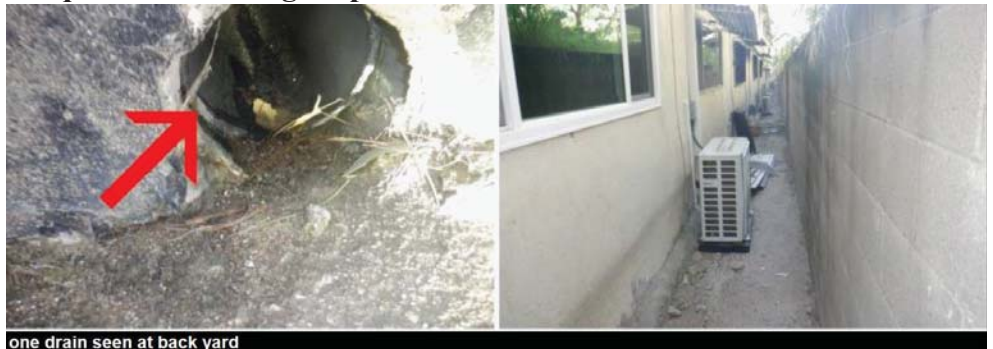
One drain is provided to drain the back yard. This may not be adequate. A Drainage expert should evaluate further.

one drain seen at back yard

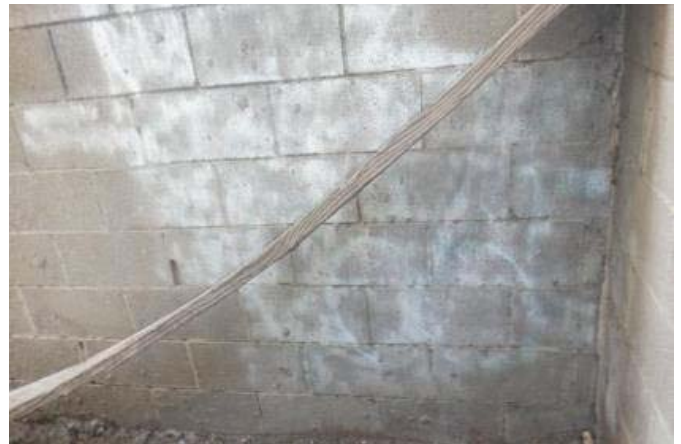
Efflorescence noted in
back wall.

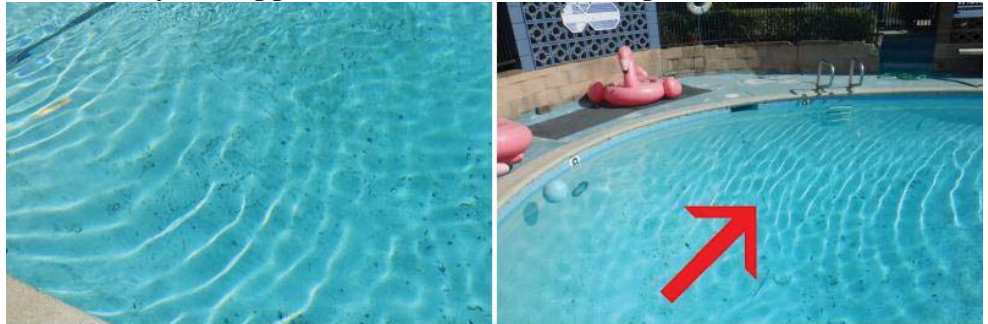
Pool is dirty and appears to have cracks in the pool walls.

A qualified pool/spa contractor should be called to make further evaluation and recommendations for repairs to the pool.

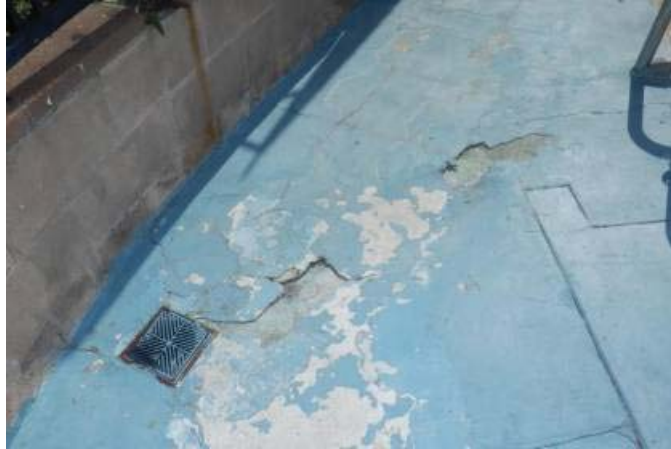
Cracks and damages noted in deck.

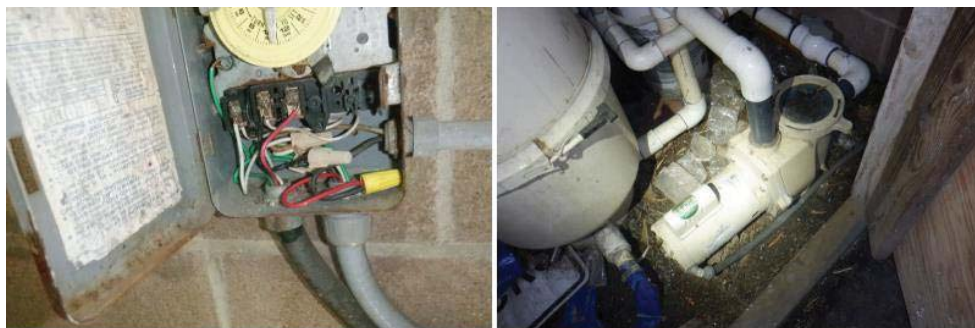
The equipment is not bonded with a bonding wire between all the pool equipment. This is a heavy copper wire that is a standard safety feature on pool equipment.

It is advised to have a pool specialist examine the pool and equipment and make any and all repairs to it to ensure that it is operating properly and safely. The specialist may find more problems with the pool and equipment as some problems were noted and it should be fully examined to ensure it is all working properly.

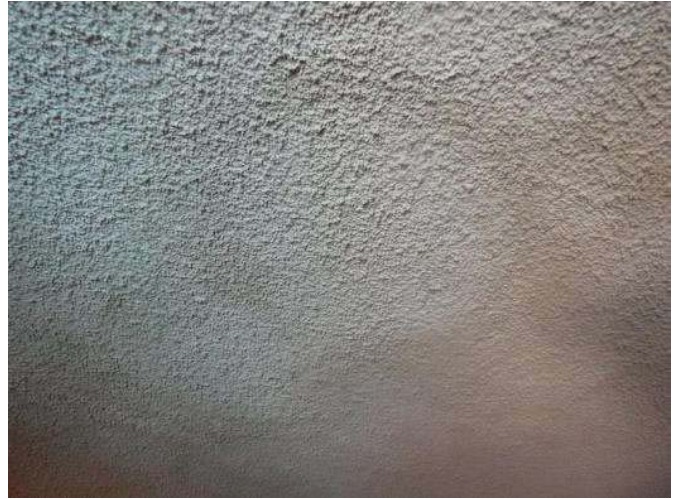
Needs Attention:

There are areas of moisture stains and/or damage on the ceiling in unit 215, 04,

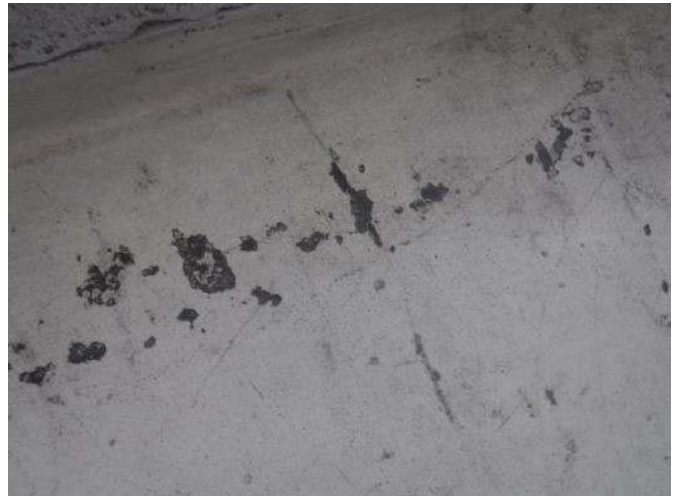
NEEDS ATTENTION:

The 2nd floor units deck surfaces have areas of wear and/or damage.

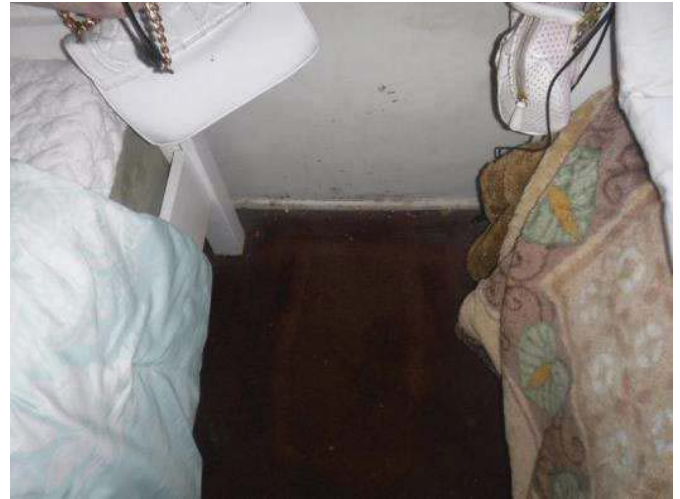
**Needs Attention:
Unit # 8**

According to the tenant her bedroom carpet gets soaking wet during rain periods. It is suspected that it may come from / through the window but there is no evidence of that. Upon inspecting the back side of the building it appears to have poor drainage.

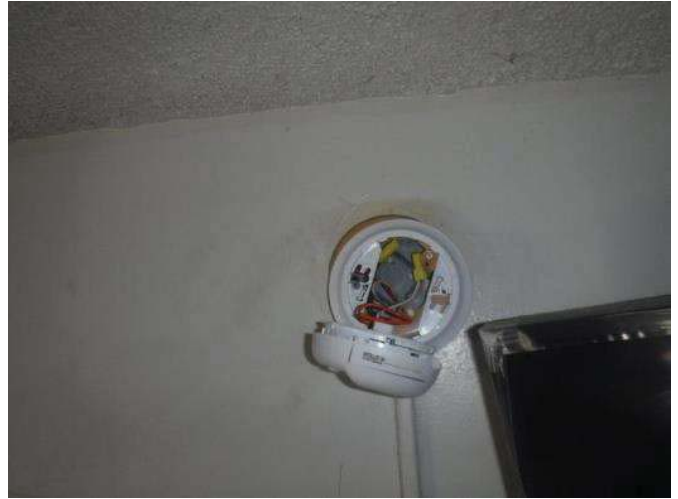
Needs Attention:

Removed / not working Smoke and CO-2 detectors were found in unit: 8, 208,

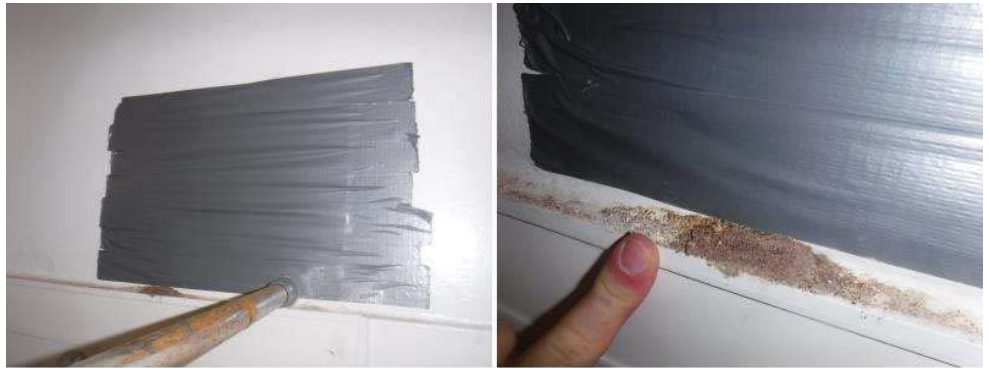
Needs Attention:

Moisture damage / rough patching to the walls in unit # 8, 1, 12

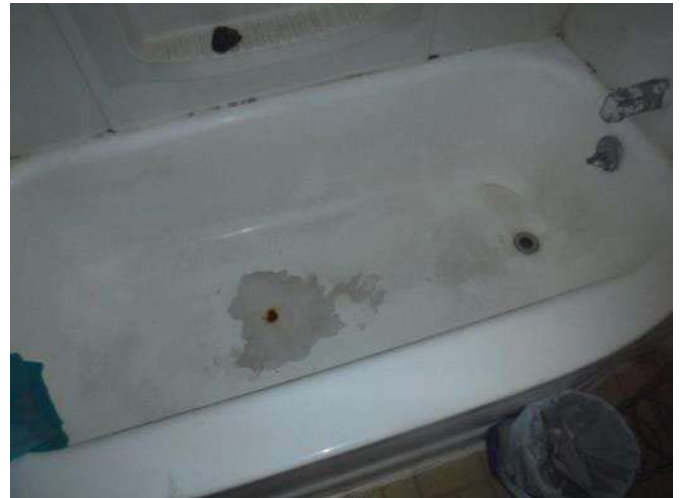
The surface of the tub is worn/damaged in unit 204, 211, 03

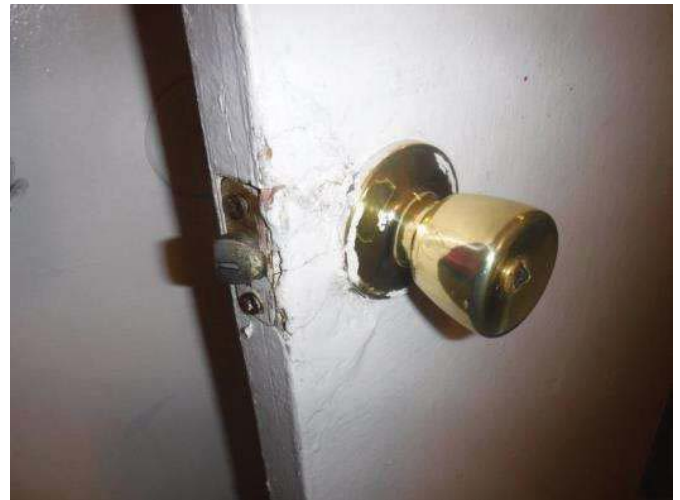
Needs Attention:

There is damage to the surface of the exterior and interior doors in units: # 01, 06.

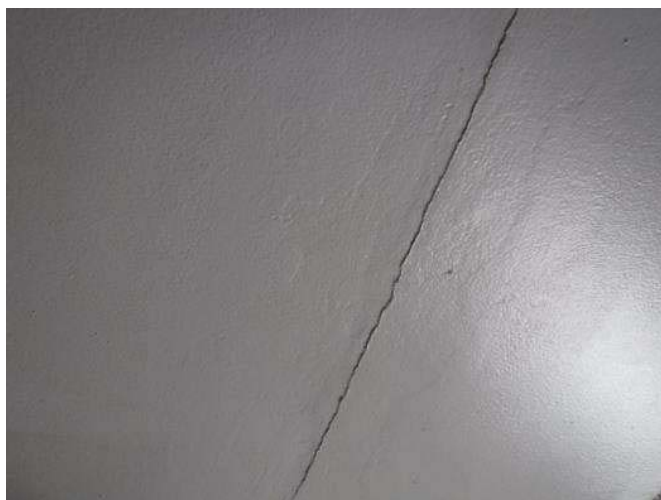
The ceilings have typical stress cracks in various areas. in most of the older units such as 214, 215.

But also in some of the newer renovated units such as # 12, 203,
