RISK Assessment® Report

RISK ASSESSMENT[®]

Commercial Real Estate Inspectors

This is an assessment of the five major systems - Plumbing, Electrical, Heating and Air Conditioning, Structure and Roofing along with an assessment of any other current deferred maintenance issues for the site.

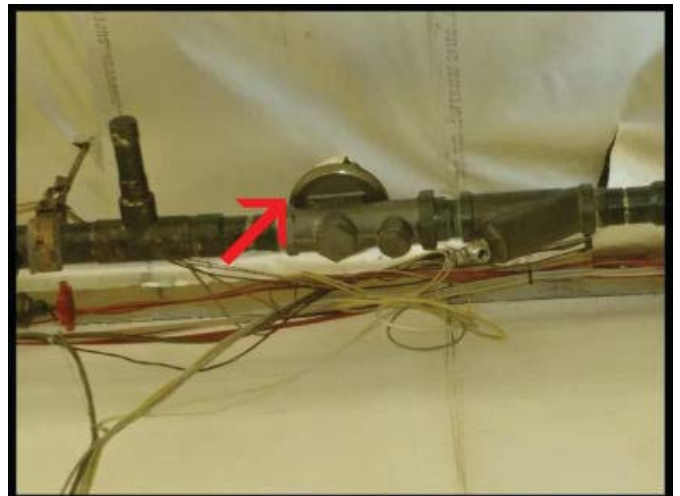
The water line at the front right is actively leaking. Immediate repairs is advised.

There was a pressure regulator observed on the water supply system. It is not known how well or if it is functioning, as this is beyond the scope of a general visual inspection.

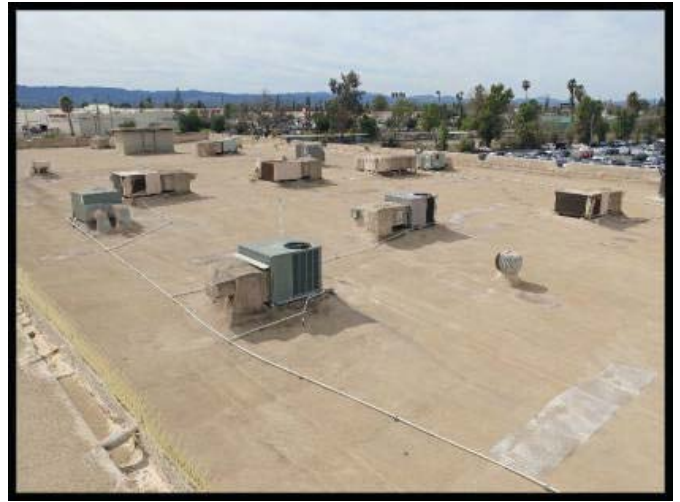
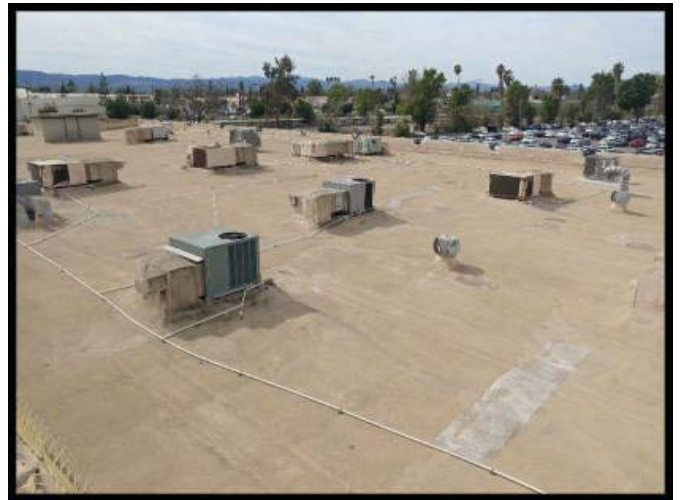
1. Heat pump unit from 2008. This is a five ton unit. Unit #13.
2. Roof package unit that is very old and appears to be approx. a 4 ton system. It is rusted and the condensate line is disconnected. Unit #12.
3. Roof package unit that is old and appears to be approx. a 3 ton unit. The condensate line is disconnected. The condensate line is disconnected.
4. Heat pump unit that is new. 3 ton unit with no condensate line. Unit # not present.
5. Heat pump unit that is old. Appears to be a 4 ton unit. Rusted with the condensate line

disconnected. Unit
#15.

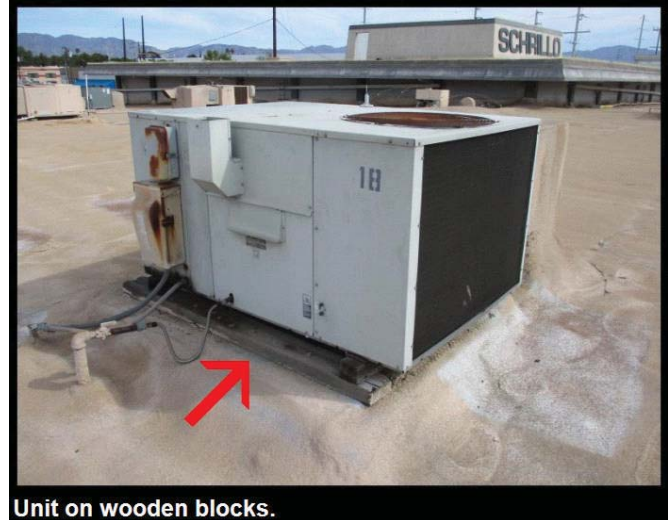
Some of the units are sitting on wooden blocks. This is not a reliable method regarding moisture intrusion. It is advised to have platforms with metal caps installed to help ensure a leak free condition.

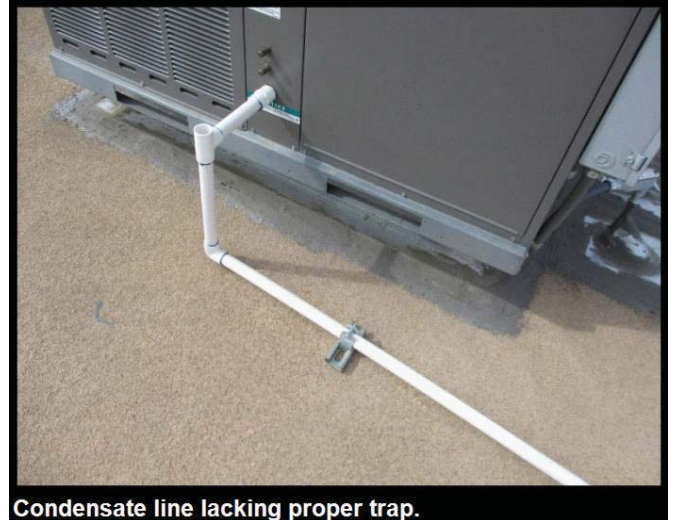
For some the condensate line(s) are not properly installed. There are missing traps, the lines do not drain to an approved drain or the lines are missing or damaged. Repairs are needed.

Condensate line lacking proper trap.

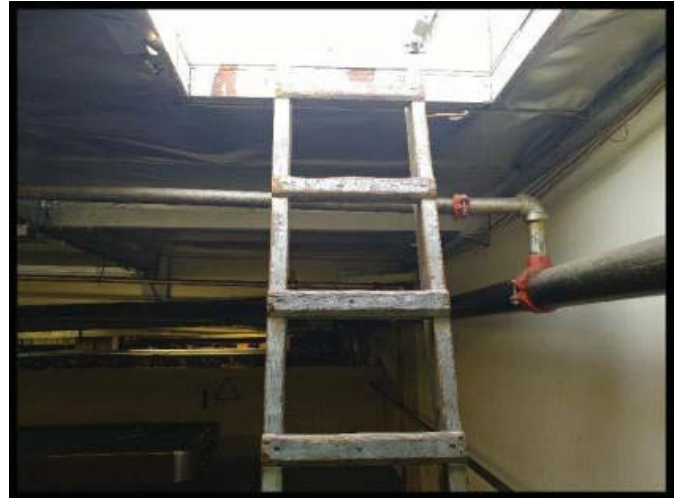
The ladder has rungs that are larger than 1 1/2" which is not recommended.

Modification is advised for safety.

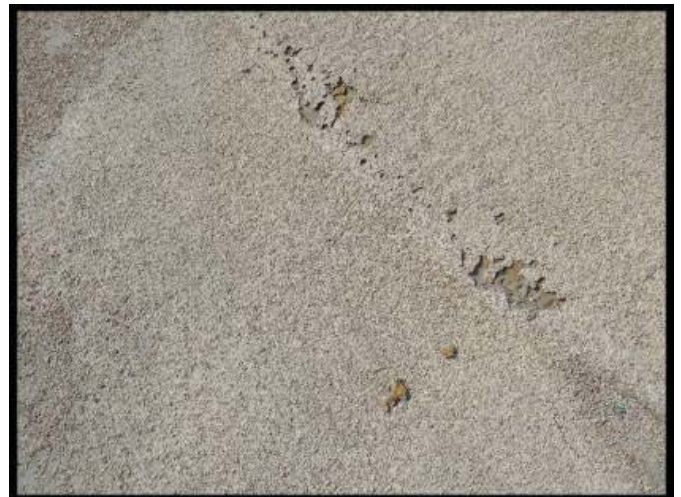
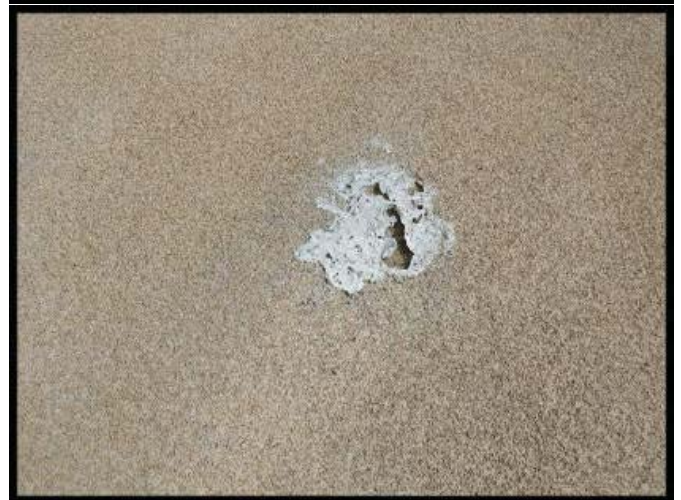
There are areas of wear and deterioration to the roofing material.

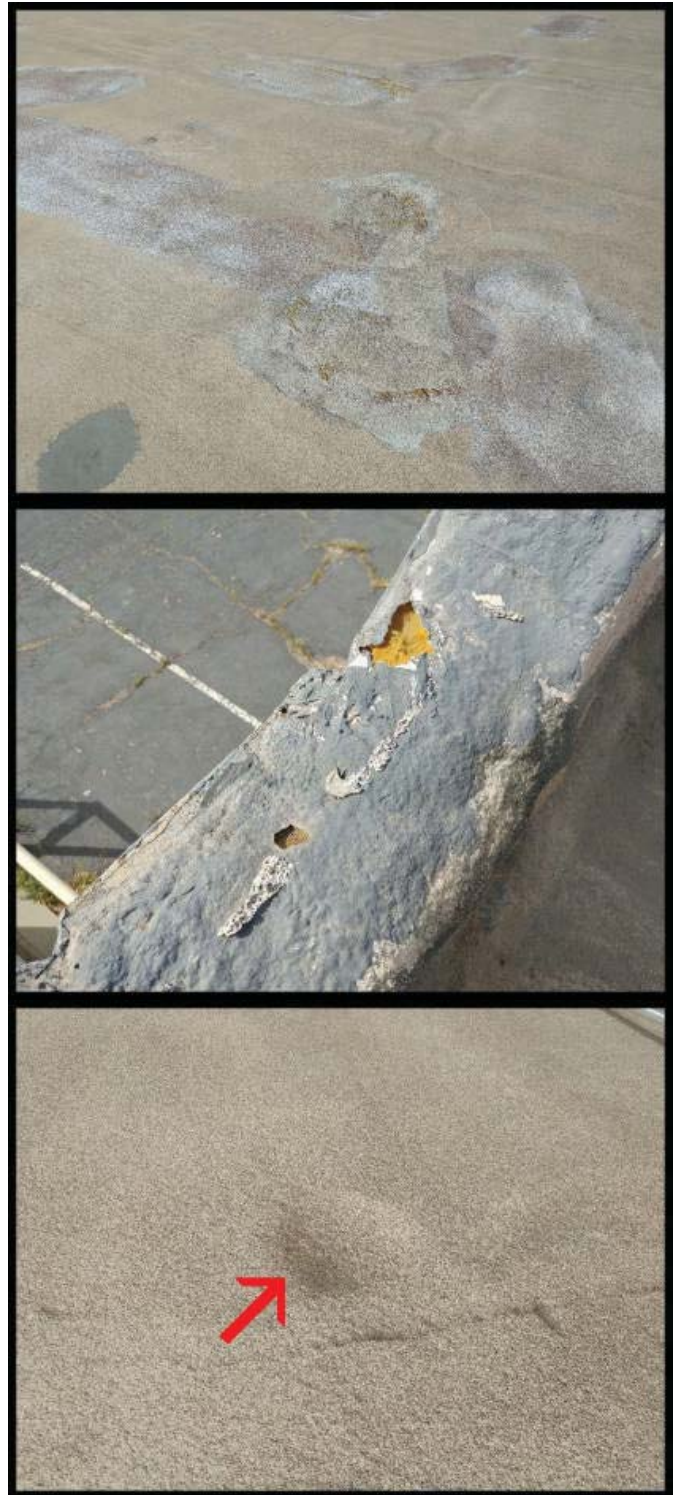
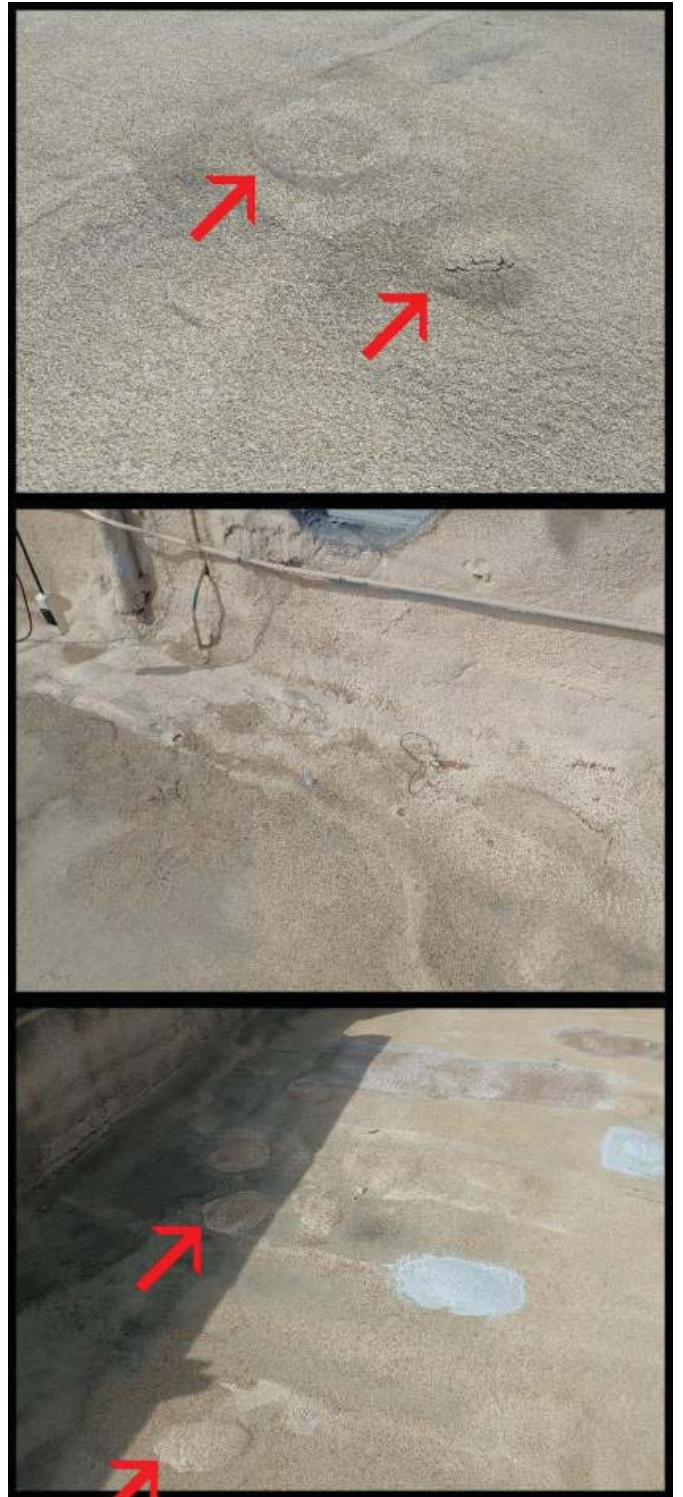
There are bubbled and uneven areas of roofing material. This is an indication that some moisture has gotten under the material.

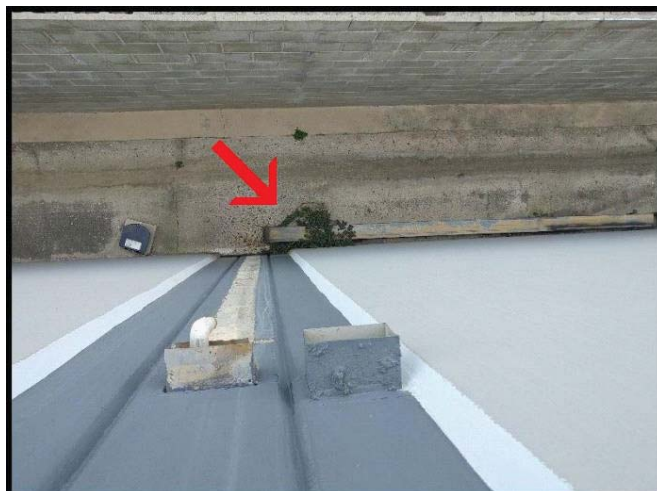
The downspouts are missing and the water will flow uncontrolled.

Disconnected downspout.

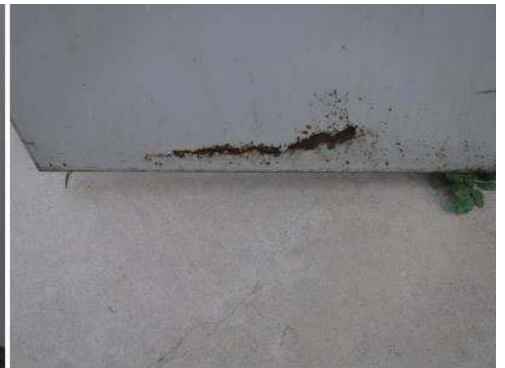
There are areas of deterioration to the exterior of the doors.

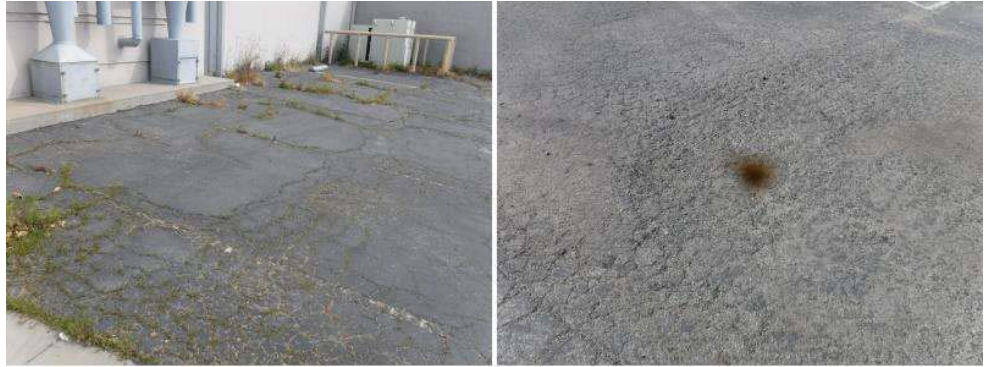
The parking area asphalt has areas of wear, weathering and

deterioration to the point that resurfacing should be strongly considered.

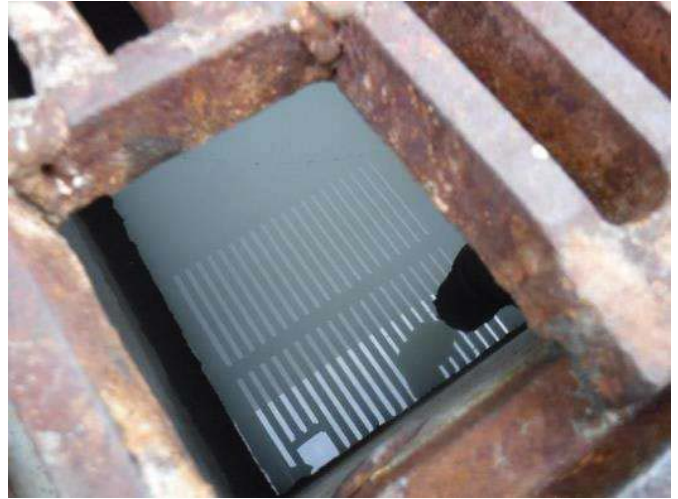
There appears to be a pollutant in the area drain. (Located in the back near the gas main)

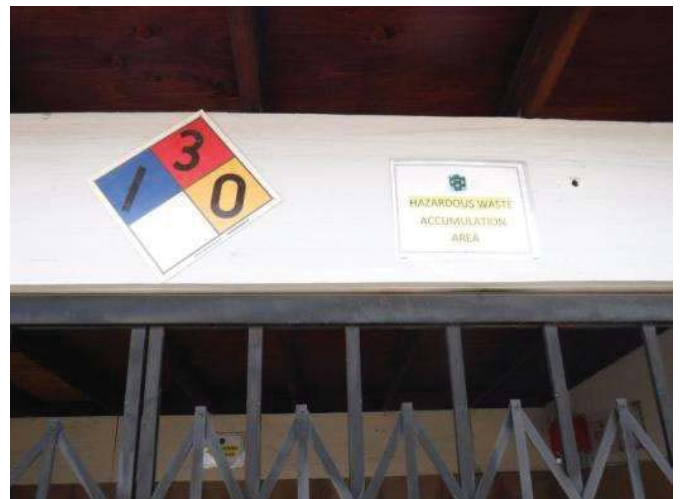
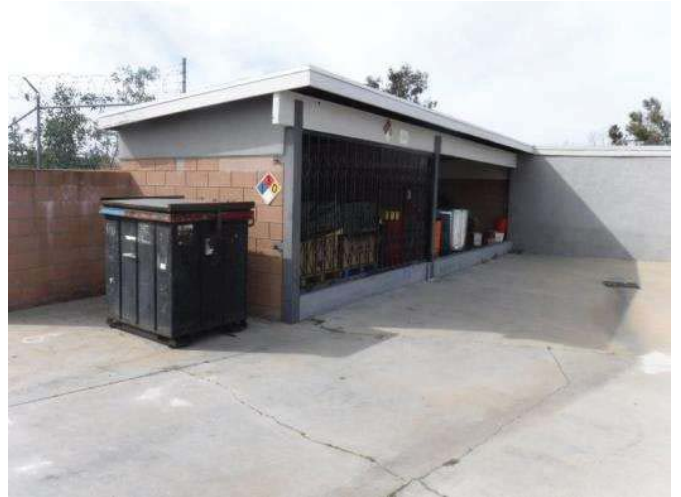
There are areas of storage noted around the property of petroleum and/or other chemical products generally deemed hazardous or of environmental concern.

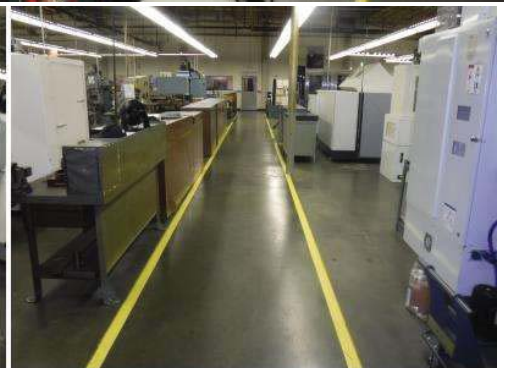
Such as typical cracking in the slab.

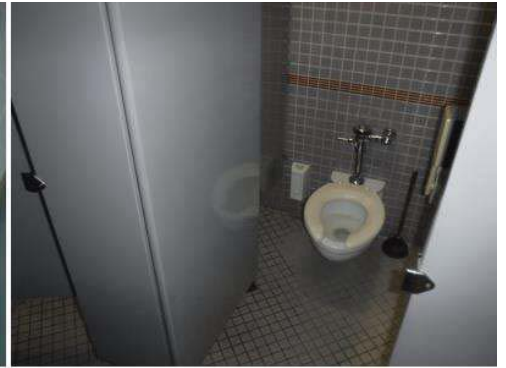
The doors into the 1st & 2nd floor office area rest rooms are less than 36"

The Warehouse production area's restrooms have no ADA facilities.

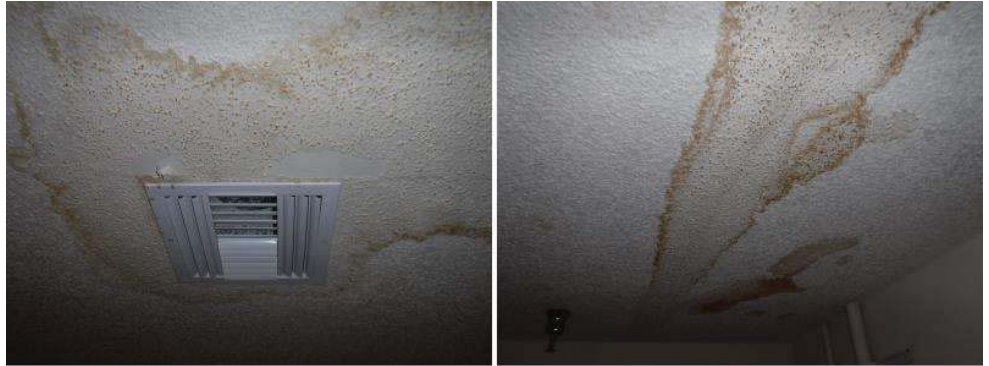
There are some stained areas of the ceiling.

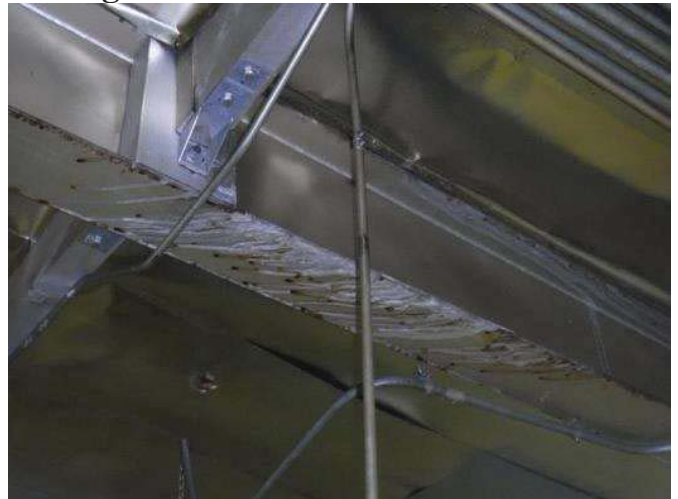
Yet there was evidence of moisture leakage throughout the warehouse areas.

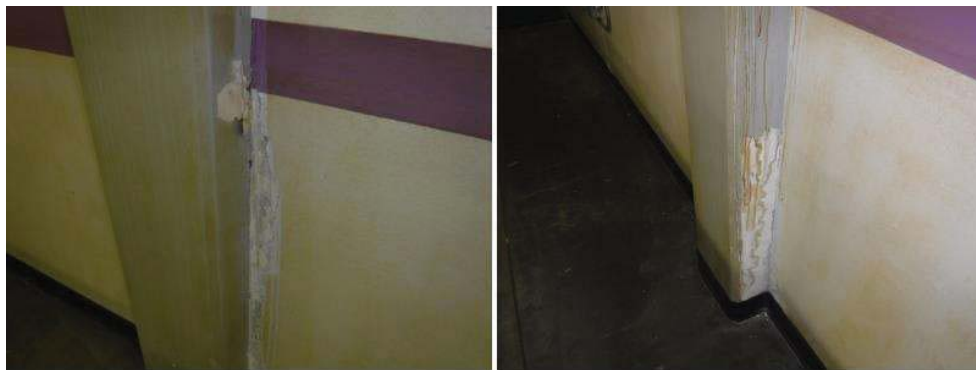
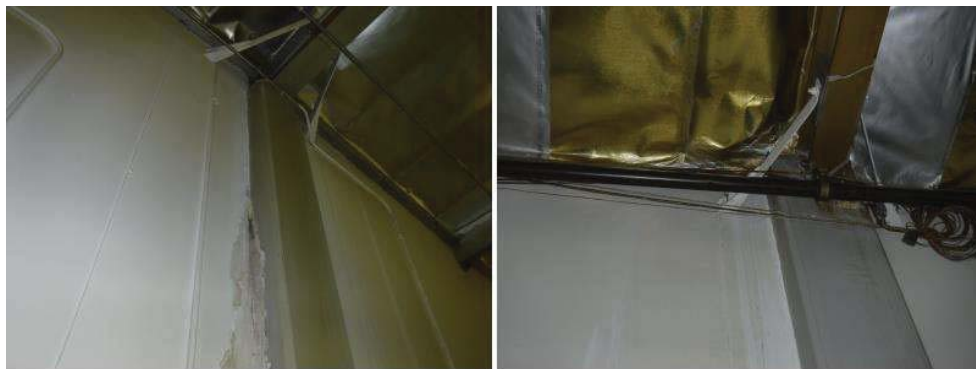
There are areas of moisture staining and or damage on the walls of the warehouse areas.

This is apparently coming from the roof.
