RISK Assessment® Report

El Monte, CA 91731

RISK ASSESSMENT[®]

Commercial Real Estate Inspectors

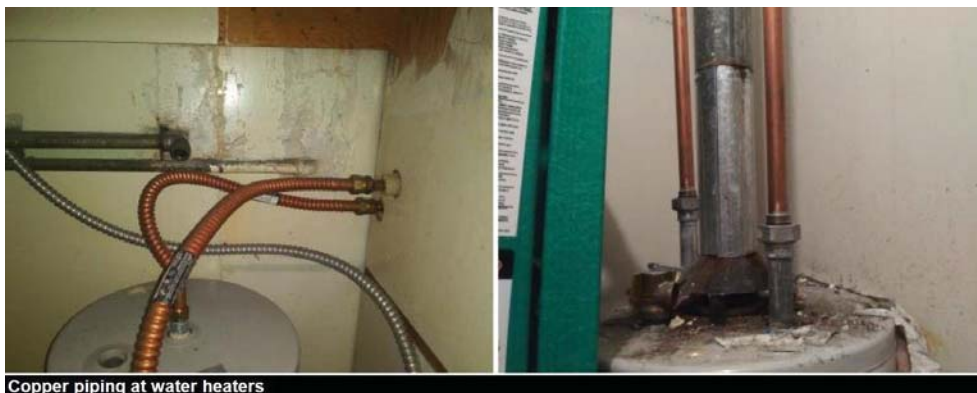
Copper piping at water heaters

It appears that the majority of the supply lines are galvanized iron piping.

The original galvanized steel piping that is left in the system is aged and at the end of its expected useful life. These will need to be replaced as they continue to wear out. While the system appears generally serviceable at this time, it is recommended to upgrade the older galvanized piping to copper piping.

Due to the age and overall condition of the supply piping it is Recommend to Replace all original galvanized iron piping.

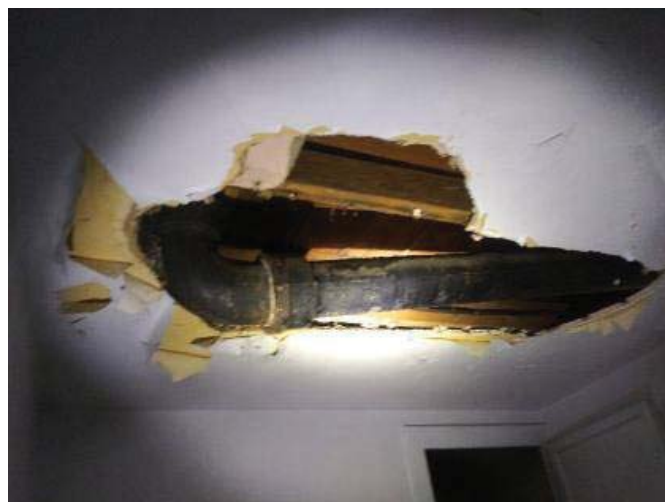
The was line vent has fallen through the ceiling in the vacant residence. Further review is advised by a qualified plumbing specialist.

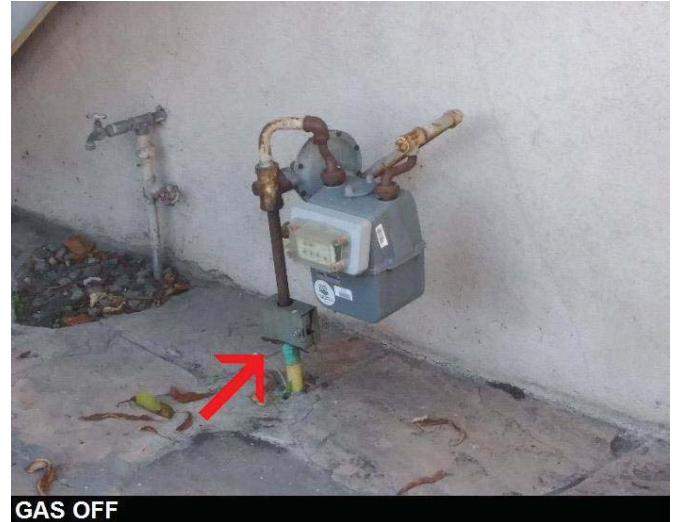
The gas was not on at the time of inspection. A lock was observed on the gas valve. It is advised to have the gas company turn on the gas and light and test all gas appliances.

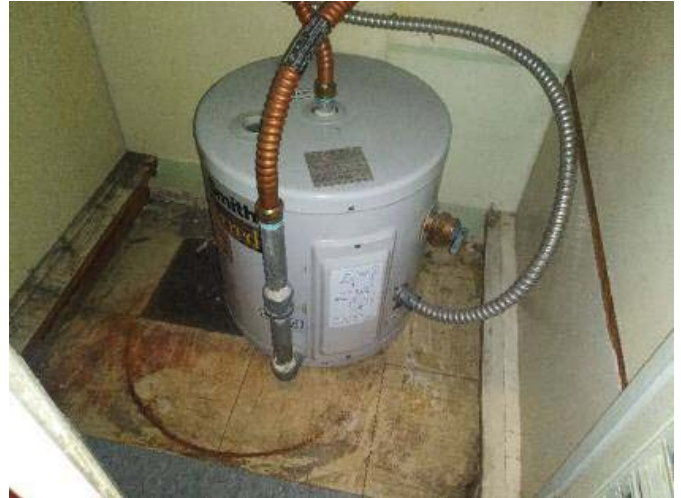
There is no catch pan under the water heater to prevent leaks from damaging the floor or structure, this is required in this location.

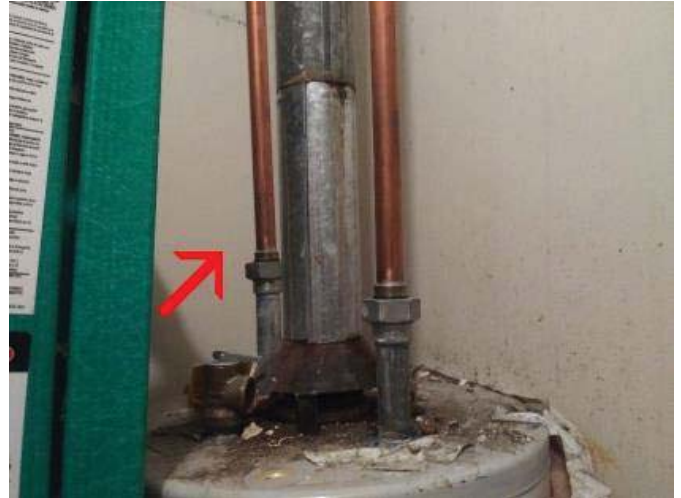
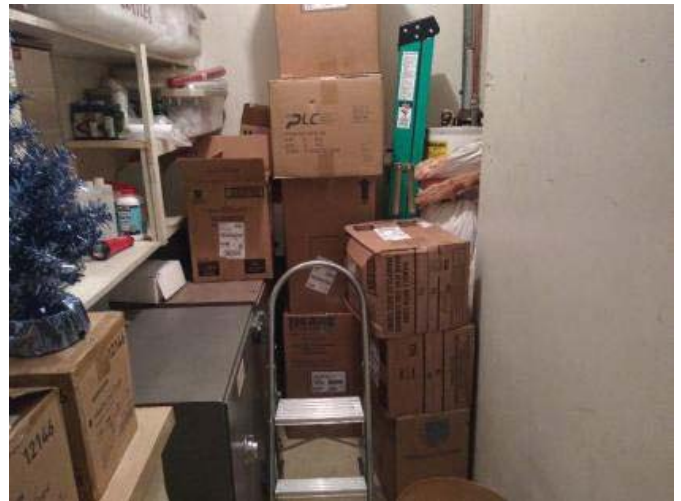
There are stored items too close to the unit. This is a fire hazard.

The water heater does not appear to have sufficient air to properly combust the natural gas it is burning.

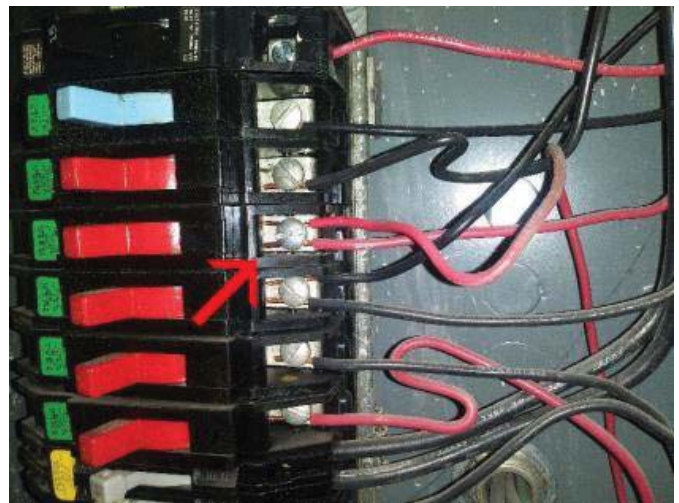
There is more than one electrical wire connected to a single circuit breaker. Only one wire should be connected to each breaker. This can sometimes cause overloading of the wires or breakers. It also can cause the wires to have improper contact with the breaker and arc between the wire and

**breaker connection.
One of these was
noted.**

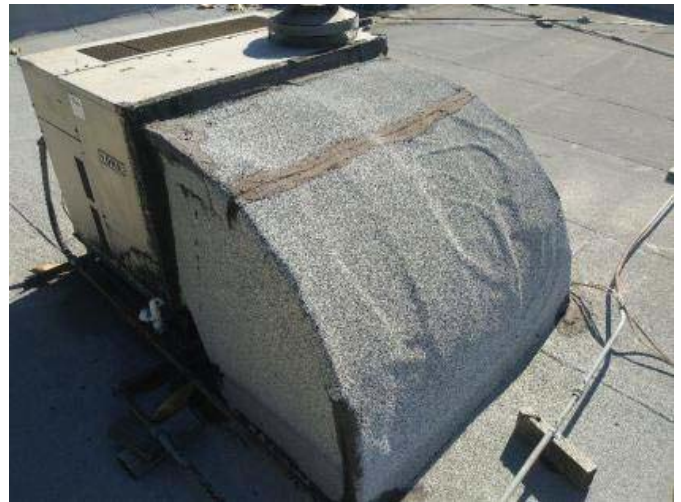
There is ducting on the roof that has improper sealing material applied to them. This type of sealer is not designed for exposed roofing ducts.

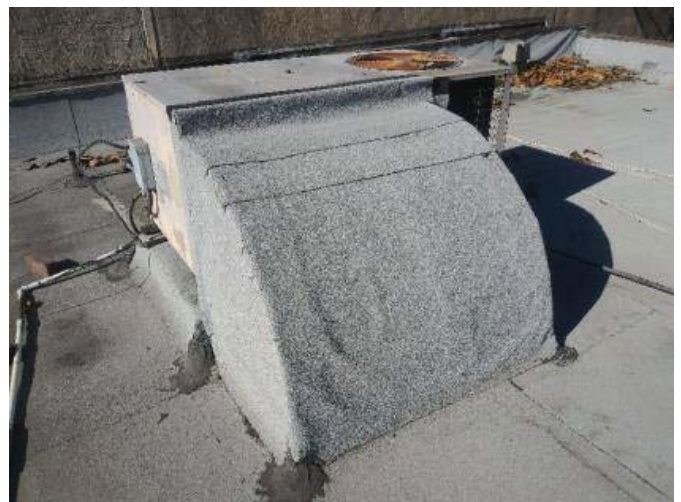
There is ducting on the roof that has improper sealing material applied to them. This type of sealer is not designed for exposed roofing ducts.

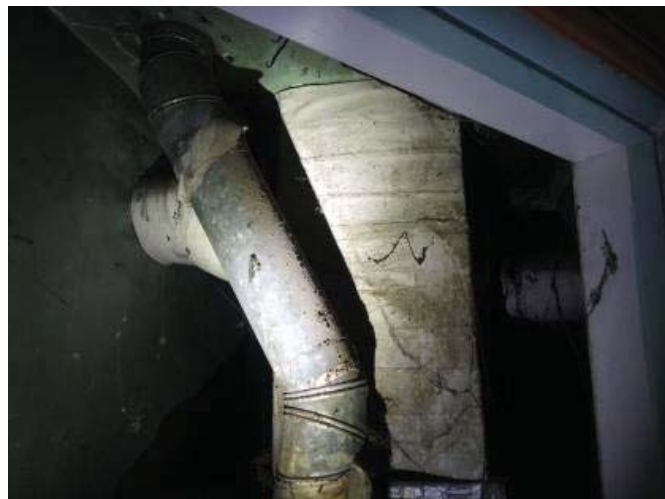
The insulation of the ducts is the type of material that is often found to contain asbestos. It would have to be tested in a laboratory to confirm what its composition is.

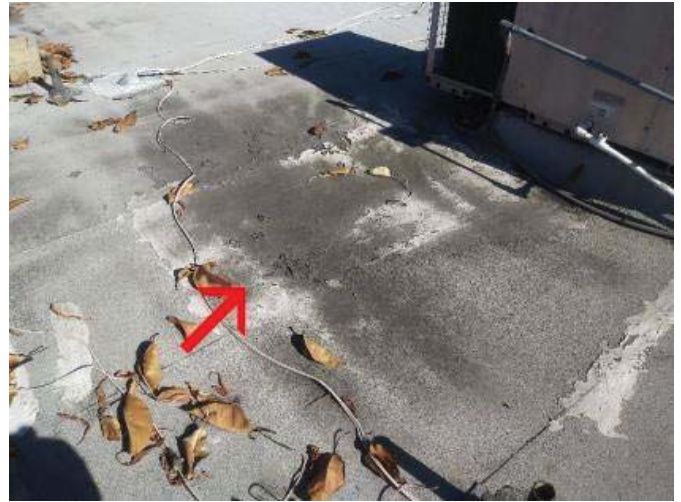
It is noted there are areas of the roof that have had patching and or repairs done to them. This is usually an indication that there have been leaks and past issues. It is advised to have full disclosure by the seller as to the history of any roof leaks.

There are signs of standing water from the past from discoloration noted over the medical building. Standing water can accelerate the deterioration of roofing areas affected. It is advised to eliminate these areas of ponding by improving the slope of the roof wherever needed, or to reinforce affected areas where slope improvement is impractical.

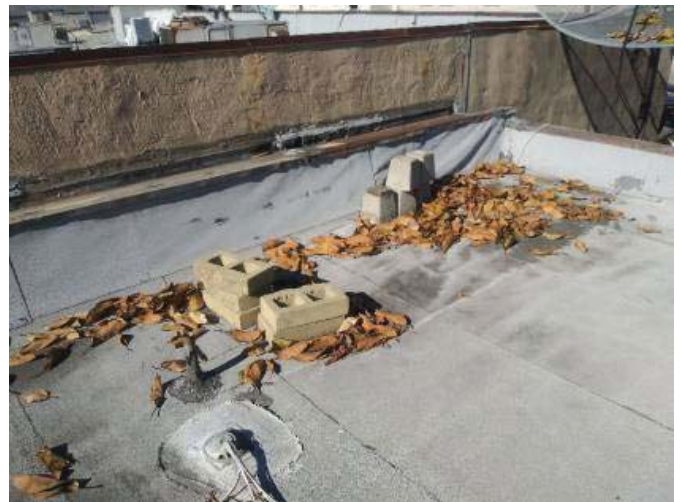
There is debris on the roof. It is advised to have this removed.

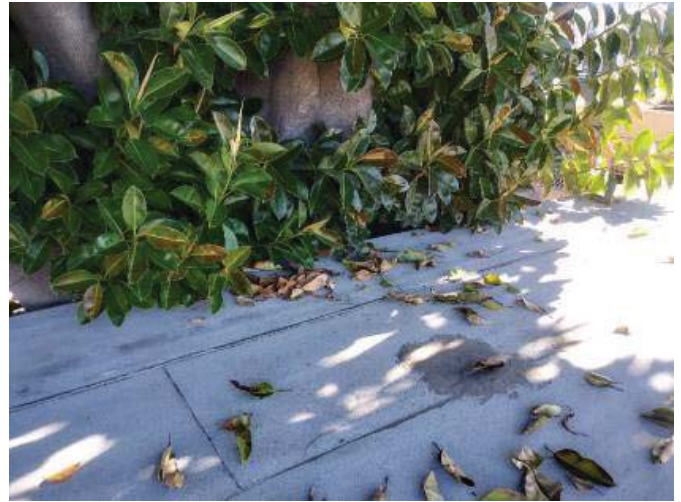
There is a tree rubbing against the roofing material.

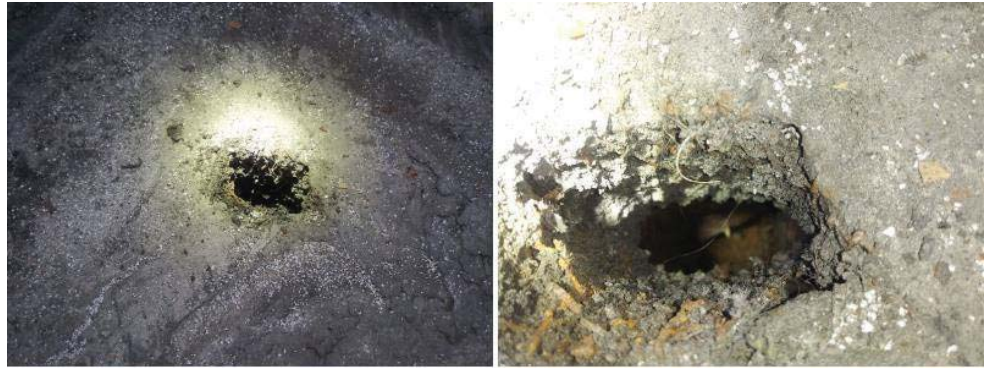
The drain screens are rusted and deteriorated. These are makeshift screens made from stucco lathe.

The openings for the drains are smaller than recommended. It appears that during rains these openings could clog with debris.

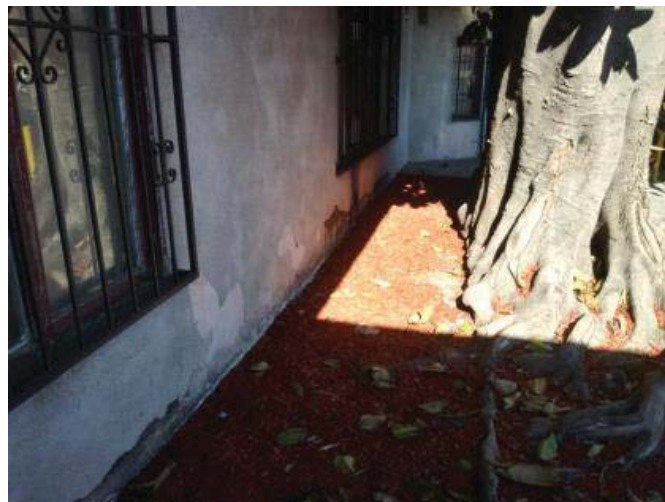
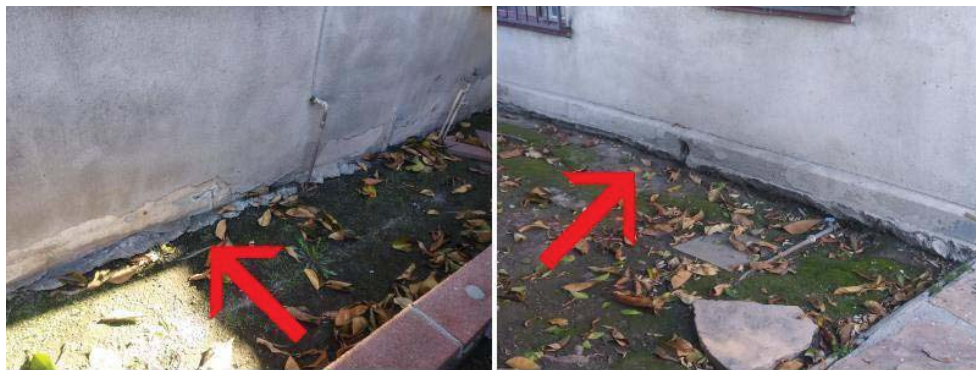
There is a tree planted closer to the structure than advised. The tree root systems does not appear to be significantly affecting with the foundation but may interfere with the foundation and plumbing systems in the future as they continue to grow.

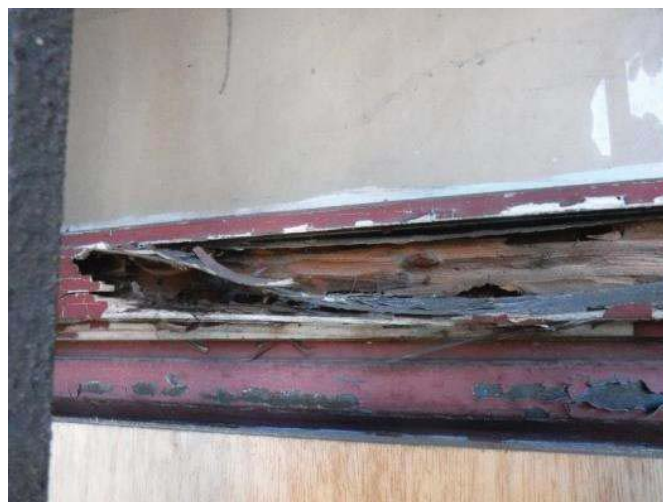
The exterior trim has areas of weathering with peeling finishes and deterioration.

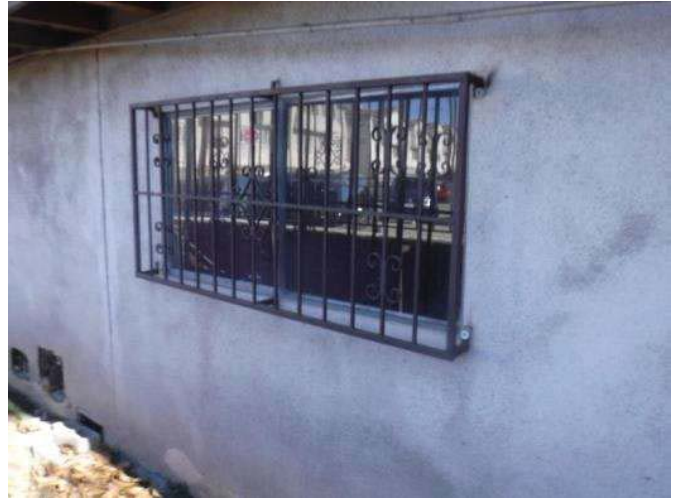
The windows are aged wooden windows. They have areas that are pulling apart at the seams and showing some areas of excessive deterioration. Some are at the end of their life and replacement is advised at this time.

Some of the windows are older steel windows. They are aged and worn and at the end of their expected useful lives. Typically these are not well sealed and can be drafty.

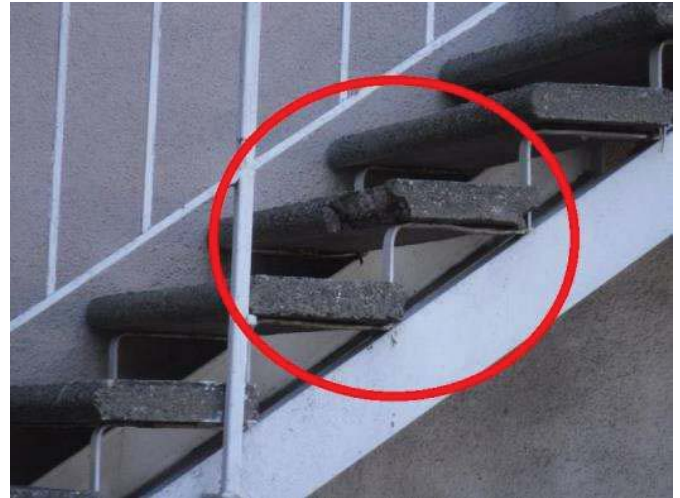
There are areas of weather beaten wood and peeling paint.

There are areas of the stairs that are deteriorated.

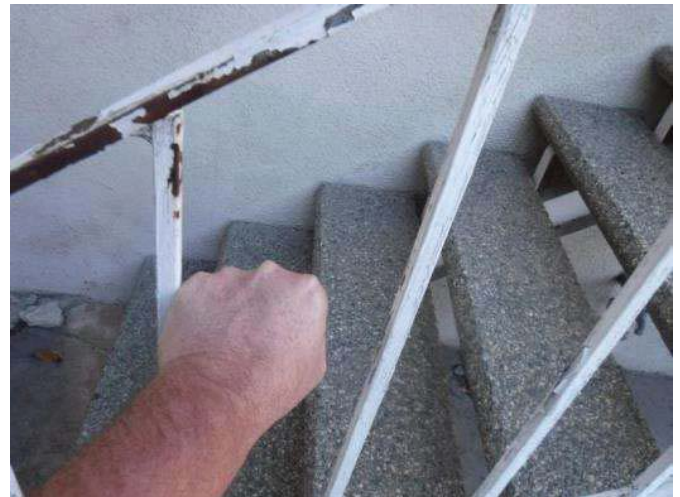
The railings do not meet current safety standards - it is recommended that there is no space greater than four inches in any portion of the railing for safety.

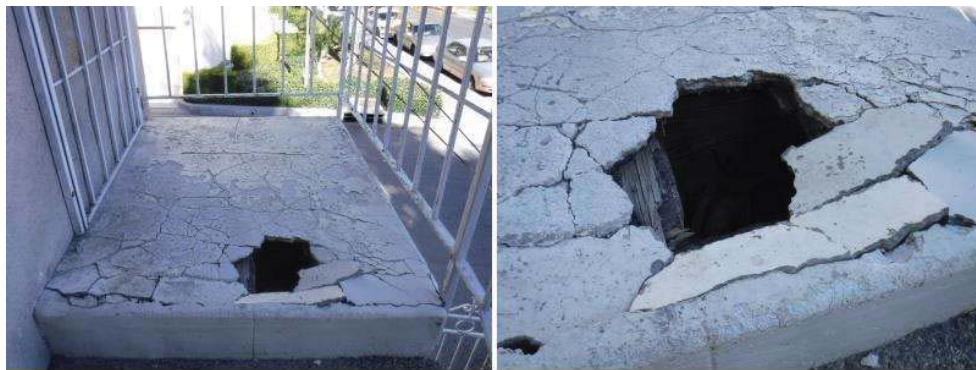
The decking has cracks in the surface and is in need of repairs to ensure a leak free condition.

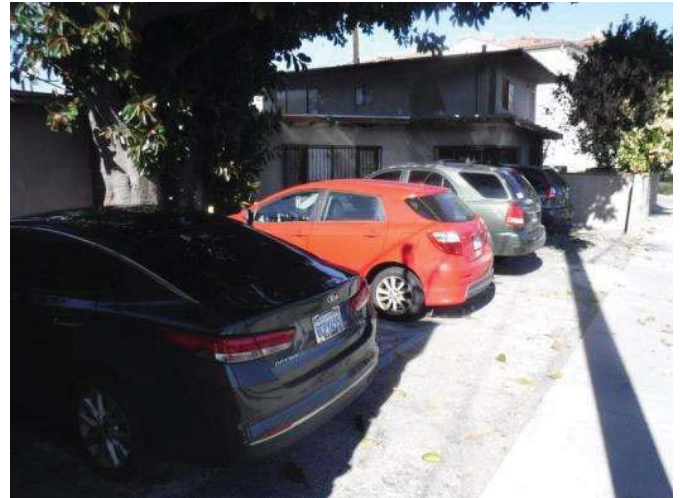
The driveway area surface is worn and aged and in need of maintenance and repairs at this time.

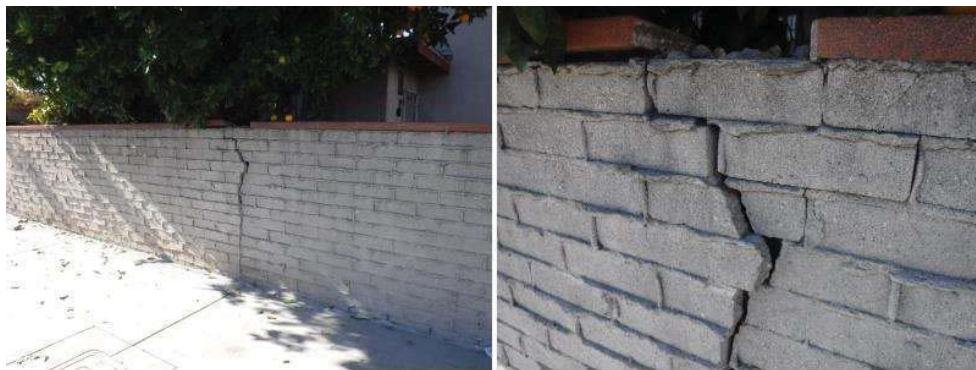
The concrete block walls are cracked in areas and do not have the intended strength they had when they were constructed. They may need repairs.

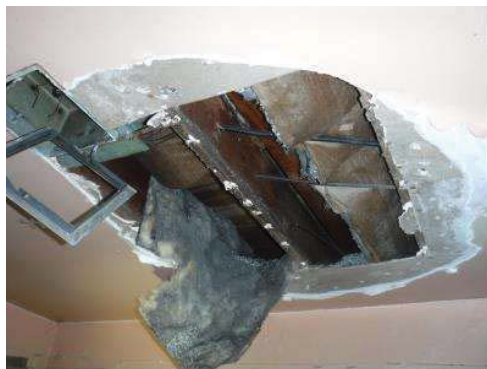
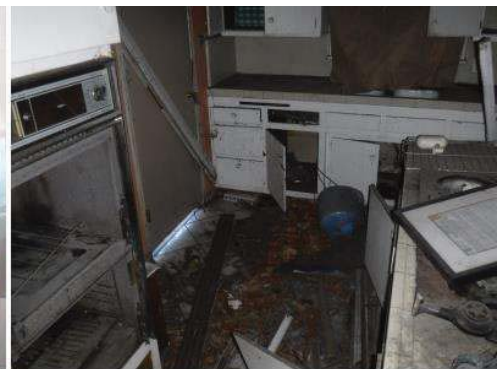
The office areas show excessive wear and tear. Upgrades are advised at this time.

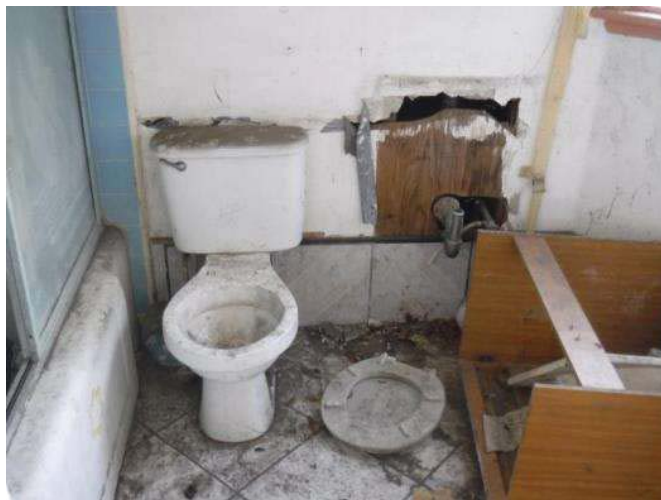
The interior surfaces, such as the walls, ceiling and cabinets are excessively worn and/or damaged in the middle building.

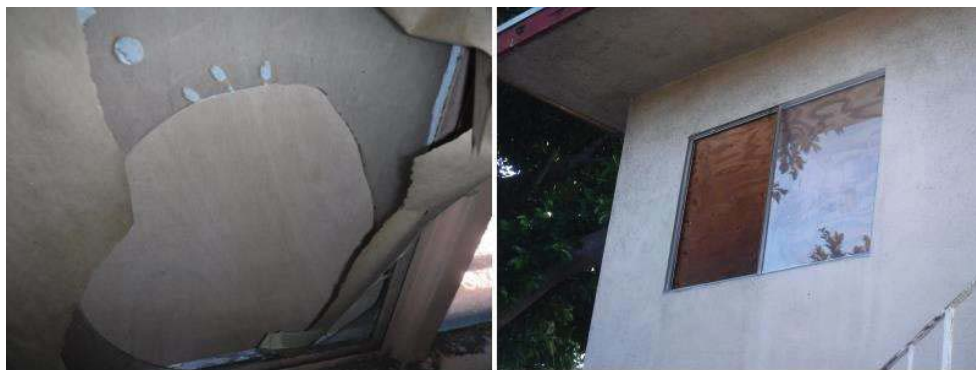
There are cracked / missing window panes.

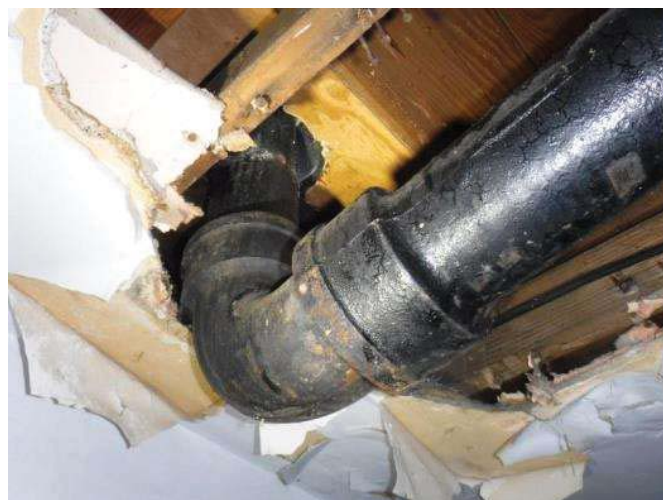
There is no flashing around this protrusion and the moisture has damaged the ceiling.
