# RISK Assessment® Report

**Anaheim, CA 92801**

Inspector - Bob Pace  
Confidential and Proprietary

# RISK ASSESSMENT<sup>®</sup>

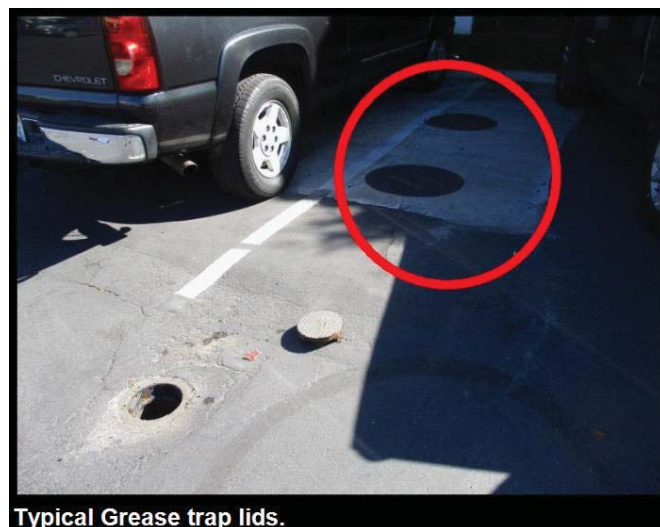
Typical Grease trap lids.

There is a kitchen on the site that appears to have a clarifier or grease trap system at the rear. Full review by a qualified plumbing professional is advised to ensure the site meets all requirements.

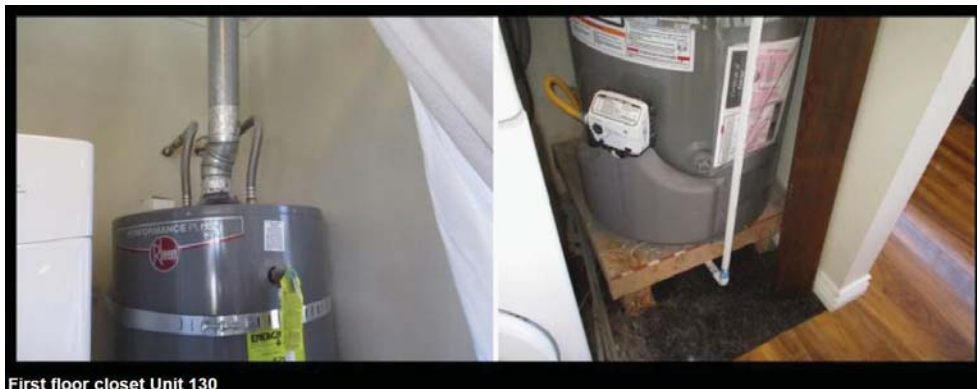
First floor closet Unit 130

The water heater is located in the utility room/closet of unit 130

**There is no catch pan under the water heater to prevent leaks from damaging the floor or structure, this is required in this location.**

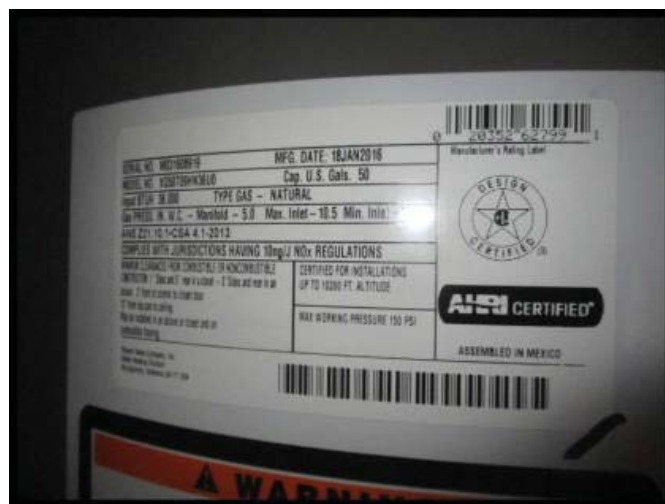
4 years old. Water heaters have an expected life of 8 - 12 years.

**The water heater temperature pressure relief valve appears to have an improper plastic drain line installed instead of material approved for this high temperature application.**

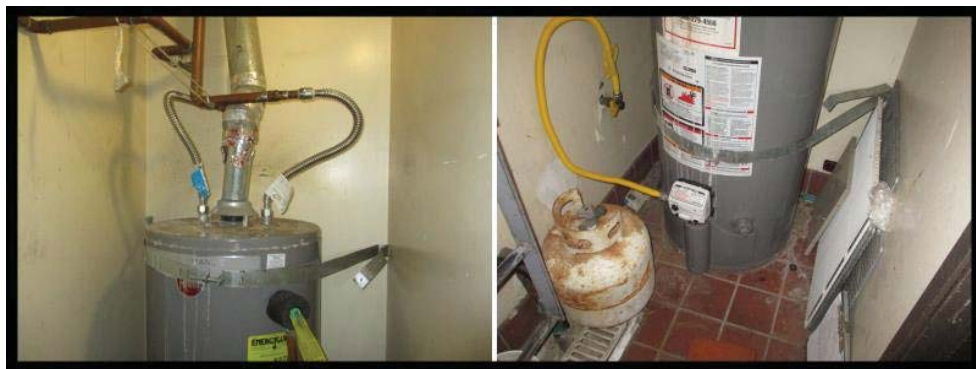
Second floor closet by the roof access.

**There is no catch pan under the water heater to prevent leaks from damaging the floor or structure, this is required in this location.**

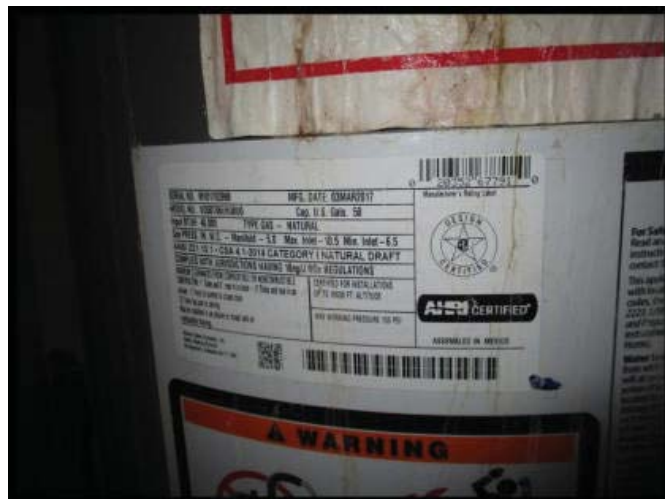
**There is corrosion on the outer tank area.**

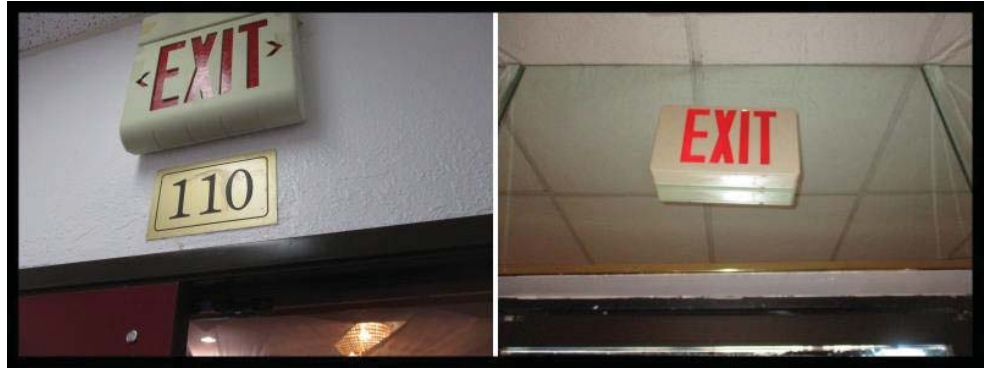
**Although there are signs present, they do not appear to be the type that are required by current standards.**

**This type of building site is required to have certain fire safety items, such as exit signs and/or fire extinguishers. It is advised to check with the local Fire Marshal to determine if this building meets current fire safety regulations.**

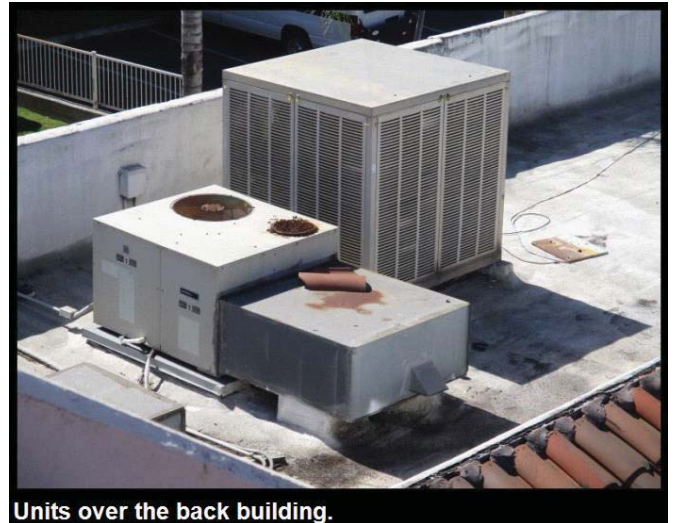
There are two units over the back building. These no longer appear to be in operation due to the space being used for storage only at this point. One appears to be a roof package type unit and the other is an evaporative cooler. Both are aged and worn and at or past the expected useful life.

Units over the back building.

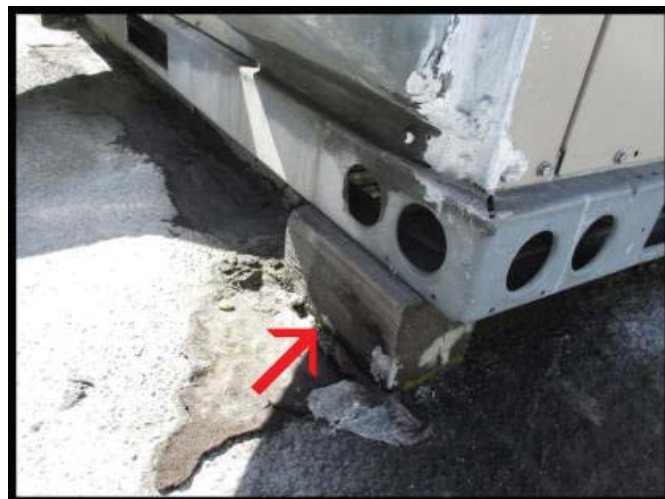
**For some the units are sitting on wooden blocks. This is not a reliable method regarding moisture intrusion. It is advised to have platforms with metal caps installed to help ensure a leak free condition.**

**This was the case for at least five of the units.**

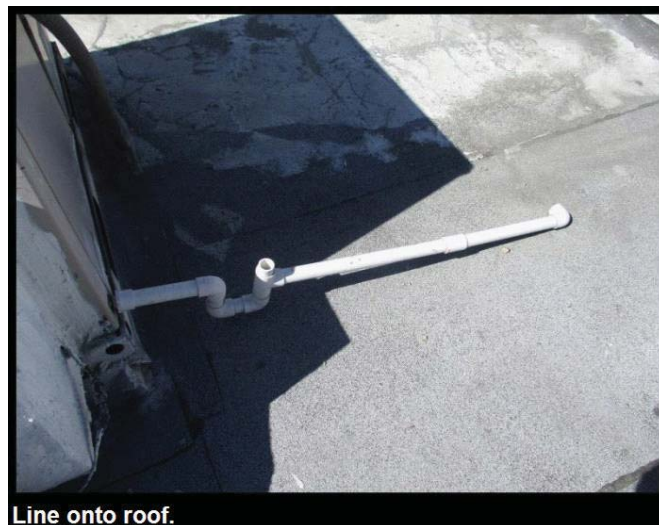
For many the condensate lines are not connected to an approved drain and are draining onto the roof or missing.

Line onto roof.

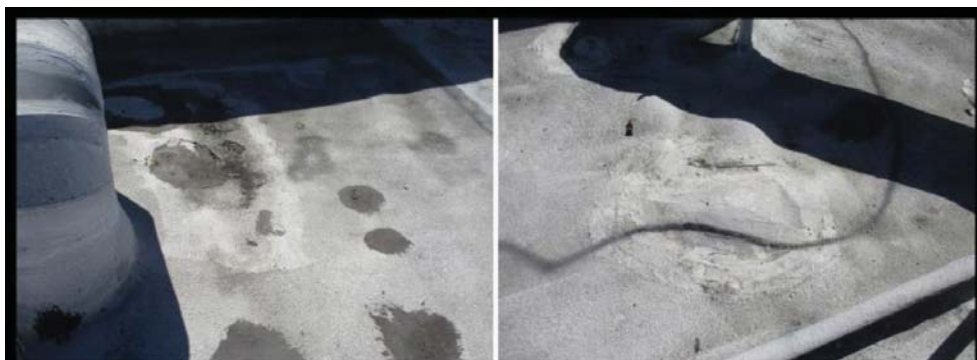
Typical roofing views.

**Though full review by a qualified roofing contractor is recommended at this time, replacement of the existing roof systems for both buildings is advised.**

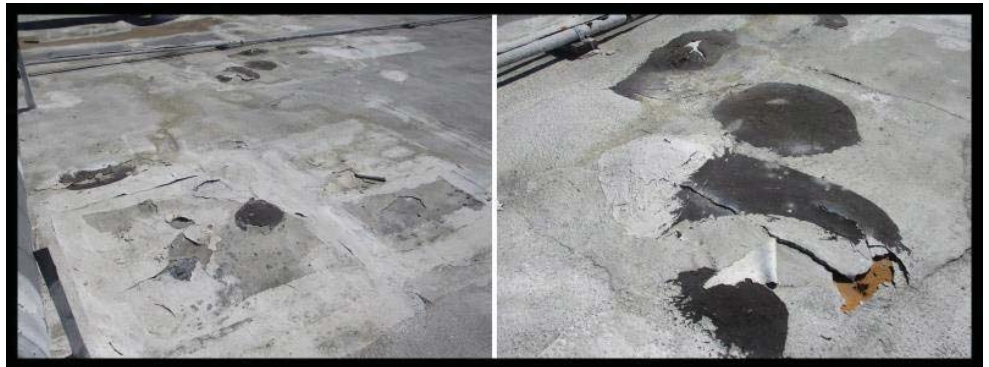
**The roofing has areas of excessive wear and is not longer a reliable moisture barrier.**

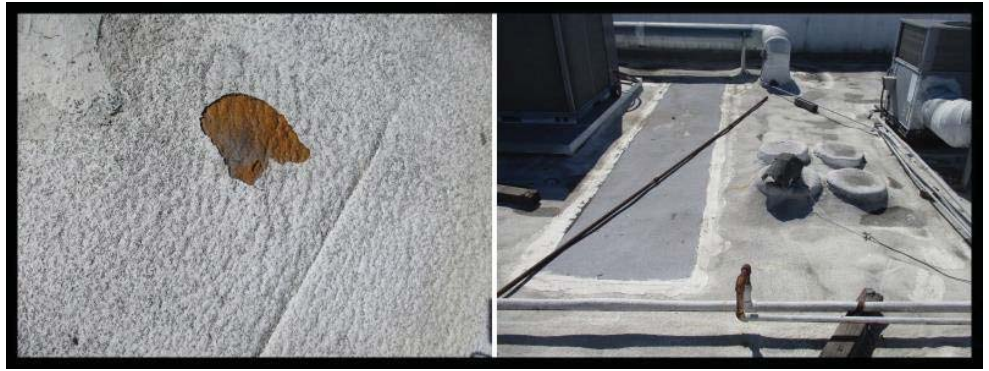
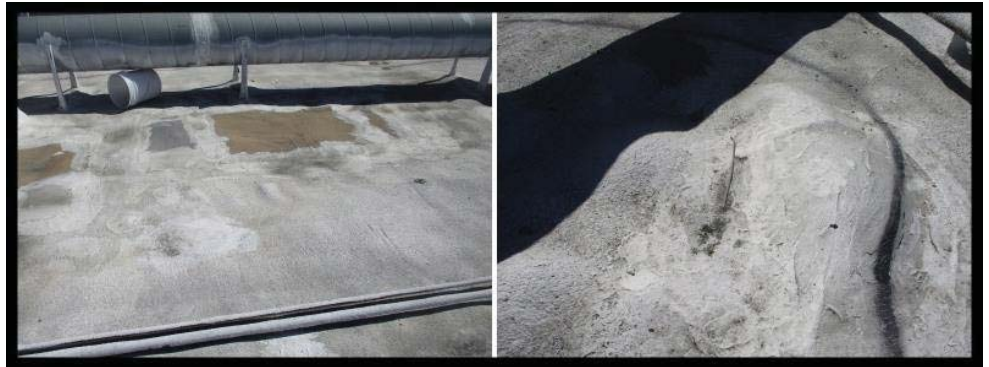
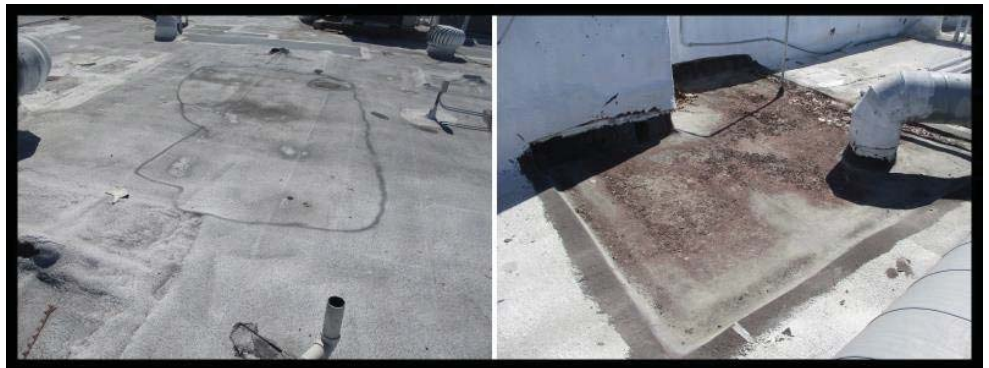
**The roofing material is excessively worn in areas. The roof is at the end of its expected useful life and it is time to replace it.**

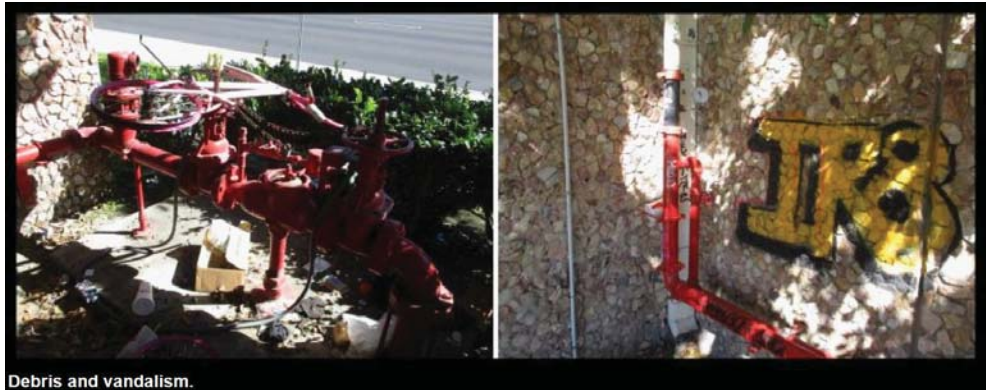
**Debris and vandalism.**

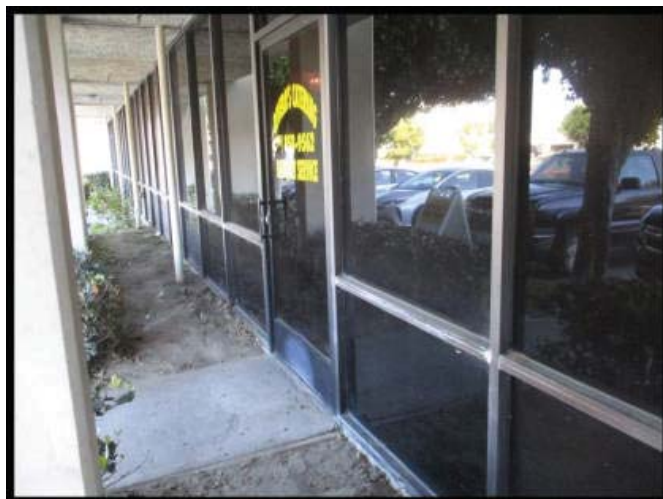
The metal window seals have areas that are aged, worn and deteriorated with some areas that no longer appear to be a weather tight seal.

There is noticeable Vandalism to the window surfaces.

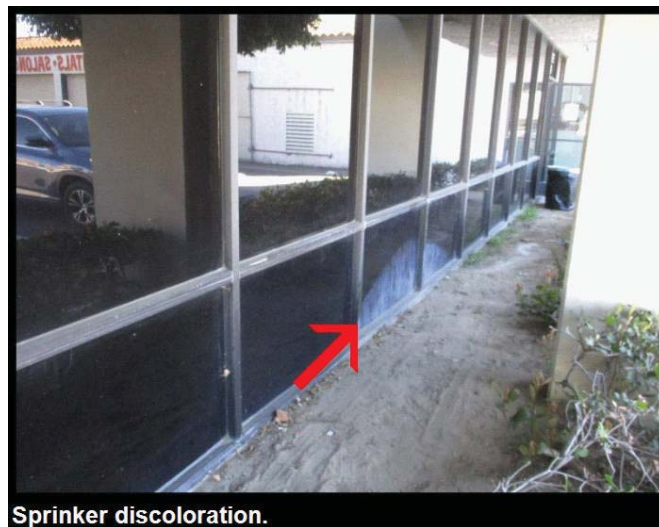
**Sprinker discoloration.**

It is advised to have the sprinkler system fully reviewed and for all repairs to be made to ensure that water is not hitting the building. This may involve some "drip" type portions of the system closest to the building.

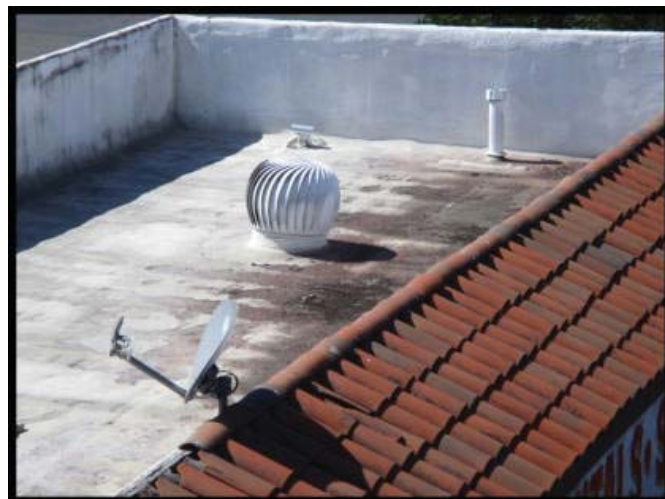
**The roofing material is excessively worn in areas. The roof is at the end of its expected useful life and it is time to replace it.**

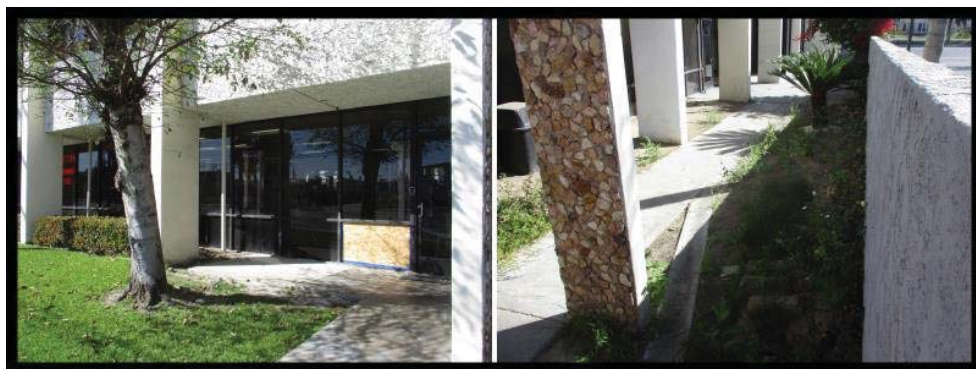
The grounds have not had the benefit of typical and routine maintenance recently.

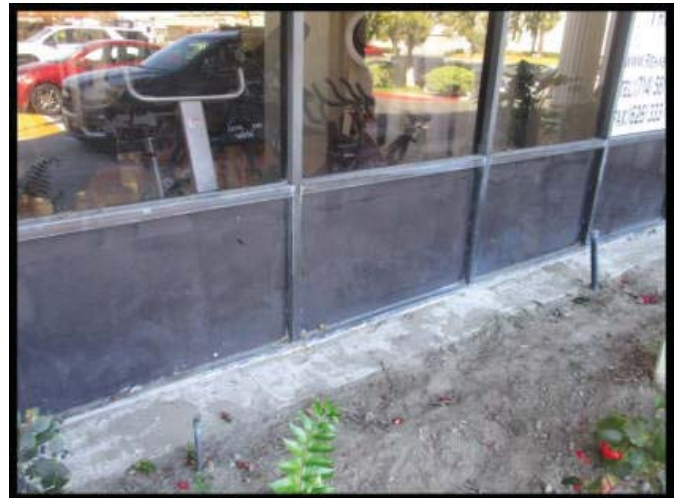
**The grounds on the property need maintenance and have areas of neglect.**

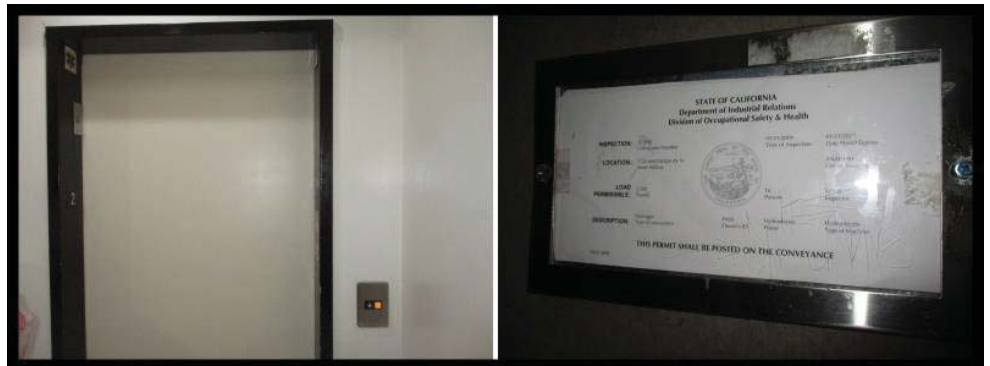
**The inspection certificate is no longer current.**

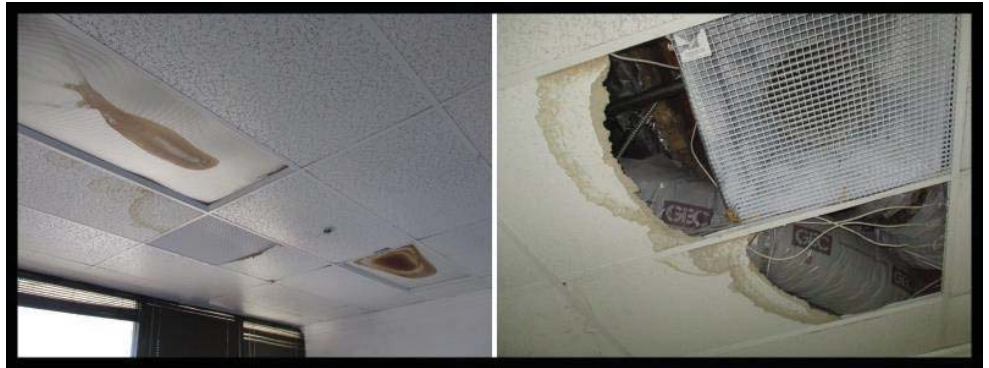
**There are areas of moisture stains and/or damage on the ceiling.**

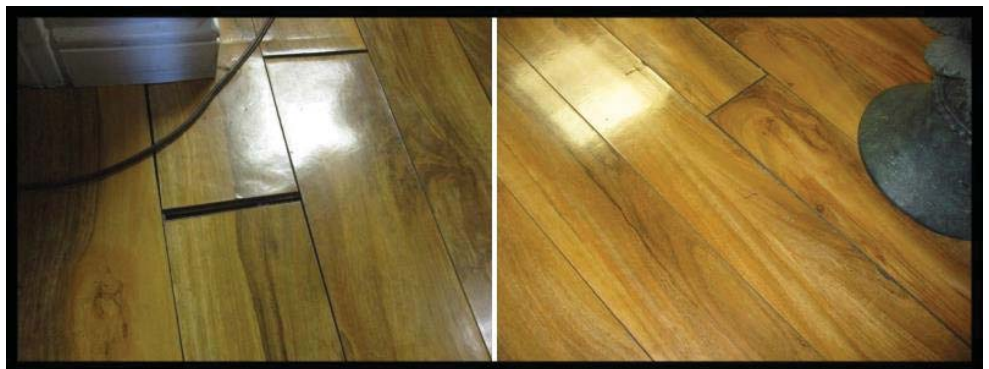
**Per tenant in unit 115,120 & 130 the sprinklers cause water to leak into the building flooring causing damage and mold. Evidence of possible moisture intrusion were viewed by the separation in the flooring material.**

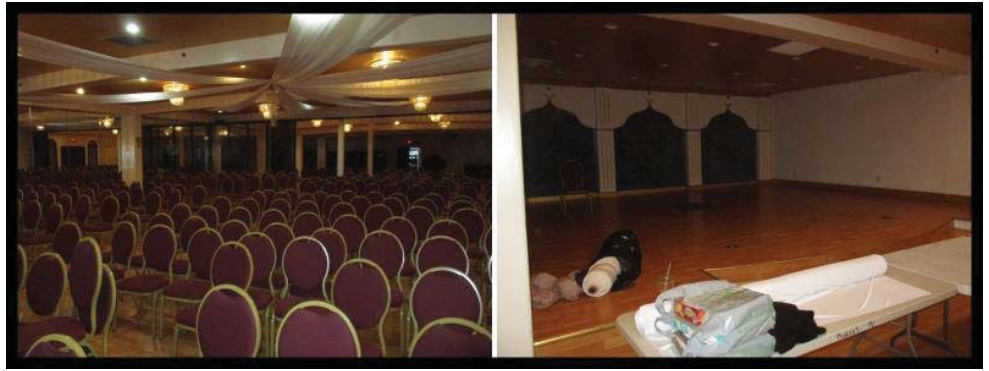
The upper floor banquet facilities are aged and worn throughout.

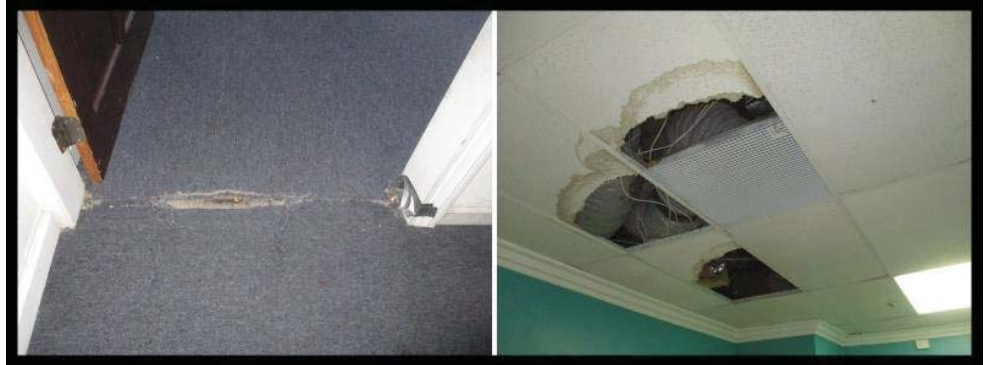
Unit 105 is vacant and has areas of missing light fixtures and worn flooring and wall and ceiling damage.

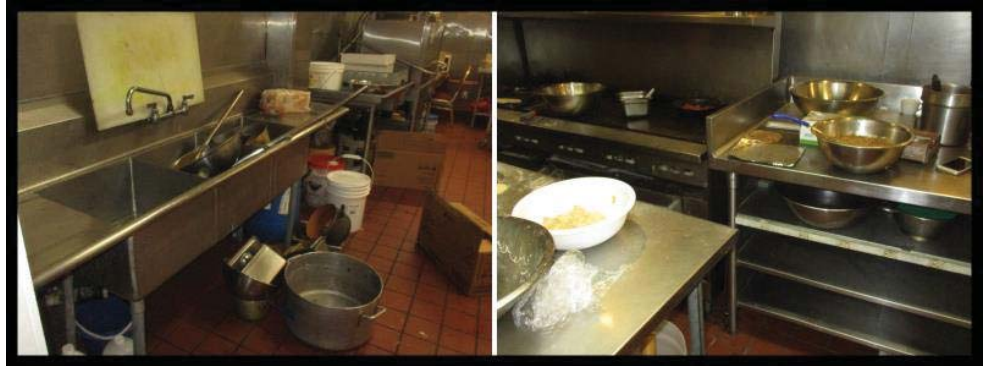
**The kitchen is overall aged and worn but serviceable.**

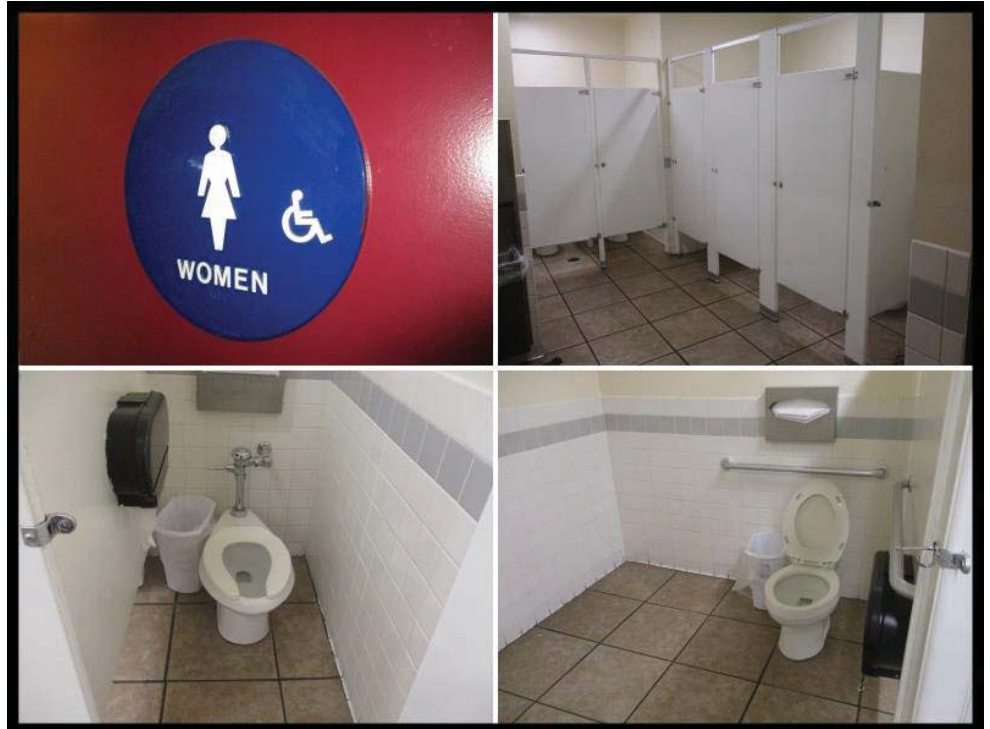
**The interior surfaces, such as walls, ceiling and cabinets are generally serviceable, but there are areas of noticeable wear.**
