RISK Assessment® Report

RISK ASSESSMENT[®]

Commercial Real Estate Inspectors

ADDRESS: 4001 Pacific Coast Hwy., Newport Beach, CA 92663

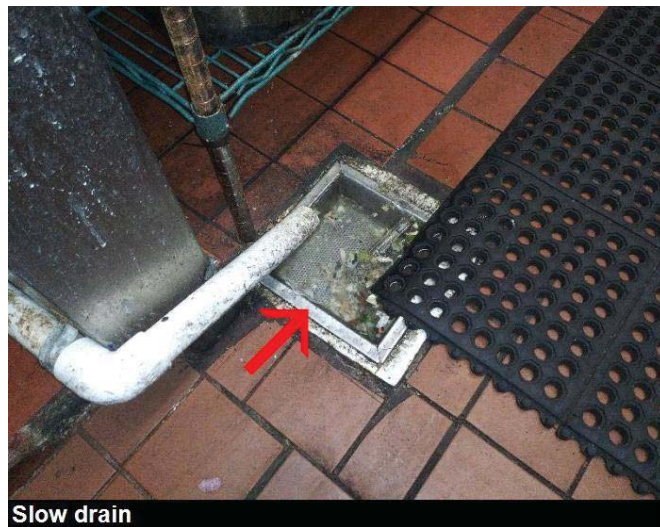
Needs Attention:

It is noted that there are a number of fixtures in the building drain slowly.

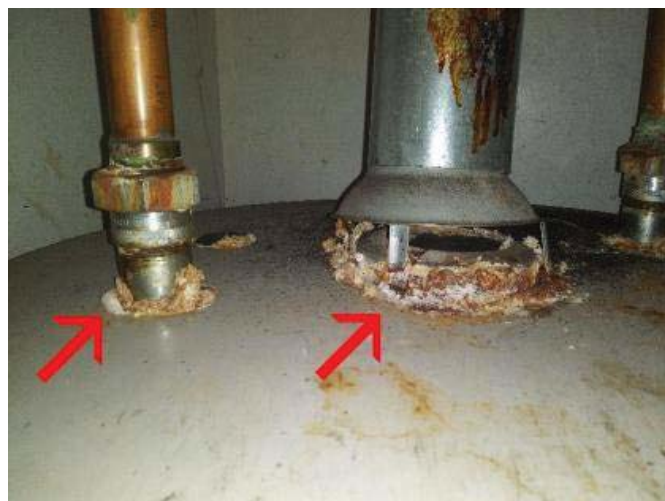
Needs Attention:

The water heater is older and nearing the end of its expected life span.

The exterior of the water heater is rusty in areas.

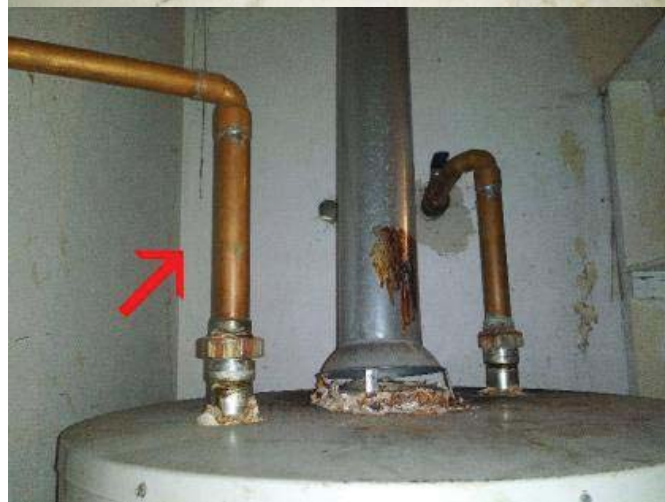
Needs Attention:

There are no flexible connections at the inlet and outlet piping. This is a requirement.

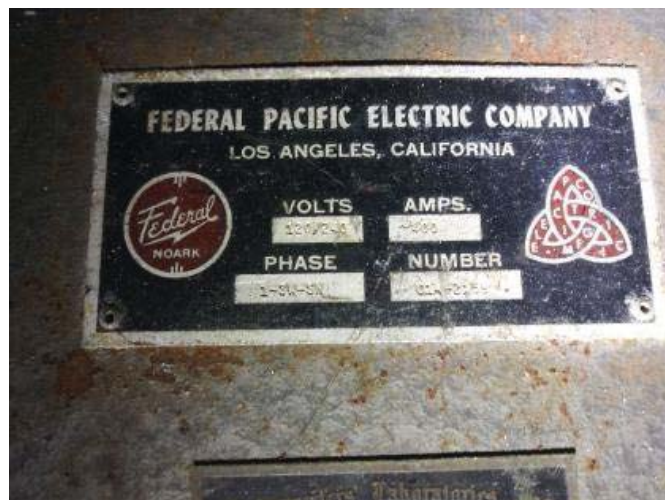
Federal Pacific panels have been observed on the site. These panels have been reported to not perform as designed and are a potential fire/safety hazard. Further review by a qualified electrician is advised at this time for safety. Replacements are the typical recommendation and should be anticipated.

The main service to the site is aged and worn and at or near the end of its expected useful life. Review is advised by a qualified electrical contractor for safety at this time.

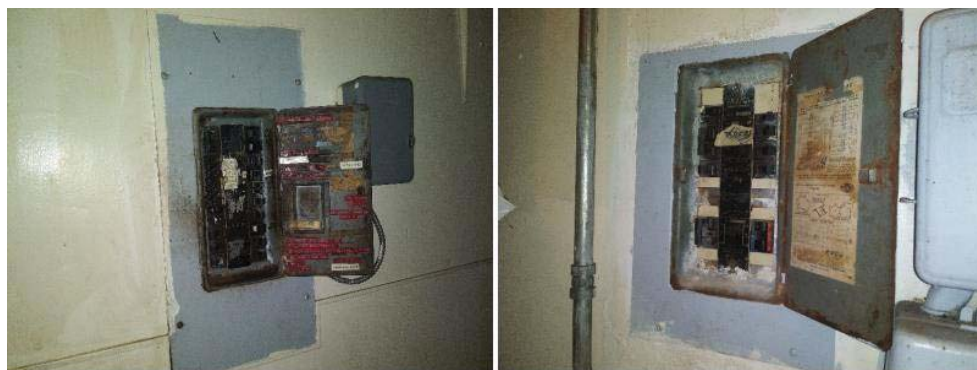
Needs Attention:

Federal Pacific panels have been observed on the site. These panels have been reported to not perform as designed and are a potential fire/safety hazard. Further review by a qualified electrician is advised at this time for safety. Replacements are the typical recommendation and should be anticipated.

The electrical specialist should examine the Federal Pacific panels to determine if further testing, repairs or replacements are needed. It is expected that when the electrical specialist checks out the system they will find more problems as this is a general inspection and not designed to list every fault but to isolate areas in need of further detailed inspections.

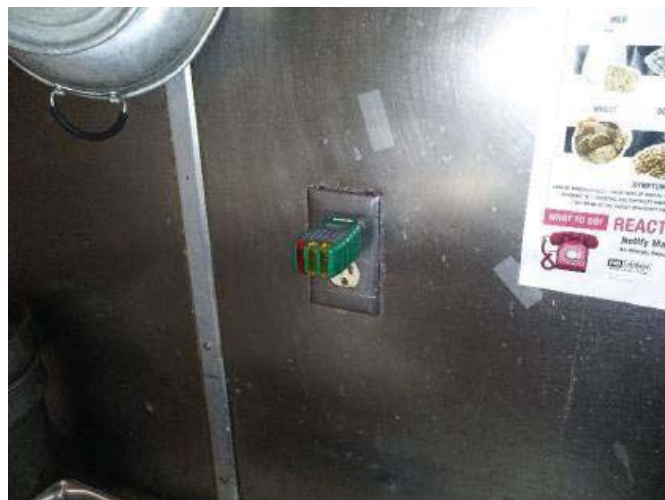
Needs Attention:

There are outlets that are dead and not working. Repairs are advised for health and safety.

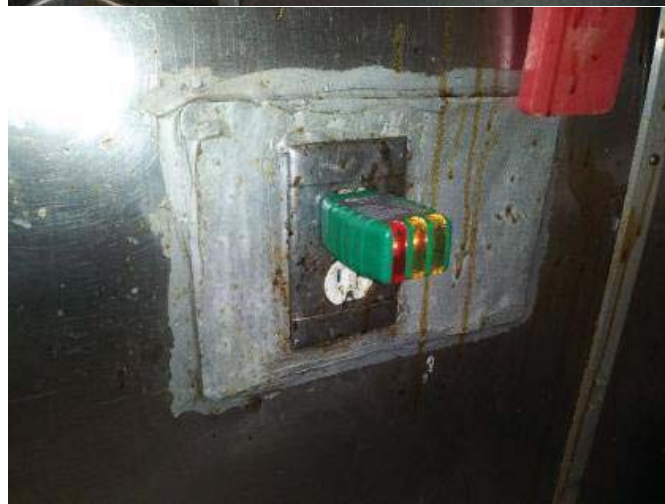
Needs Attention:

The electrical testing equipment indicates there are outlets that are improperly wired. Repairs are advised for health and safety.

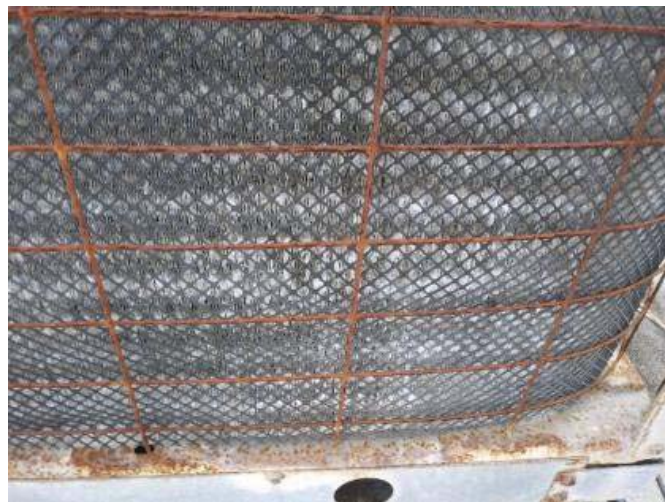
Needs Attention:

The metal fins on the side of the unit show excessive deterioration or damage. This can effect the performance of the system.

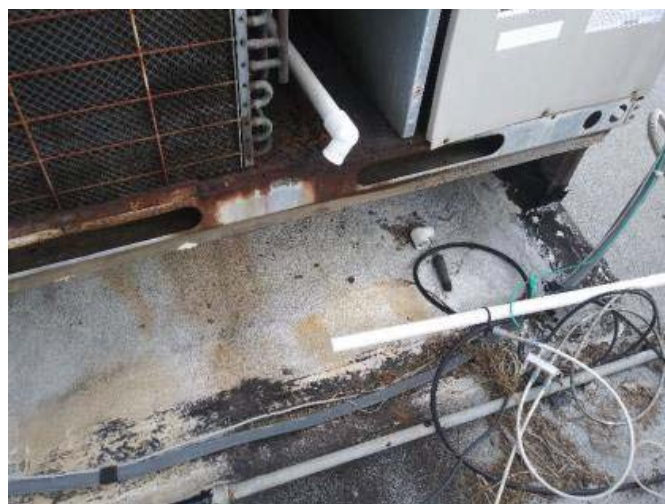
Needs Attention:

The condensate line is disconnected / damaged. The line should be properly installed to remove moisture to an approved drain.

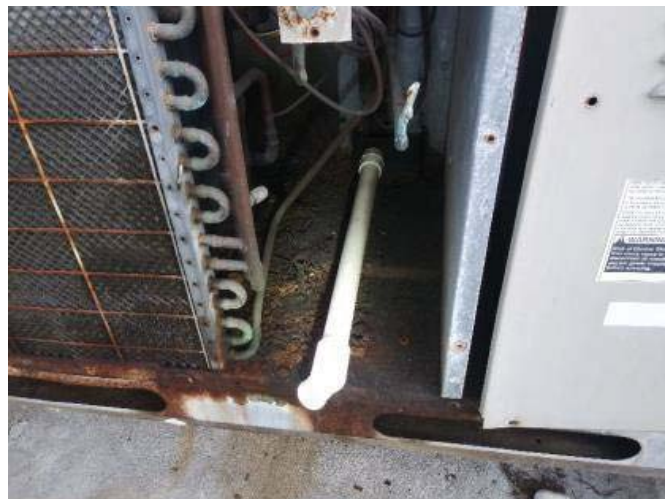
Needs Attention:

The heating and cooling system is aged and worn.

While the system may still be functional and working, it is noted that this type of system has a life expectancy of approx. 15 - 20 years.

Depending on the quality of maintenance, the system is at or near this age.

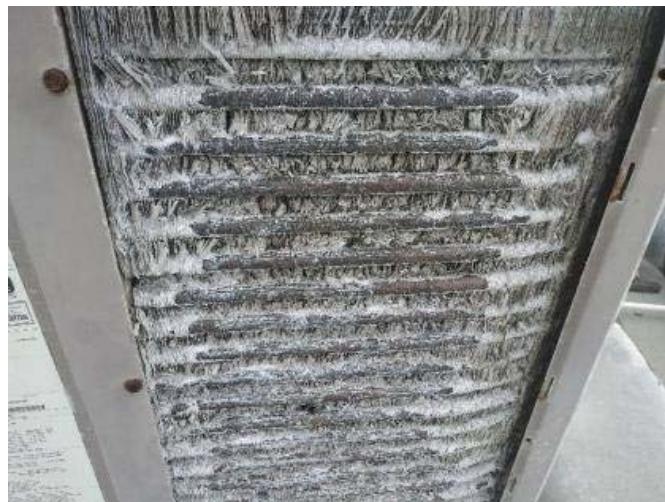
Needs Attention:

The metal fins on the side of the unit show excessive deterioration or damage. This can effect the performance of the system.

The temperature dissipation fins are deteriorated and damaged. that appear to be due coastal salt air exposure that deteriorate the fins at an accelerated rate.

Due to condition of the system, further review is advised by a qualified HVAC specialist, however replacement should be anticipated.

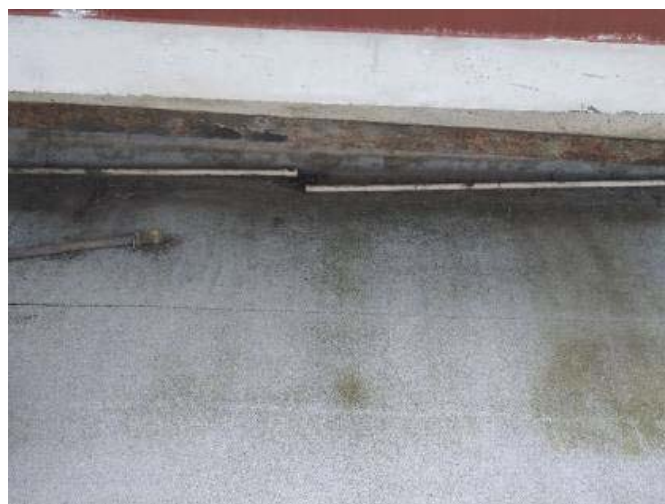
Needs Attention:

The condensate line is disconnected / damaged. The line should be properly installed to remove moisture to an approved drain.

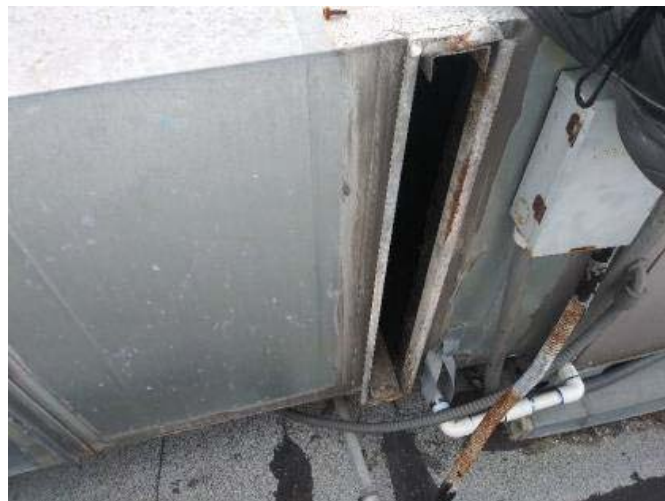
Needs Attention:

The air filters were missing or not viewed at the time of the inspection.

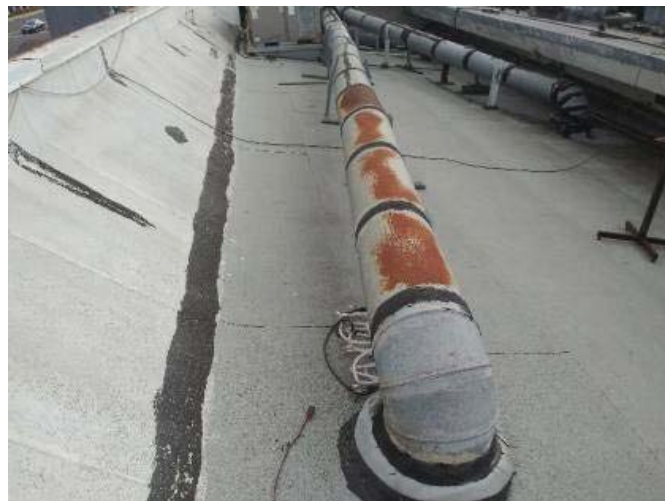
Needs Attention:

There is ducting on the roof that are rusted.

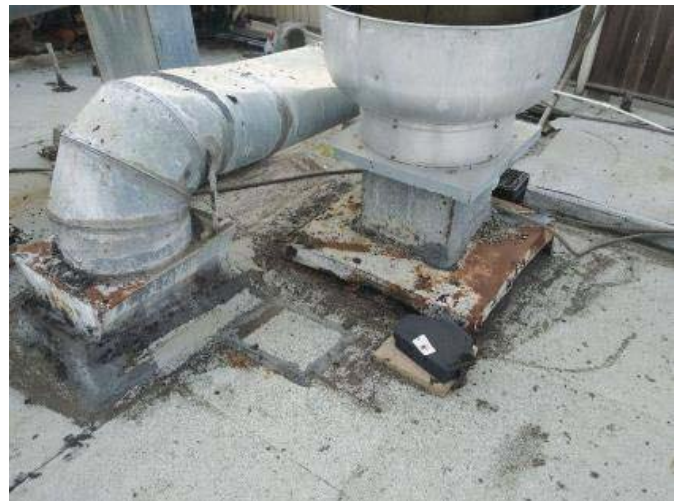
There is some staining
of the roofing noted
around the grease trap.

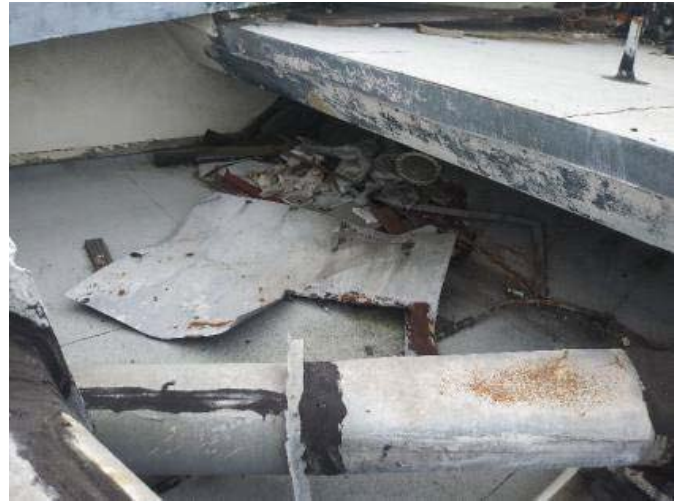
Needs Attention:

There is debris on the roof. It is advised to have this removed.

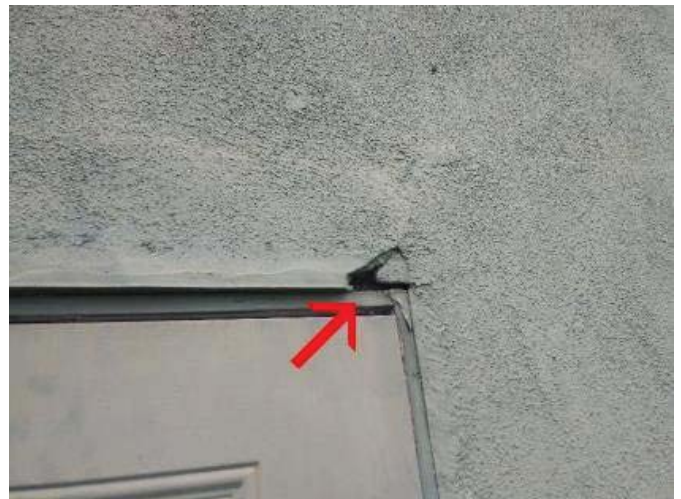
Needs Attention:

There is cracking in the exterior walls which should be caulked or sealed to prevent moisture intrusion into the building.

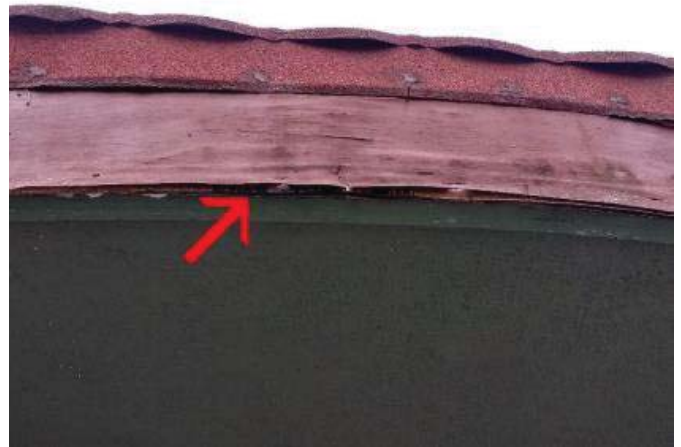
Needs Attention:

The trim is deteriorated in areas.

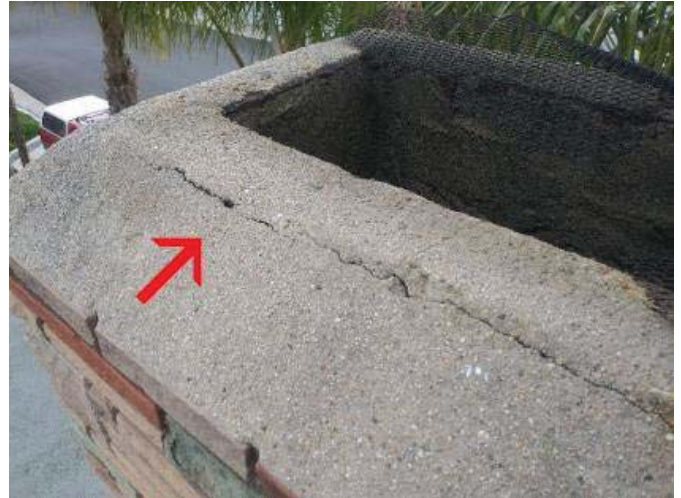
Needs Attention:

There are cracks in the mortar chimney cap that need minor repair.

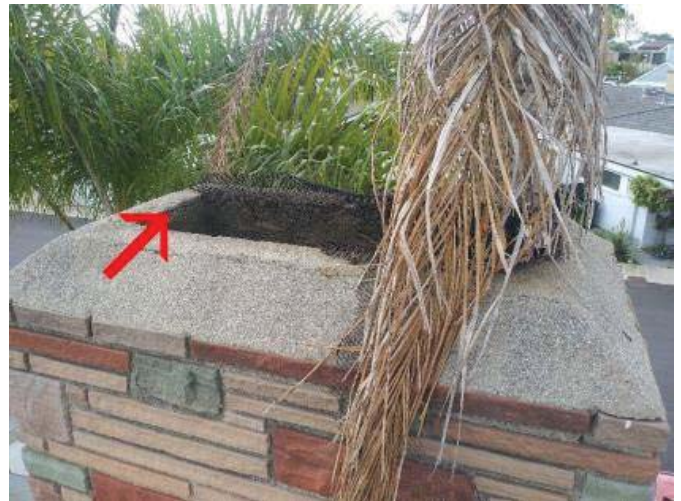
Needs Attention:

The spark arrester is damaged.

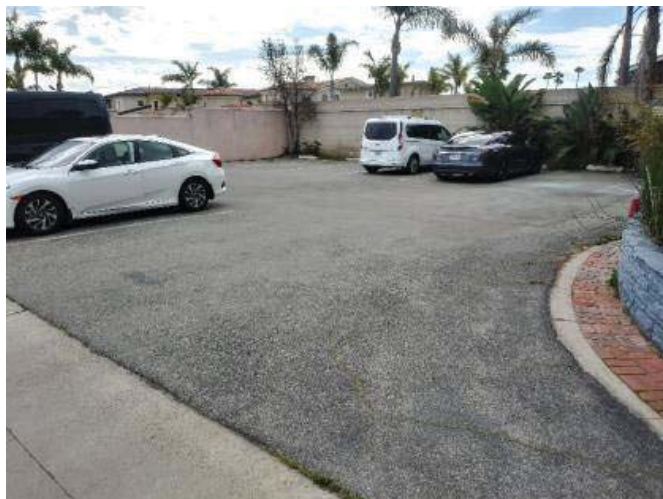
Needs Attention:

The asphalt parking areas are in need of being resealed and restriped.

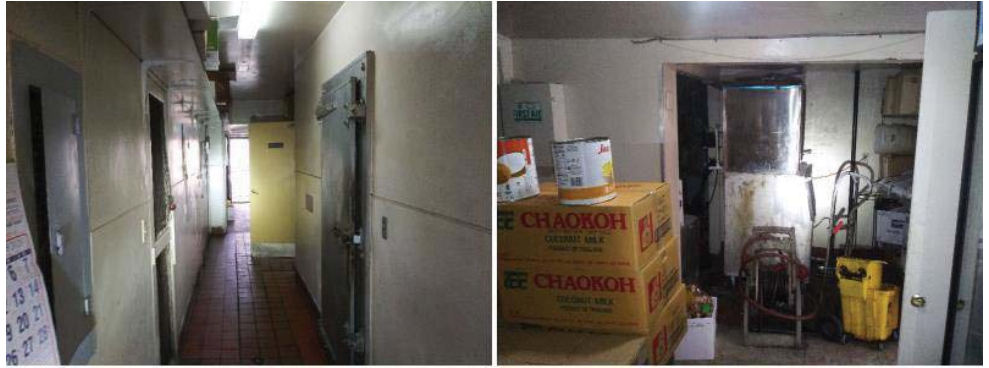
Needs Attention:

The rear hallway and storage areas is generally worn.

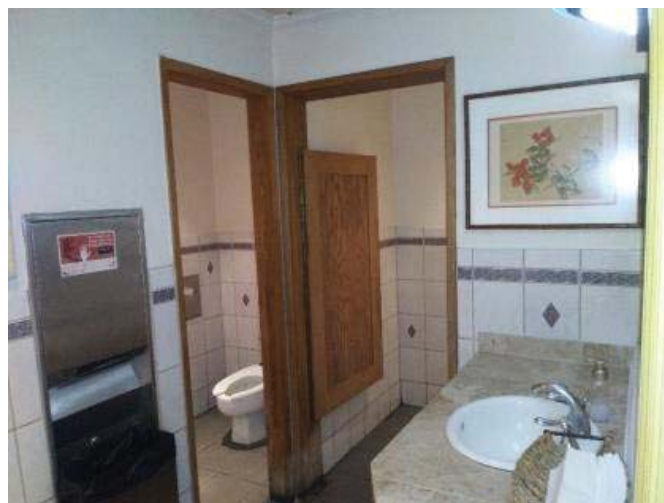
Women's Restroom

Needs Attention:

Though outside the scope of a general visual inspection the bathrooms do not appear to be up to current ADA requirements. This is mentioned as a courtesy however further review by a qualified ADA specialist is advised to determine the best course of action for this site.

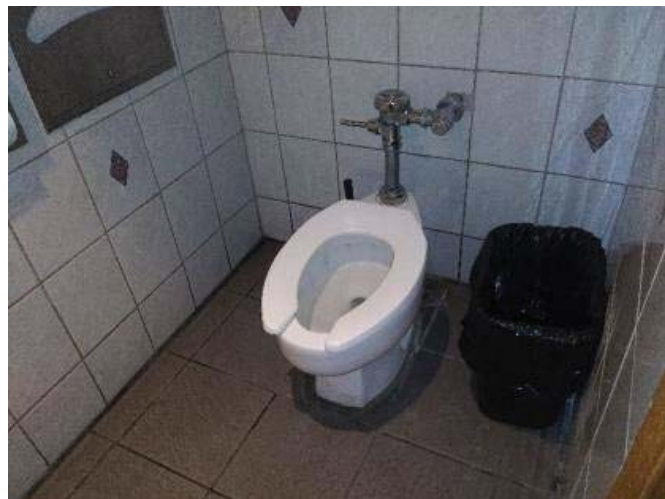
Needs Attention:

The toilet is not securely mounted at the base.

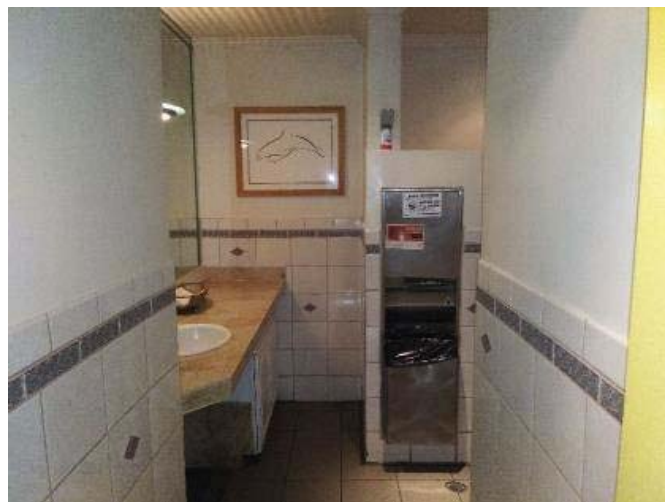
Men's Restroom

Needs Attention:

Though outside the scope of a general visual inspection the bathrooms do not appear to be up to current ADA requirements. This is mentioned as a courtesy however further review by a qualified ADA specialist is advised to determine the best course of action for this site.

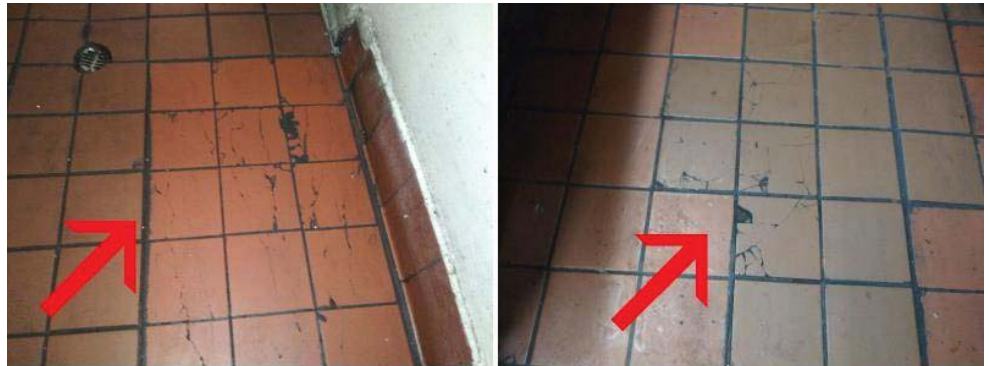
Needs Attention:

There are areas of cracked floor tiles in the kitchen.

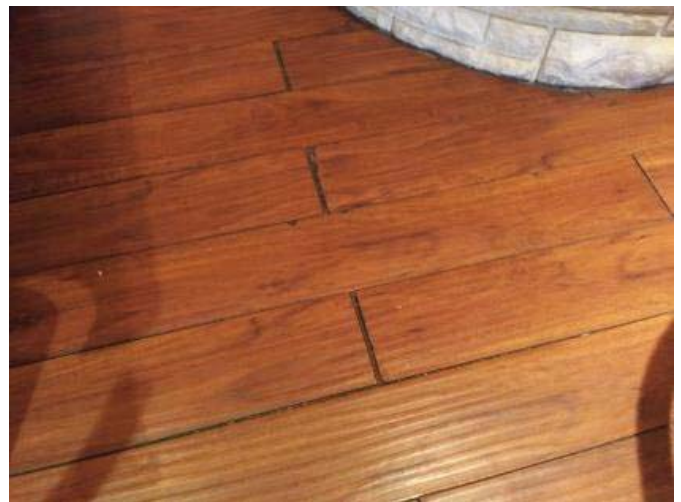
Needs Attention:

There flooring is worn with gaps in the planks.

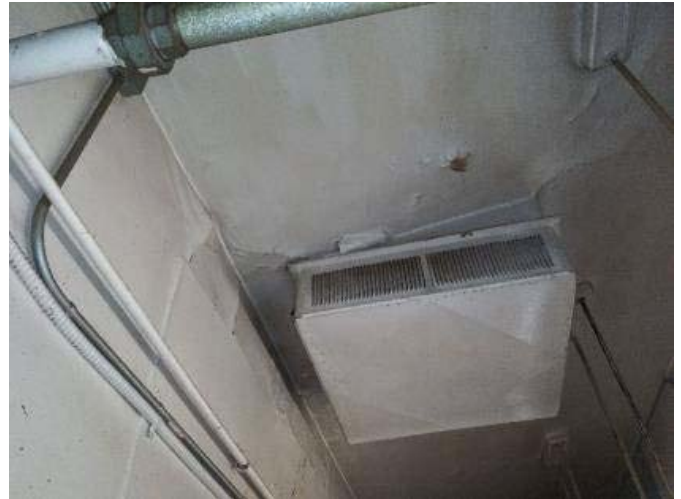
Needs Attention:

There is wear and damage to the ceiling.

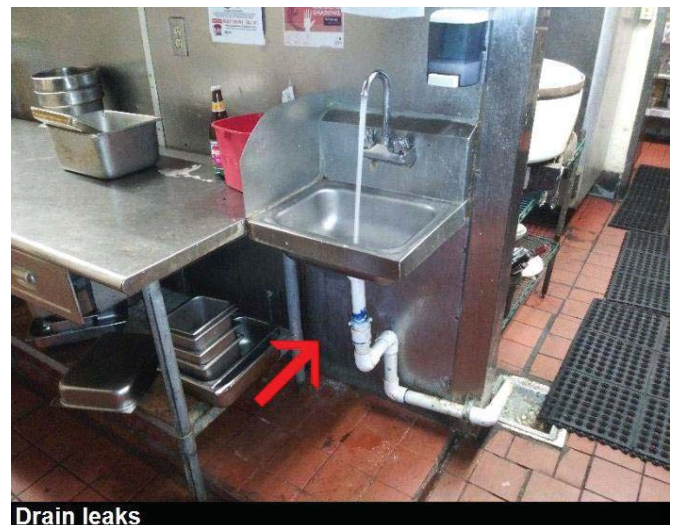
Needs Attention:

The drain under the sink is leaking and needs repair.

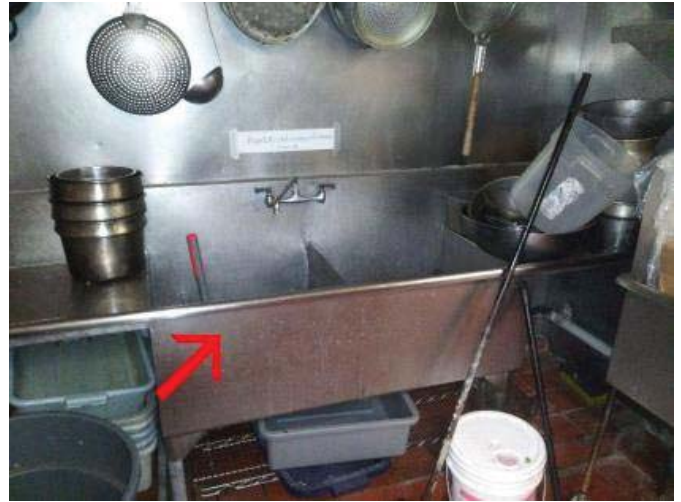
Needs Attention:

The sink drain is slow.
