RISK Assessment® Report

Anaheim, CA 92806

RISK ASSESSMENT®

Commercial Real Estate Inspectors

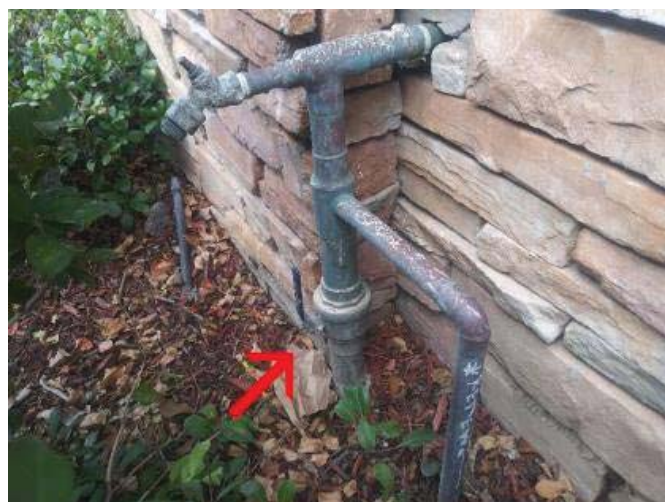
MAIN WATER SHUT OFF
LOCATION:

On the right side of the building.

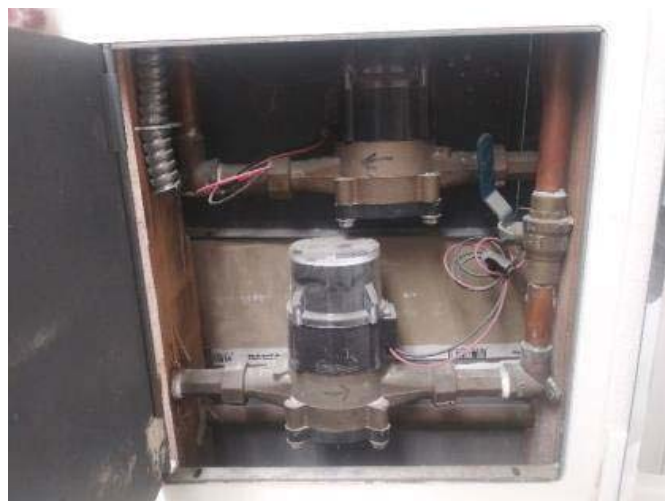
It appears each unit has a separate meter installed to monitor water usage.

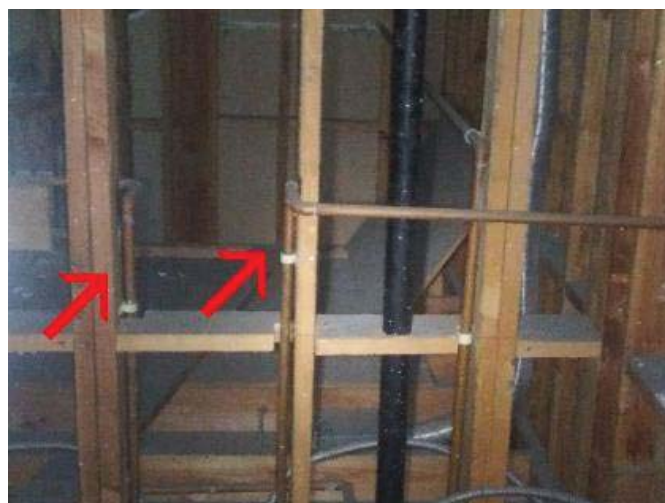
The interior piping that supplies the water throughout the building is made of copper where viewed.

Serviceable where viewed.

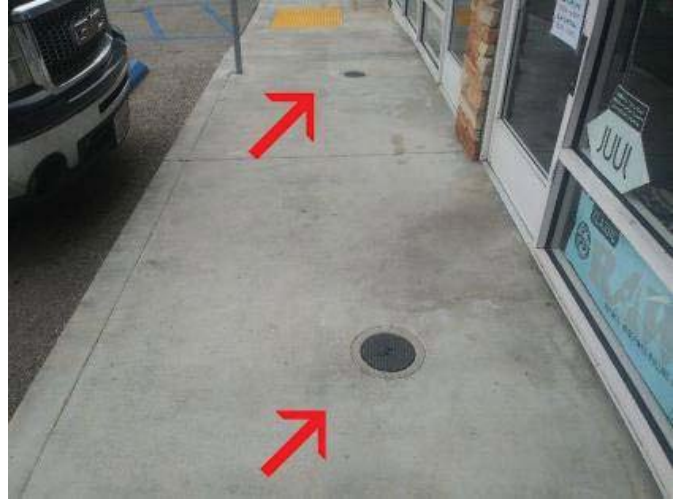
The piping that takes the waste water to the sewer system is made of cast iron where viewed.

The visible waste lines appear to be serviceable, however the view is very limited due to the majority of the piping being either in the wall or under the building.

The interior of the waste lines are not visible. A detailed investigation can only be performed by the use of an internal camera by a specialty contractor. Such an inspection is recommended at this time.

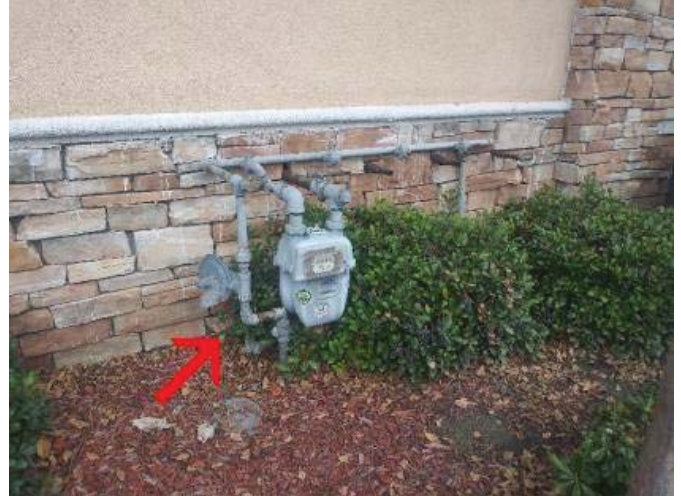
The meter is located on the right side of the building.

Serviceable.

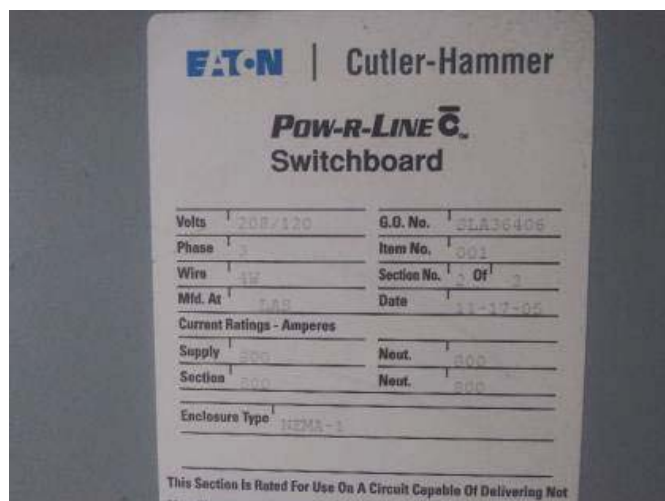
Service Amperage
rating - 800 amp stand
up panel.

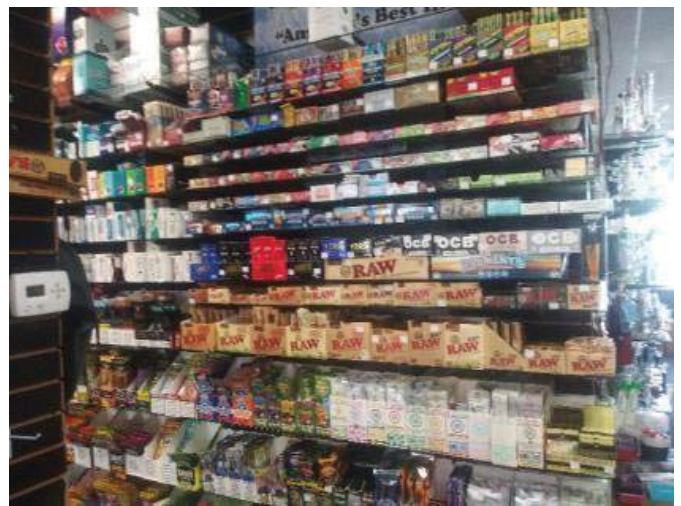
Needs Attention:

There are sub panels on the site that do not have the recommended 36" of clearance for safety such as in the smoke shop.

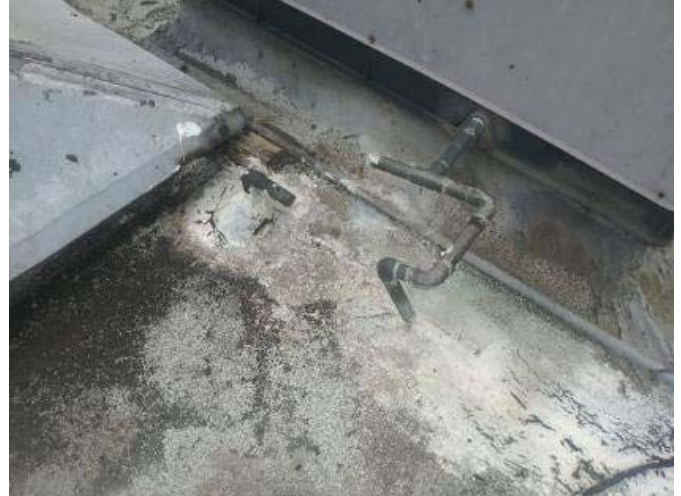
Needs Attention:

Several of the condensate lines are not connected to an approved drain and are draining onto the roof.

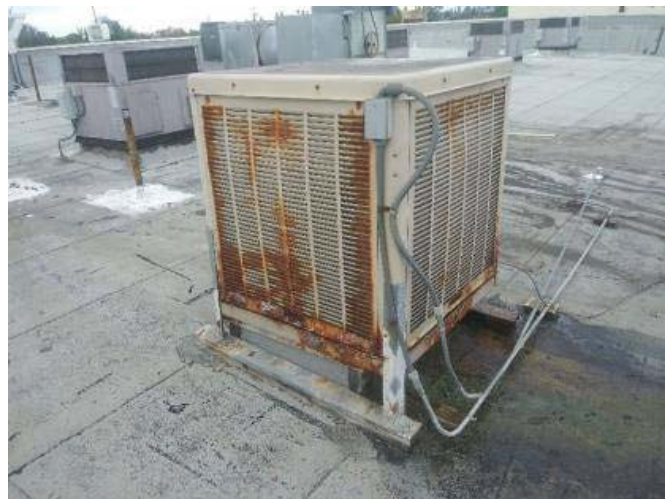
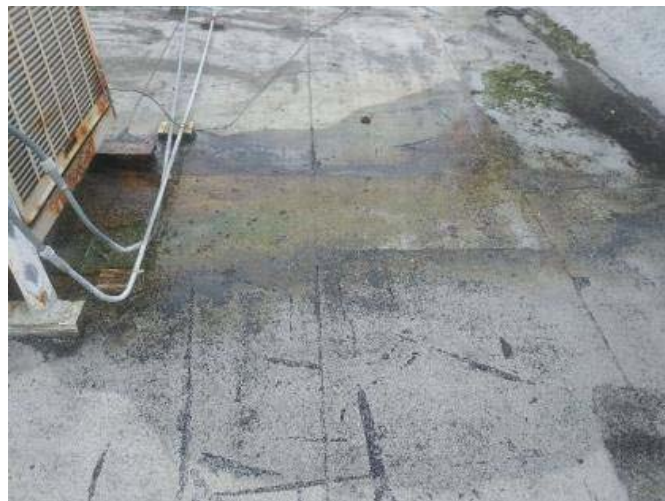
The heating and cooling system is aged and worn. While the system may still be functional and working, it is noted that this type of system has a life expectancy of approx. 15 - 20 years. Depending on the quality of maintenance, the system is at or near this age.

It is advised to have each unit serviced and cleaned at this time to ensure safe and proper function along with any needed repairs done. It is beyond the scope of this general visual inspection to inspect the inner workings of any system. This servicing should be done by a licensed Heating and Cooling specialist at this time.

Due to the overall condition, replacement should be anticipated at this time or in the near future.

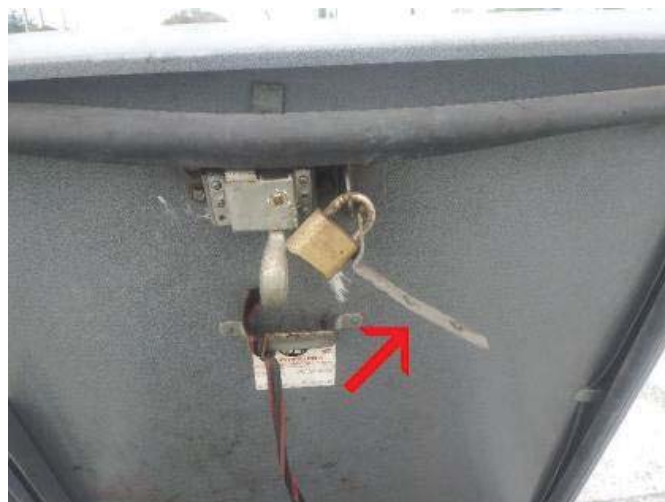
Needs Attention:

The hatch lid is damaged and does not operate properly.

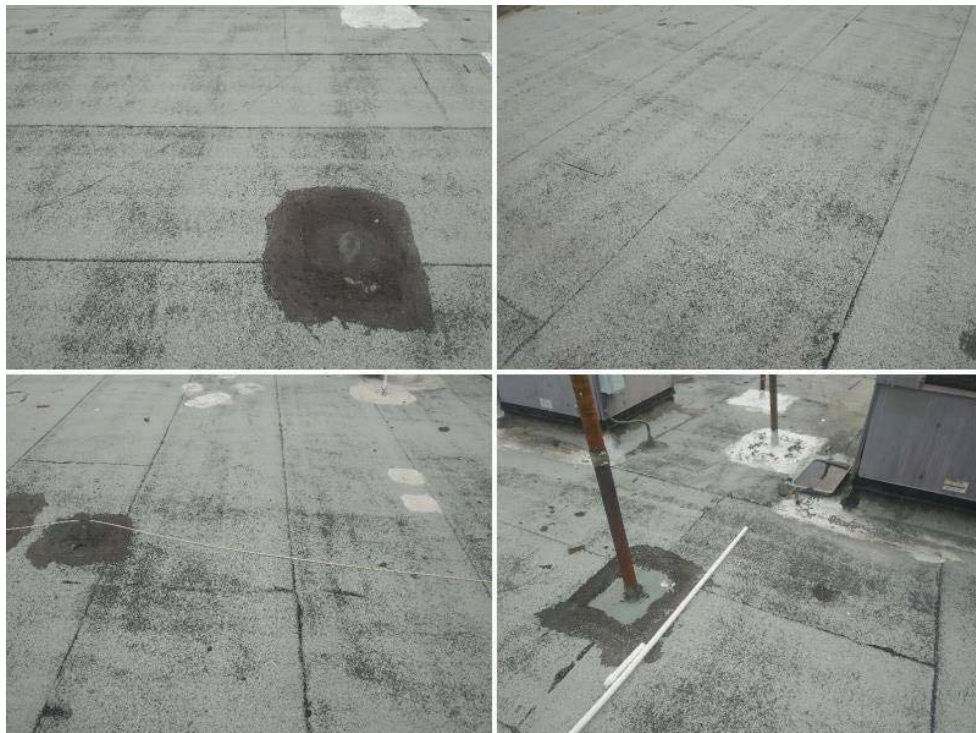
Needs Attention:

The roofing has areas of excessive wear and is not longer a reliable moisture barrier.

Due to the overall condition of the roofing system replacement is advised now. A licensed roofing contractor should examine the roofing system now and make all needed repairs (or replacements) to ensure a long lasting leak free condition. The roofing contractor may find more problems with the roof. It is for this reason it is being referred to a specialist, as he can determine all the problems and give an accurate estimate of the costs involved.

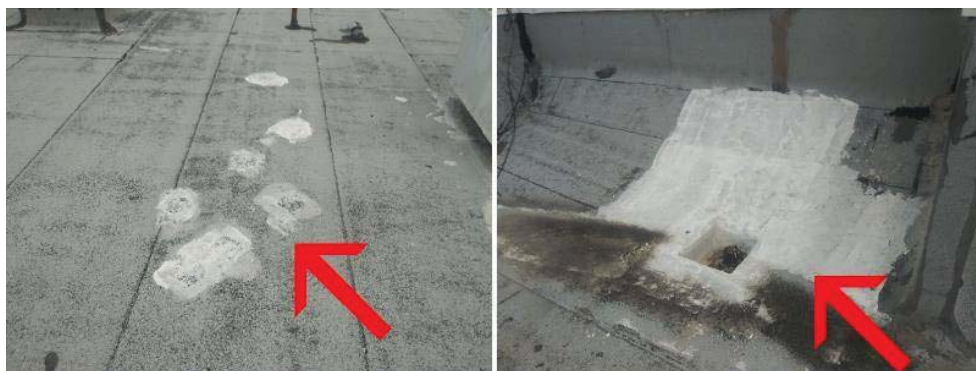
Needs Attention:

It is noted there are areas of the roof that have had patching and or repairs done to them. This is usually an indication that there have been leaks and past issues. It is advised to have full disclosure by the seller as to the history of any roof leaks.

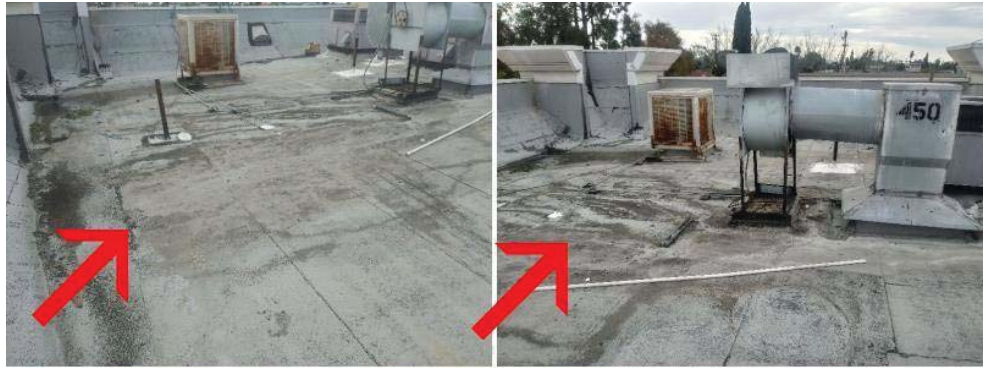
Needs Attention:

There is a grease trap on the roof that does not appear to be well maintained with grease spilled onto the roofing.

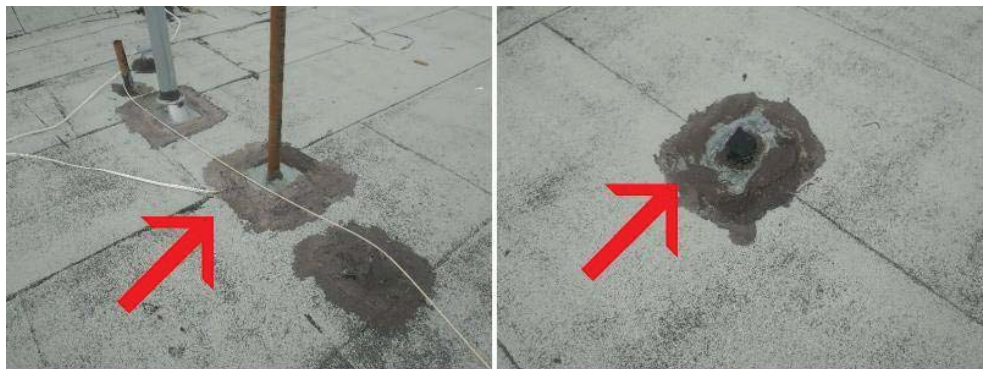
Needs Attention:

The flashing does not appear standard in all areas and may not be a reliable moisture barrier. Review and any needed repairs are advised by a qualified roofing specialist.

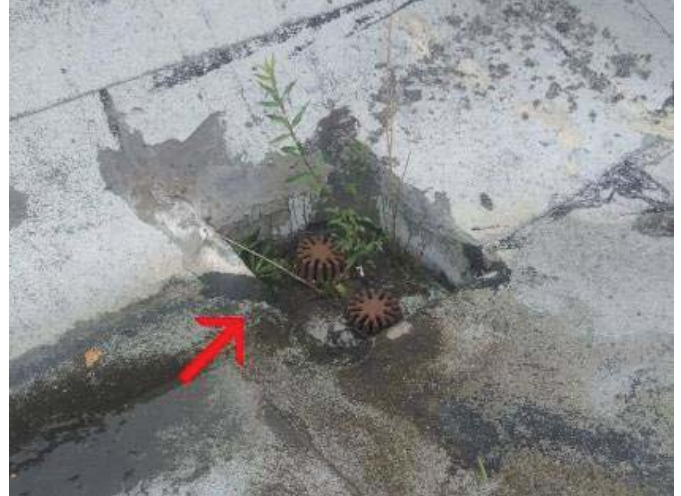
Needs Attention:

The roof need cleaning around the drains. Moisture is not able to easily flow off the roof.

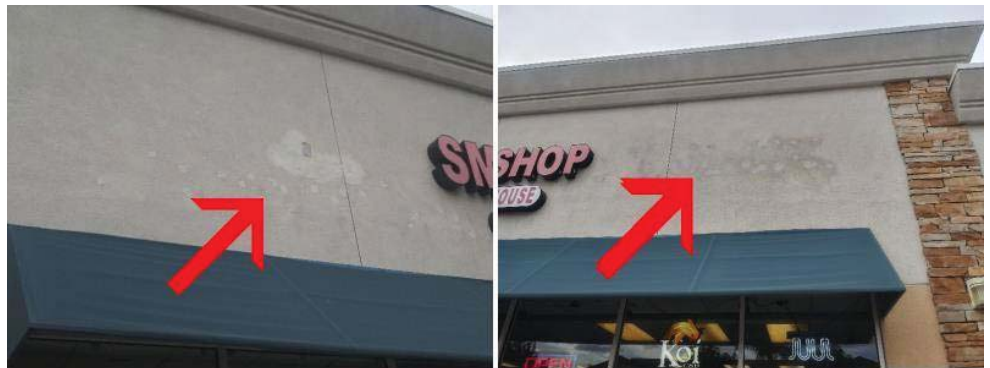
Serviceable.

There is some wear and repairs noted from what appears to be old signage anchors.

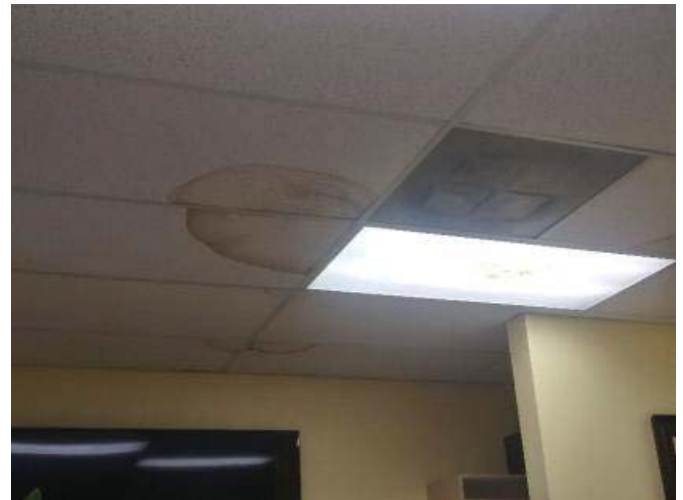
Needs Attention:
There are areas of
moisture stains and/or
damage on the ceiling.

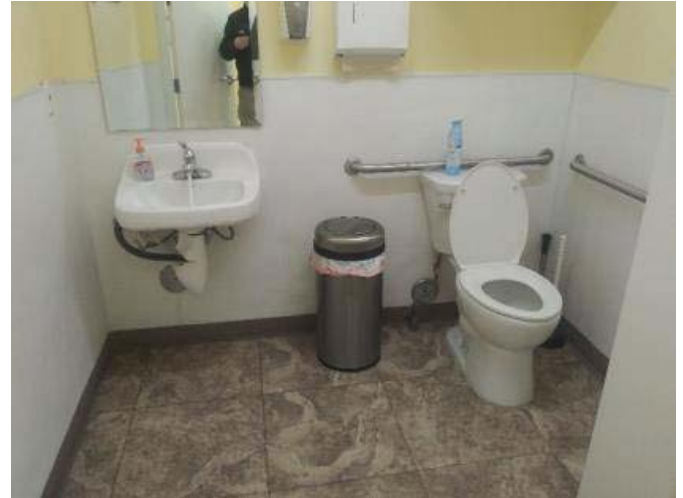
Not Acceptable:
There is no hot water
provided to the sink,
which is required for
sanitary purposes.

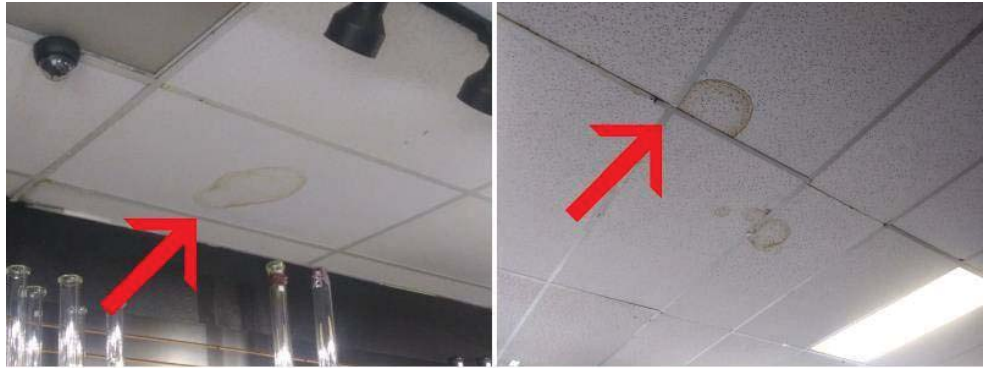
Needs Attention: There are areas of moisture stains and/or damage on the ceiling.

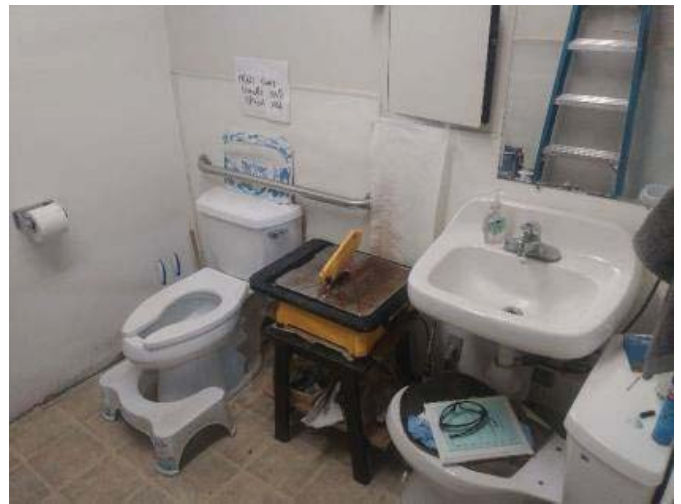
Needs Attention: The restroom was generally serviceable however there are areas with noticeable age and wear.

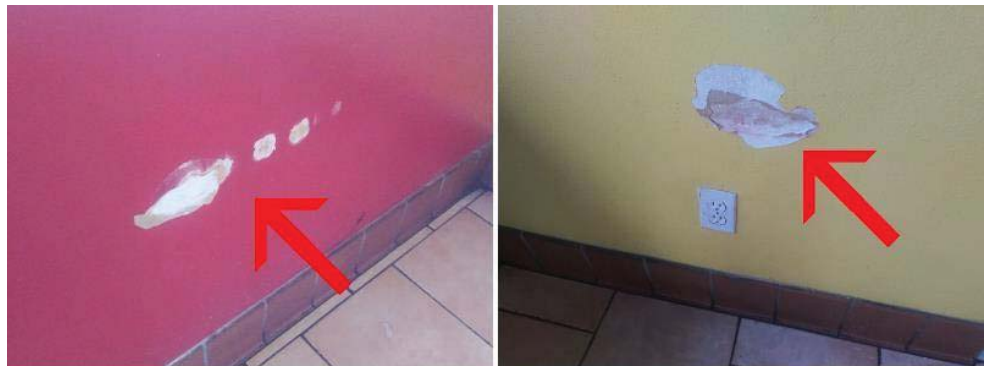
Needs Attention: There are areas of damage to the walls.

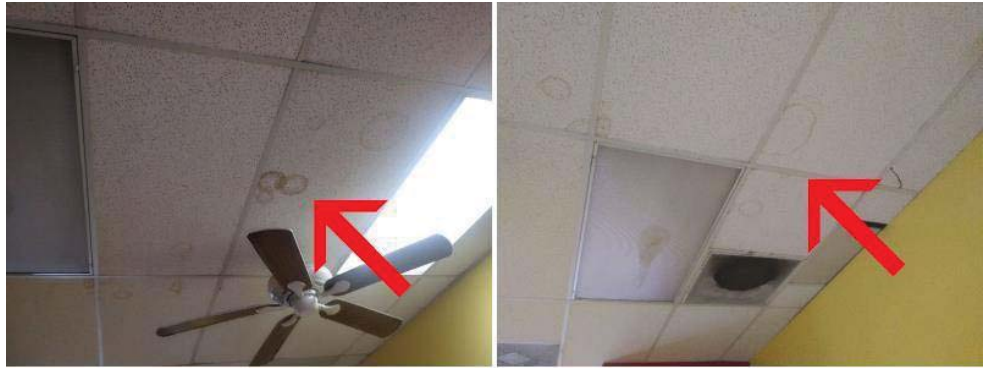
Needs Attention: There are areas of moisture stains and/or damage on the ceiling.

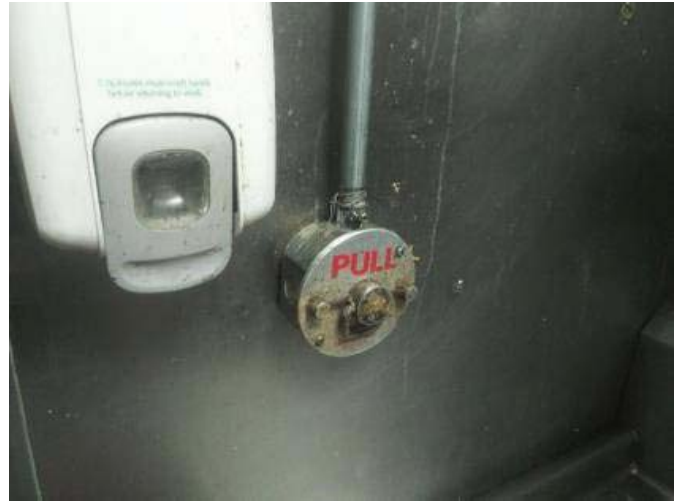
Needs Attention:
There is a fire suppression system present in the kitchen.
Inspection of the fire suppression system is beyond the scope of this general visual inspection however it is noted that the inspection tag was either missing or appears older. A detailed review is advised for health and safety.

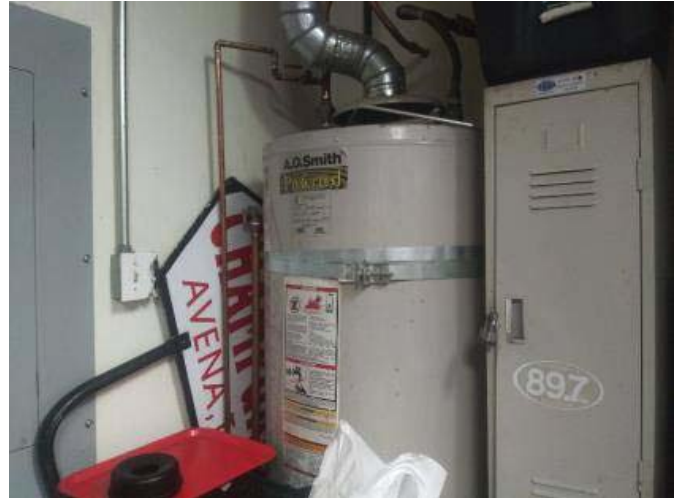
CONDITION - Needs Attention: The water heater is old and at or near the end of its expected life span.

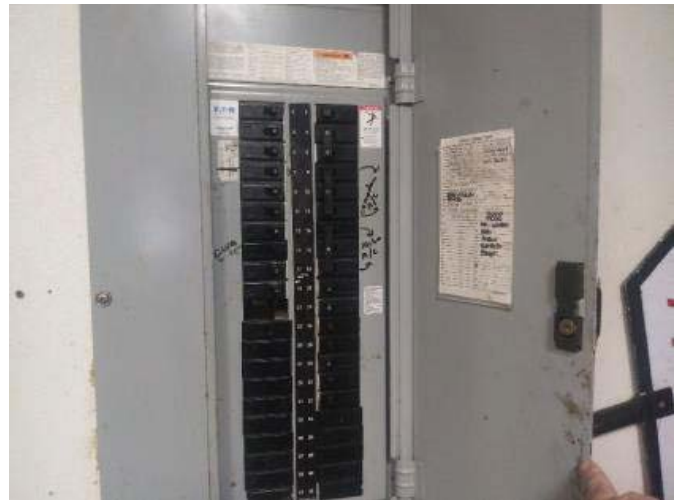
Needs Attention: There are knock-outs missing at the panel leaving exposed electrical items as a result. This is inexpensive to correct but should be repaired to make the panel safer
