# RISK Assessment® Report

**Moreno Valley, CA 92553**

# RISK ASSESSMENT<sup>®</sup>

## Commercial Real Estate Inspectors

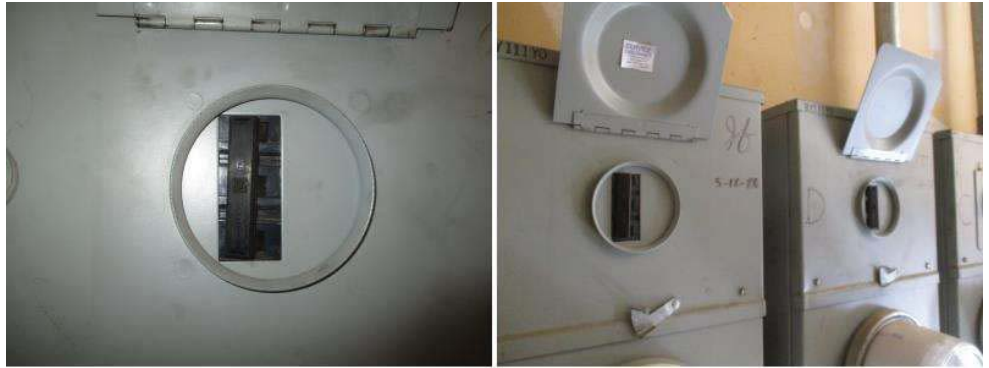
**The panel is missing some required labels. This is a safety issue. Each panel and breaker is required clearly visible label as to its size and what area it serves.**

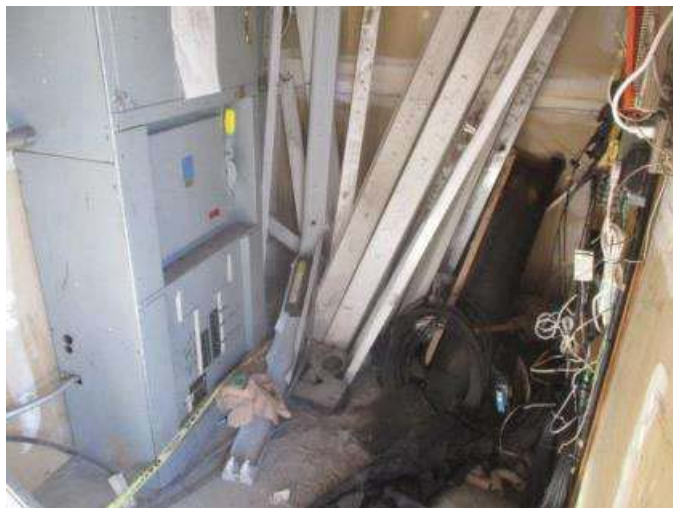
**The main electrical panel does not have three feet of clearance in front of it as is required for safe access.**

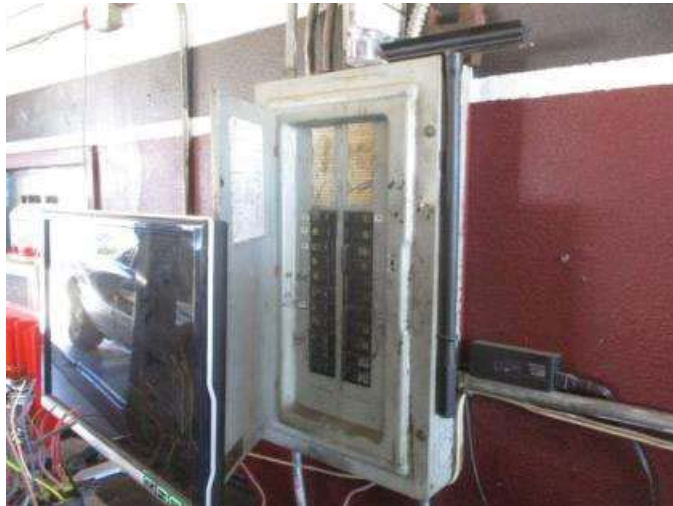
The subpanels are not properly labeled as is required in all locations.

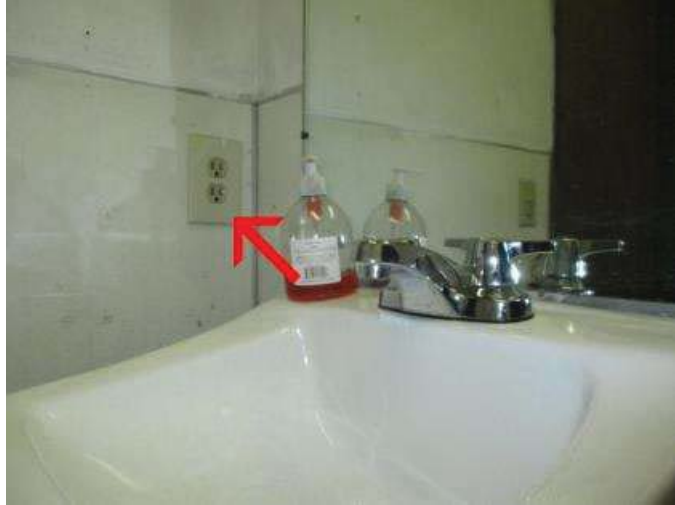
**It is recommended that Ground Fault Circuit Interrupter (GFCI) safety outlets be installed at the exterior, restrooms, & any kitchen outlets. Not all the outlets may have these at the proper locations. This is advised for health and safety.**

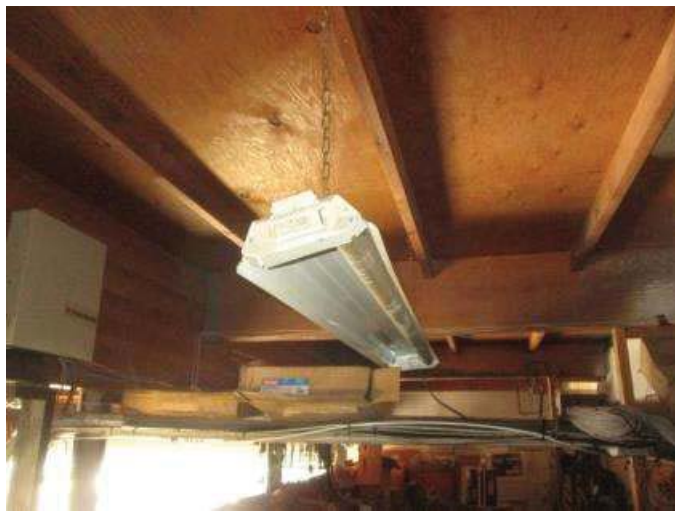
**Needs Attention:**

**There are damaged fixtures**

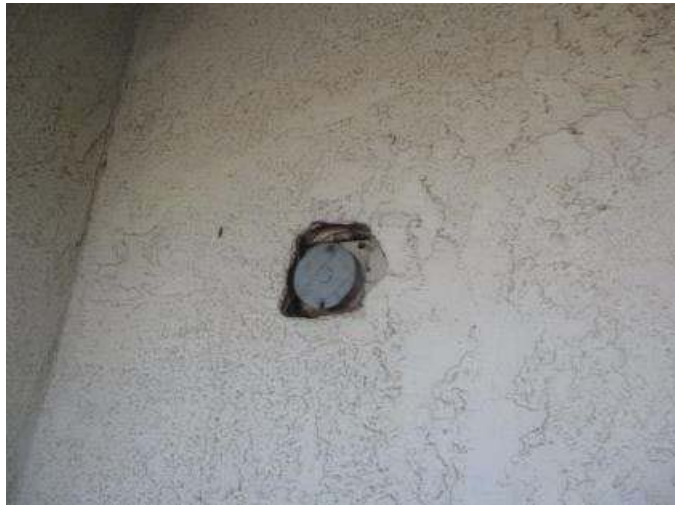
**Exterior lighting is not part of this inspection but some broken exterior fixtures were noted.**

**It is advisable to have an electrician examine the system and make all needed repairs to ensure a properly installed and correctly operating electrical system. It is expected that when the electrical specialist checks out the system they will find more problems as this is a general inspection and not designed to list every fault but to isolate areas in need of further detailed inspections.**

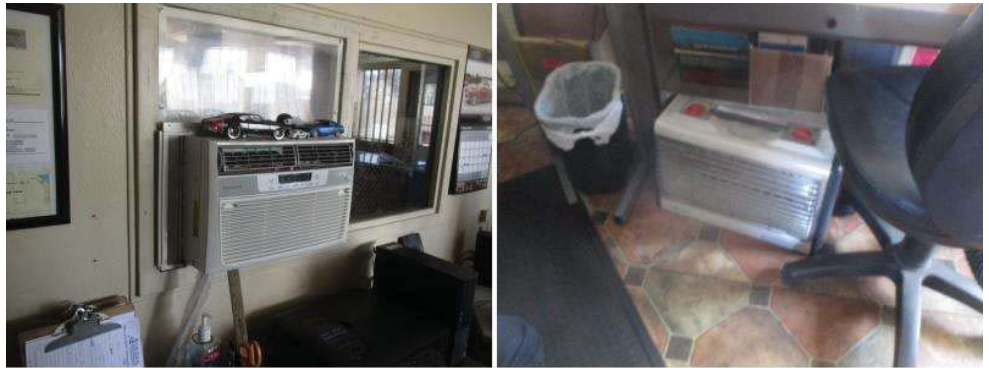
**The auto repair office areas have no permanent sources of heating in required locations. A functional permanent source of heating is a requirement. Installing approved heating in all required locations is advised at this time.**

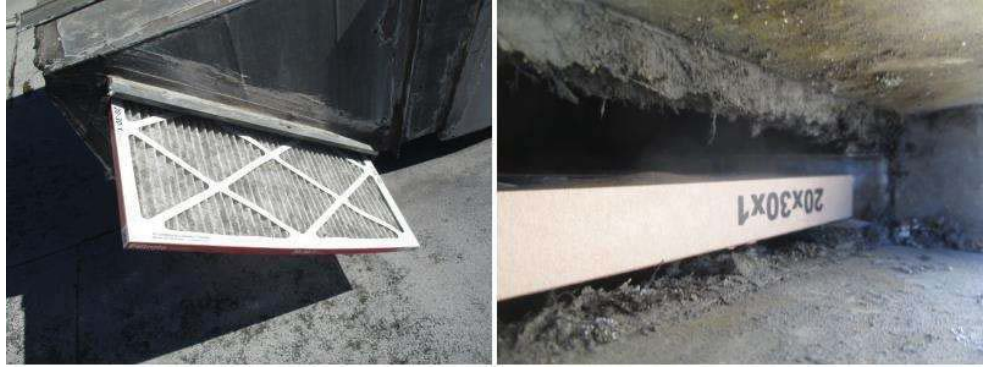
**The filter does not fit properly. This can allow it to not filter the air fully as designed when the fan is in operation.**

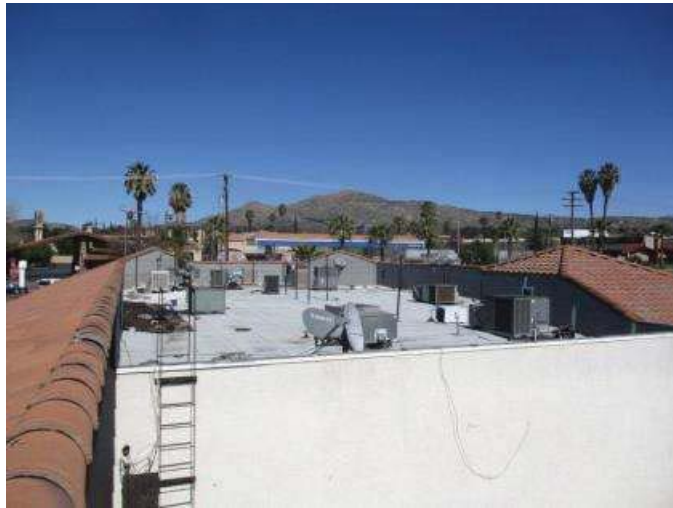
**Though full review by a qualified roofing contractor is recommended at this time, replacement of the existing roof system is advised for older portions of the roofing.**

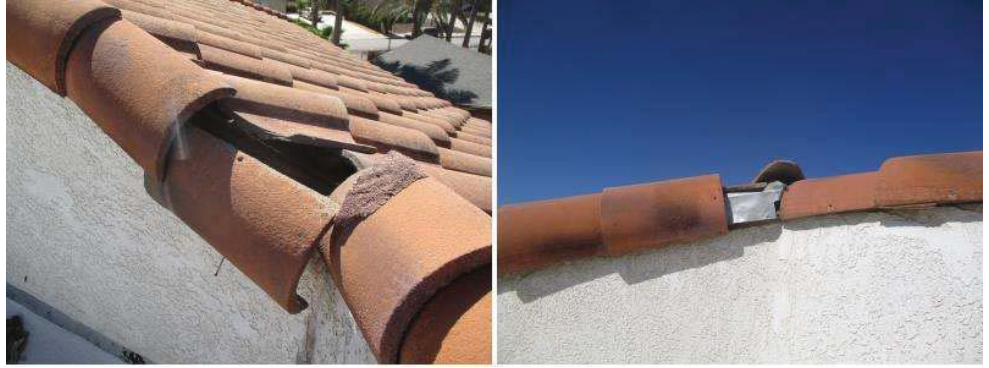
**On the tile roof, there are areas of cracked/damaged tiles.**

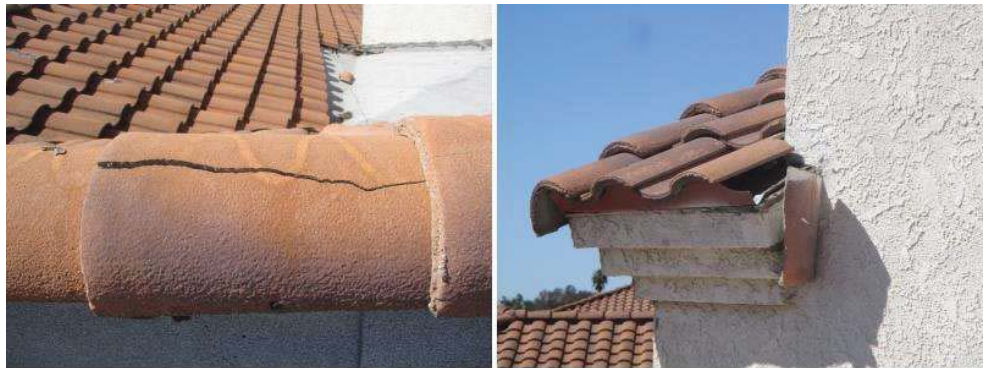
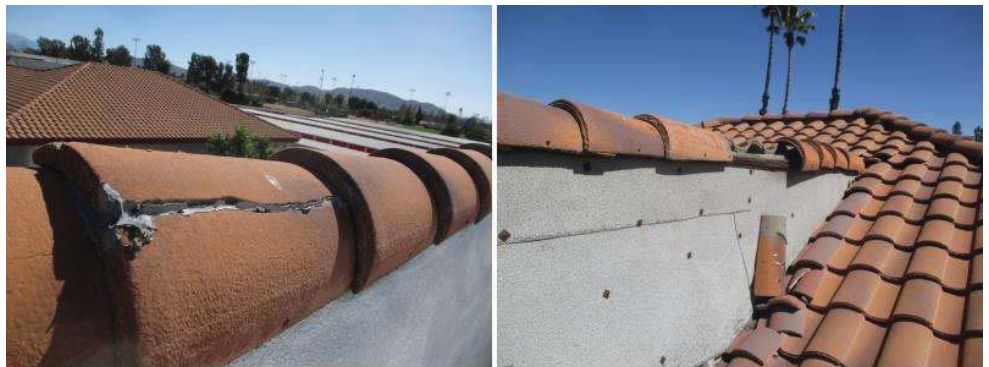
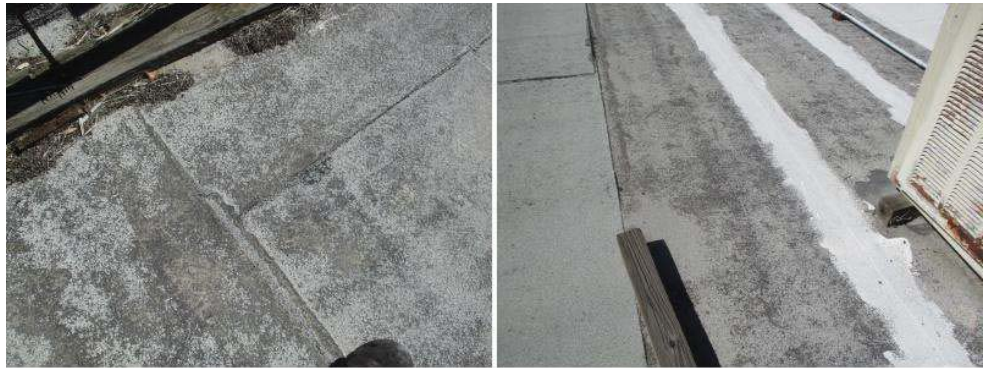
**Needs Attention:**

**The roofing material has areas of wear, deterioration and in some areas it is losing its granule surface. This sort of wear is usually an indication that the roofing material is at or beyond the end its expected useful life.**

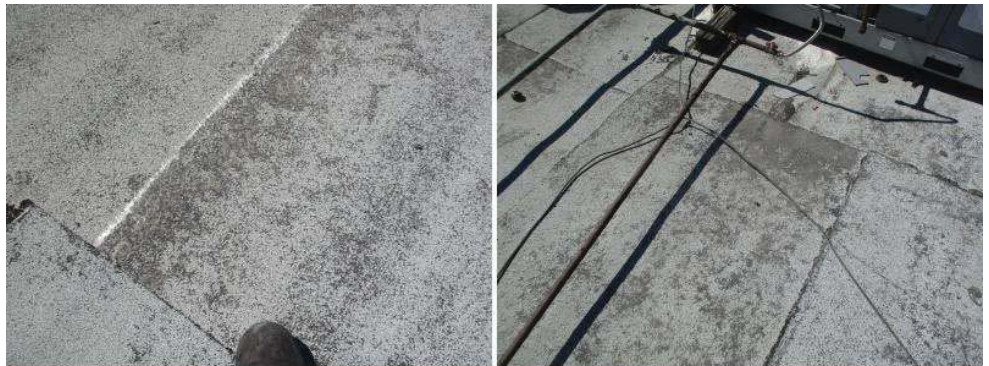
**Needs Attention:**

**There are areas of standing water on the roof during the inspection. Standing water will accelerate the deterioration of roofing materials affected. It is advised to eliminate these areas of ponding by improving the slope of the roof wherever needed, or to reinforce affected areas where slope improvement is impractical.**

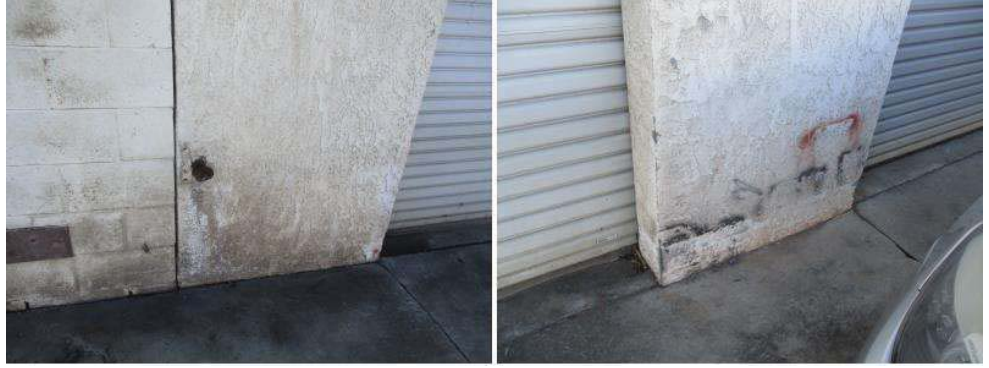
**Needs Attention:**

**There are areas of damage to the exterior walls.**

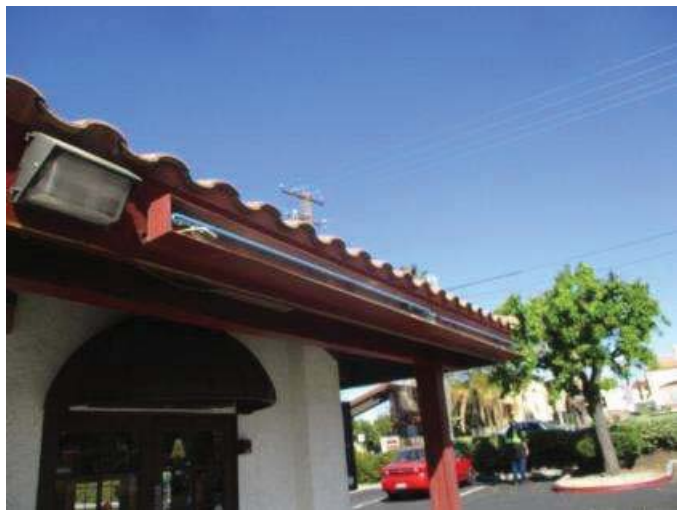
There is sign damage on 24811 Suite A

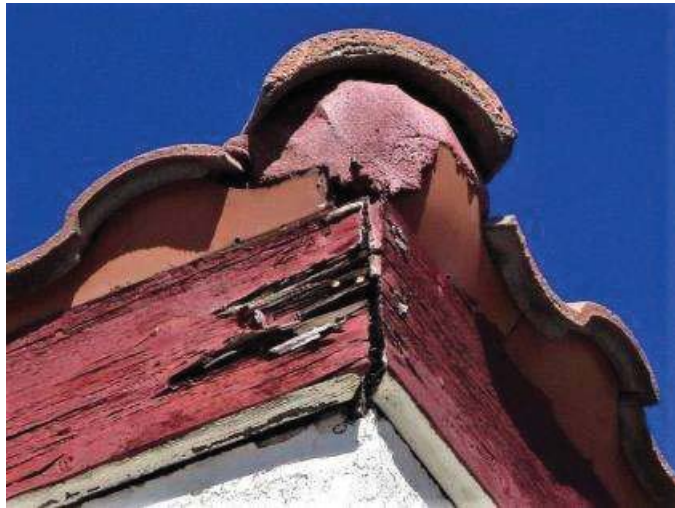
**Needs Attention:**

**The exterior trim has areas of weathering with peeling finishes and deterioration.**

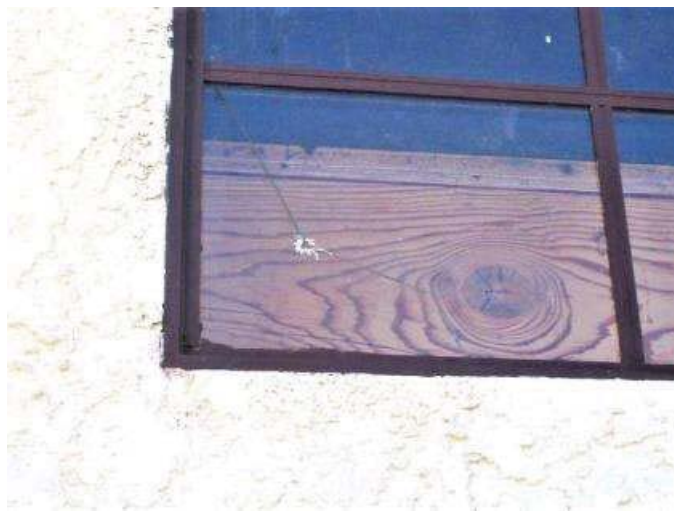
**Needs Attention:**

**There are cracked window panes.**

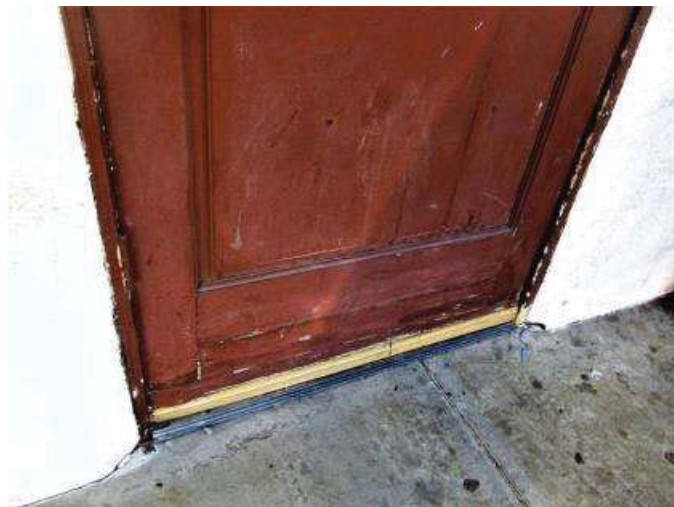
**Needs Attention:**

**Some of the exterior wooden doors are weatherbeaten for some units such as 248111 - A.**

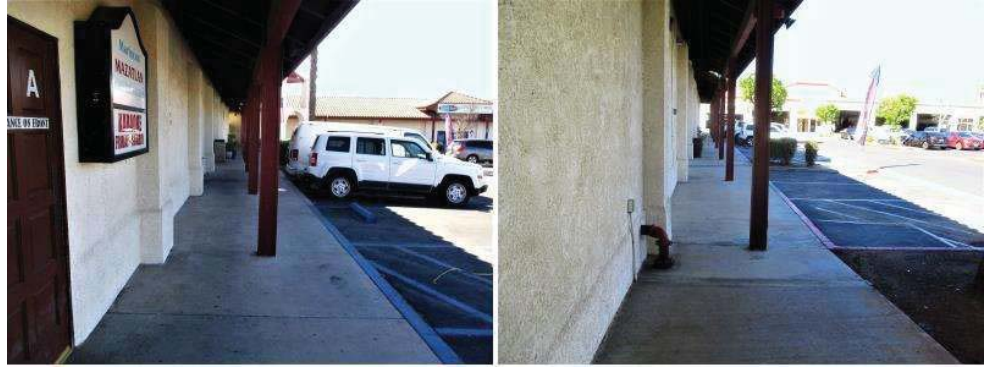
There are cracked areas of the walkways that are typical for the age and style of construction.

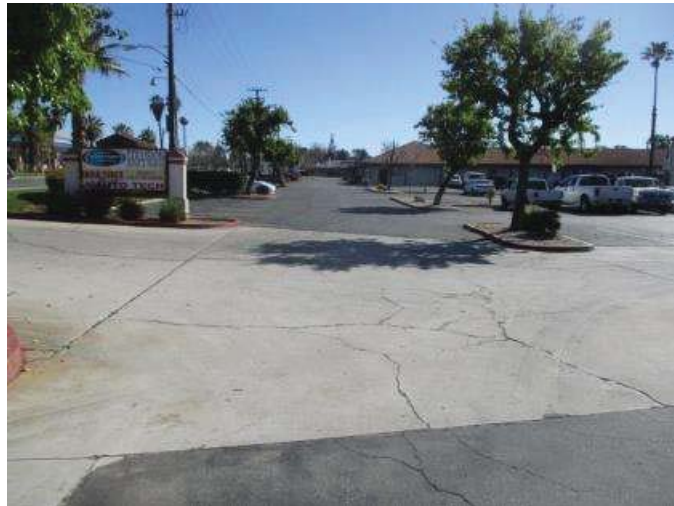
There are cracked areas in the driveway that are typical for the age and style of construction.

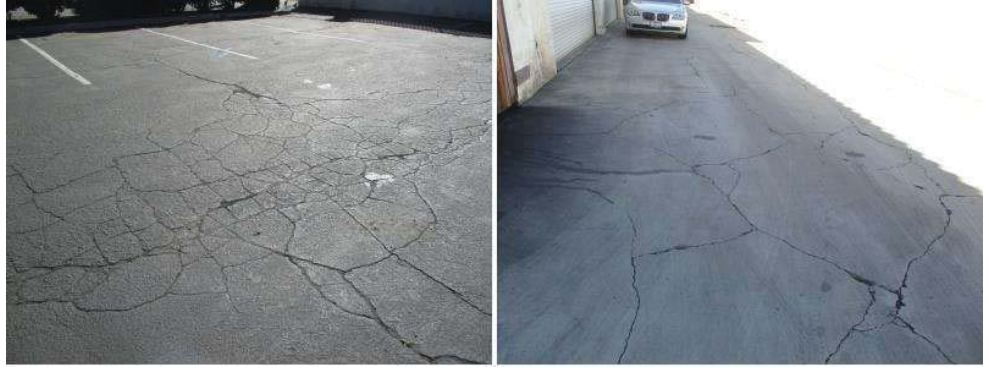
### **Needs Attention:**

**The parking areas are worn and aged.**

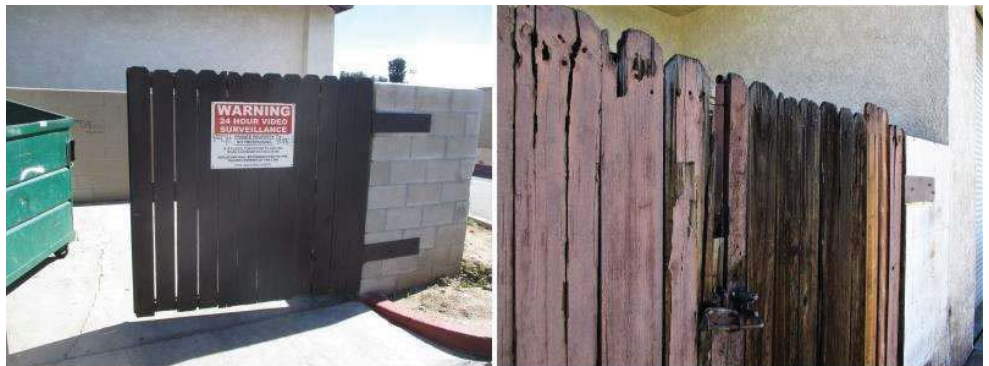
### **Needs Attention:**

**The wood fencing/walls are generally worn.**

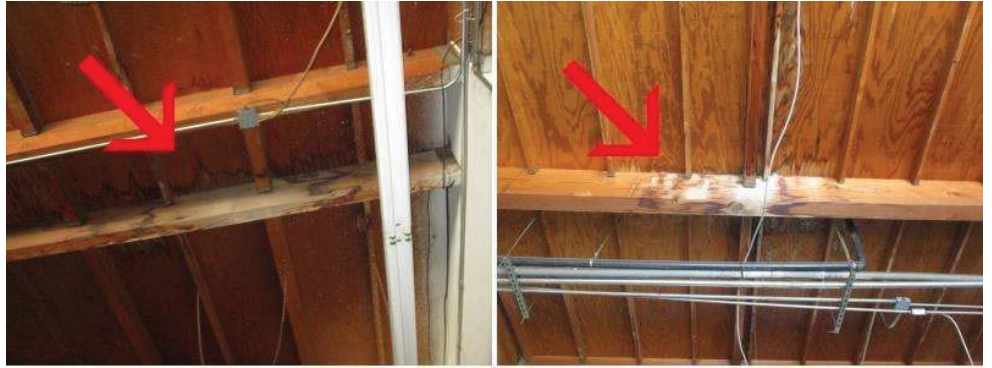
**Needs Attention:**

**There are areas of moisture stains and/or damage on the ceiling 24759 A - D.**

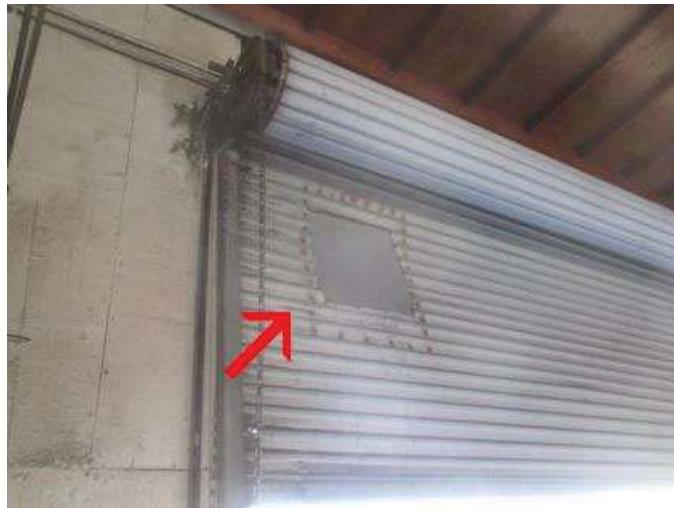
**Needs Attention:**

**There is damage to the roll up door.24759 - B, C**

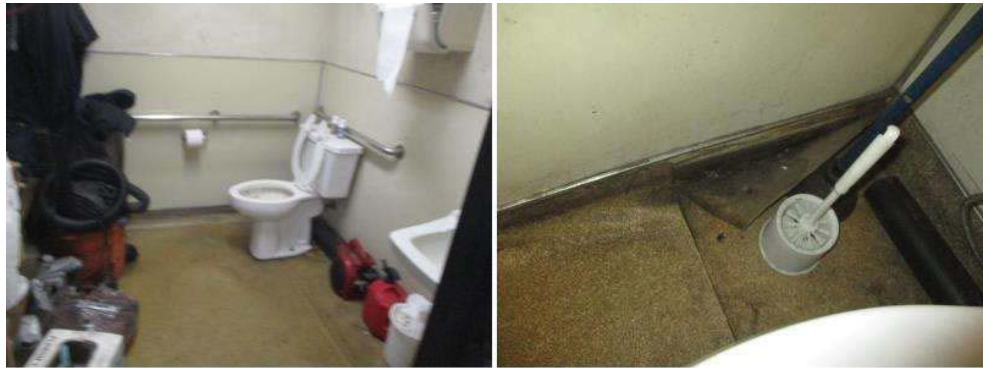
**Needs Attention:**

**Too much stuff. This may also be an ADA out point.**

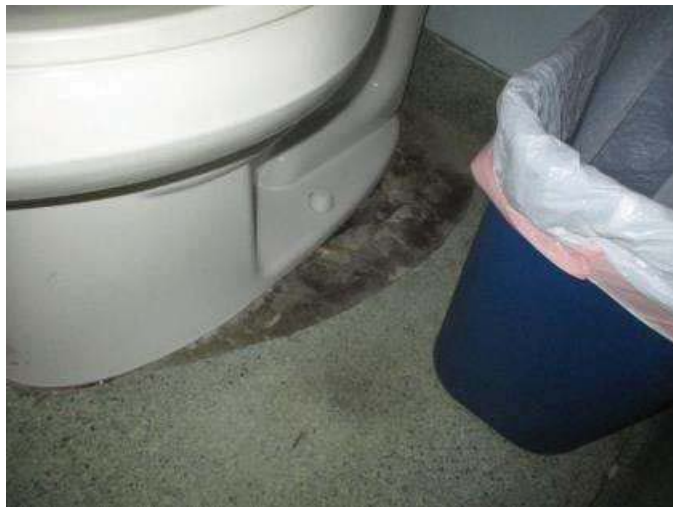
**Needs Attention:**

**The toilet is not securely mounted at the base.  
Unit # 24759 A, C**

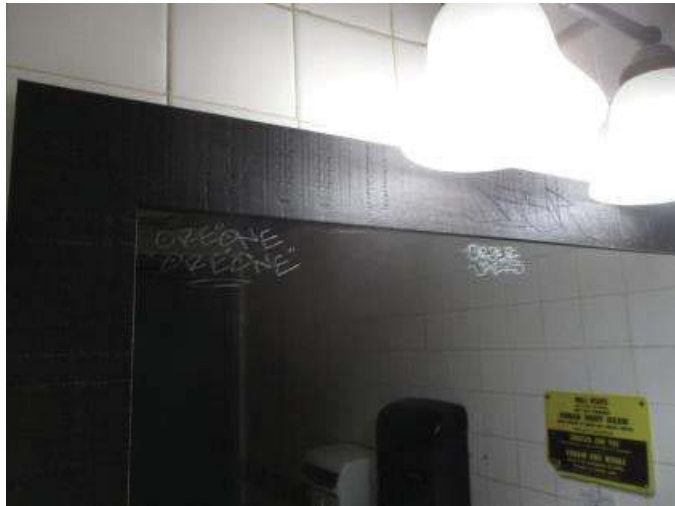
**Needs Attention:**

**There is vandalism on the mirrors.**

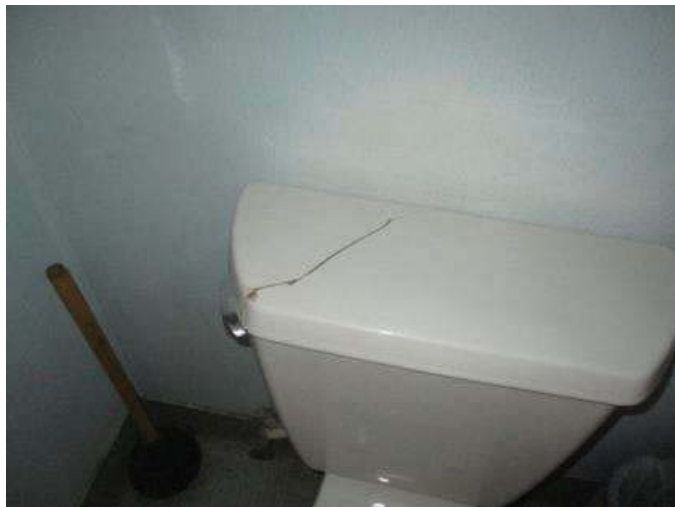
**Needs Attention:**

**The toilet is worn and/or damaged 24811 B (Women's Restroom)**

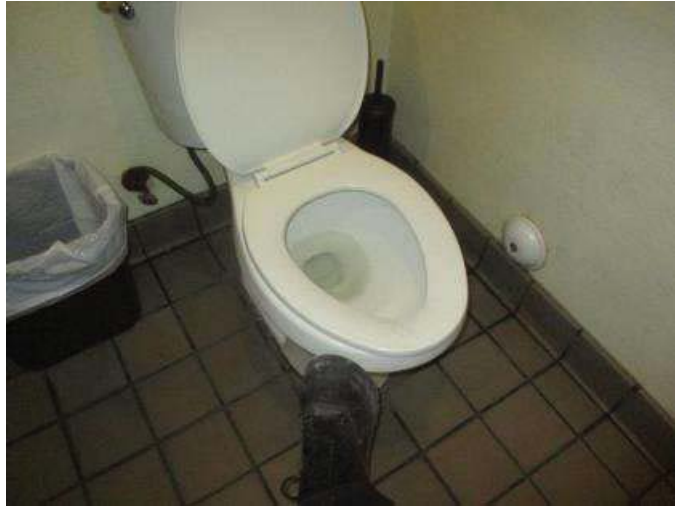
**Needs Attention:**

**The toilet is not securely mounted at the base.**

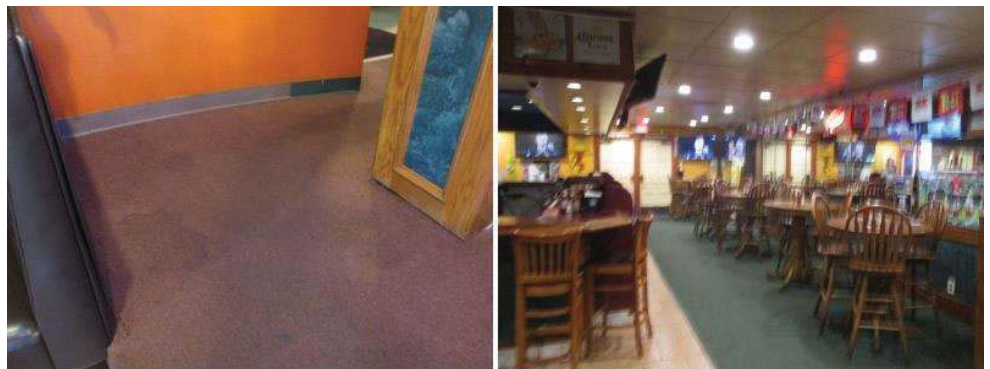
**Needs Attention:**

**The carpeting is generally worn.**

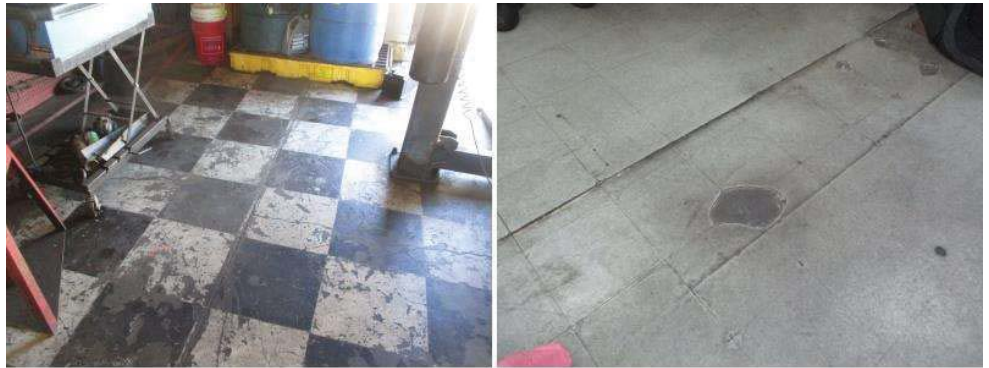
**Needs Attention:**

**There are areas of worn floors and floor tiles in the automotive areas and offices of # 24759 A, B, C, D.**

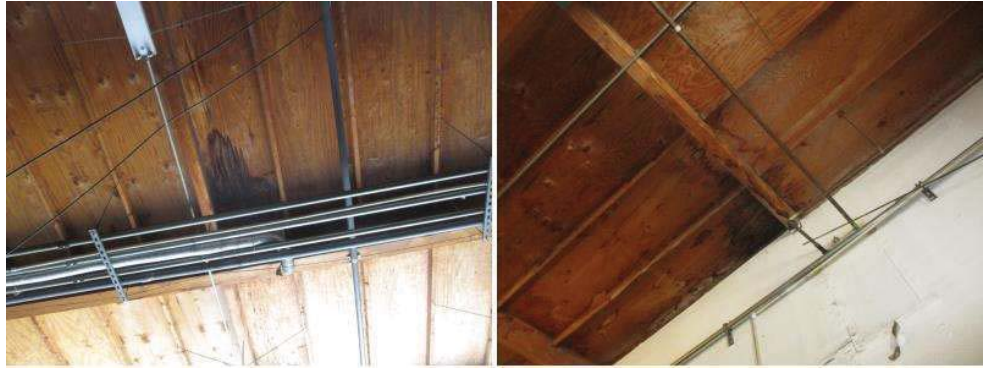
**Needs Attention:**

**There are some stained areas of the ceiling in the warehouse / service bay areas of 24759.**

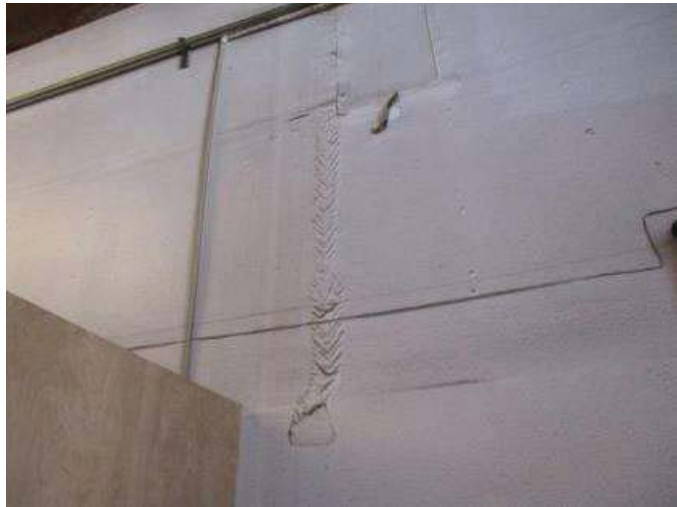
**Needs Attention:**

**There are areas of excessive moisture damage on the walls 24759 C.**

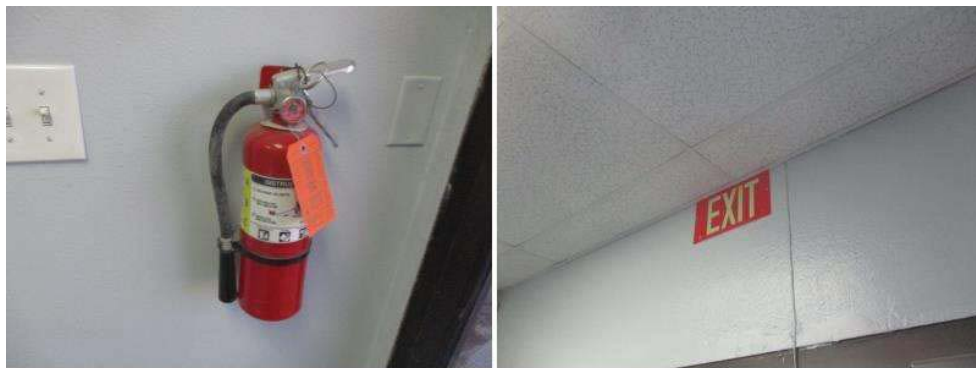
**This type of building site is required to have certain fire safety items. These are items such as exit signs and fire extinguishers. It is advised to check with the local Fire Marshal to determine if this building meets current fire safety regulations.**
