RISK Assessment® Report

RISK ASSESSMENT[®]

Commercial Real Estate Inspectors

This is an assessment of the five major systems - Plumbing, Electrical, Heating and Air Conditioning, Structure and Roofing along with an assessment of any other current deferred maintenance issues for the site.

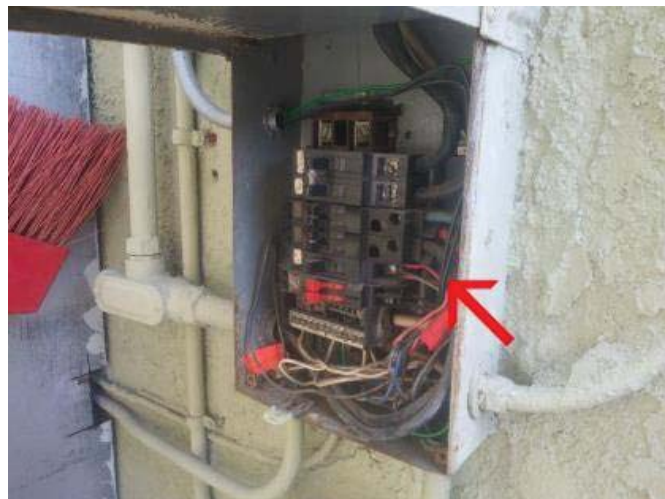
Not Acceptable:

The panel cover is missing inside the electrical box and the live wiring and circuits are exposed when the outside cover is opened.

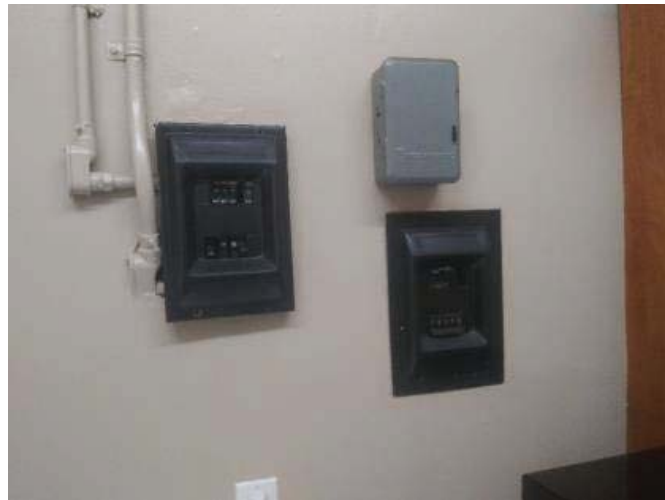
Needs Attention:

Federal Pacific panels have been observed on the site. These panels have been reported to not perform as designed and are a potential fire/safety hazard. Further review by a qualified electrician is advised at this time for safety. Replacements are the typical recommendation and should be anticipated.

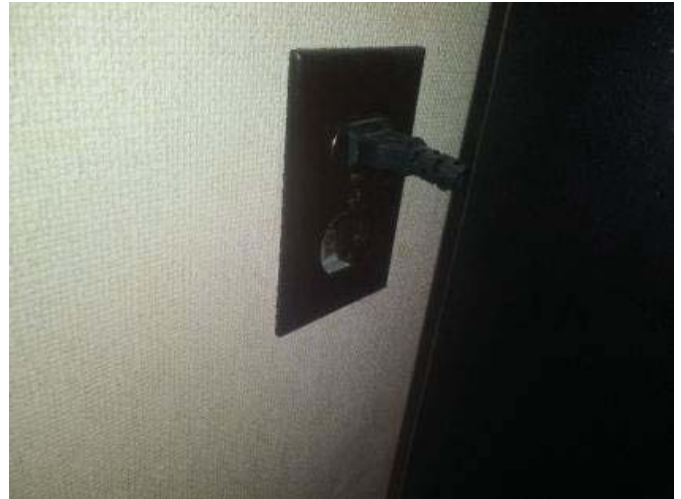
Needs Attention:

A damaged Outlet was found in the mobile unit which needs repairs for health and safety.

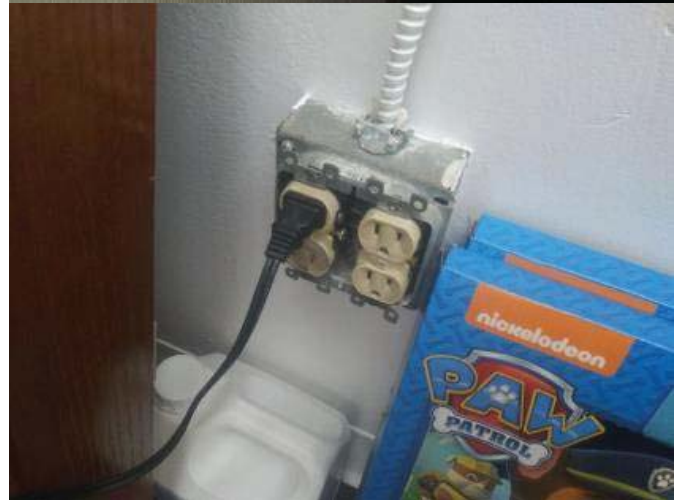
Needs Attention:

There are missing covers at some of the electrical outlets.

It is recommended that Ground Fault Circuit Interrupter (GFCI) safety outlets be installed at the exterior, restrooms, & any kitchen outlets. Not all the outlets may have these at the proper locations. This is advised for health and safety.

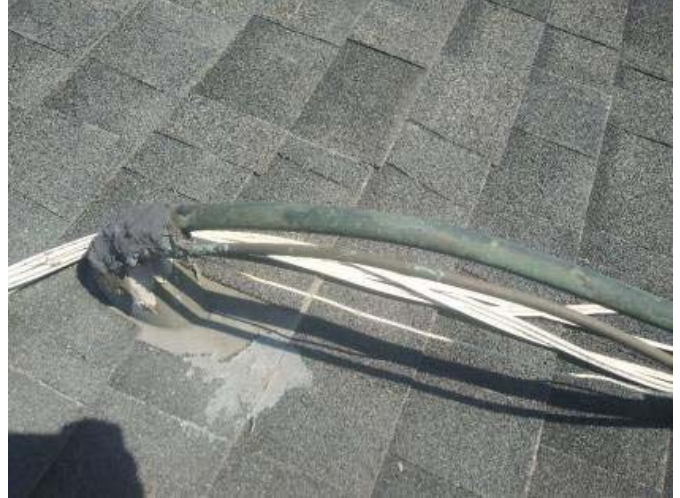
Needs Attention:

The refrigerant lines have damaged insulation on them. This will cause them to be inefficient and they should have the insulation repaired. This is usually not an expensive item.

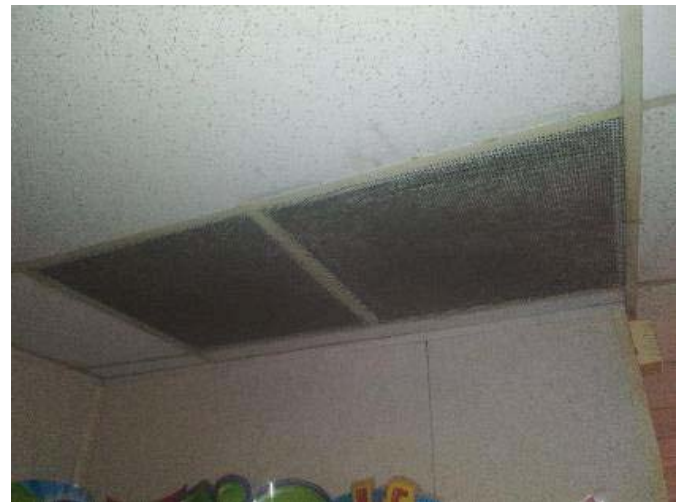
Needs Attention:

There are dark stains around the air supply grills in the building. This may indicate that the system needs maintenance and it is advised have it serviced at this time to ensure that it is functioning properly.

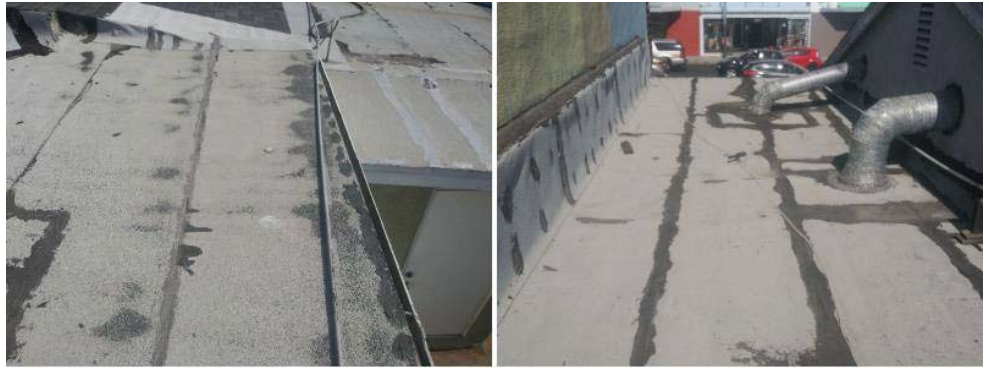
Needs Attention:

There are areas of wear and deterioration to the low slope roofing material.

It is noted there are areas of the roof that have had patching and or repairs done to them. This is usually an indication that there have been leaks and past issues. It is advised to have full disclosure by the seller as to the history of any roof leaks.

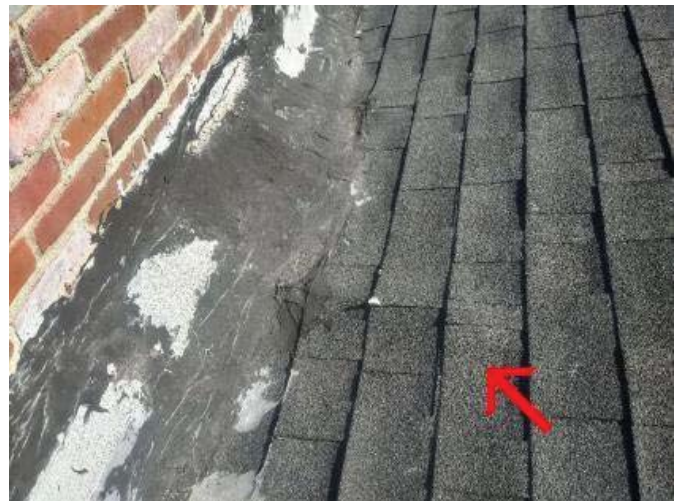
Needs Attention:

The roofing around the chimney is not properly nailed and installed.

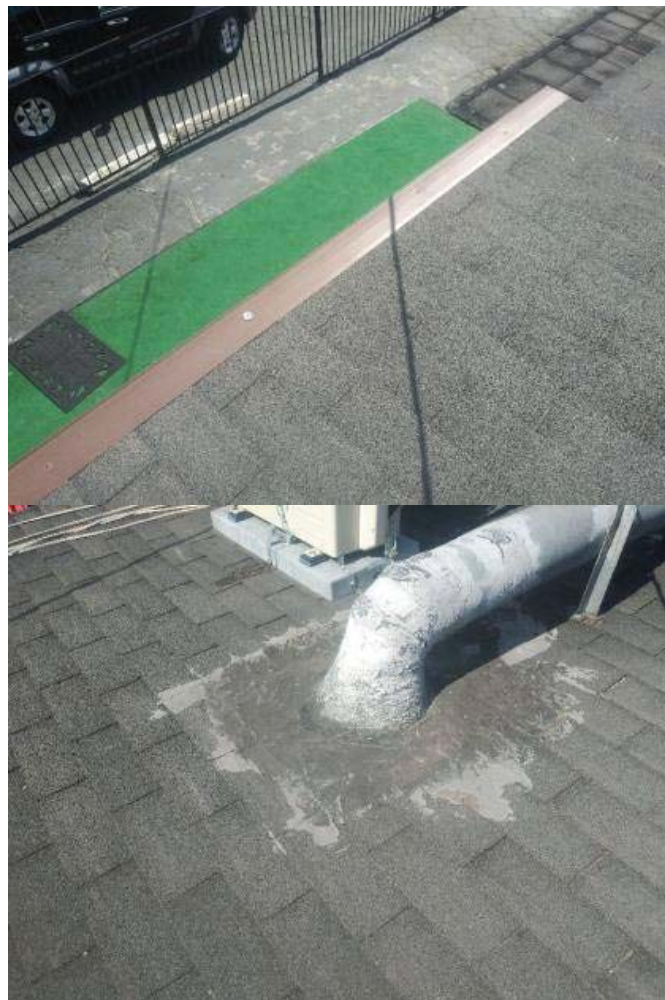
Needs Attention:

The flashing does not appear standard in all areas and may not be a reliable moisture barrier. Review and any needed repairs are advised by a qualified roofing specialist.

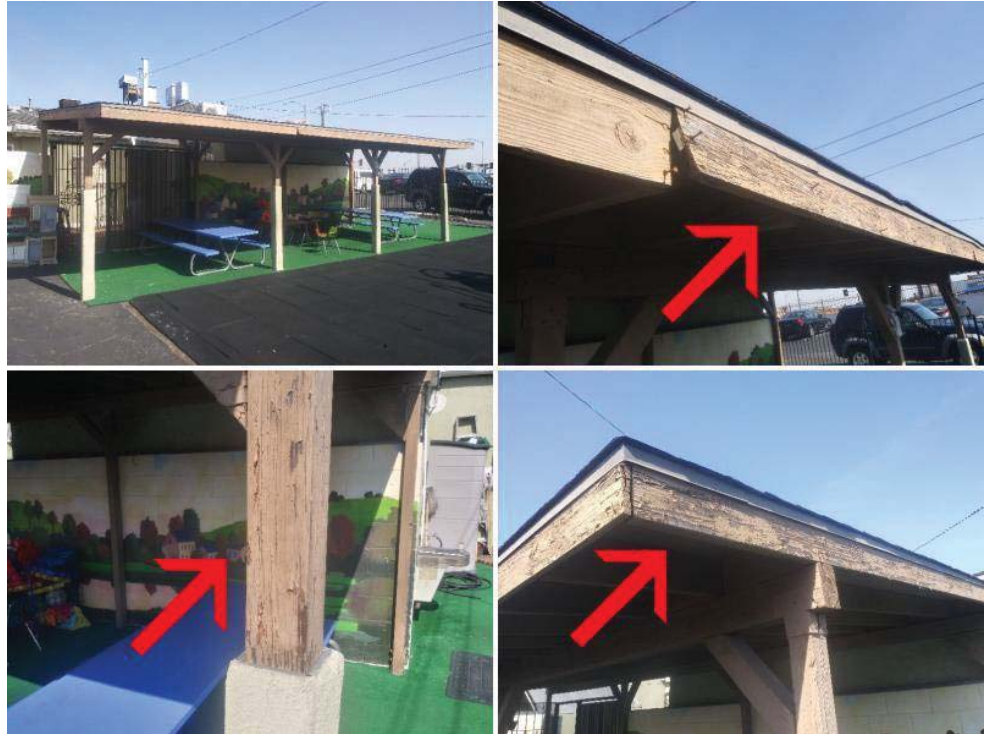
Needs Attention:

There are areas of deterioration to the patio awning.

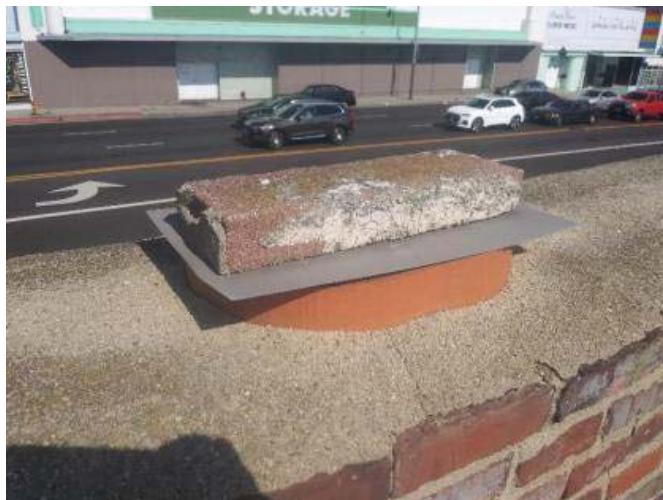
Needs Attention:

The chimney is not equipped with a proper spark arrester.

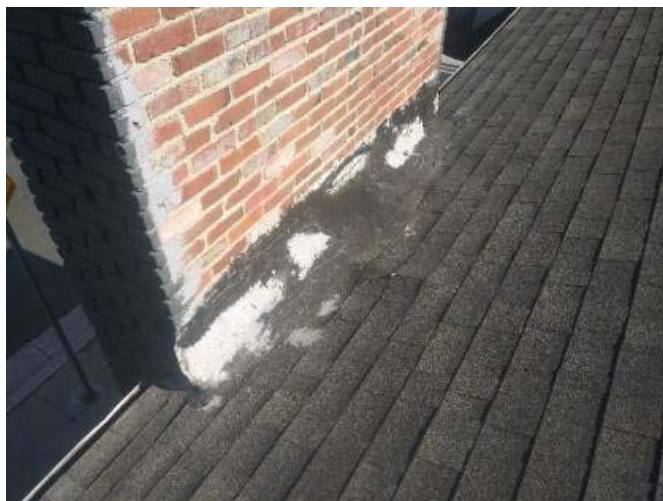
Needs Attention:

There is no metal flashing around the chimney where it meets the roof, it is only mastic. This method requires high maintenance if it is to remain leak free.

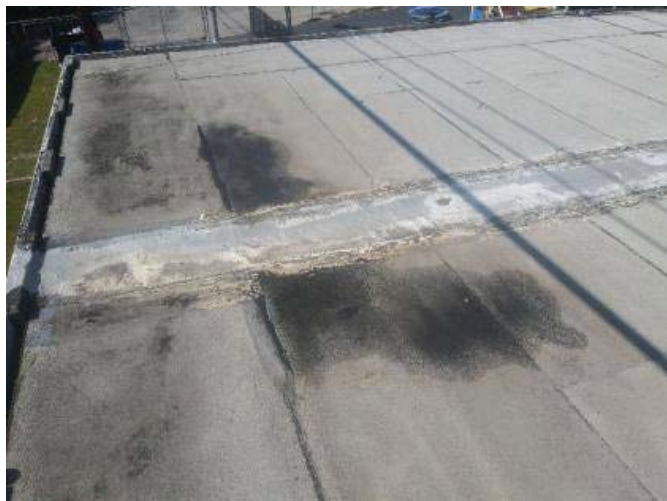
Needs Attention:

There are areas of standing water on the roof during the inspection. Standing water will accelerate the deterioration of roofing materials affected. It is advised to eliminate these areas of ponding by improving the slope of the roof wherever needed, or to reinforce affected areas where slope improvement is impractical.

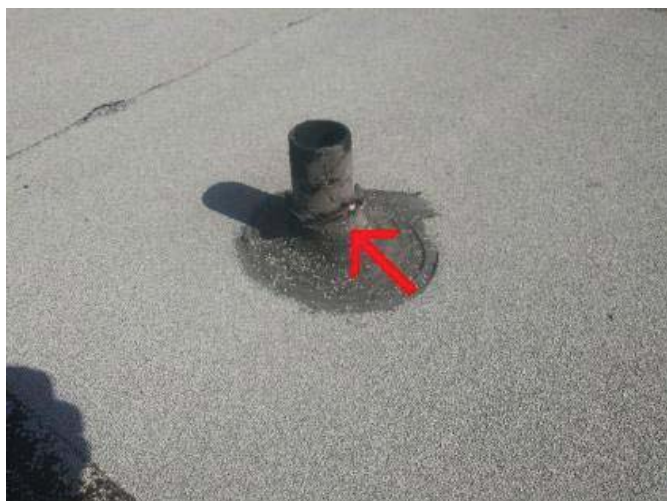
Needs Attention:

The mastic is cracked in areas and is not reliable to ensure a watertight seal.

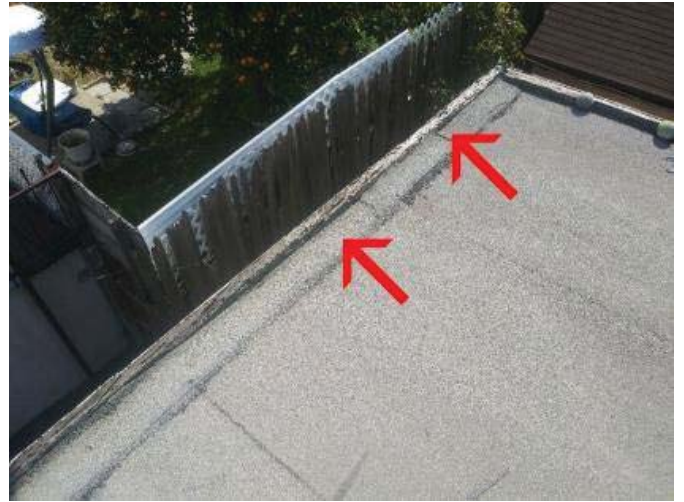
Needs Attention:

**The wood trim
around the roof is
deteriorated.**

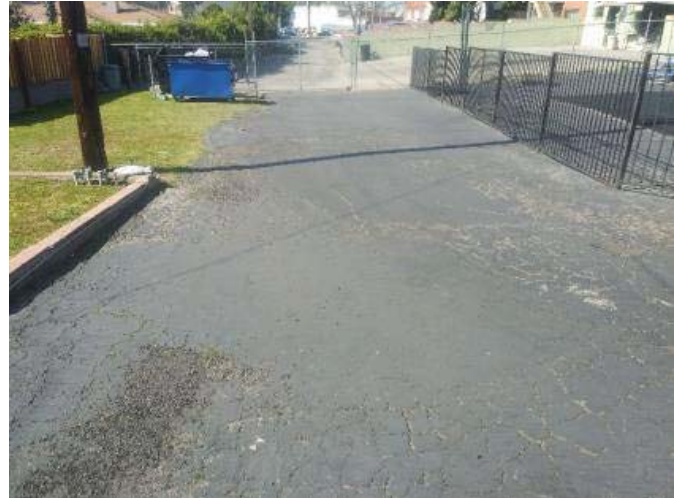
Needs Attention:

The driveway area surfaces are deteriorated and in need of being resurfaced at this time.

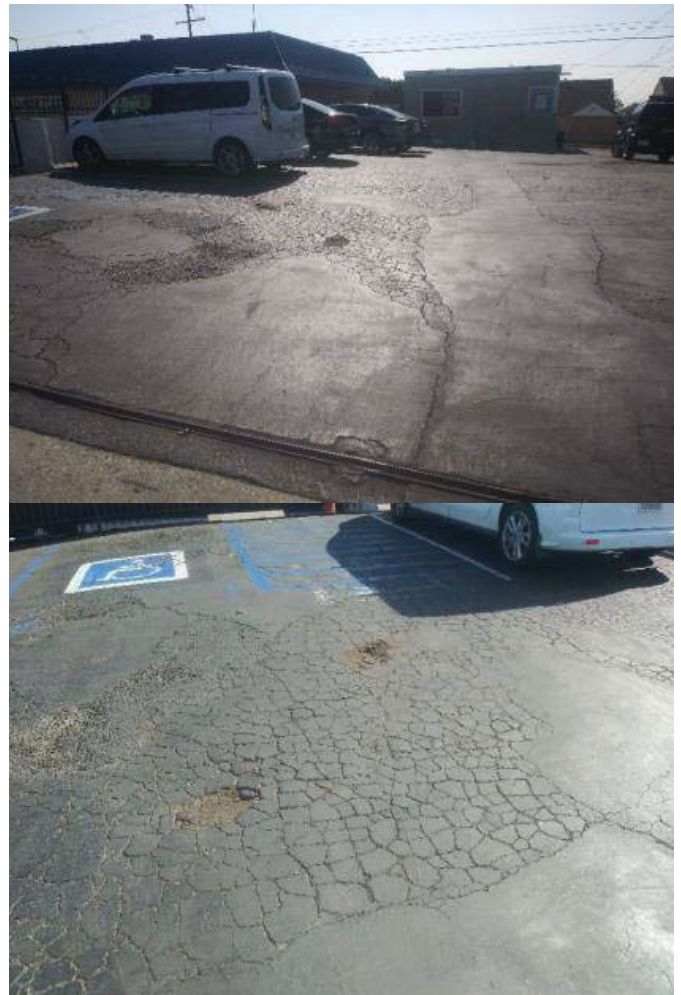
Needs Attention:

The parking area asphalt has areas of wear, weathering and deterioration to the point that resurfacing should be strongly considered.

It is noted that the parking areas appear to have been recently resealed without proper resurfacing.

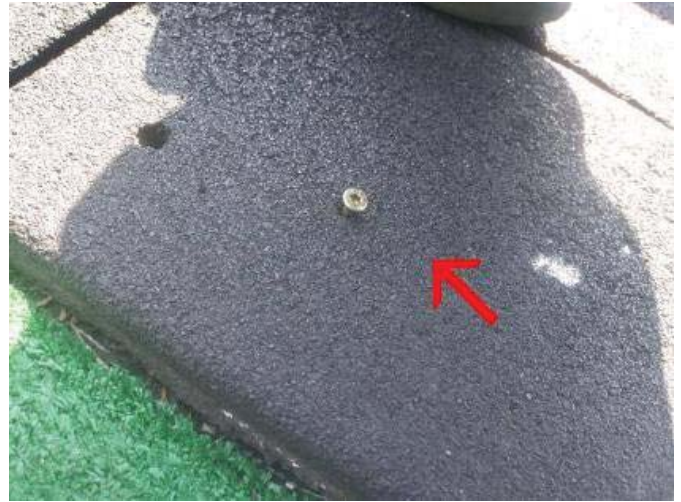
Needs Attention:

The mastic is cracked in areas and is not reliable to ensure a watertight seal.

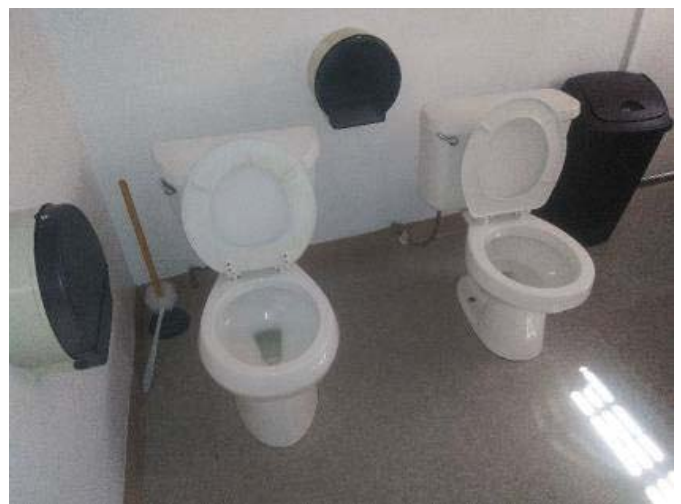
Needs Attention:

**The toilet is not
securely mounted at
the base.**

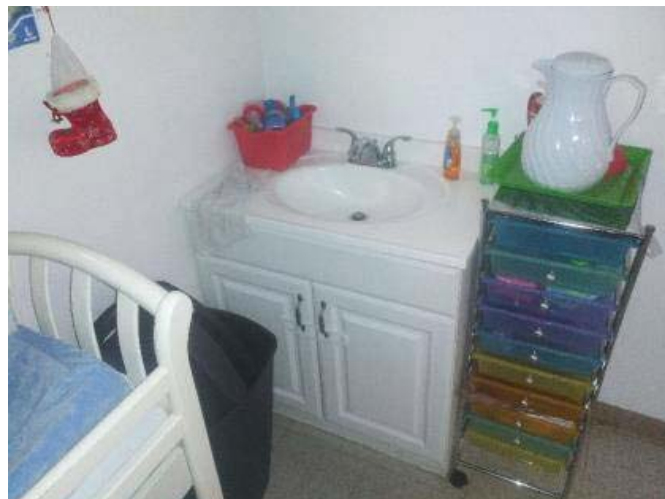
Needs Attention:

**The surface of the
sink is worn/chipped.**
