RISK Assessment® Report

RISK ASSESSMENT[®]

Commercial Real Estate Inspectors

This is an assessment of the five major systems - Plumbing, Electrical, Heating and Air Conditioning, Structure and Roofing along with an assessment of any other current deferred maintenance issues for the site.

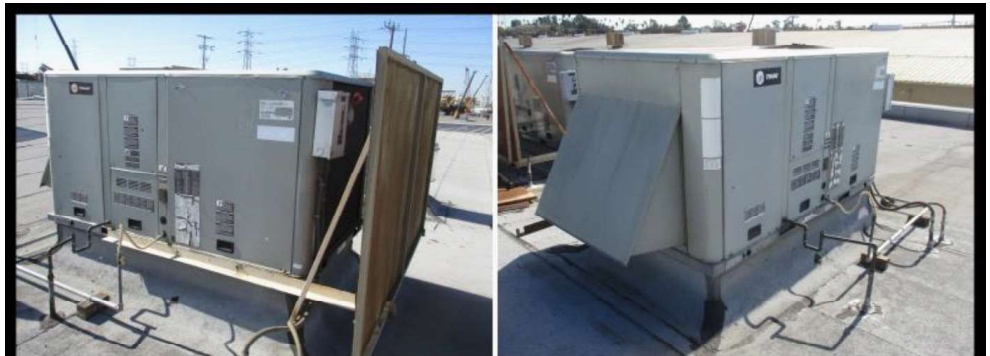
Typical views of roof top HVAC units.

Serviceable overall.

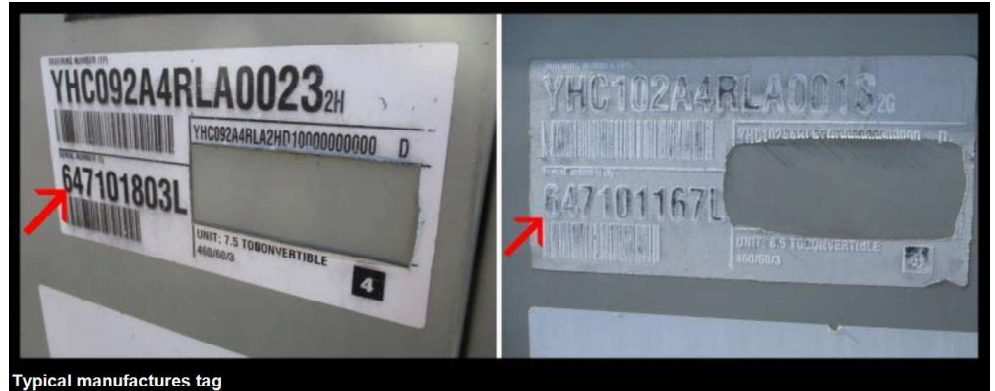
The systems are approx. 14 years old from 2006.

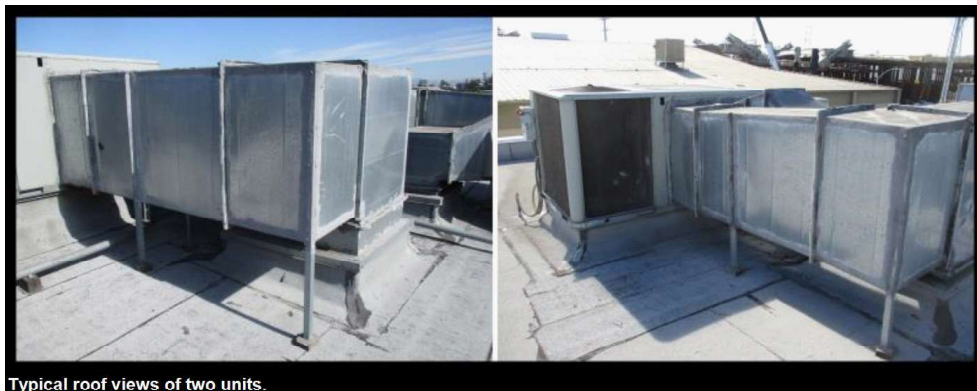
Typical roof views of two units.

Serviceable, however the views are very limited.

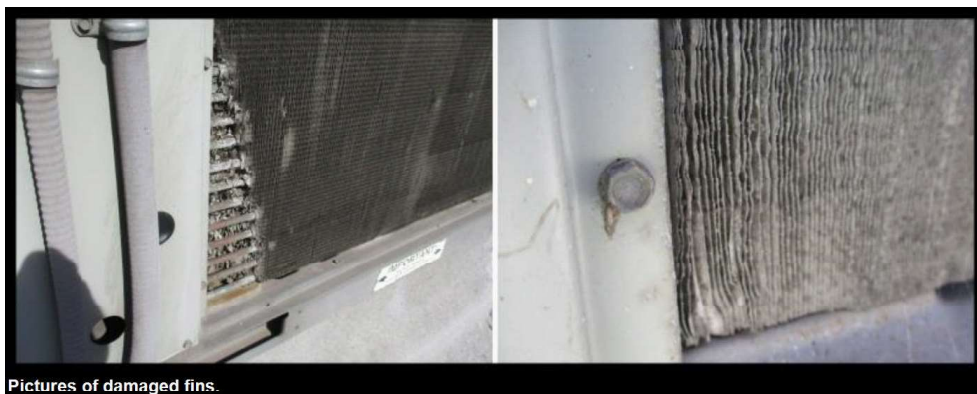
Pictures of damaged fins.

The eleven roof package type units over the office areas are aged and worn to the point that repairs are needed now for at least some of them. It is advised to have each unit fully cleaned and serviced at this time. Typical cost is approx. \$100 - \$150 per individual unit. Expect some of the units to need extensive repairs for proper operation.

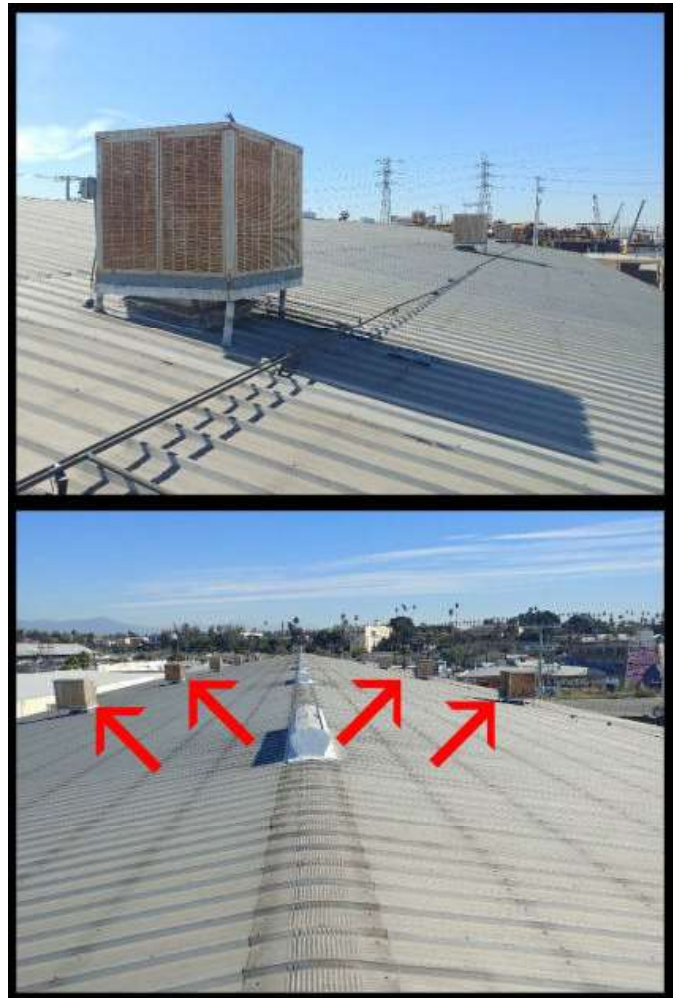
For 560 there are 10 Evaporative coolers. All are Aged and worn and at or near the end of their expected useful life.

The evaporative coolers, ten of them, over the 560 warehouse area are in such poor shape for at least half of them replacement is advised now. Extensive maintenance and repairs are needed for all the evaporative cooler units.

Replacement of each evaporative cooler is approx. \$5,000 - \$7,500+ depending on the methods and materials used. Expect replacement of at least 5 of them in the near future to be needed along with extensive repairs to the rest.

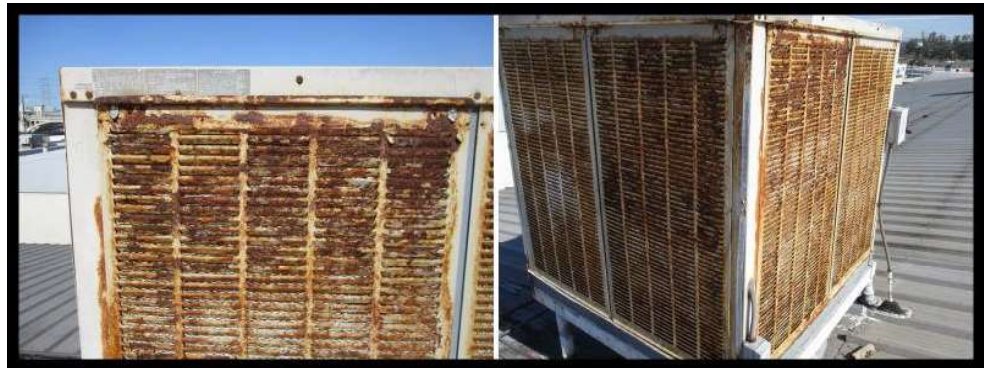
The heating and cooling units are very old and aged. While these may still be working at this time, each is well past its expected life span.

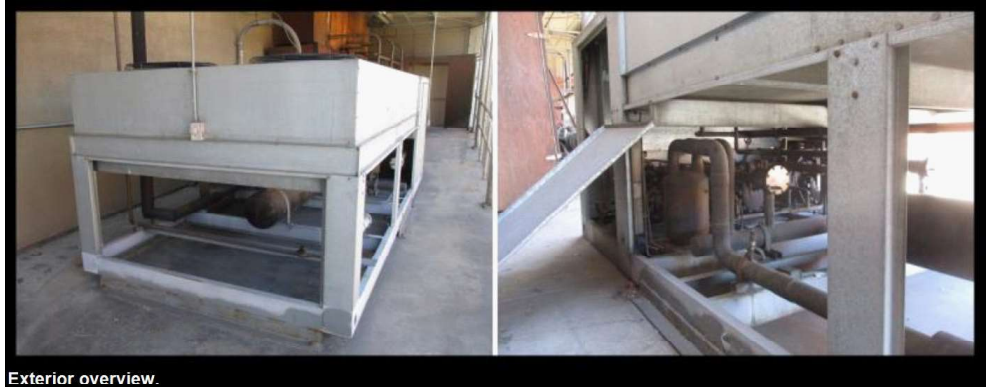
Exterior overview.

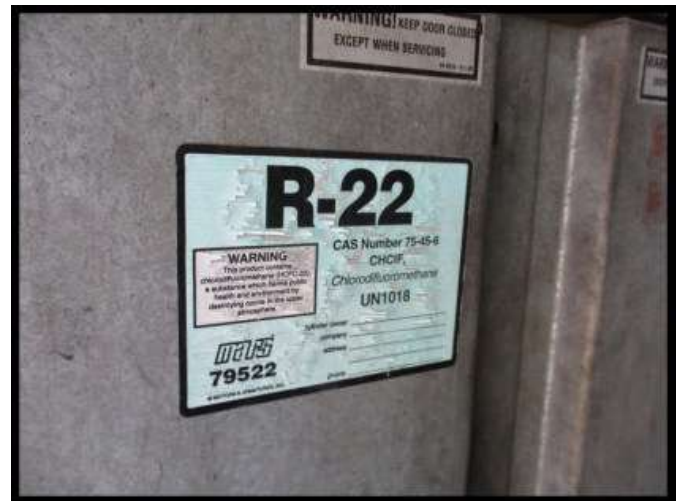
Per disclosure the system has had the R22 coolant removed and nitrogen installed.

In it's current condition the system can't be started and tested. It will require a team of professionals to install coolant and then start up the system to determine if it is functional and if any other repairs are needed.

Due to the age of the units, approximately 10 years or more since the date of manufacture, the presence of the coolant known as R22 is typical. This coolant is no longer allowed to be used and if repairs are needed that involve installing more

Just to get the condensing unit system up and running to determine what further work might be needed is approx. \$20,000 - \$30,000 depending on the methods and materials used. This will be needed just to determine the true condition of the system.

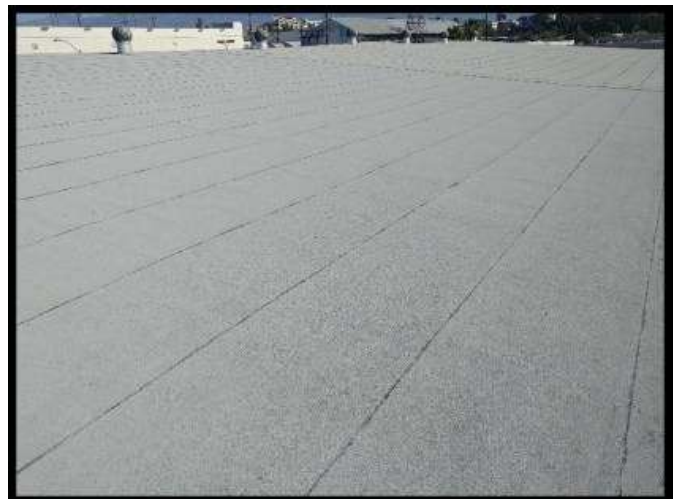
There are areas of wear and deterioration to the roofing material.

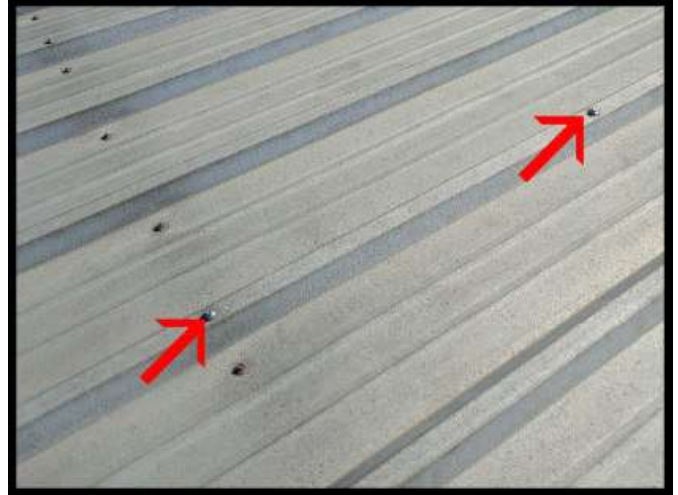
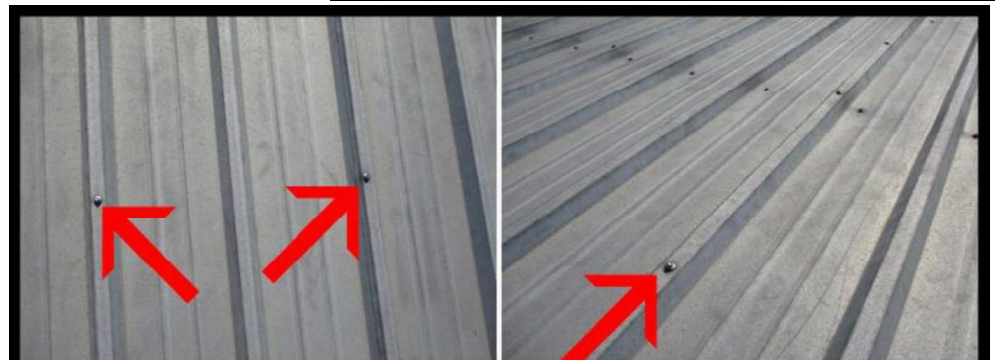
There are areas of
relatively recent
maintenance in the form
of replacement and
upgraded screws.

Silver screws are newer screws.

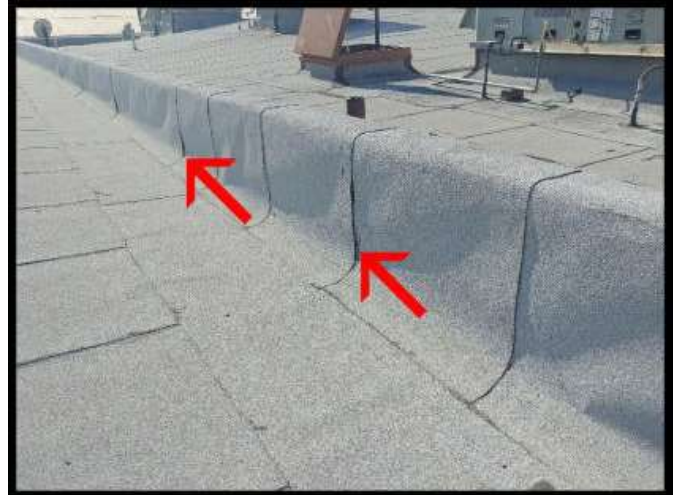
It is noted that there are areas where the seams are not fully sealed such as app the office area partition. This is a defect in installation.

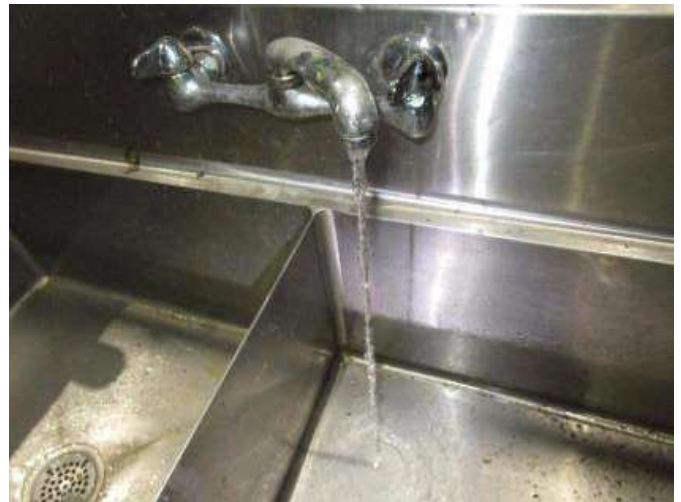
**Low water volume
noted in 560
warehouse production
area sink.**

**Why water had low
pressure at this sink is
unknown.**

Note; there is low water volume at 560 warehouse production area sink. Repairs are advised.

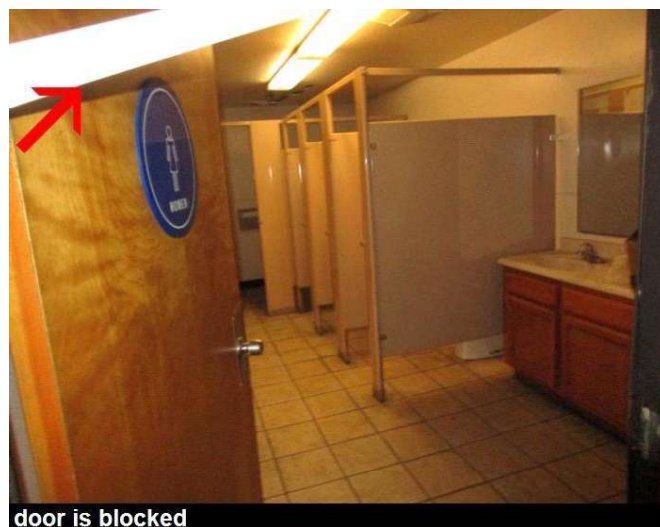
Some toilets are dried up. Bathroom in 560 warehouse has a sign Do not enter. It is unknown why this restroom is blocked off (Women's restroom)

Some maintenance or repairs are needed to the interior plumbing fixtures such as in 560 the toilets are dried up and there is a Do Not Enter sign on the womens warehouse bathroom door. The reason for this is not known however the dried up toilets allow sewer gasses to enter the site. This is an unhealthful condition and repairs are advised.

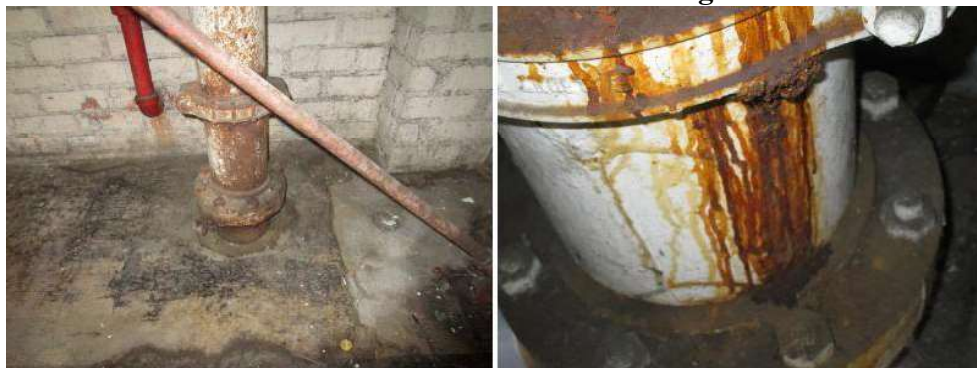
Also rusted areas are seen on risers in both buildings.

<p>It is advised to have the Fire Sprinkler system Reviewed by a qualified sprinkler specialist at this time with an Annual Review mainly due to some areas of rust and deterioration of the stand pipes.</p> <p>3. What costs are expected over the next five years for the Plumbing System:</p> <p>The above reviews and minor repairs appear to be \$1,500 - \$2,500 Depending on the methods and materials used</p>	<p>TOTAL:</p> <p>\$1,500 - \$2,500</p> <p>Routine Maintenance. Specialty Evaluation recommended</p>
---	--

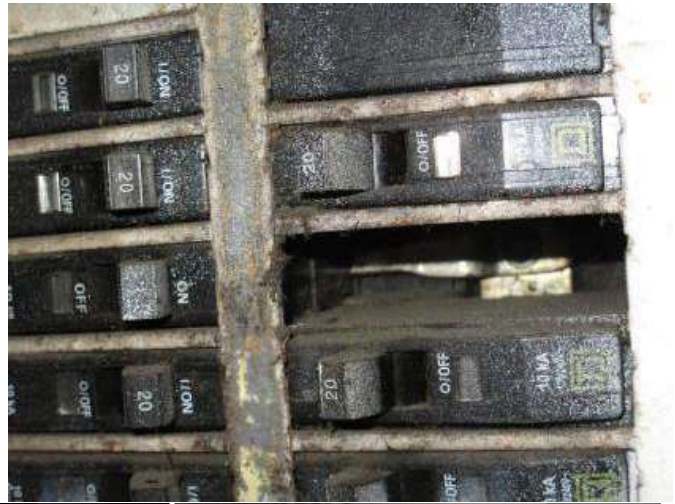
There are knock-outs missing at the panel leaving open spaces in the cover and there are exposed live electrical items as a result. This is inexpensive to correct but should be repaired for health and safety.

Due to the age and overall condition it is advised to have a complete cleaning and servicing done for health and safety for all sub panels.

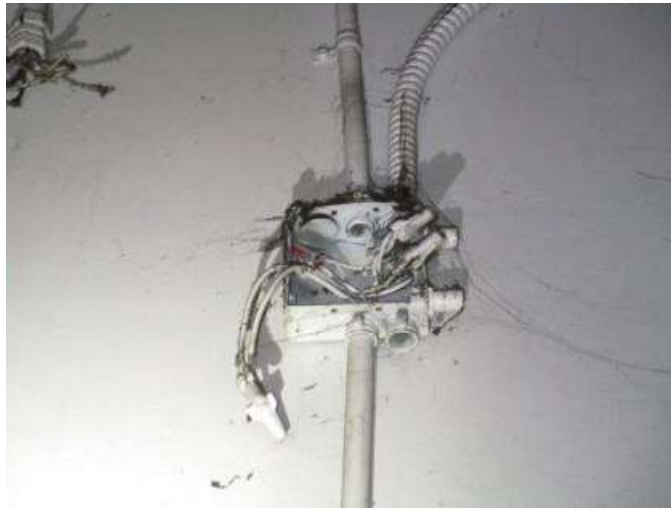
There are open junction boxes with wires exposed. Any such junction boxes need to have covers installed. There are areas of exposed and/or dangling wiring that are not properly secured.

It is advisable to have an electrician examine the system and make all needed repairs to ensure a properly installed and correctly operating electrical system. This investigation of the system should be done prior to the expiration of the contingency period so the repair or replacement costs are known and unwanted expenses are avoided. It is expected that when the electrical specialist checks out the system they will find more problems as this is a general inspection and not designed to list every fault but to isolate areas in need of further detailed inspections by a specialist.

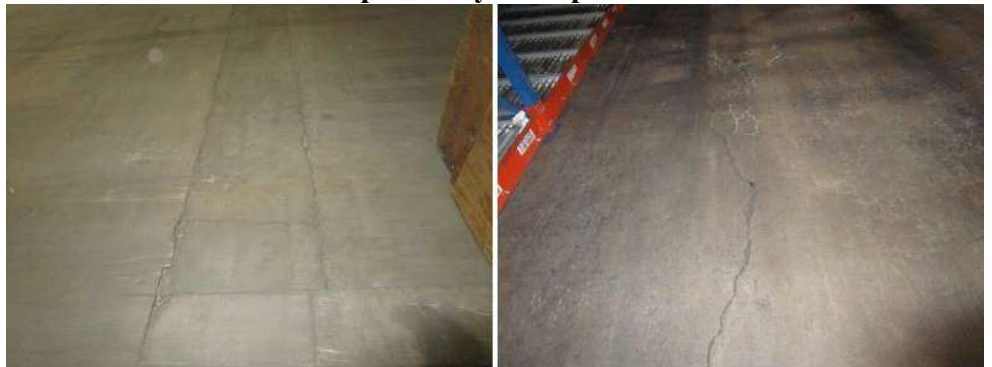
Slab foundation has cracks in areas. Most are typical. Some are larger cracks which should be repaired by an expert.

There are cracks in the slab that appear to be typical for the age and style of construction. However if you need a more detailed evaluation it is advisable to contact a structural engineer or a foundation specialist.

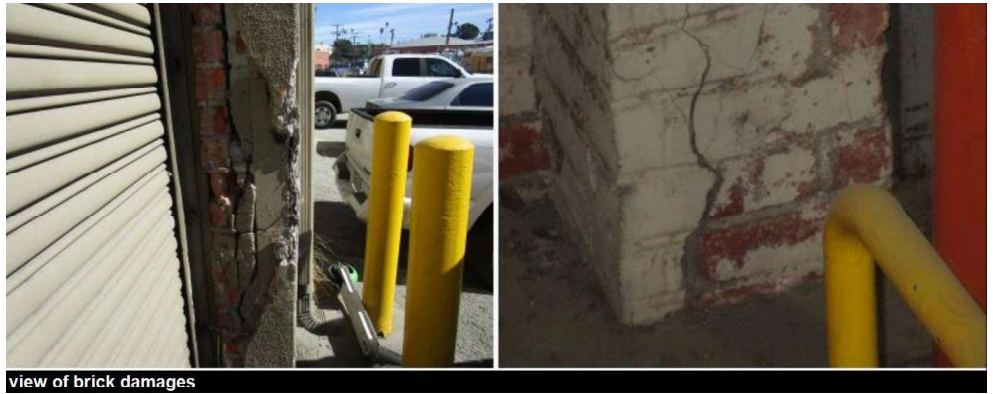
It is noted that brick columns in places are cracked and damaged, as seen in 560 warehouse areas.

view of brick damages

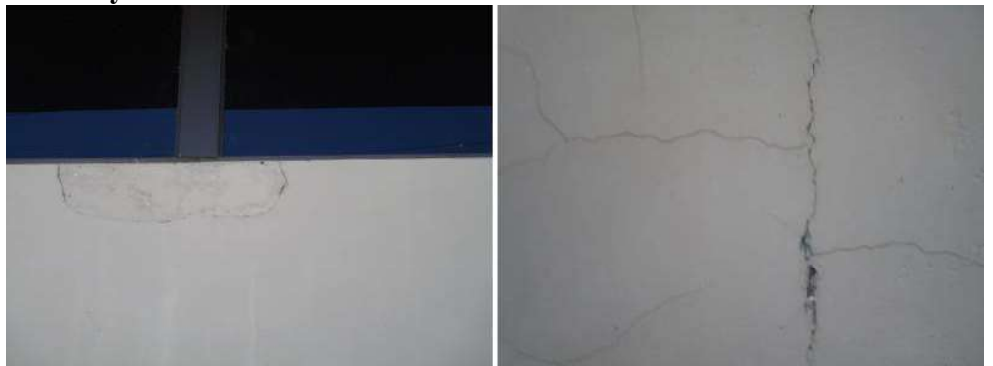
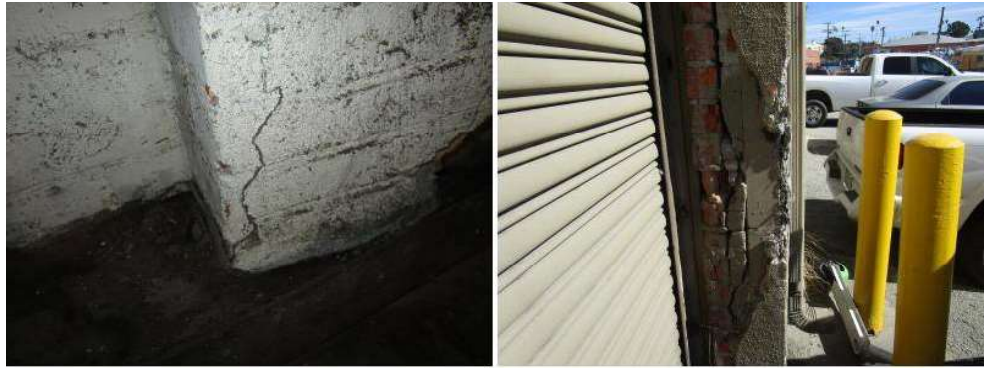
Brick wall damages noted in several areas , mostly at columns and doorways.

Walls should be patched and painted.

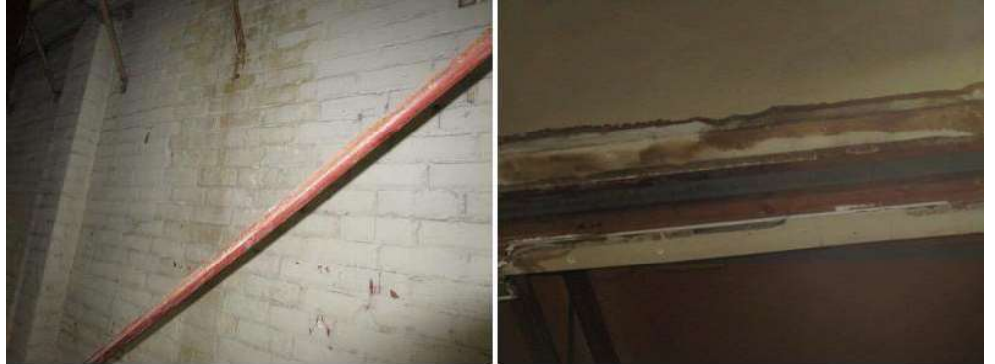
Moisture stains seen in walls and ceilings in warehouse areas.

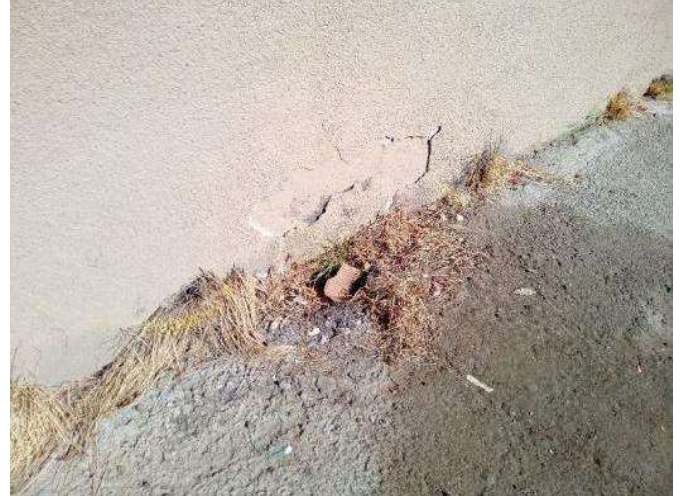
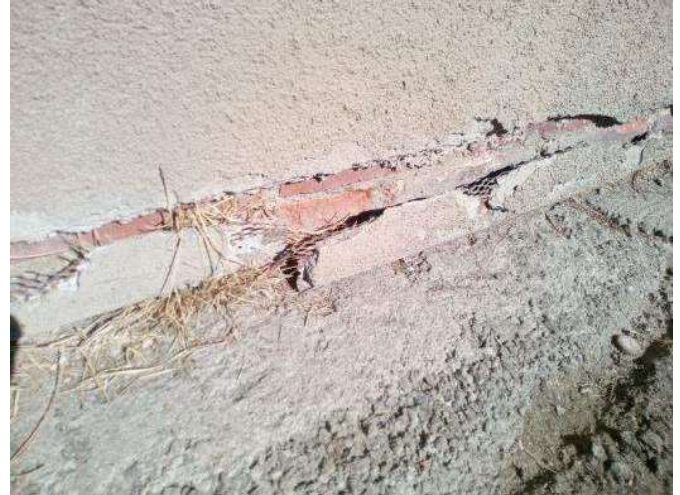
There's some small
areas of
deterioration

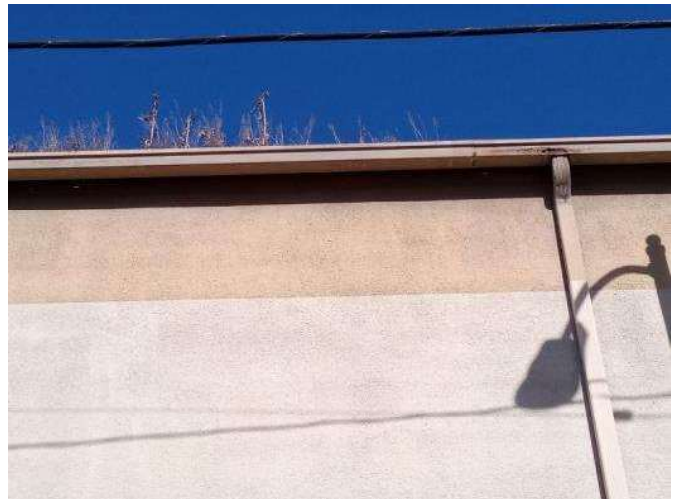
The trim is deteriorated in areas.

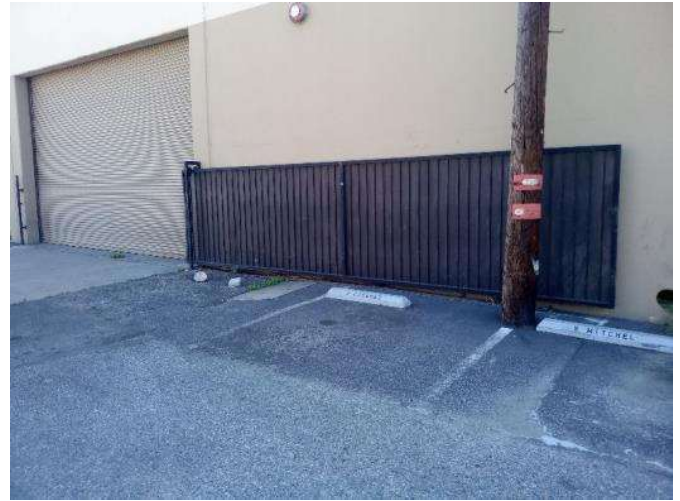
This gate was not operational

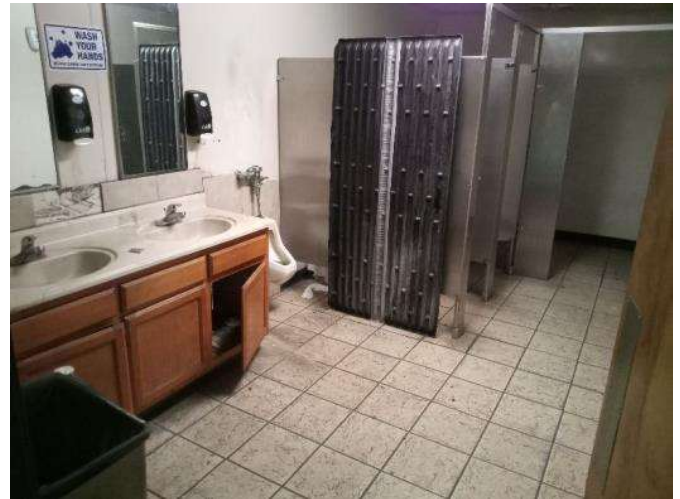
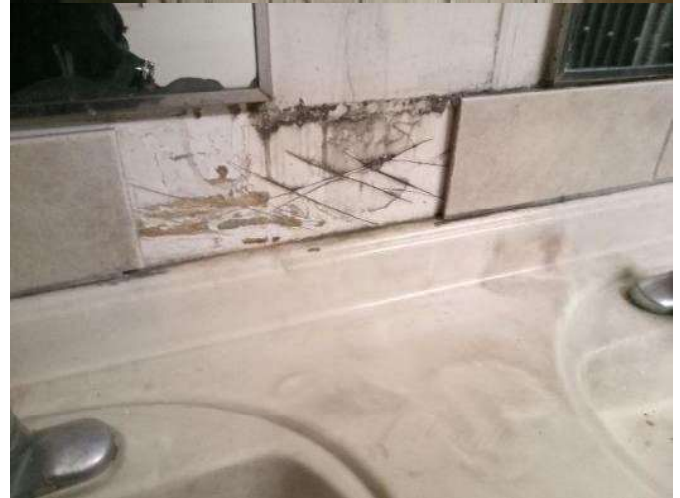
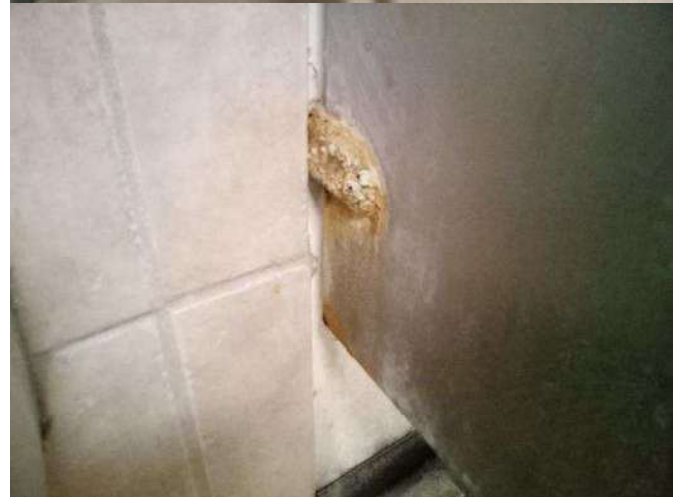
The interior surfaces, such as the walls, ceiling and cabinets are excessively worn and/or damaged.

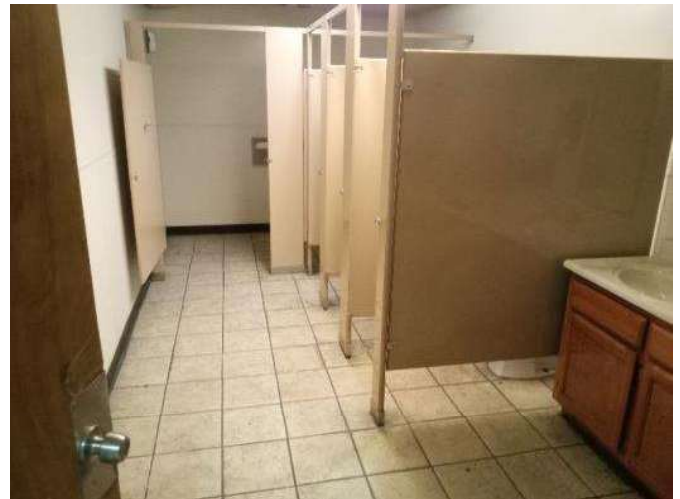
Women's Restroom

The interior surfaces, such as the walls, ceiling and cabinets are excessively worn and/or damaged.

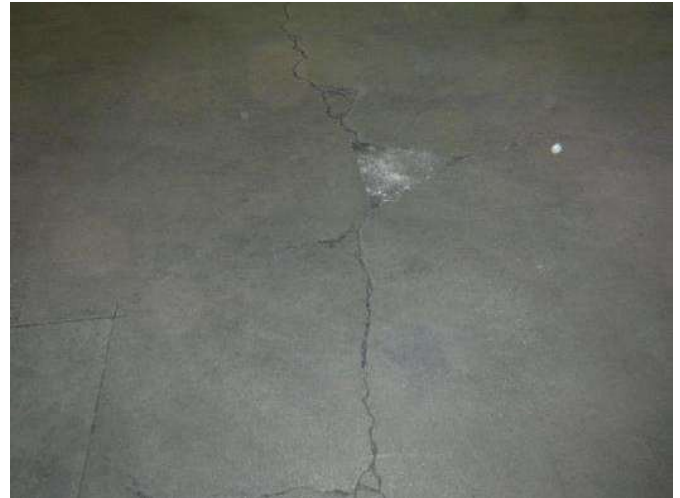
Warehouse:
Typical cracking for
this type of
construction and
use.
