RISK ASSESSMENT[®]

ADDRESS: Cerritos, CA

CLIENT: TFP Investments

RISK Assessment[®] Report

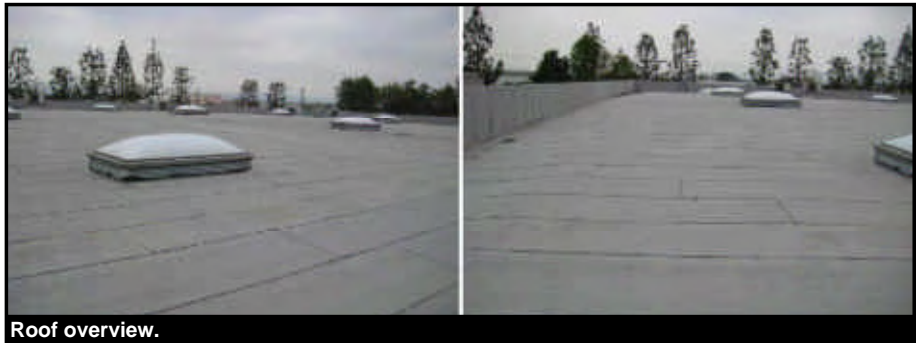
ROOF OVERVIEW:

While it is possible some prior repairs and leaks may be reported, it is not the intention of the inspection to identify and report all prior repairs and conditions. It is recommended to refer to the seller and sellers disclosure about the presence of any roof leaks or prior repairs. Also it should be noted that all gutters have rust and have a limited life span before they need to be replaced.
