RISK Assessment® Report

February 03, 2010.

Warehouse Client

City of Industry, CA

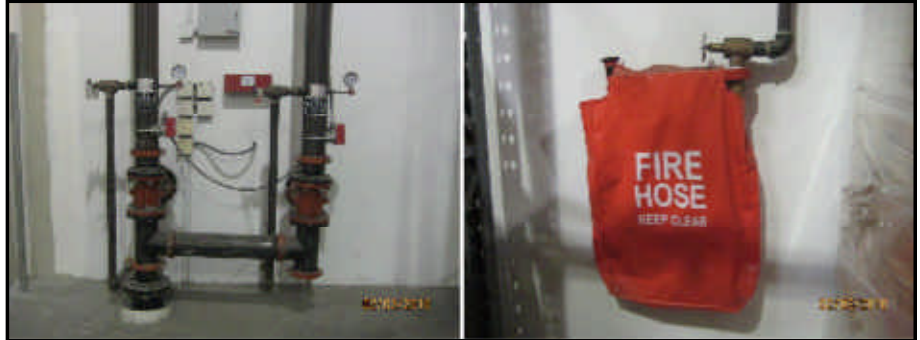
**GENERAL
COMMENTS:**

The majority of the water supply pipes, waste lines and gas lines are underground, in walls or installed in concealed parts of the structure and thus are not visible. Their condition cannot be determined and no representation is made as to their status.

There is an interior fire suppression system in the building. This is not tested as part of a general visual property inspection. It is advised to have a five year inspection done on the system. No Five year tag was observed.

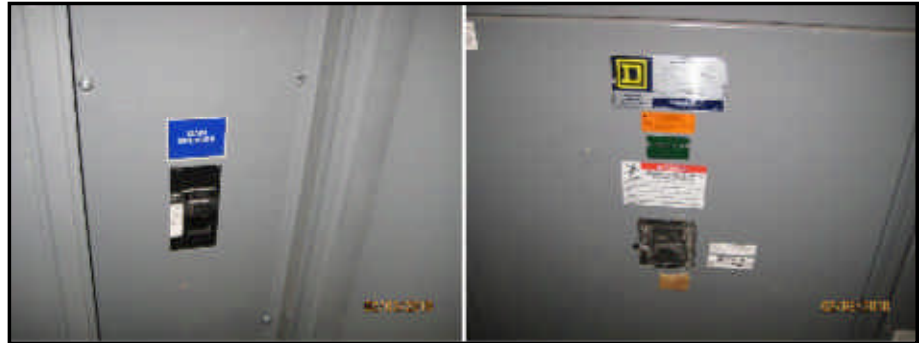
**MAIN PANEL
PROTECTION DEVICE:**

The main panel disconnect is a circuit breaker for each unit.

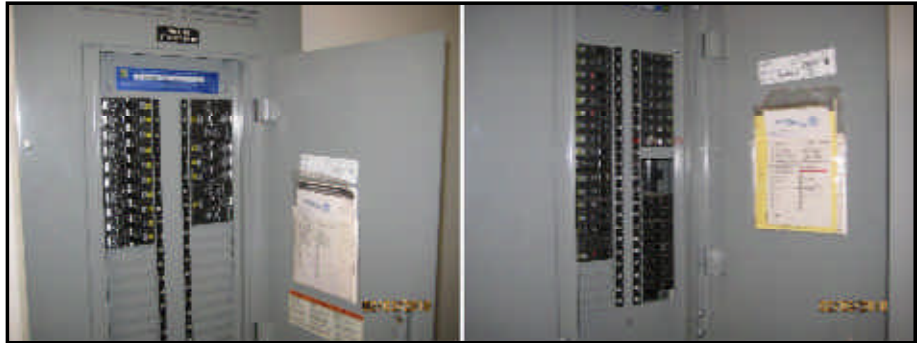
SUBPANEL
LOCATION:

There is an electrical subpanel in each of several areas on the property and next to the main panel.

SUBPANEL
CONDITION: Serviceable.

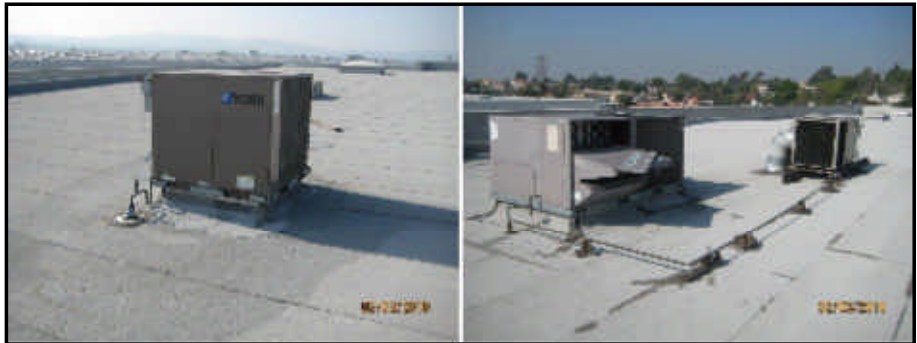
LOCATION:

The heating and cooling units are located on the roof.

Needs Attention, one of the units, the smaller of the two on the left side is sitting on wooden blocks. This is not a reliable method regarding moisture intrusion. It is advised to have platforms with metal caps installed to help ensure a leak free condition.

Not Acceptable two of the three units are leaking. Corrections are needed at this time.

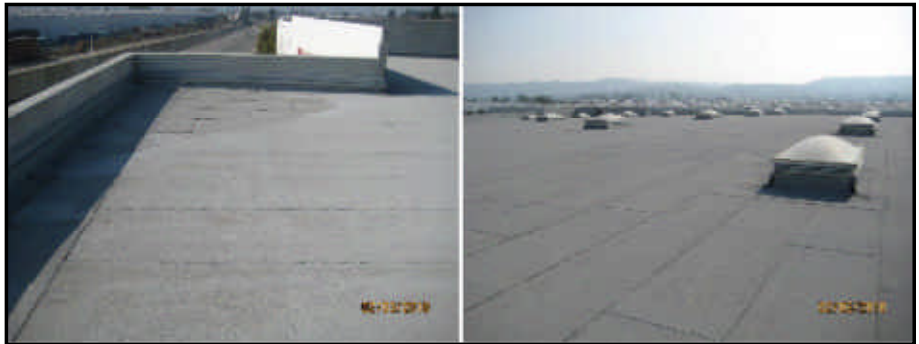
ROOF STYLE:

The roofing system is a flat roof with a low pitch.

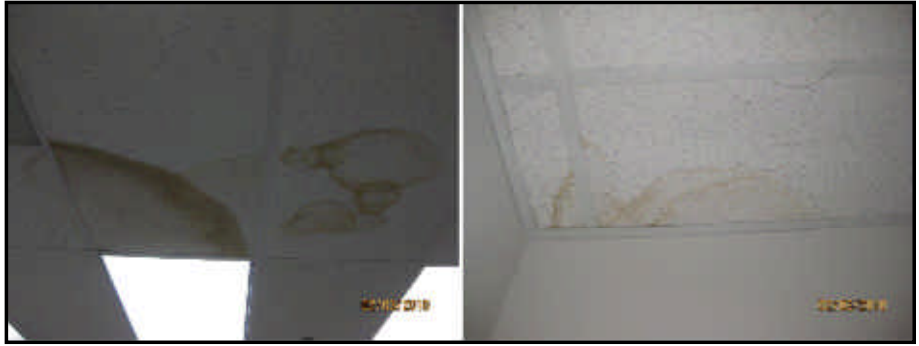
PICTURES:

It was reported that the major moisture staining within the large office occurred in the last rain storm, with the balance being due to moisture that appears to be originating from the roof mounted air conditioning units. See the heating section of the report for additional information.

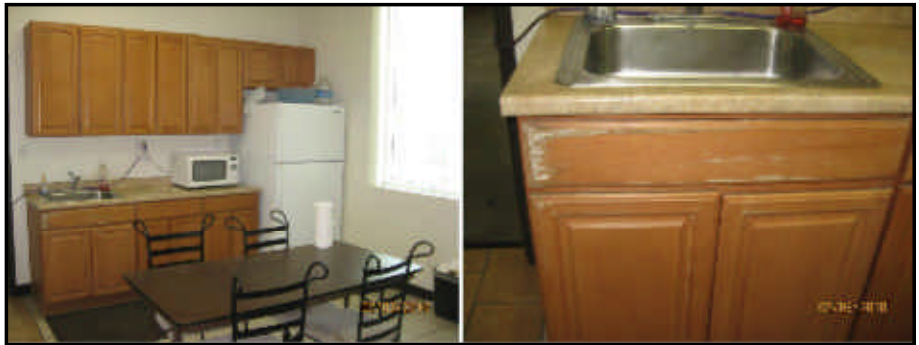
KITCHEN FACILITIES:

19895 - Serviceable.

The kitchen surfaces and primary components in this brief test appeared to be in serviceable condition.

Serviceable: However the cabinet finish has deteriorated at the sink area.

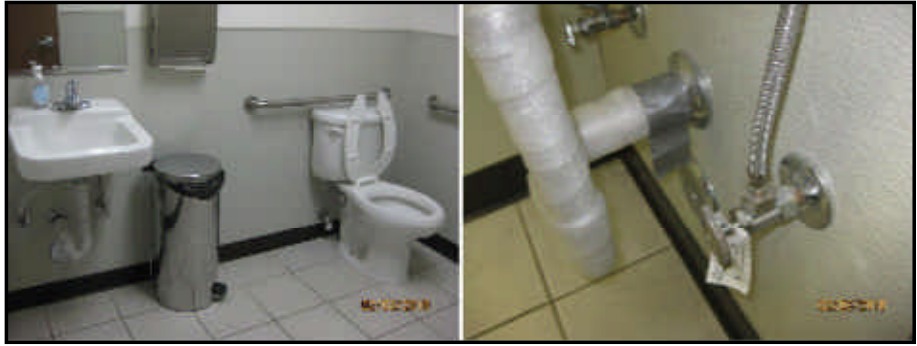
199895 - Mens Restroom

Serviceable overall. The fixtures were operated briefly and all operated in a serviceable manner.

Needs Attention: The sink is loose.

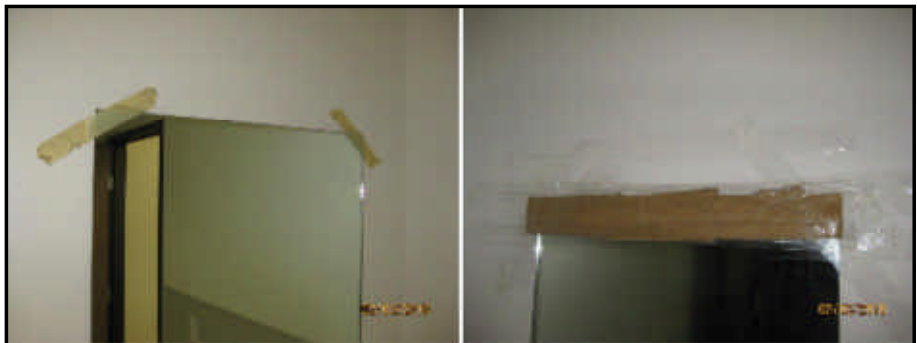
The interior surfaces, such as the walls, ceiling and such were found to be serviceable.

It was noted that all of the bathroom mirrors in this side were taped to the walls.
