# RISK Assessment® Report

**Pomona, CA 91767**

# RISK ASSESSMENT<sup>®</sup>

This is an assessment of the five major systems - Plumbing, Electrical, Heating and Air Conditioning, Structure and Roofing along with an assessment of any other current deferred maintenance issues for the site.

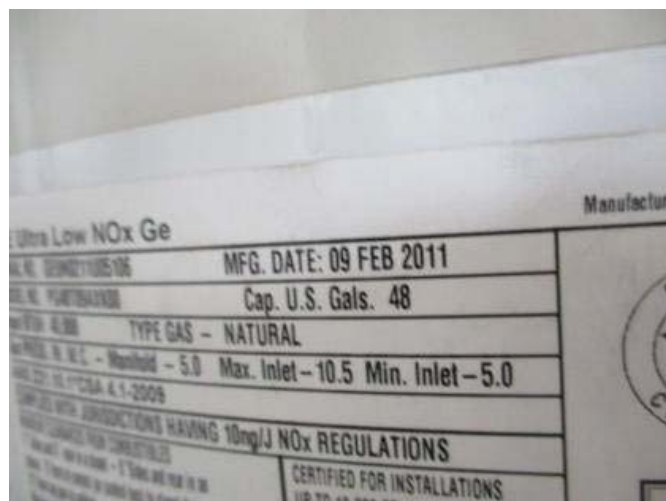
**The temperature pressure relief valve does not have a correctly installed drain line to take the water away to a safe location.**

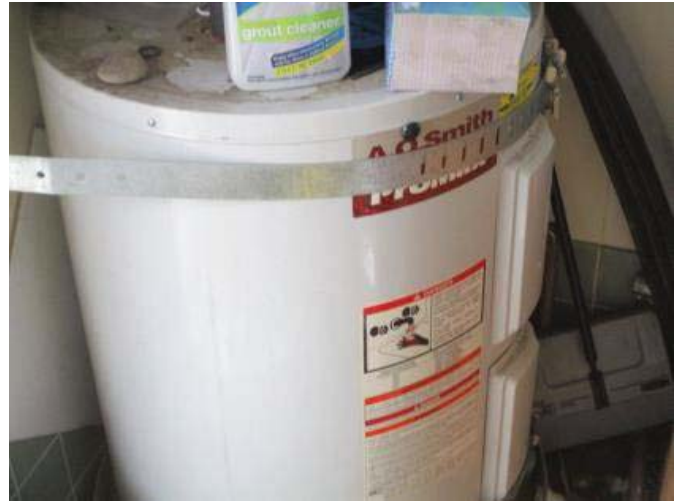
**The temperature  
pressure relief valve  
does not have a  
correctly installed  
drain line to take the  
water away to a safe  
location.**

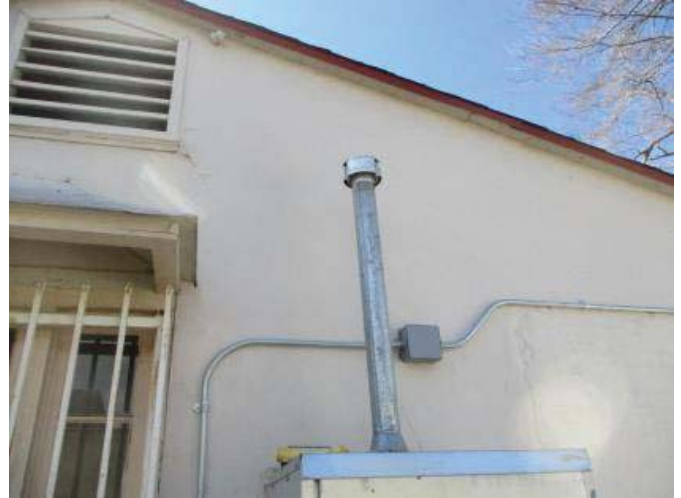
**The vent (flue) is too short. It should extend to above the roof line for proper & safe operation.**

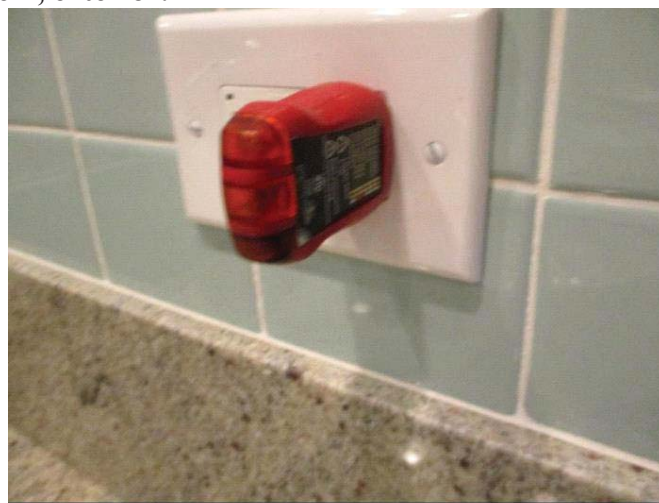
**Restroom building  
GFCI outlet is dead in  
women's restroom for  
an unknown reason.**

**dead outlet restroom**

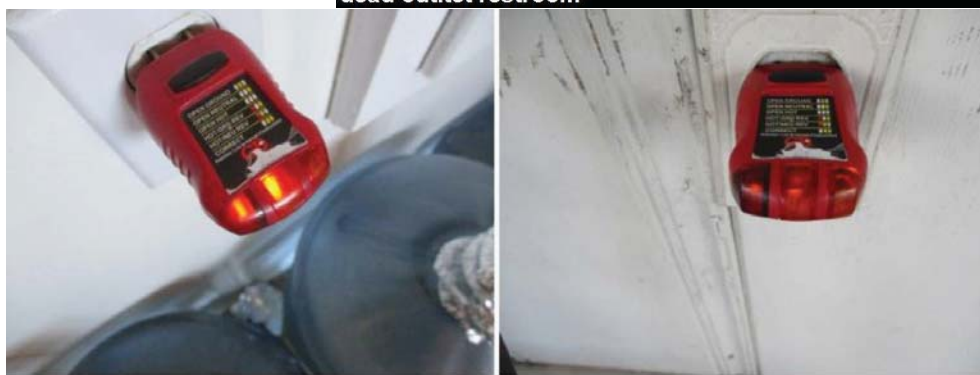
**outlets reversed wired**

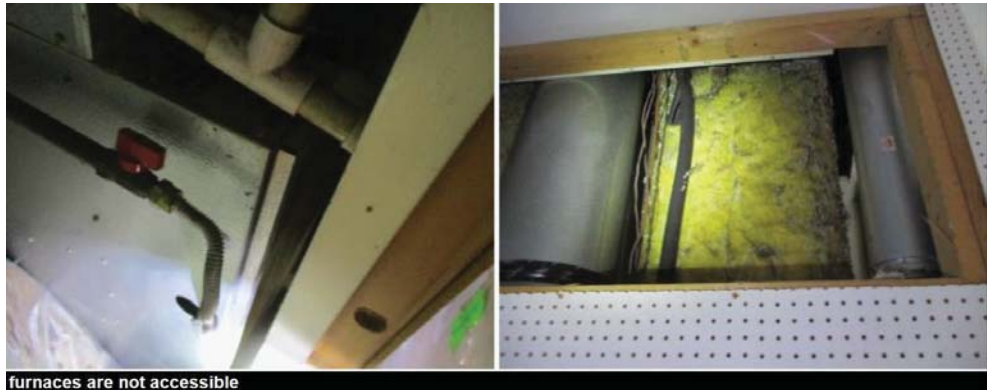
**Furnaces are blocked with storage and are not approachable.**

**Wall or partition in front of furnaces blocks access to their front covers which are removable for service men.**

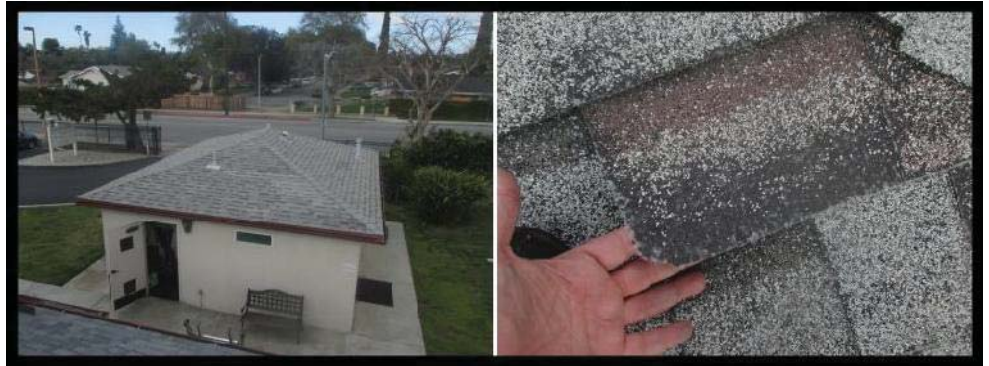
**On the composition roof over the bathroom building, the shingles are older, deteriorating and losing their surface granules. It is nearing the time to replace this roof.**

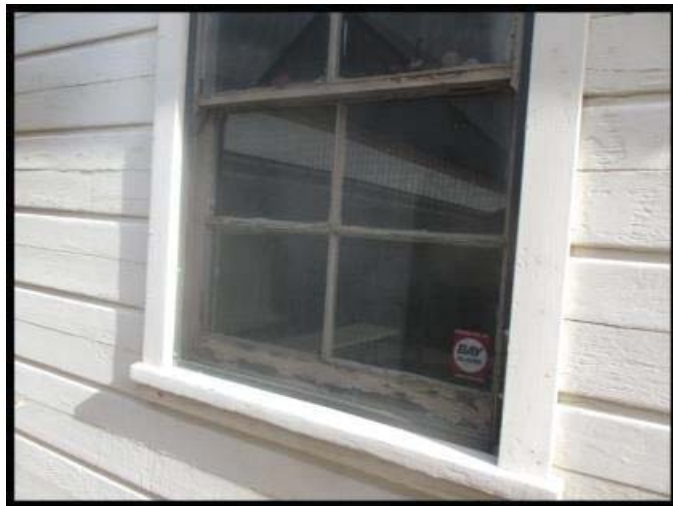
**The windows are aged wooden windows. They have areas that are pulling apart at the seams and showing some areas of excessive deterioration. Some are at the end of their life and replacement is advised at this time.**

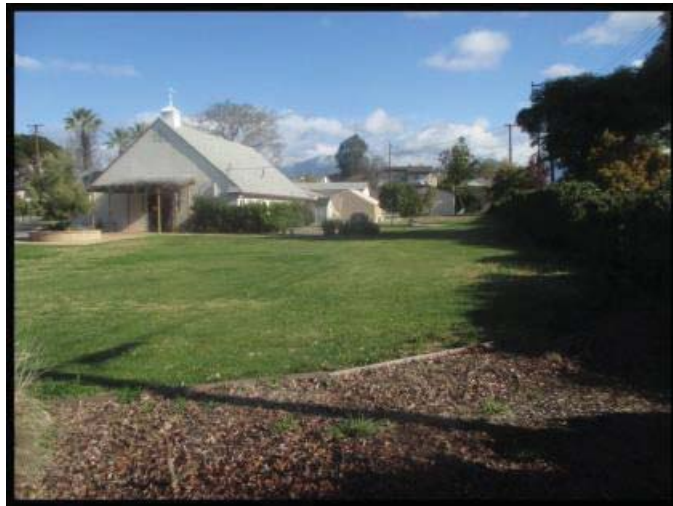
## **GROUNDS OVERVIEW:**

Overall the grounds are generally serviceable, however there are some areas in need of repairs or maintenance at this time.

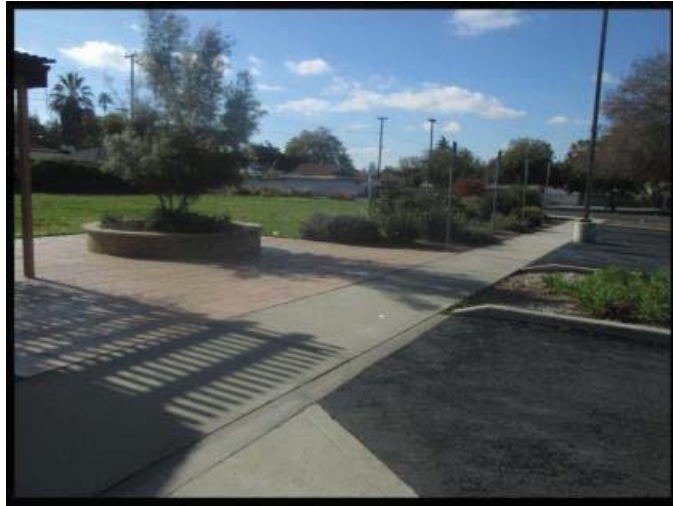
## **WALKWAYS:**

Serviceable.

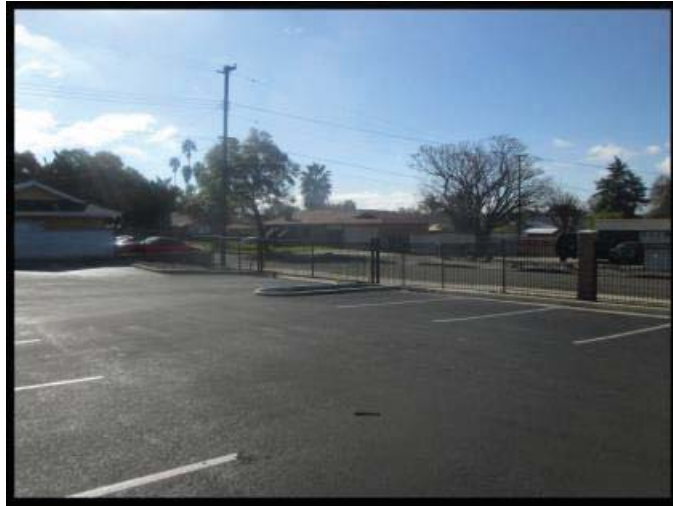
## **PROPERTY WALLS, FENCES & GATES:**

Serviceable.

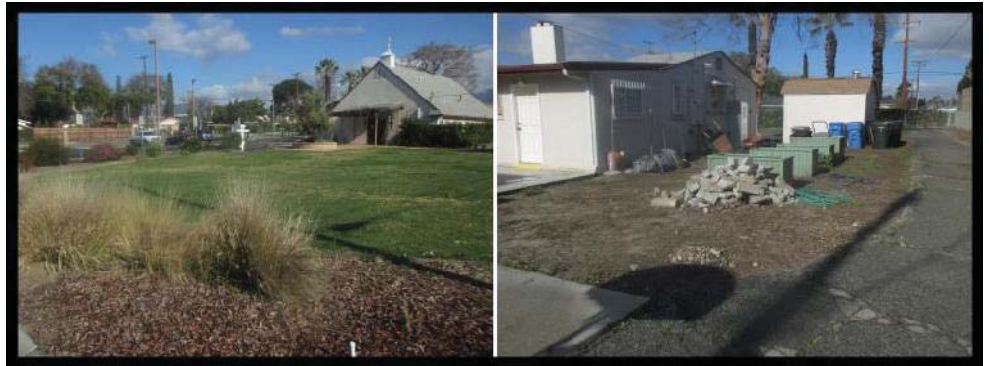
## **LANDSCAPING:**

The grounds on the property need minor maintenance in some areas.

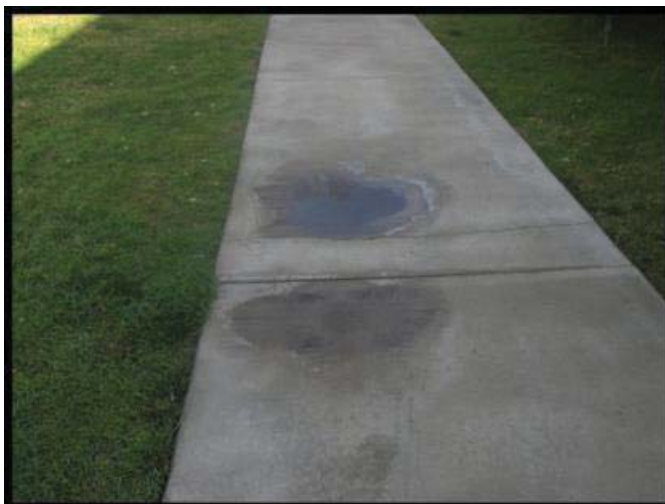
#### DRAINAGE CONDITION:

The site is a relatively flat site, it is expected that there will be some areas where water will pool during rainy periods such as in the parking areas and walkways.

Determining the adequacy of the grounds to shed water and prevent moisture intrusion into the structure is beyond the scope of the inspection. It is advised to obtain the history of any drainage problems and monitor the site regarding water run-off and drainage in general.

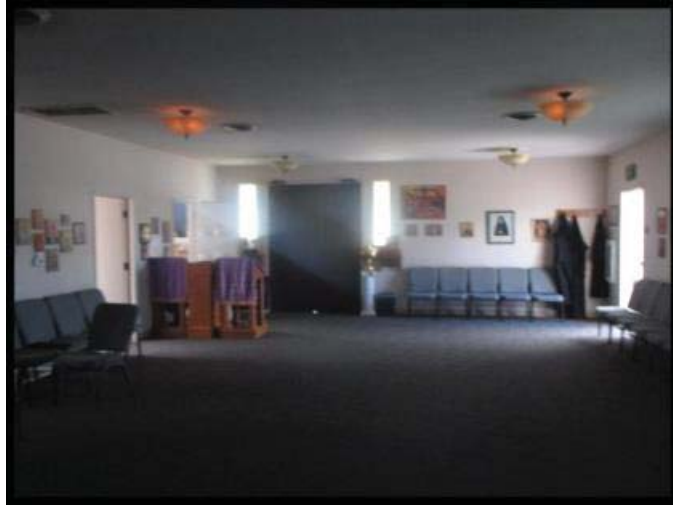
## **INTERIOR AREAS:**

Finishes, surfaces and fixtures of the interiors were found to be generally serviceable.

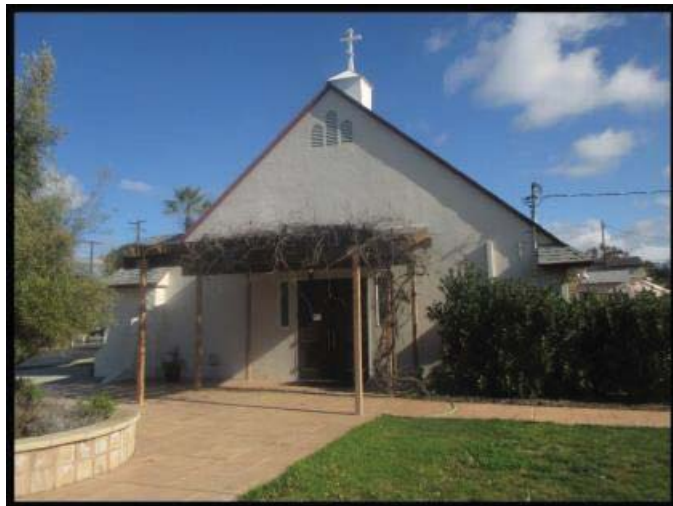
ENTRY:

Serviceable overall.

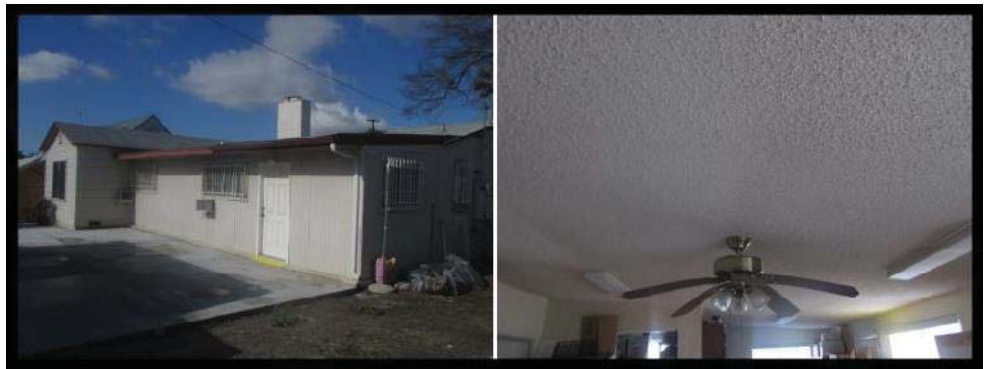
INTERIOR AREAS:

**The ceiling has a texture material that may contain asbestos.**

**There are areas of moisture stains and/or damage on the ceiling.**

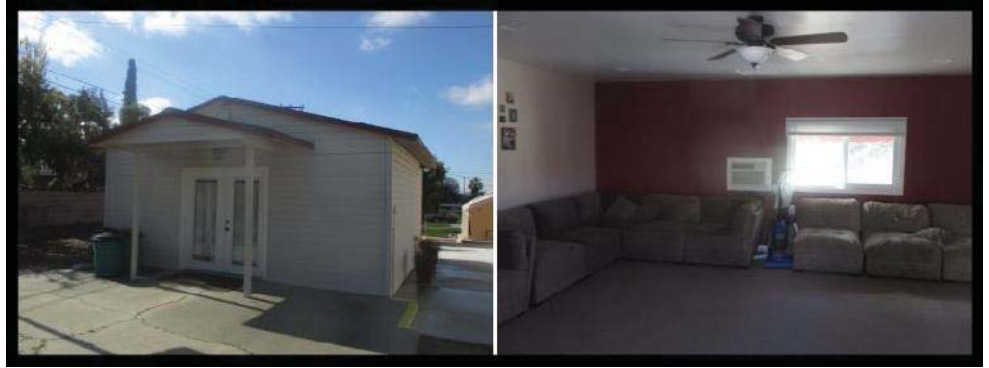
OFFICE AREAS:

Serviceable overall.

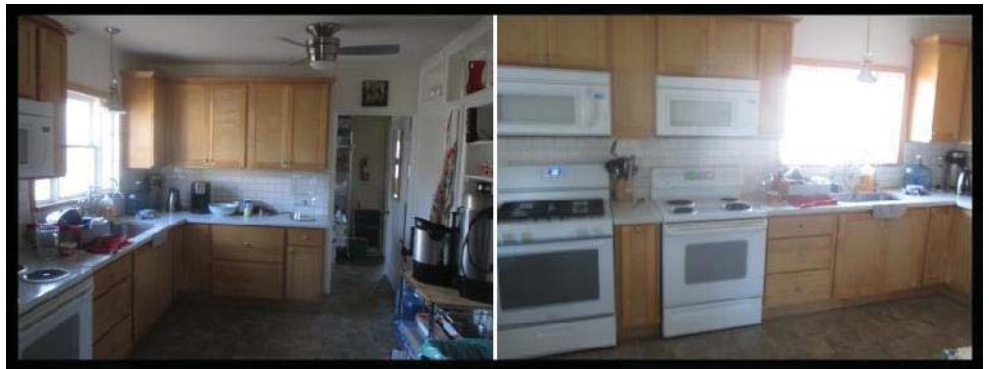
KITCHEN FACILITIES:

Serviceable.

Some wear was noted.

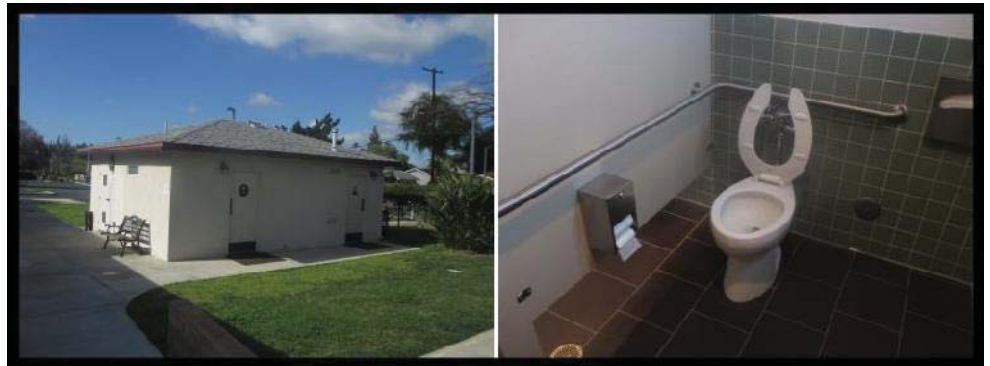
INTERIORS:

Though outside the scope of a general visual inspection the bathrooms appear to be up to current ADA requirements. This is mentioned as a courtesy and exact details and measurements were not taken.

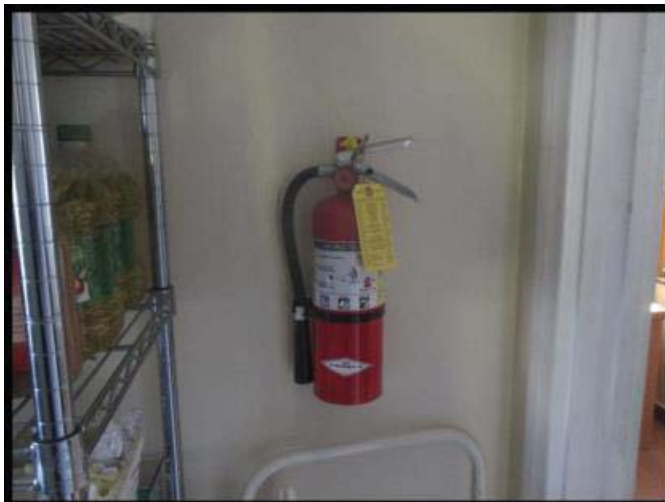
#### FIRE SAFETY COMMENTS:

**This type of building site is required to have certain fire safety items. These are items such as exit signs and fire extinguishers. It is advised to check with the local Fire Marshal to determine if this building meets current fire safety regulations.**
