RISK Assessment® Report

RISK ASSESSMENT®

Commercial Real Estate Inspectors

This is an assessment of the five major systems - Plumbing, Electrical, Heating and Air Conditioning, Structure and Roofing along with an assessment of any other current deferred maintenance issues for the site.

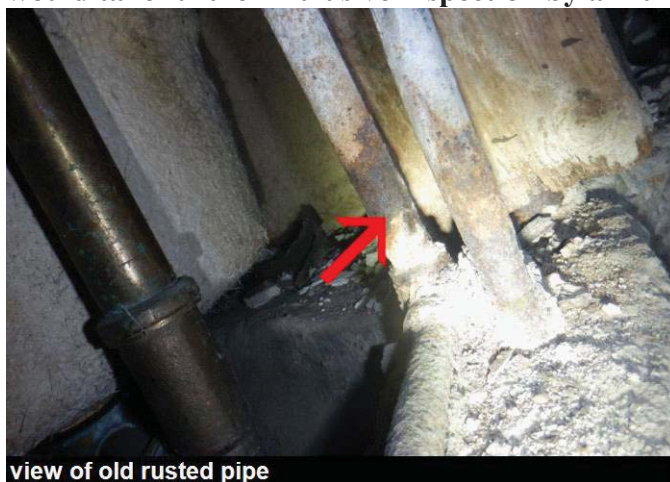
Needs Attention:

While copper pipe is visible in most areas, old rusted galvanized pipe was seen in wall cavity at the back which may not be active ,however it is not a certainty that all old iron pipe has been replaced with copper. It would take further intrusive inspection by a Plumber to determine this.

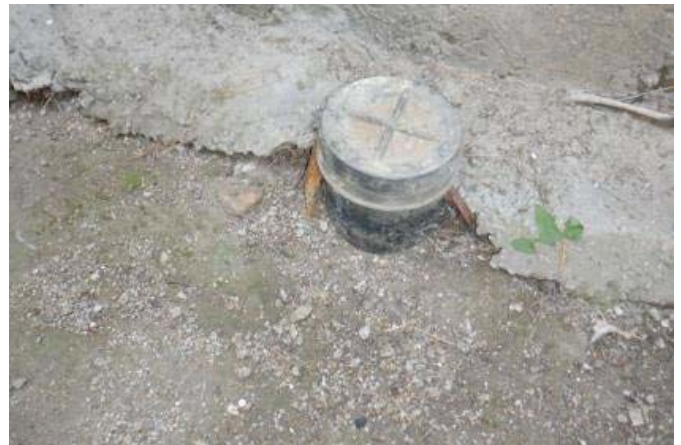
MAIN SEWER CLEANOUT:

Back of building there are several clean-outs.

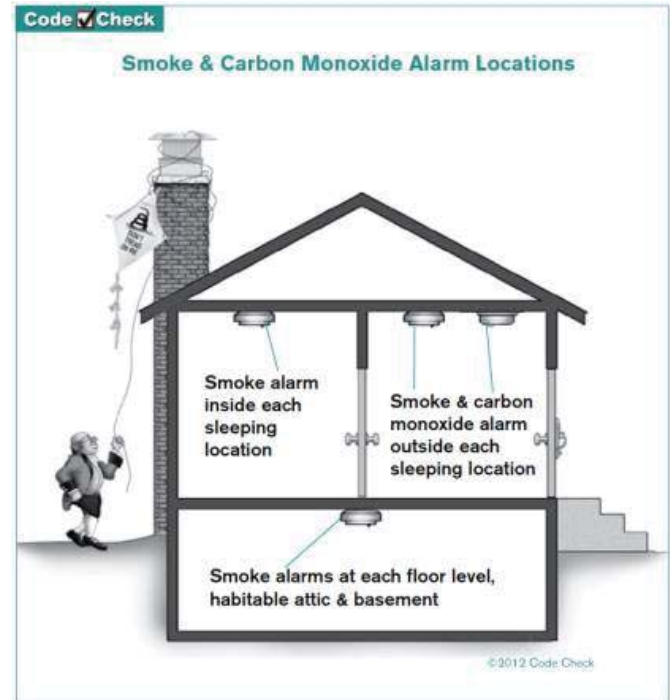
There are missing smoke detectors in some areas.

Smoke detectors are needed to comply with local safety regulations and escrow instructions. Most local cities require detectors in each sleeping area and the adjoining living area, within twelve feet of the door of the sleeping areas. It is advised to check with the local municipality to determine their requirements. See illustration.

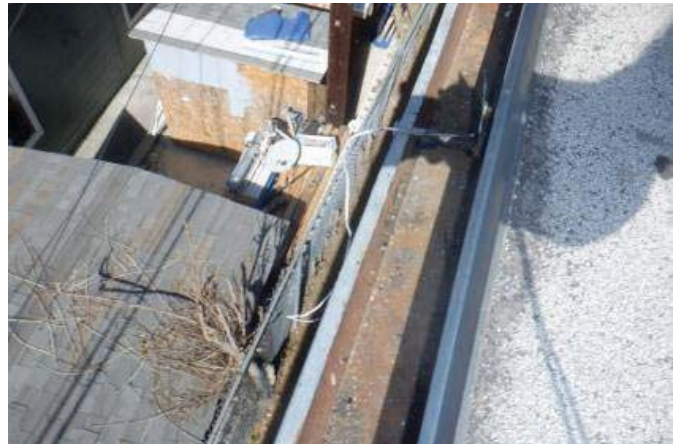
There are areas of the roof where water is ponding and not flowing freely off the roof, as evidenced by discoloration of the roofing surfaces or accumulations of dirt and debris.

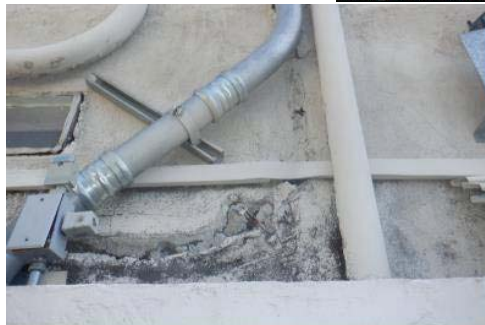
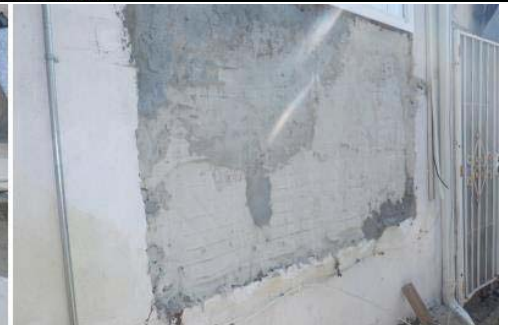
bulge noted back wall

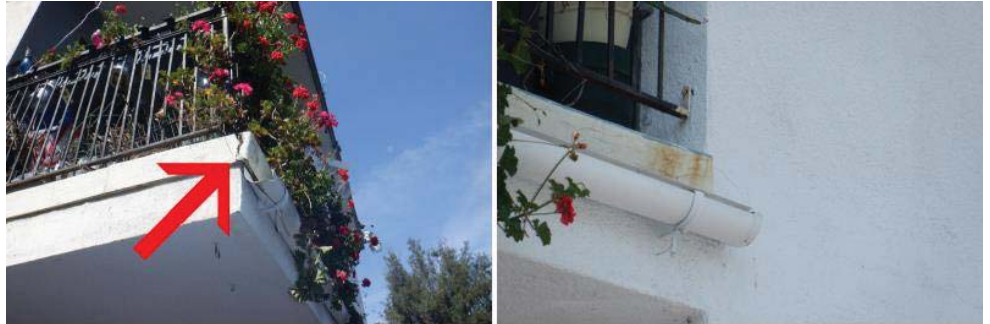
Some stains and damages are noted.

A proper Deck and Balcony inspection is advised.

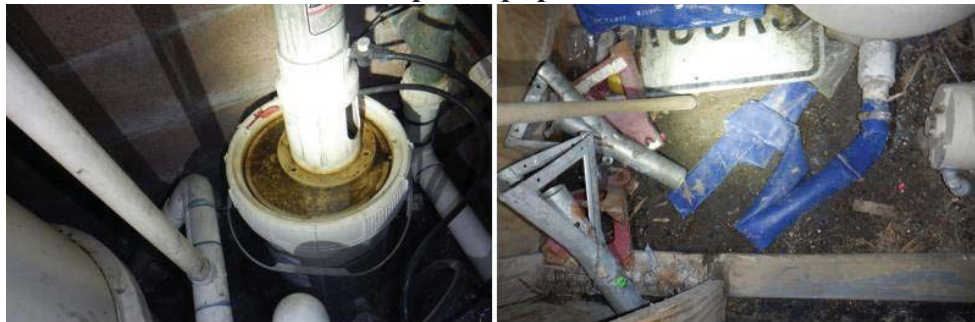
Needs Attention:

There is water on the floor in pool equipment area.

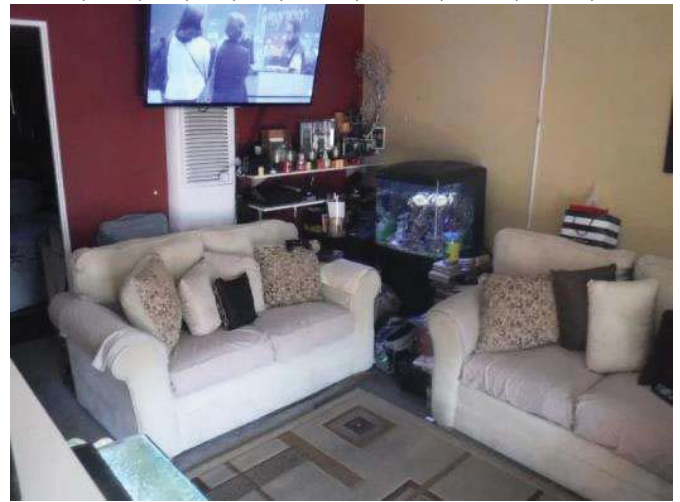
The interior living areas are aged and worn but remain serviceable overall.

Older units: 6, 2, 8, 9, 3, 1, 5, 14, 4, 204, 209, 211, 214, 215, 207, 210,

Needs Attention:

There are areas of moisture stains and/or damage on the ceiling in unit 215, 04,

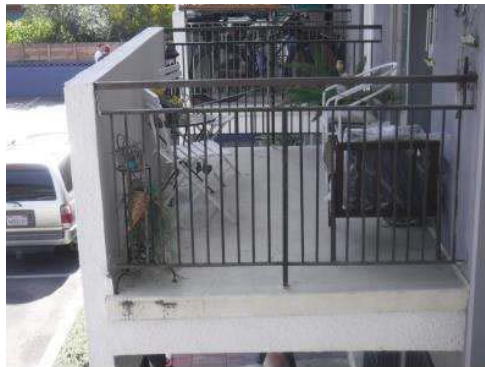
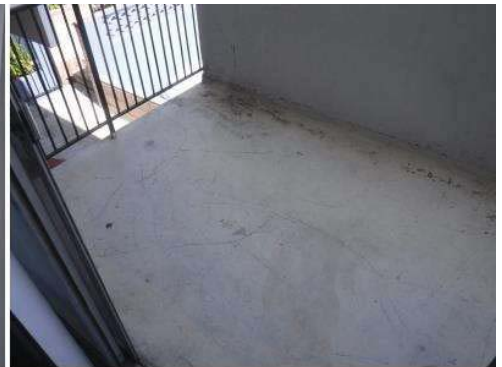
BALCONY / PATIO

NEEDS ATTENTION:

The 2nd floor units deck surfaces have areas of wear and/or damage.

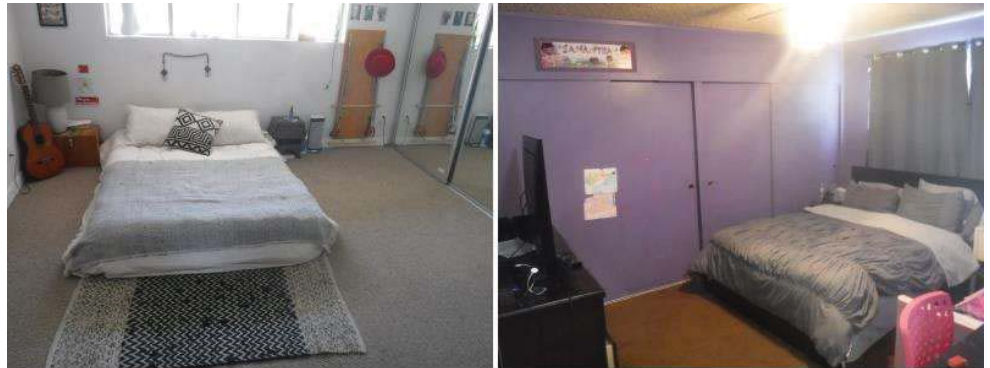
BEDROOMS:

As above there are newer units and older units. The level of wear is high in the older units but not excessively except as noted below.

**Needs Attention:
Unit # 8**

Removed / not working Smoke and CO-2 detectors were found in unit: 8, 208,

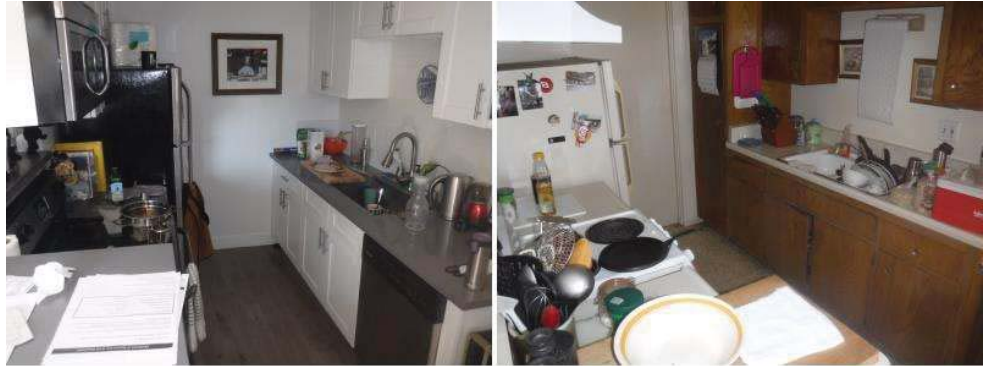
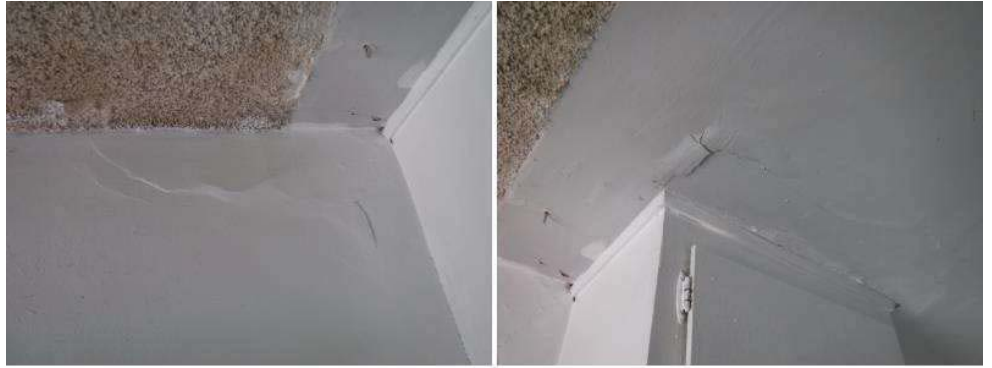
KITCHENS:

As above there are newer units and older units. The level of wear is high in the older units but not excessively except as noted below.

Needs Attention:

There are areas of moisture stains and/or damage on the ceiling in unit #01

This kitchen is showing excessive wear in unit 210

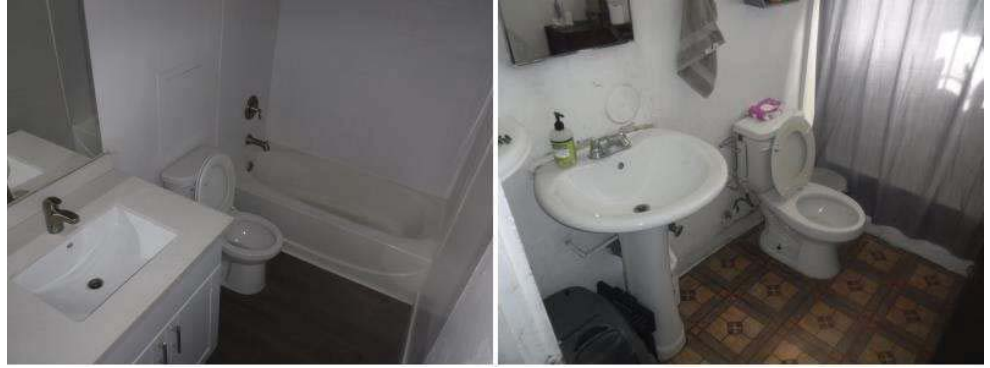
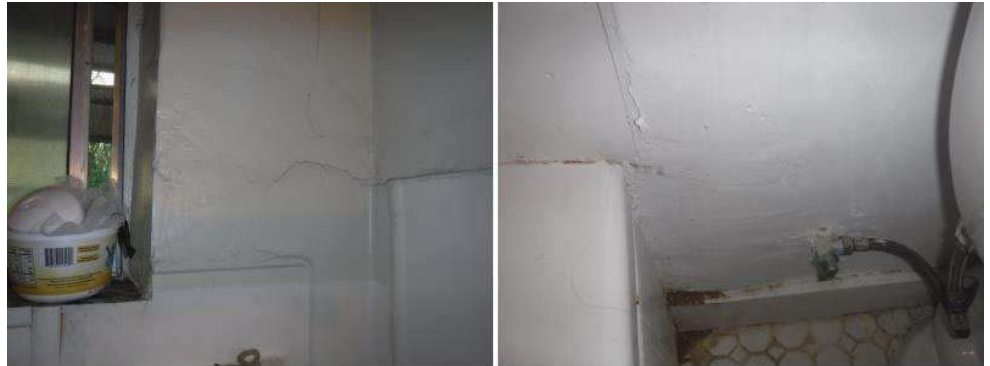
BATHROOMS:

As above there are newer units and older units. The level of wear is high in the older units but not excessively except as noted below.

(Note: Not all or the renovated units had new tubs installed. However they were still in good condition)

Needs Attention:

Moisture damage / rough patching to the walls in unit # 8, 1, 12

The sink faucet leaks at the base or handles during use in unit 207.

The surface of the tub is worn/damaged in unit 204, 211, 03

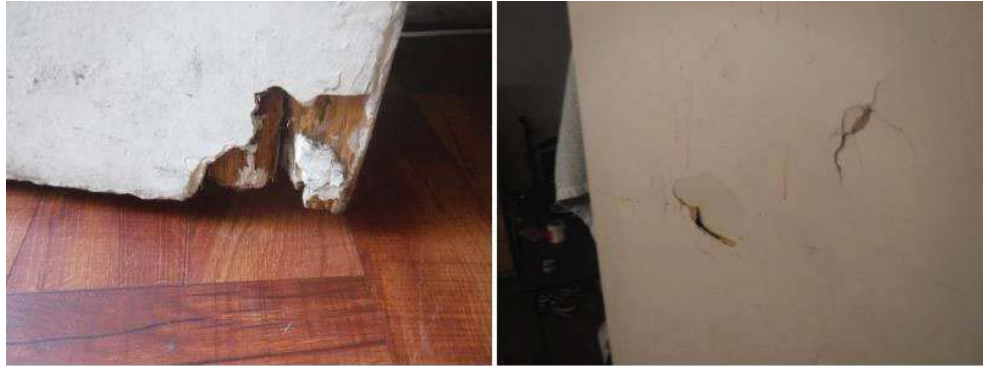
INTERIOR DOORS:

Needs Attention:

There is damage to the surface of the exterior and interior doors in units: # 01, 06.

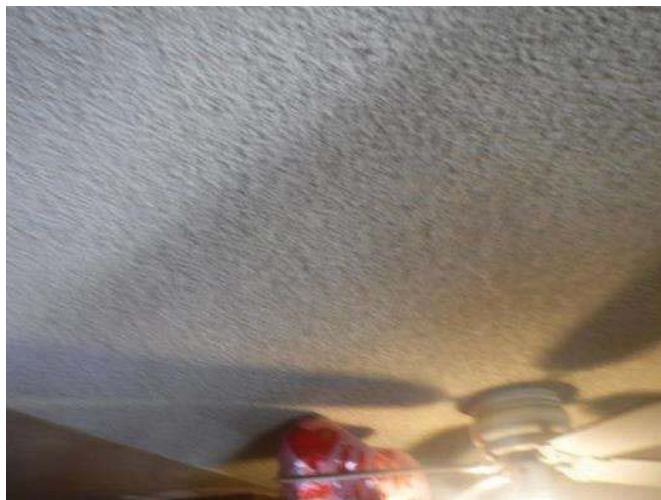
The ceilings are spray texture material. If the original construction is before 1978 it is possible that this spray contains asbestos materials.

The ceilings have typical stress cracks in various areas. in most of the older units such as 214, 215.

But also in some of the newer renovated units such as # 12, 203,

The only way to determine if this is the case is to have a sample taken and examined by a qualified professional lab.
