# RISK Assessment® Report

**Moreno Valley, CA 92553**

# RISK ASSESSMENT<sup>®</sup>

## Commercial Real Estate Inspectors

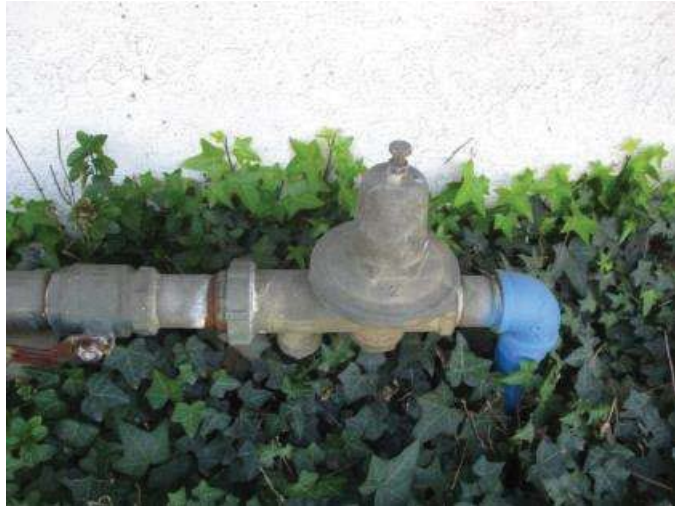
There was a pressure regulator observed on the water supply system. It is not known how well or if it is functioning, as this is beyond the scope of a general visual inspection.

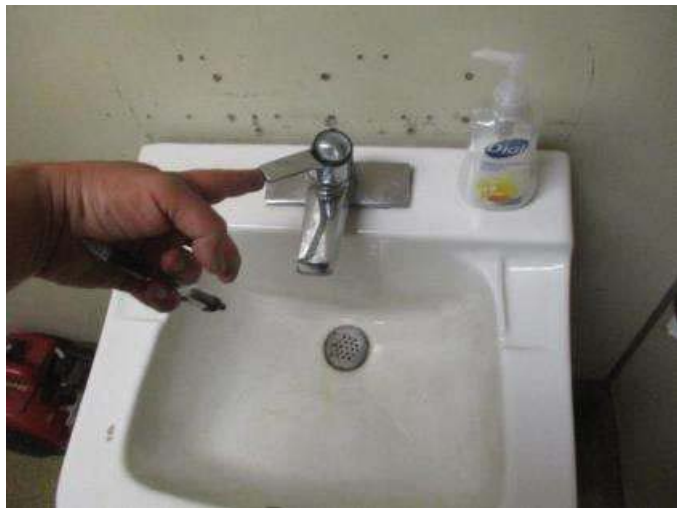
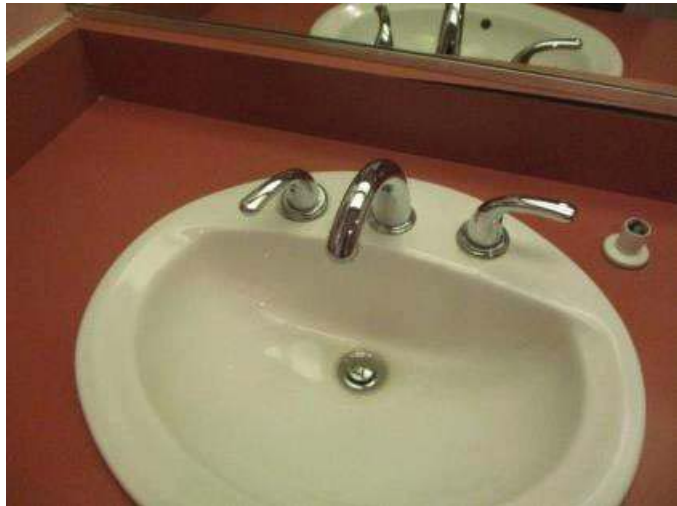
**Needs Attention:**

**In the auto shops there was no Hot Water Provided to the bathroom sinks and a sink in 24811 Unit A (Woman's restroom).**

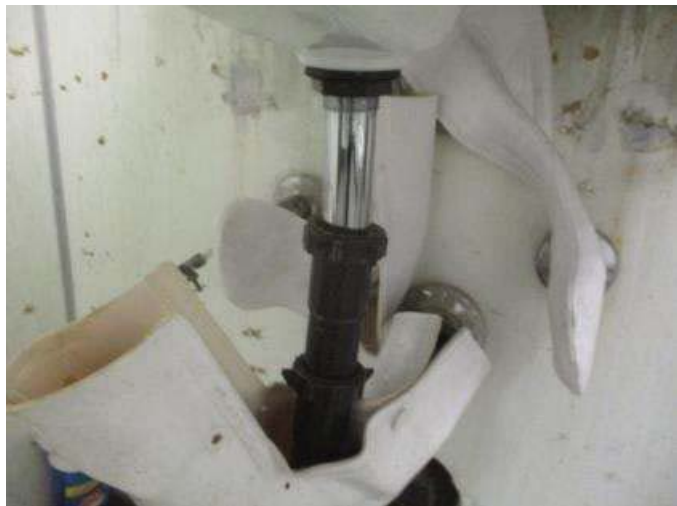
The piping that takes the waste water to the sewer system is a combination of different materials where viewed.

**The interior of the waste lines are not visible. A detailed investigation can only be performed by the use of an internal camera by a specialty contractor. Such an inspection is recommended at this time as only by this kind of inspection can the actual condition of the waste lines be determined.**

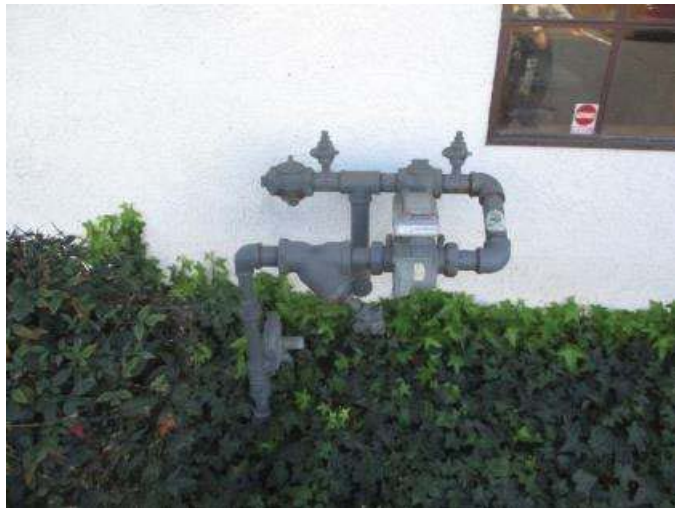
**There is no automatic seismic gas shut-off valve on the main gas line. It is advised to have this installed for health and safety purposes.**

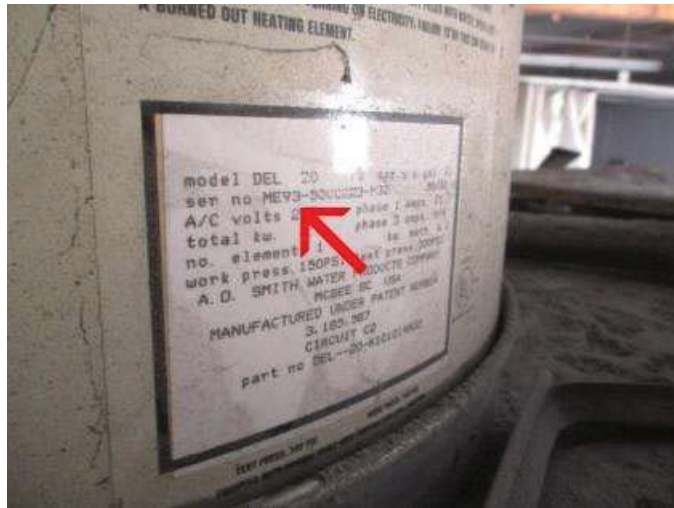
27 years old (1993). Water heaters have an expected life of 8 - 12 years.

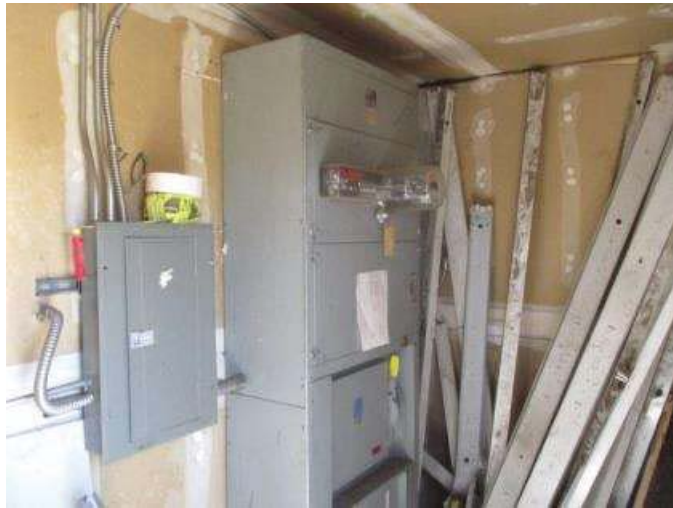
The system is in need of some repairs. These repairs do not appear to be overall significant but are recommended for health and safety.

**It is advisable to have an electrician examine the system and make all needed repairs to ensure a properly installed and correctly operating electrical system. It is expected that when the electrical specialist checks out the system they will find more problems as this is a general inspection and not designed to list every fault but to isolate areas in need of further detailed inspections.**

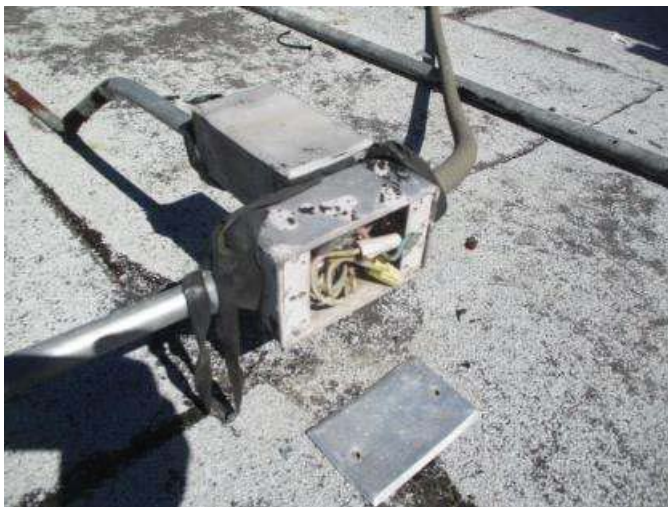
**There is exposed wiring in areas. It may or may not be part of the system anymore and its function is unknown at this time. It should be removed or re-installed properly and not left in this condition.**

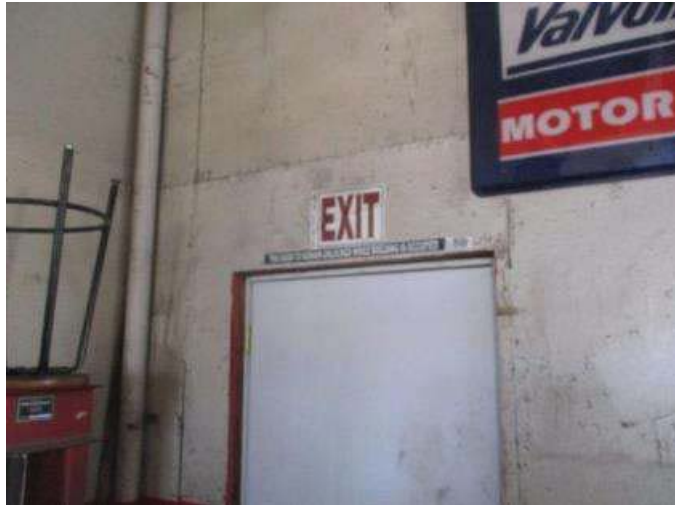
**Although there are signs present, they are not of the type that are required by current standards.**

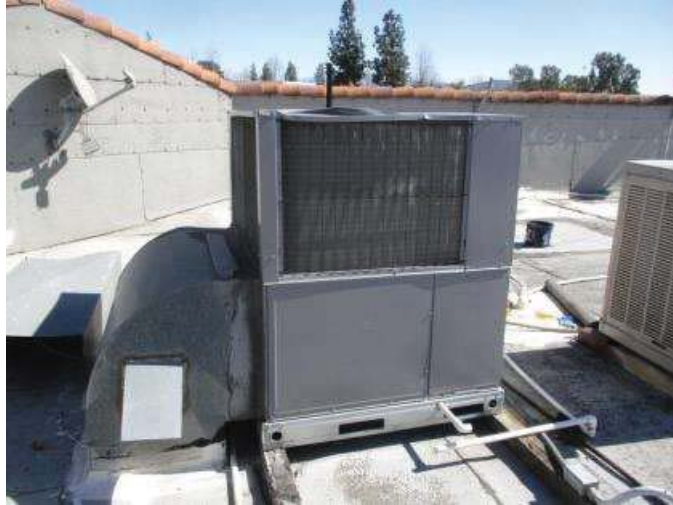
**Needs Attention:**

**The units are sitting on wooden blocks. This is not a reliable method regarding moisture intrusion. It is advised to have platforms with metal caps installed to help ensure a leak free condition.**

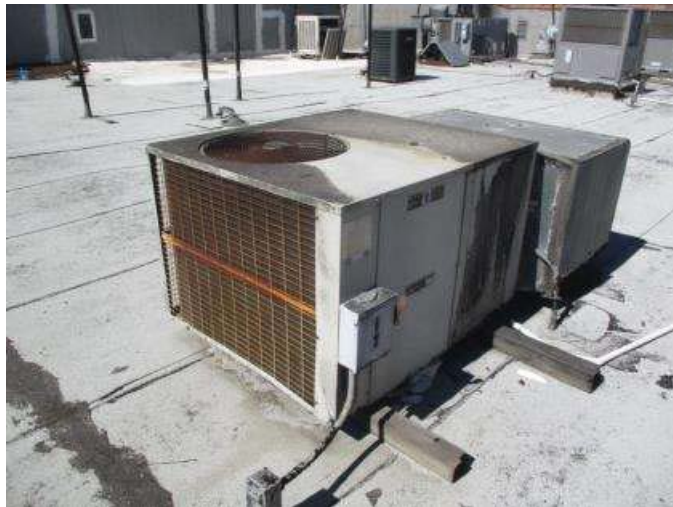
The heating and cooling units are located on the roof.

**The units are sitting on wooden blocks. This is not a reliable method regarding moisture intrusion. It is advised to have platforms with metal caps installed to help ensure a leak free condition.**

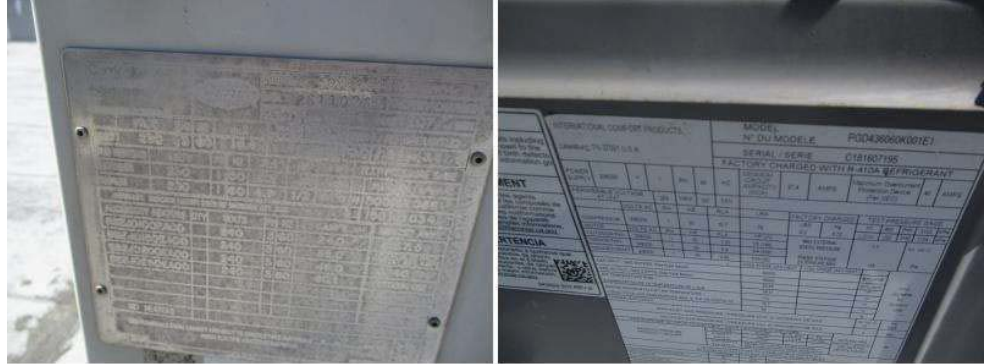
24801 - The system is approx. 20 years old. (2000)

24811 - The system is approx. 7 years old. (2013)

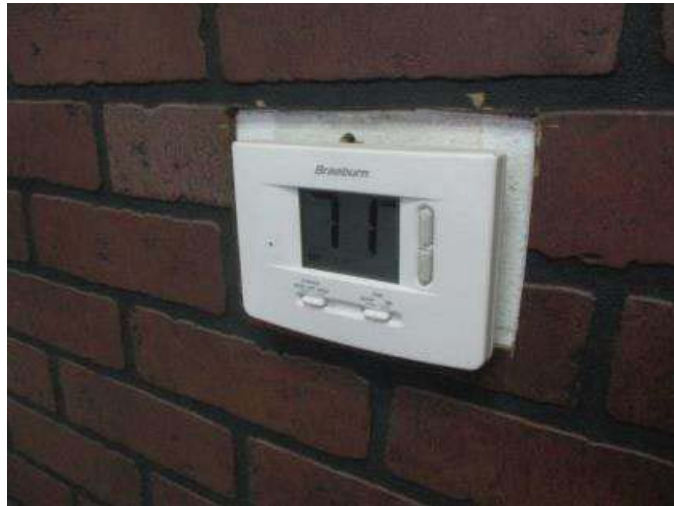
The thermostats did cause most of the units to respond when tested.

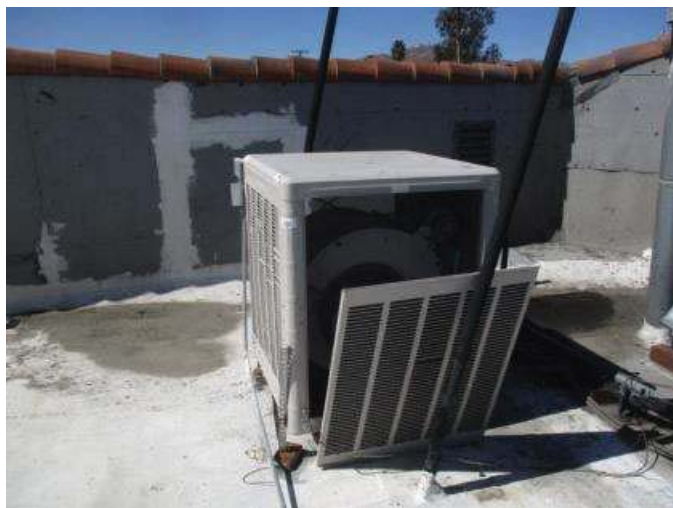
All but one unit are older and aged.

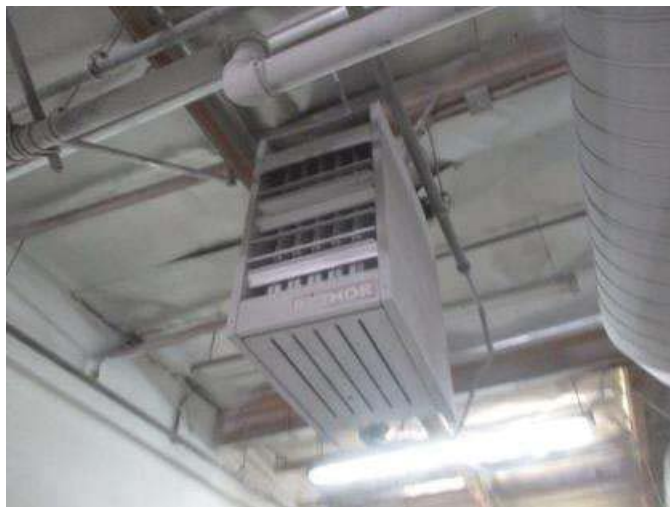
The units are open warehouse gas furnaces that are suspended from the ceiling.

It is unknown how old the unit is, but it appears older. (4 noted)

**Repairs may be possible to the system. Examination by a qualified Heating and Cooling specialist is recommended.**

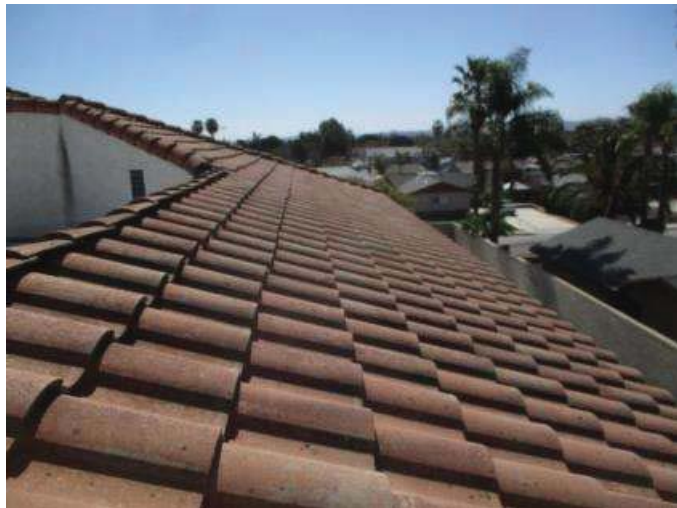
The roofing material on the sloped roof is made of concrete tile.

**On the tile roof, there are areas of cracked/damaged tiles.**

**Though full review by a qualified roofing contractor is recommended at this time, replacement of the existing roof system is advised for older portions of the roofing.**

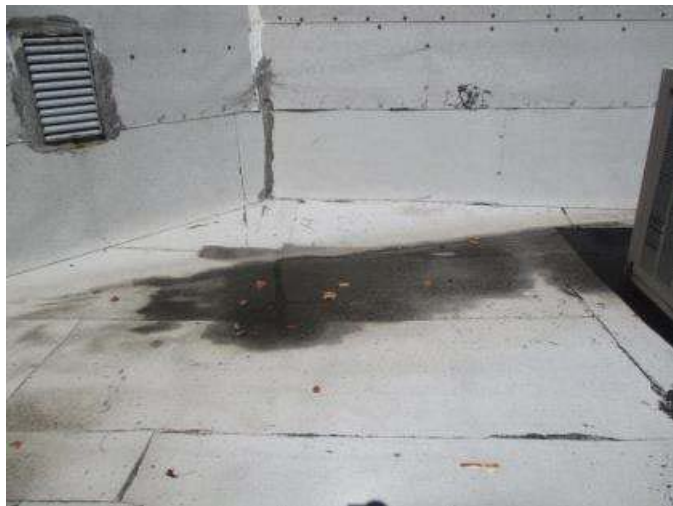
**There are areas of standing water on the roof during the inspection. Standing water will accelerate the deterioration of roofing materials affected. It is advised to eliminate these areas of ponding by improving the slope of the roof wherever needed, or to reinforce affected areas where slope improvement is impractical.**

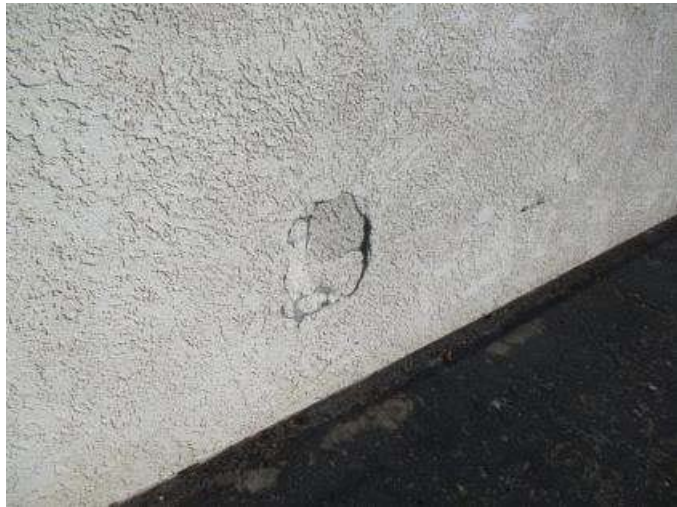
**There are areas of damage to the exterior walls.**

Repairs are needed to the exteriors, such as wood trim and stucco repairs.

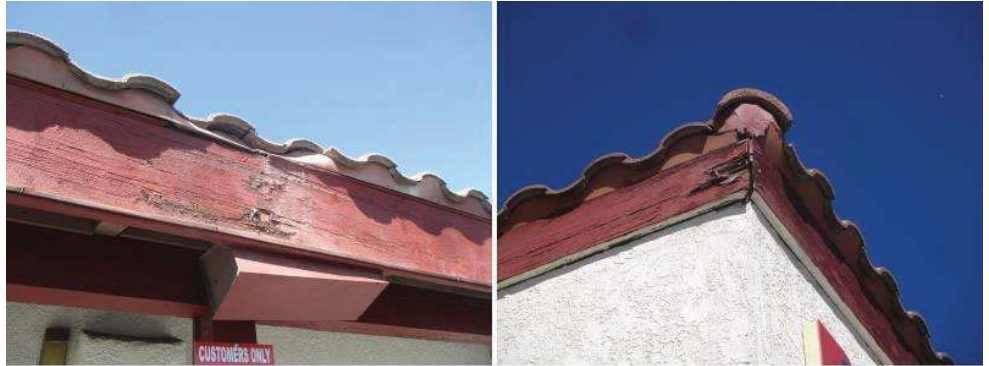
The exterior trim surfaces are wood.

**The exterior trim has areas of weathering with peeling finishes and deterioration.**

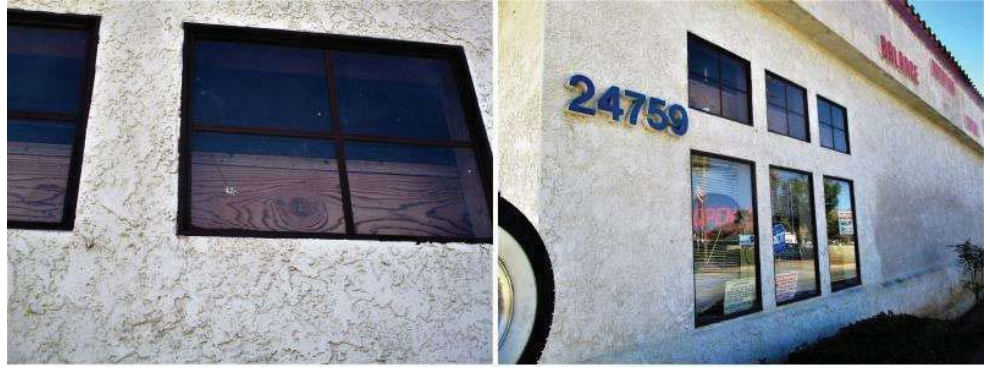
The exterior window surfaces are metal.

**There are cracked window panes.**

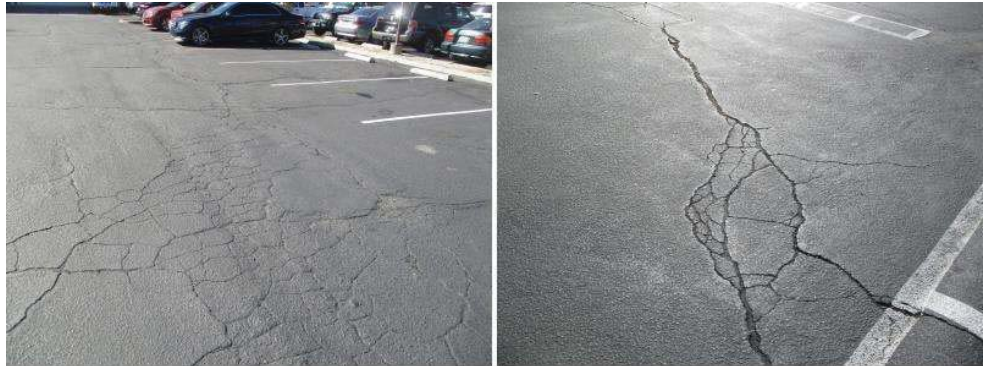
**The parking areas are worn and aged.**

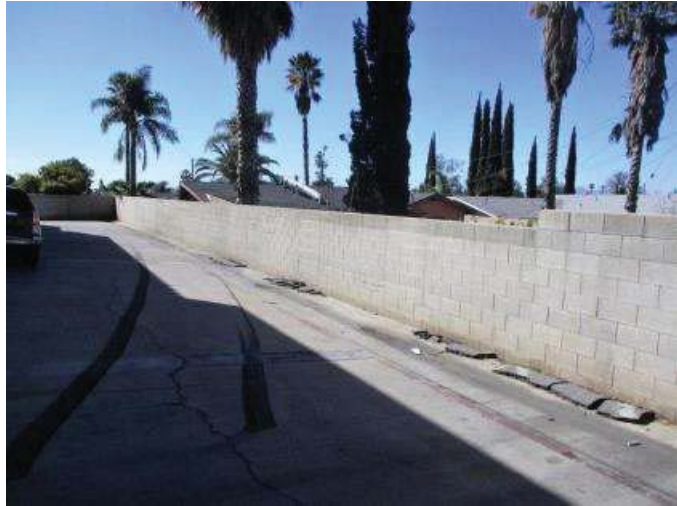
**The wood fencing/walls are generally worn.**

The Block Walls are generally serviceable.

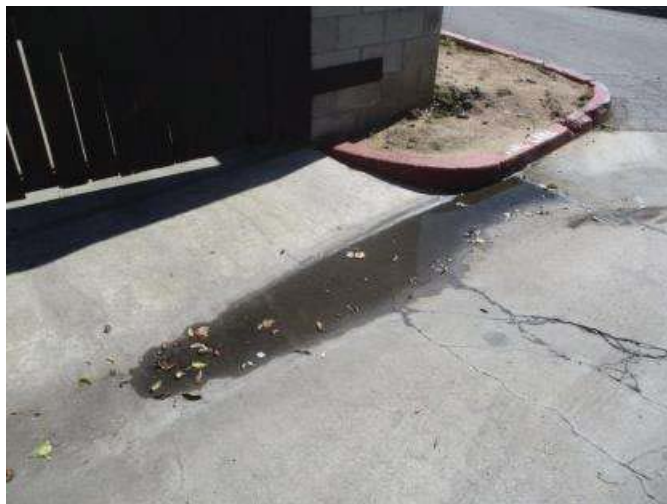
**The site is a relatively flat site, it is expected that there will be some areas where water will pool during rainy periods in the parking areas.**

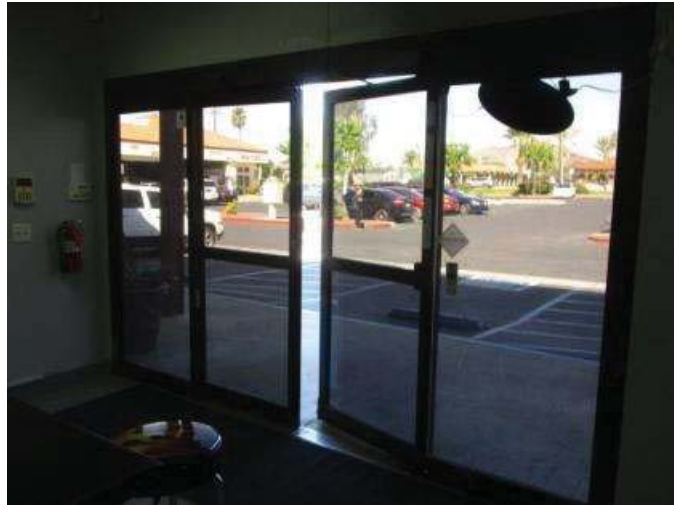
**24801 Front door works poorly.**

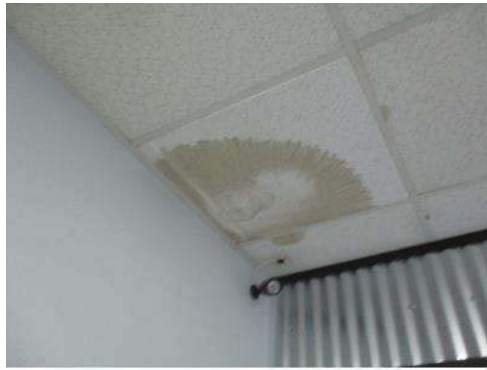
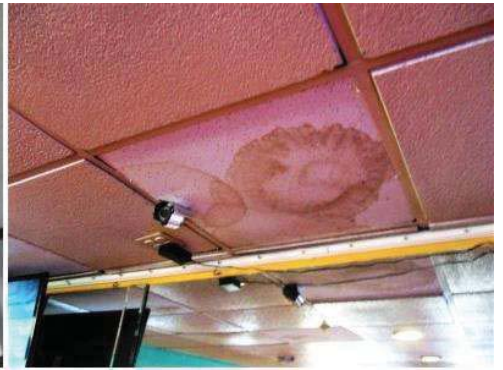
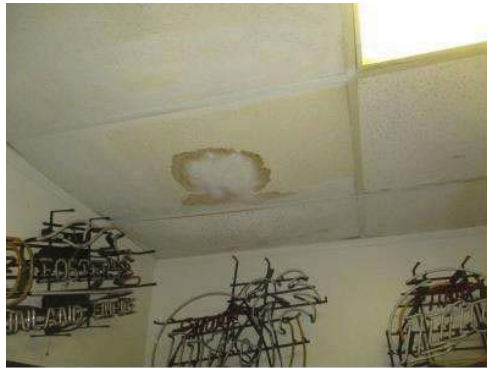
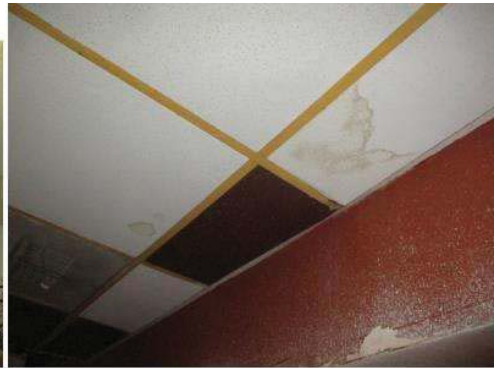
**There are areas of moisture stains and/or damage on the ceiling 24801 & 24811: A & B**

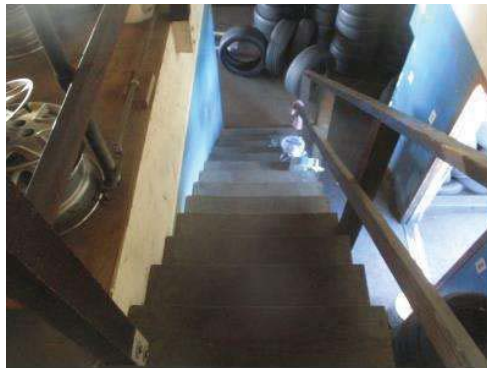
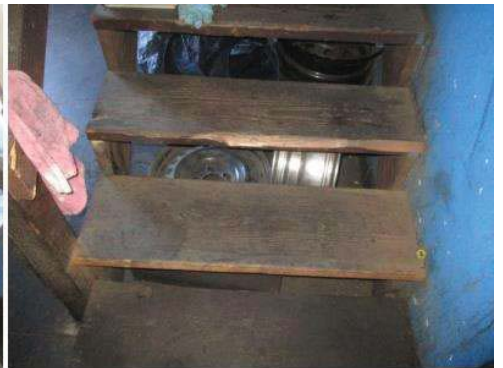
**STAIRWELLS:**

The stairwells are aged and worn for the auto shops units.

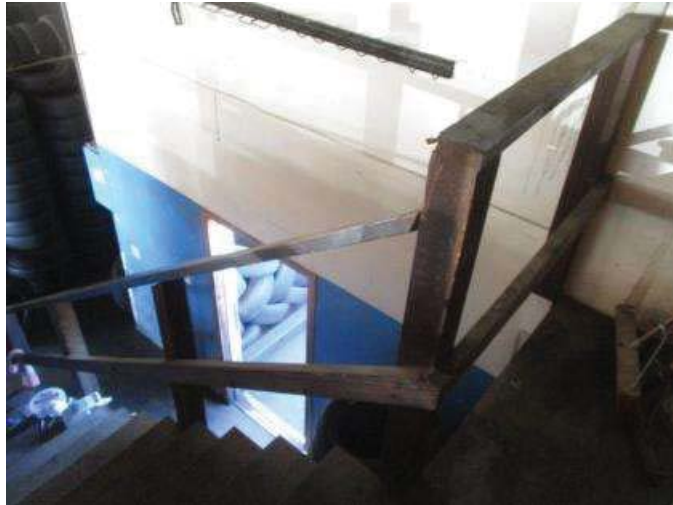
## RAILING CONDITION:

### **Needs Attention:**

**The space between the rails is greater than is currently recommended for child safety. The railings should not have any space greater than four inches in any portion of them.**

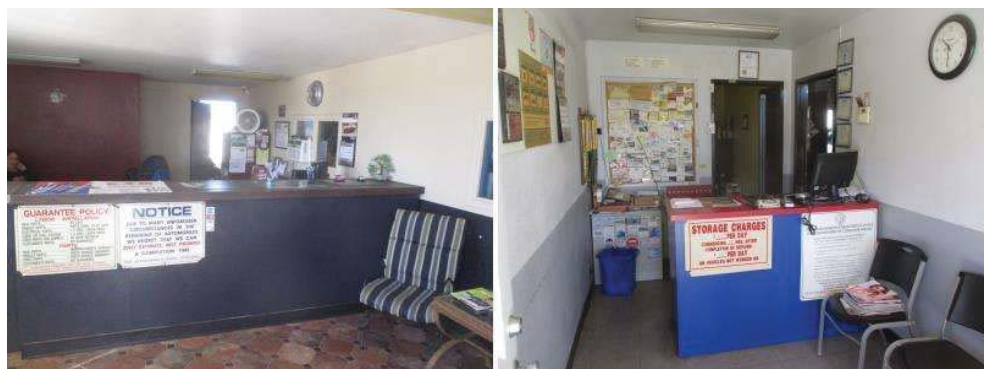
### OFFICE AREAS:

The surfaces and finishes of the office areas of the building appear generally serviceable, with typical wear to walls and flooring.

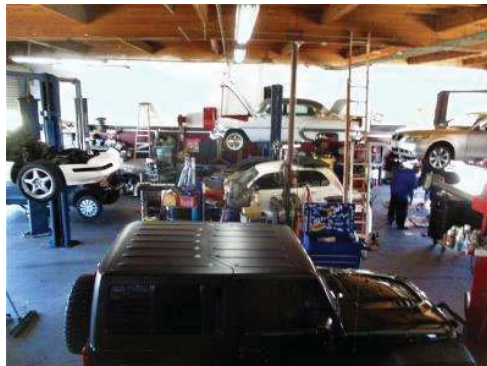
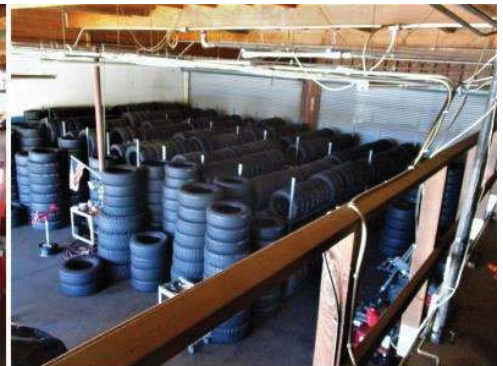
WAREHOUSE AREAS:

The warehouse / automotive service areas are generally serviceable with the typical wear and tear for this type of construction and use.

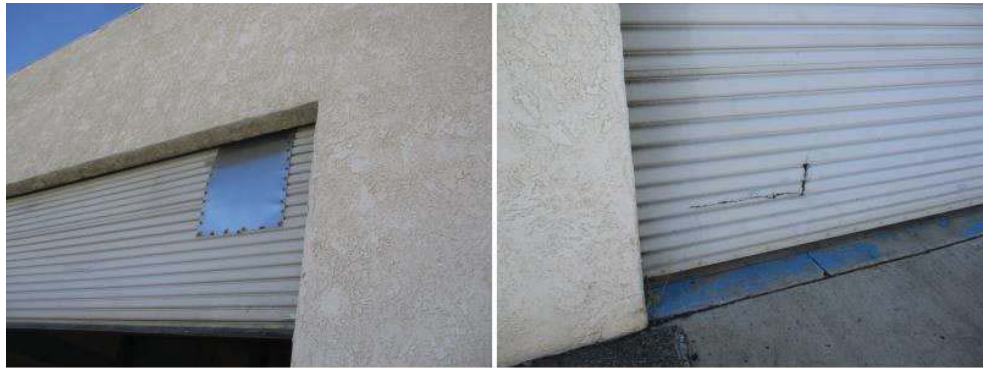
**Needs Attention:**

**There is damage to the roll up door.24759 - B, C**

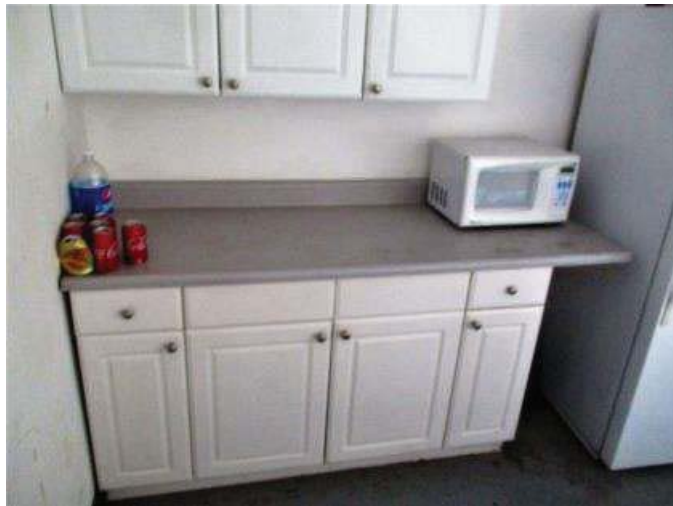
### **KITCHEN FACILITIES:**

The kitchenette area was found to be in generally serviceable condition, with typical wear to surfaces, finishes and fixtures.

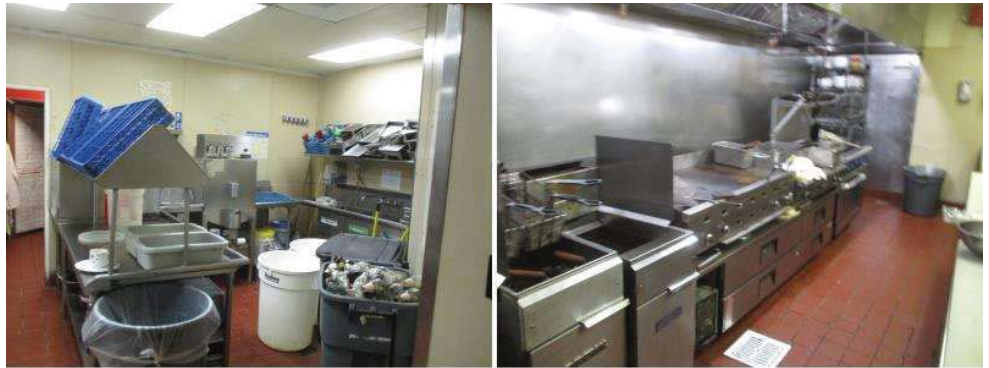
UNIT # 24811 A

This is a commercial restaurant kitchen currently in use. Appliances and components such as commercial ovens, stoves, ventilation and exhaust fans, refrigerators and freezers, sinks, waste systems and other kitchen specialty equipment fall outside the scope of a general building inspection.

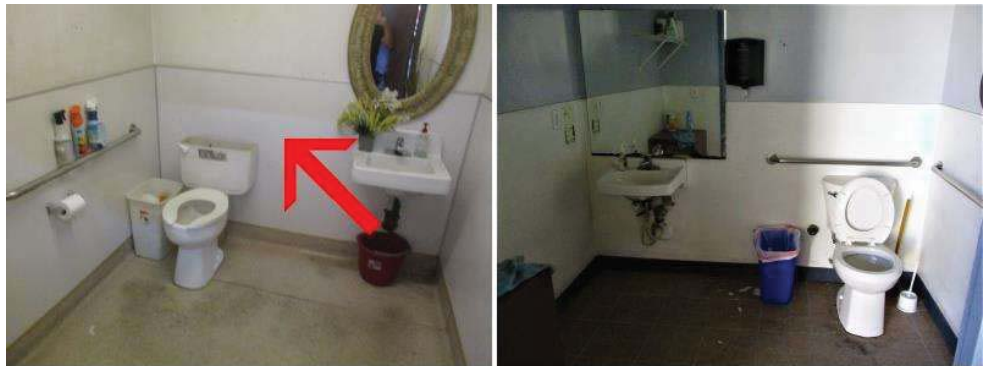
BLD # 24759

The restrooms are generally serviceable however there are areas with noticeable wear.

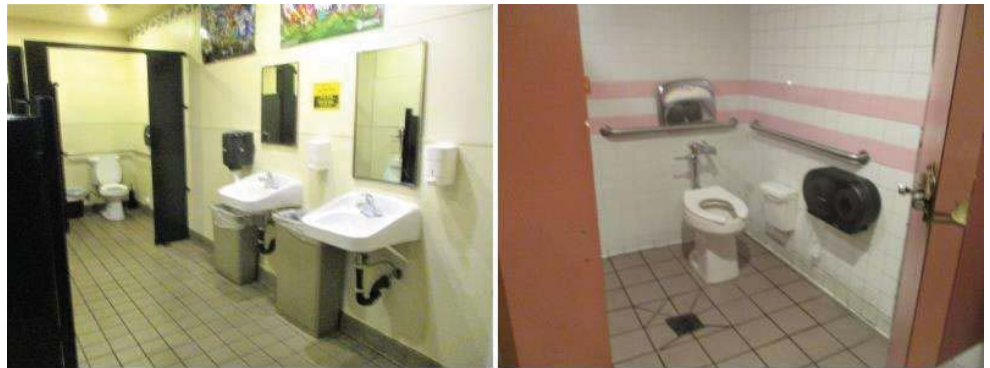
**BLD # 24801 - 11**

The interior surfaces, such as walls, ceiling and cabinets are generally serviceable, but there are typical areas of noticeable wear.

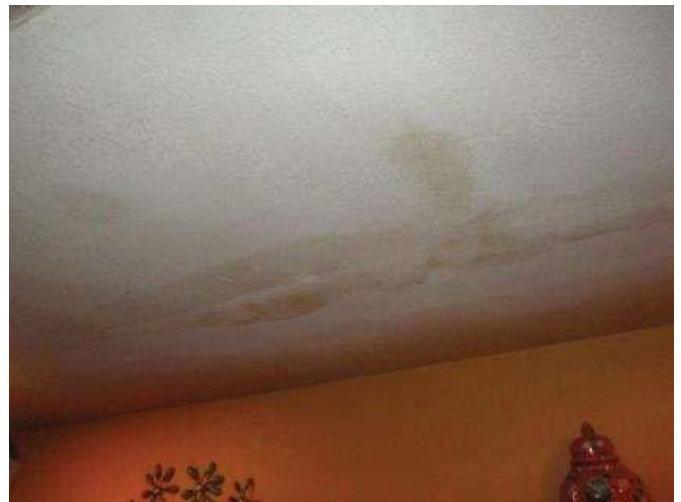
**Needs Attention:**

**There are some stained areas of the ceiling in the Commercial areas of 24801 - 11**
