RISK Assessment® Report

Venice 90291

Inspector - Mike Howson
Confidential and Proprietary

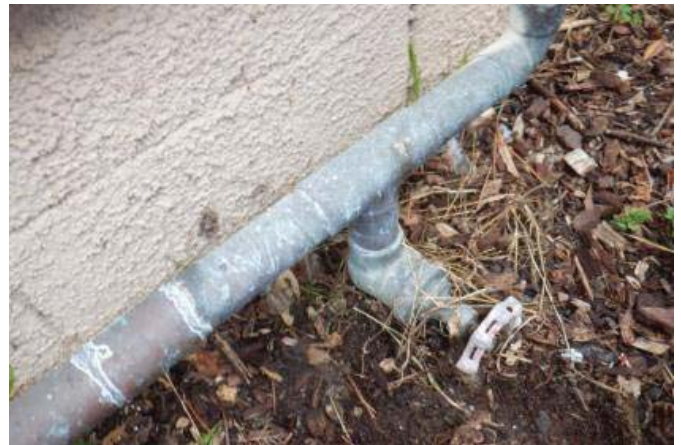
CONDITION:

Serviceable overall.

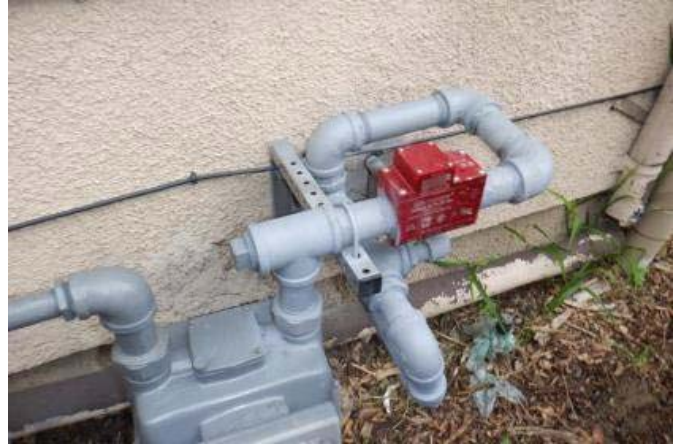
One meter is seen at the right side of the building.

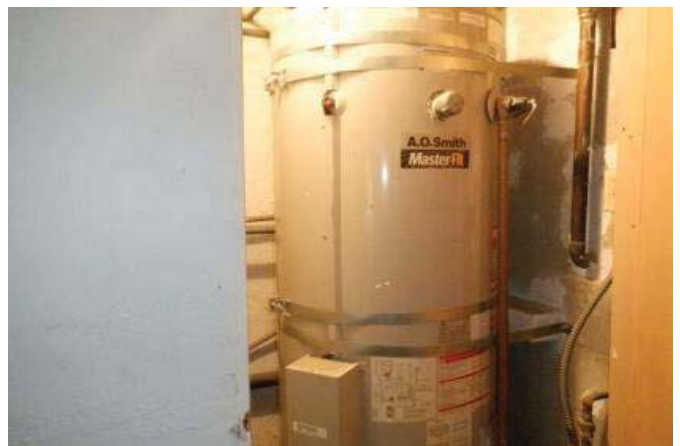
Only one water heater seen which is in the parking garage.

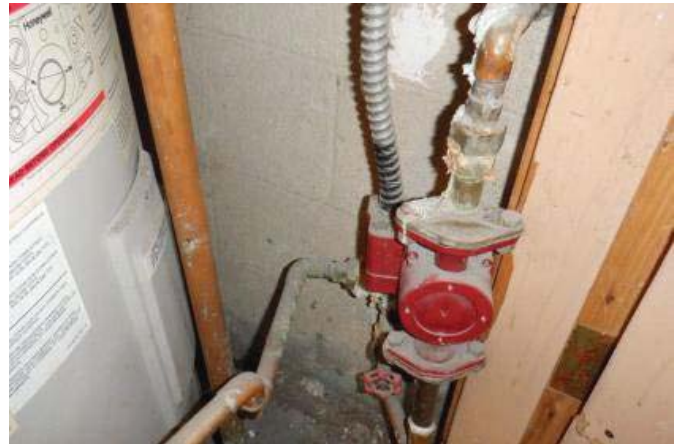
There is one.

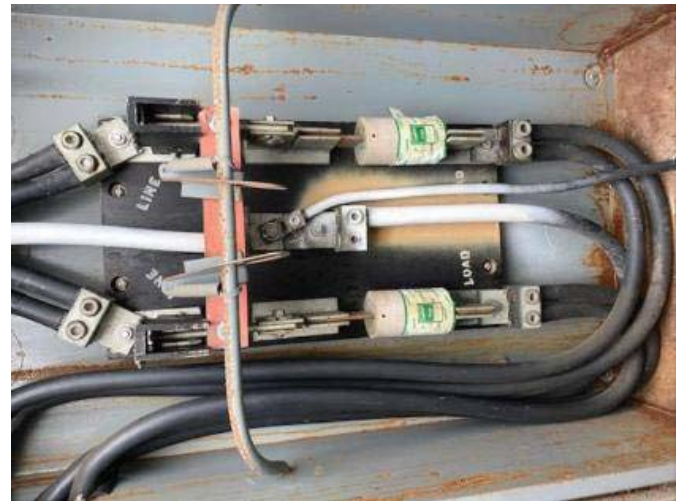
Service Amperage rating - appears to be 600 AMP.

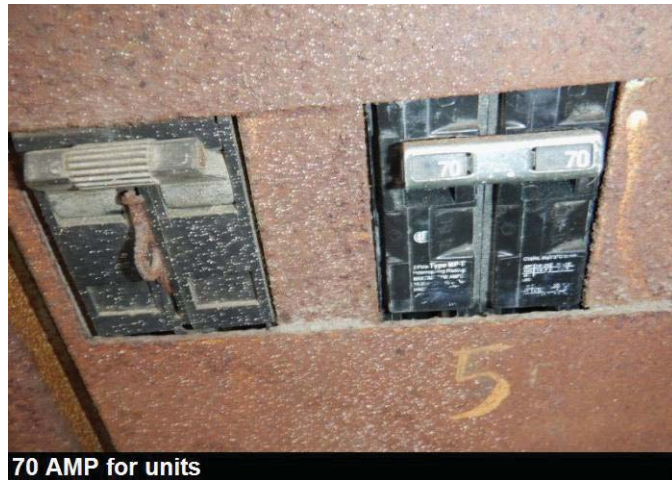
Due to age and condition of the electrical panels, upgrade replacement is recommended. Main panels in the exterior cabinet are aged and rusted. Most breakers in the area are illegible but they are assumed to be 70 AMP panels like the one newer one which is legible.

Service Amperage rating -70 AMPs , though only one is legible and can be read.

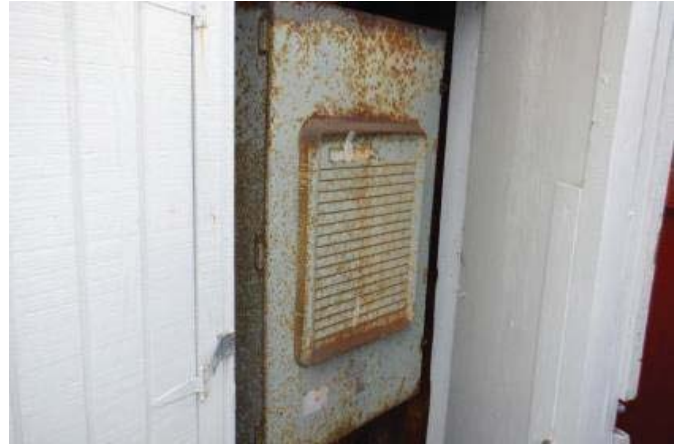
Federal Pacific panels have been observed on the site. These panels have been reported to not perform as designed and are a potential fire/safety hazard. Further review by a qualified electrician is advised at this time for safety. The Main panel is a Federal Pacific using bus fuses. This may not be the type of Federal Pacific panel that is of safety concern.

The main panel(s) for the building is (are) made by a company known as Federal Pacific. These panels have been known to have breakers that did not trip when overloaded, meaning that the power continued to flow through the wires when the breaker did not cut the power as designed due to an overload.

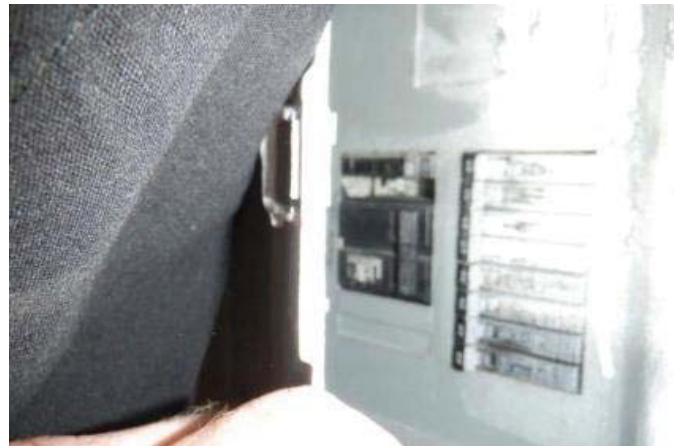
Due to the overall condition of the electrical system it is advised to have all panels fully cleaned and serviced at this time for health and safety. Sub-panels which have been painted over may be damaged or disabled from being able to trip when needed.

Units each have a
sub-panel in the hall or
bedroom.

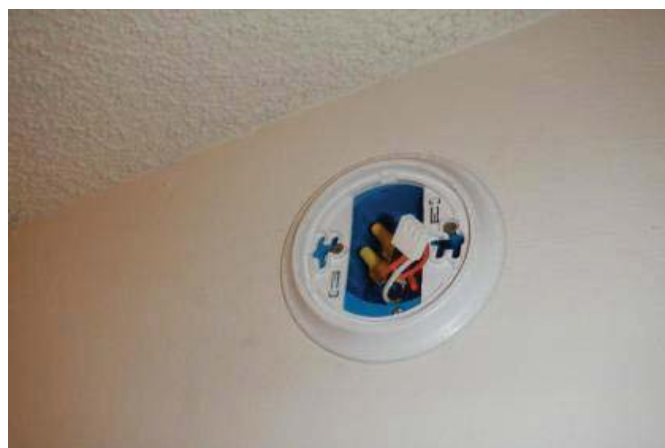
**Some removed by
tenants such as unit
11.**

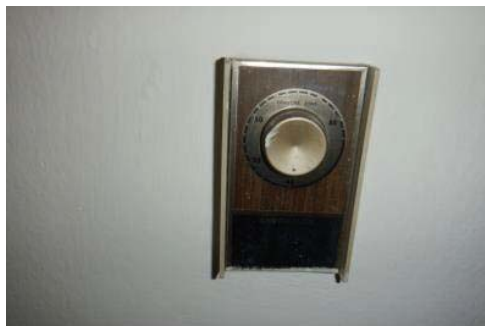
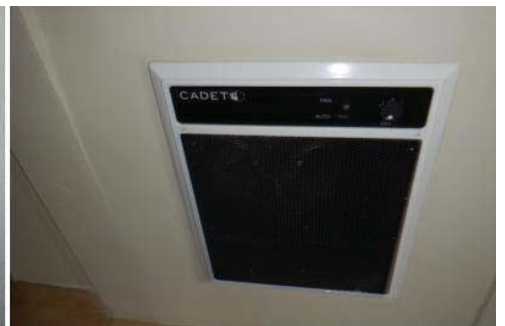
This is an electric wall heater.

This is a radiant heat system. It is an electric heating system embedded in the plaster of the ceilings. It sends electricity through the wires in the plaster and this radiates the heat into the rooms.

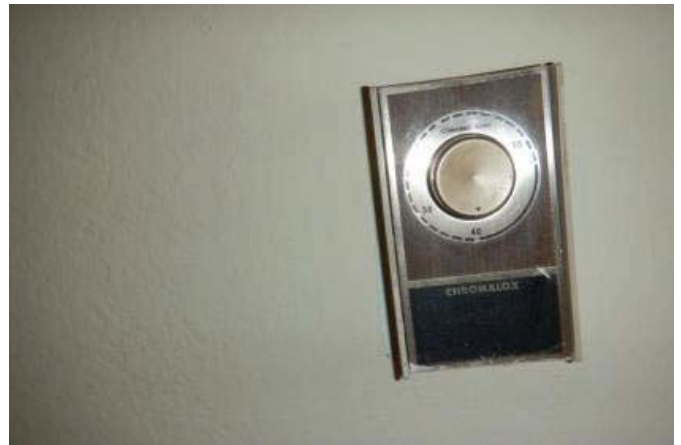
Radiant Heating units in ceilings are an old system and , though some may still work, they are at or beyond their expected serviceable life.

7 old electric wall heaters are also of the age where they are past their expected serviceable life.

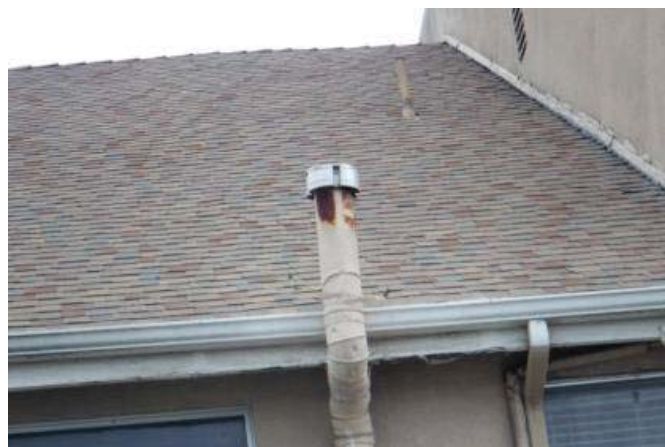
The roofing material on the sloped roof is made of composition shingles.

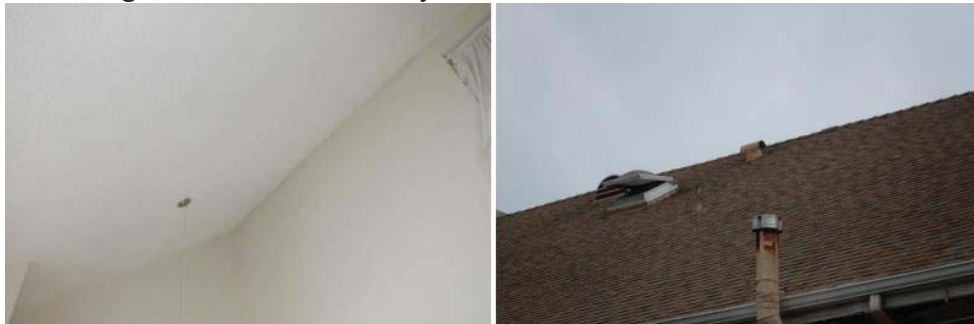
Roof has a steep slope and appears generally serviceable

No ceiling stains were seen in any of the units.

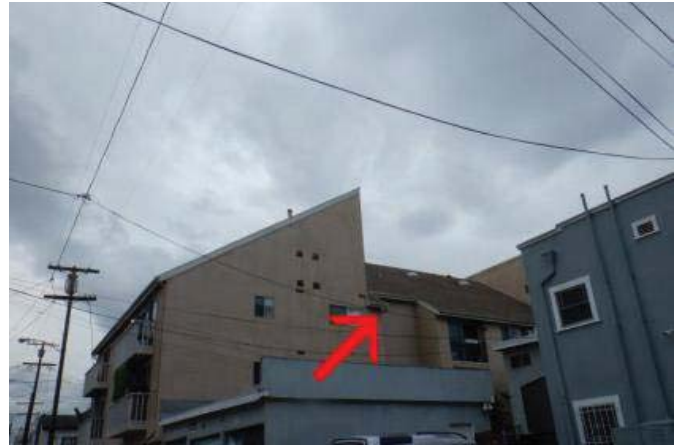
There are rain gutters .
They were not viewed
closely.

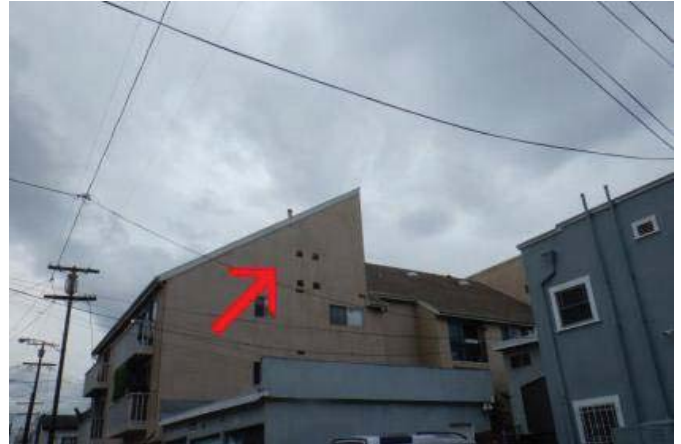
There is reportedly, an attic section or old utility room at the back of the building. This was not accessible and was not inspected.

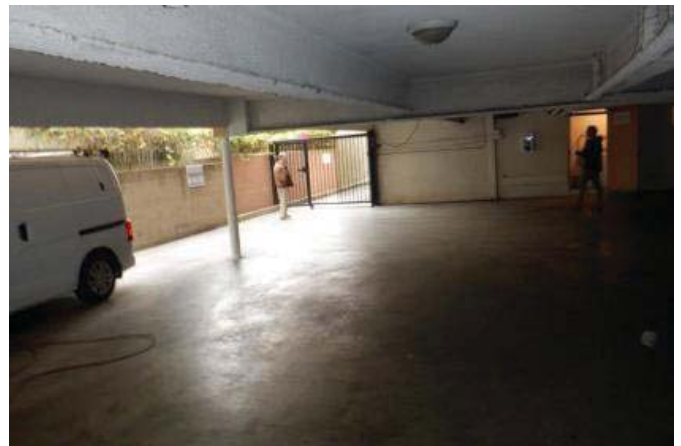
The building is supported by a below grade concrete system.

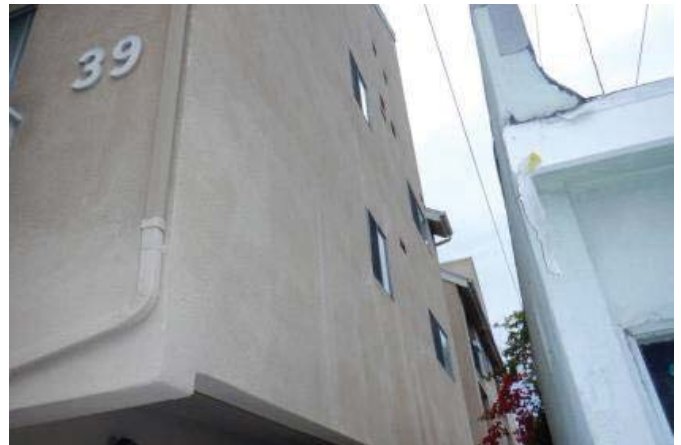
This appears to be a Wood Frame building with stucco walls.

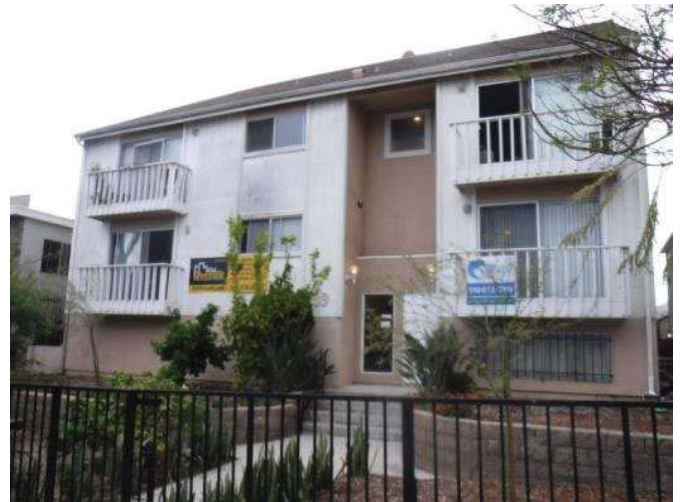
Overall the exteriors are generally serviceable exhibiting typical wear.

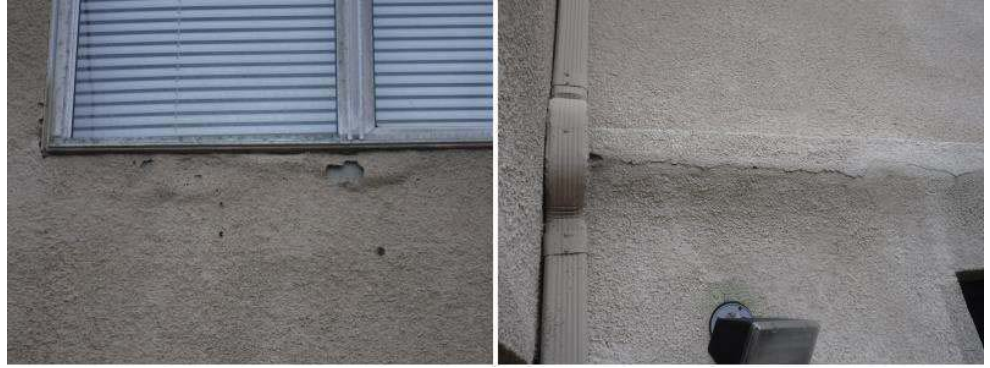
There are areas of cracking, peeling or bubbling paint to the exterior of the building.

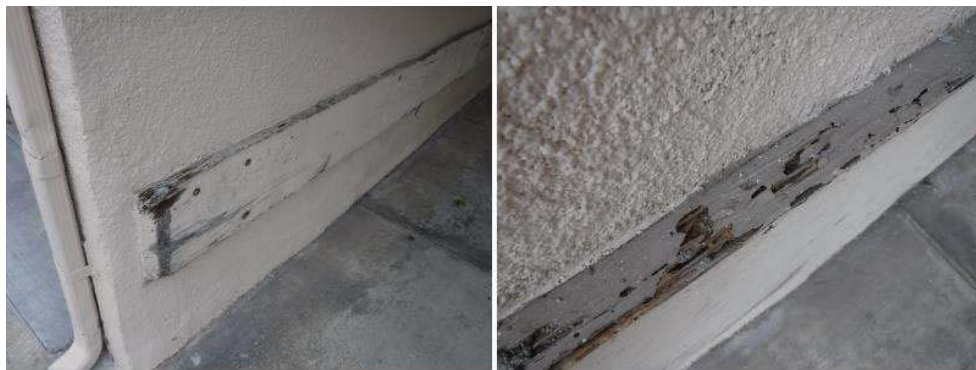
The trim is deteriorated in areas.

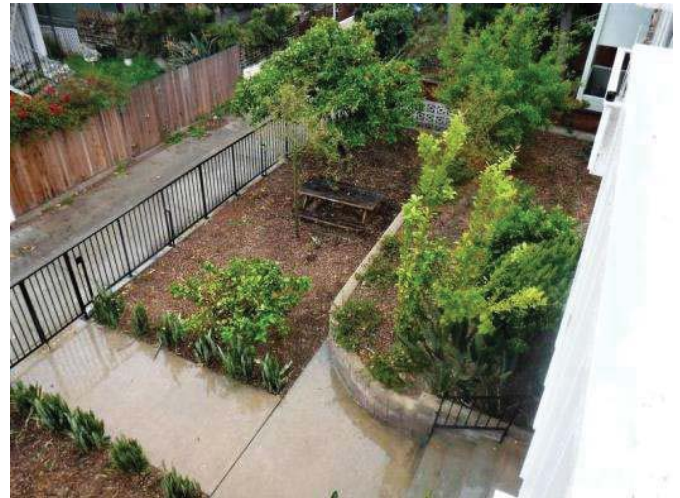
Overall the grounds are generally serviceable and exhibit typical wear.

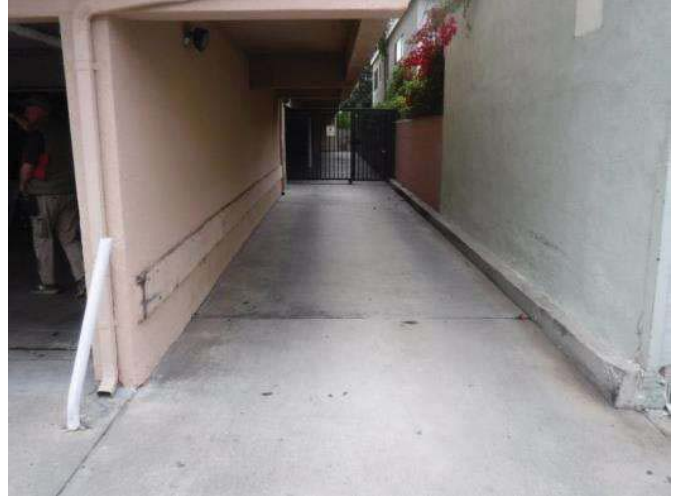
DRIVEWAY:

Serviceable.

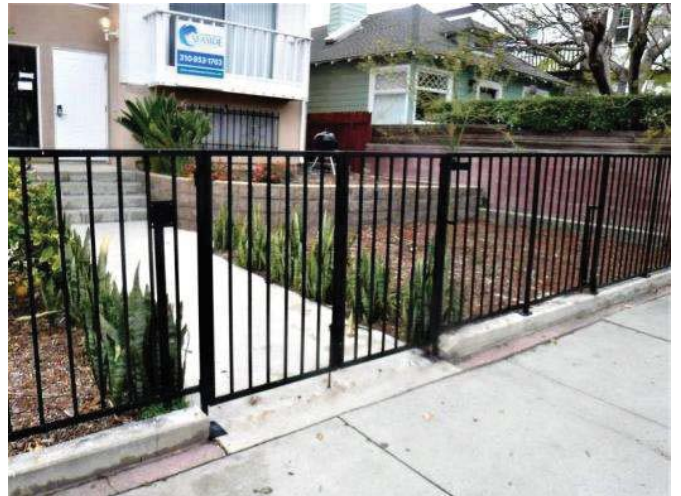
PARKING LOT:

The parking is under the living areas.

Serviceable.

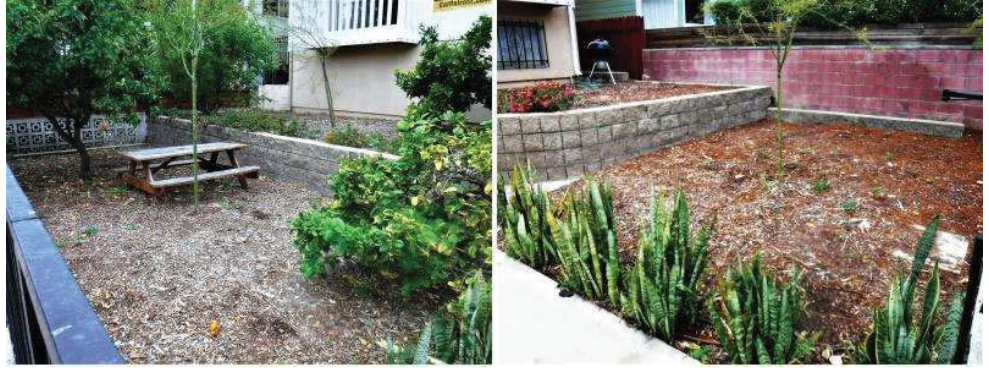
LANDSCAPING:

Serviceable. The grounds on the property have generally been maintained.

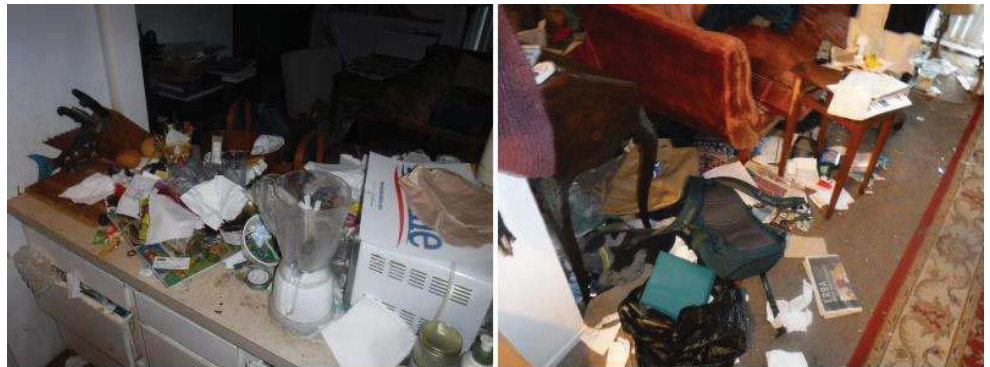
Needs Attention:

Excessive wear is noted in unit 10

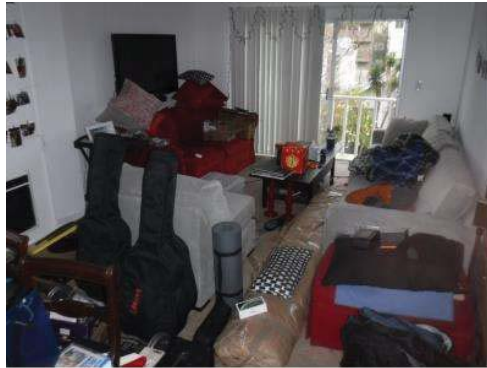
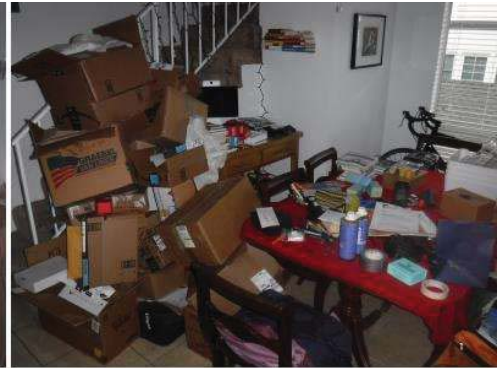
Needs Attention:

Excessive personal items were viewed in unit ; 12

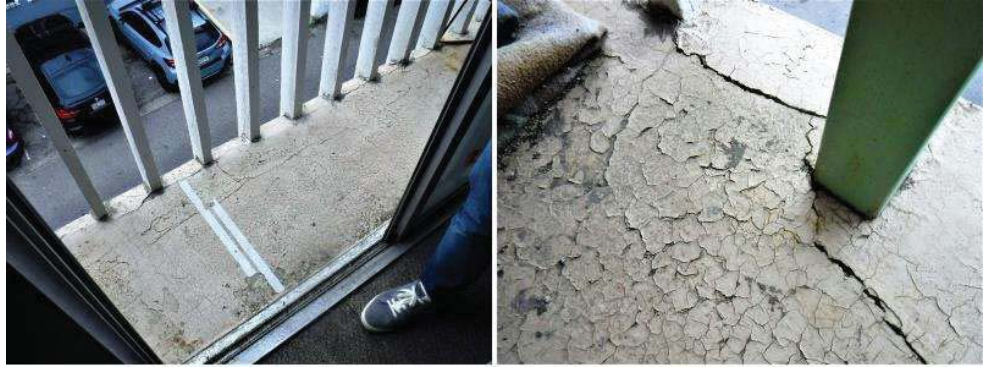
BALCONY / PATIO

NEEDS ATTENTION:

Most of the deck / balcony surfaces have areas of wear and/or damage such as in units 14, 8, 12, 4.

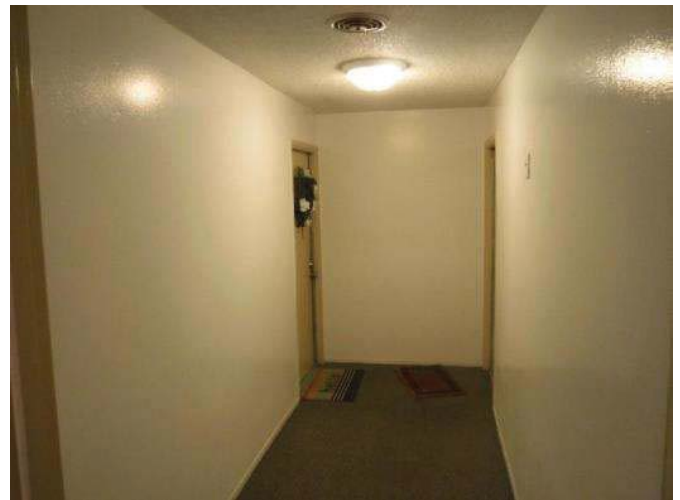
(NOTE: There are exhaust fans in the hallways. This is the only ventilation. Some are noisy. One on the first floor didn't work.)

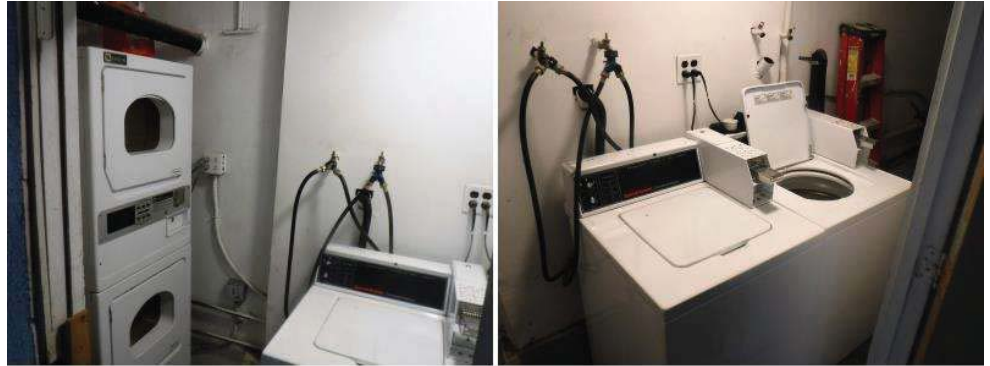
LAUNDRY AREA:

Serviceable.

However it is quite small and is basically in a closet.

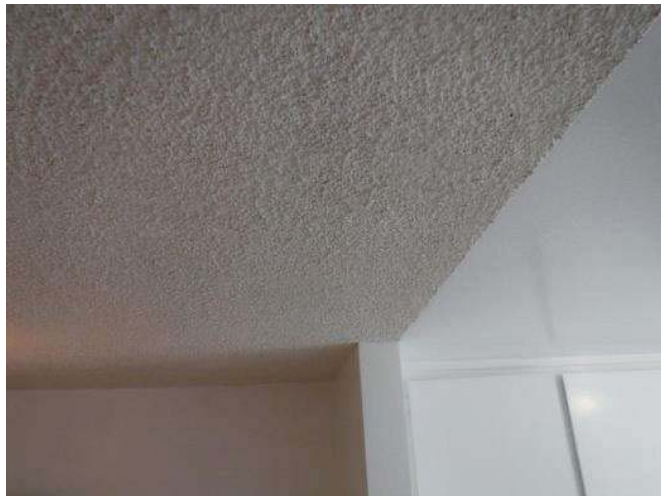
The ceilings are spray texture material. If the original construction is before 1978 it is possible that this spray contains asbestos materials.

The only way to determine if this is the case is to have a sample taken and examined by a qualified professional lab.
