RISK Assessment® Report

Studio City, CA 91604

RISK ASSESSMENT®

This is an assessment of the five major systems - Plumbing, Electrical, Heating and Air Conditioning, Structure and Roofing along with an assessment of any other current deferred maintenance issues for the site.

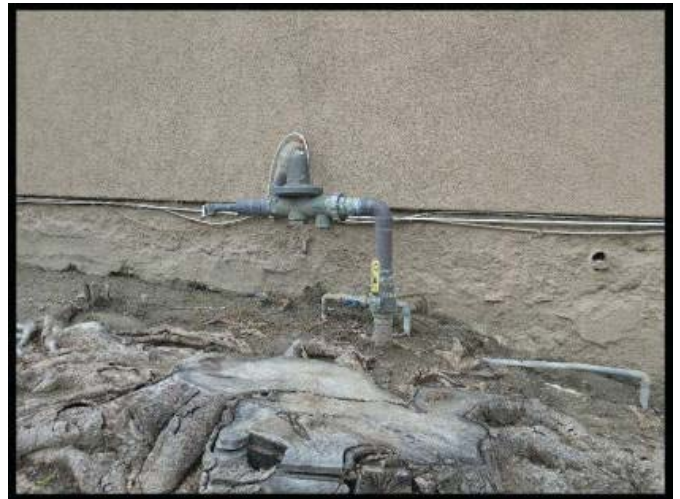
MAIN WATER SHUT OFF
LOCATION:

On the left side of the building.

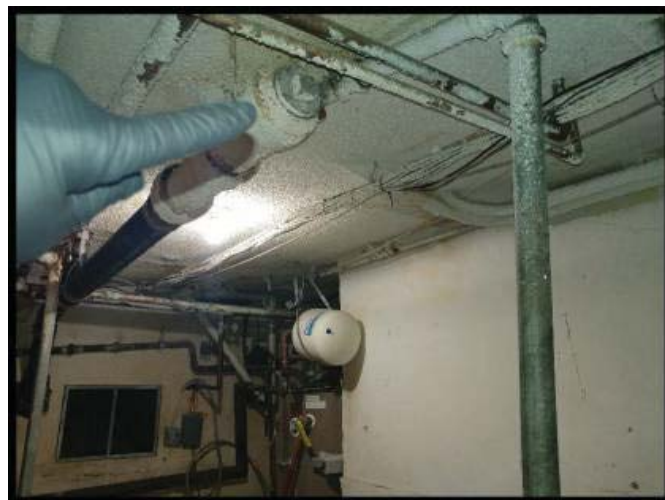
MAIN SEWER CLEANOUT:

A main waste line cleanout was located Basement in the water heater room

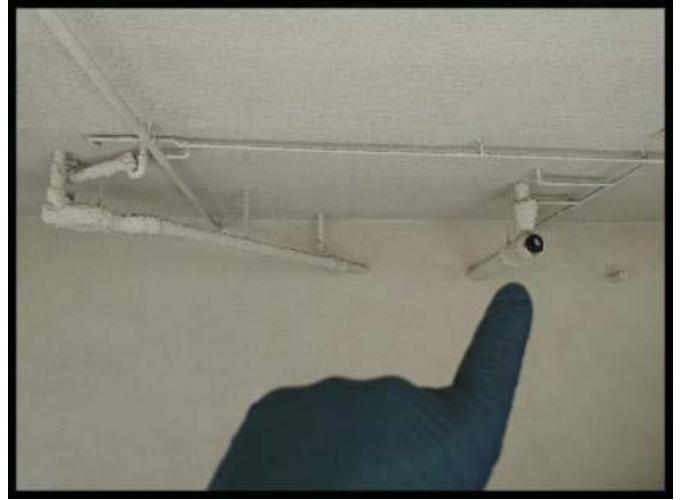
A main waste line cleanout was located in the garage.

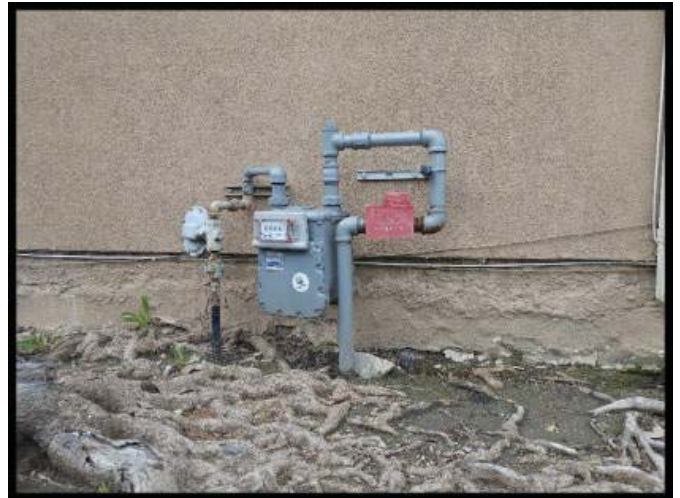
GAS METER LOCATION:

The meter is located on the left side of the building.

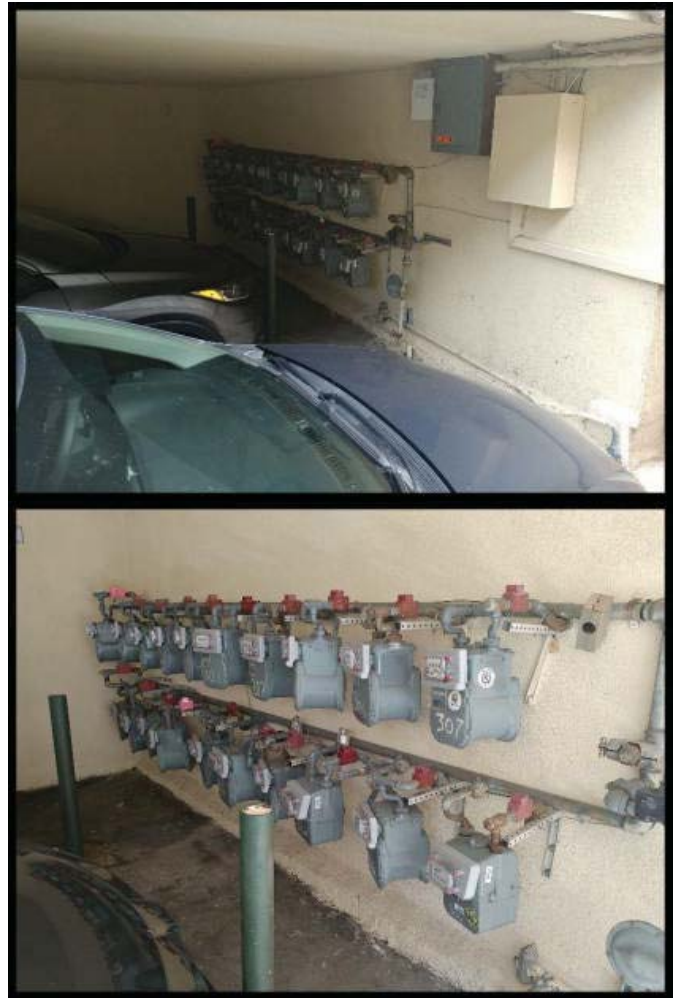
The meters are located on the back of the building.

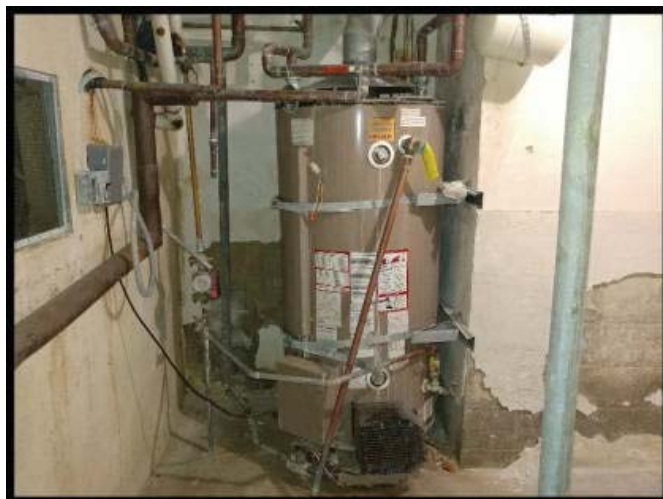
The water heating system is common to all the units in the building.

The water heater is located in the basement.

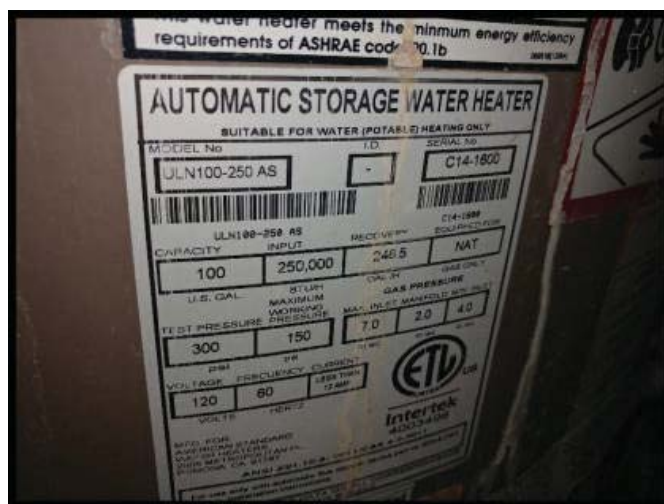
SIZE:

100 gallons.

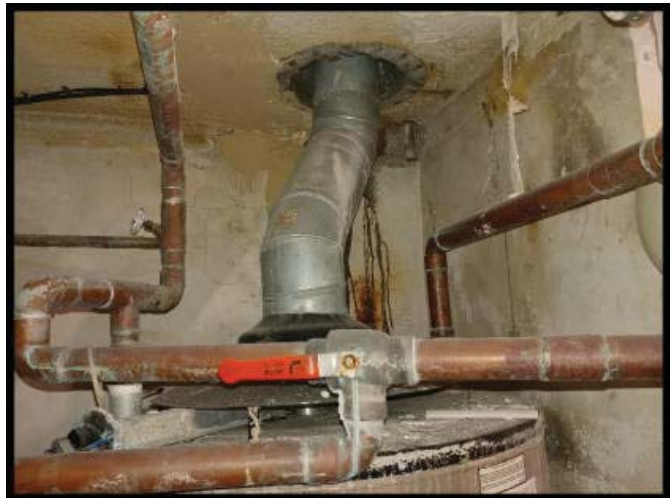
Needs Attention:

There are no flexible connections at the inlet and outlet piping. This is a requirement.

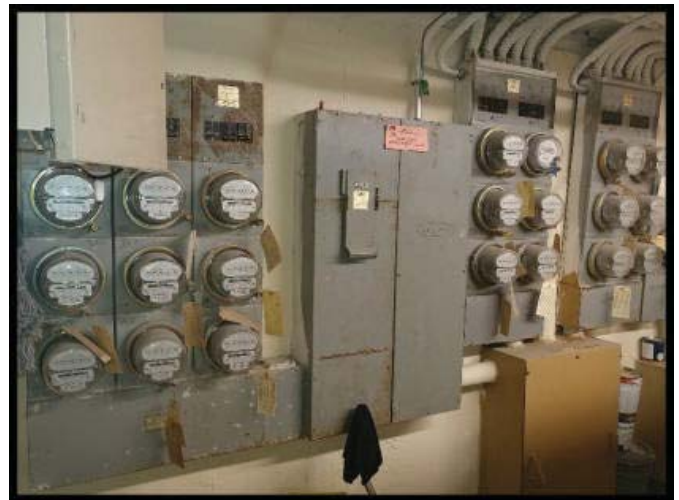
PANEL LOCATION:

The main electrical
panel is located in the
basement.

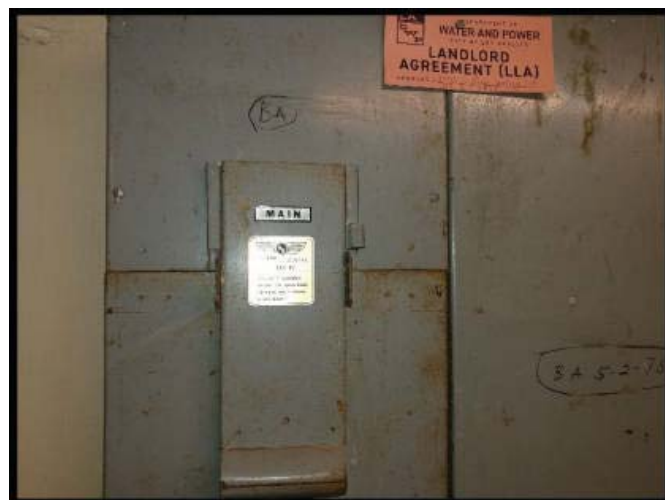
MAIN PANEL PROTECTION
DEVICE:

The main panel
disconnect is a lever.

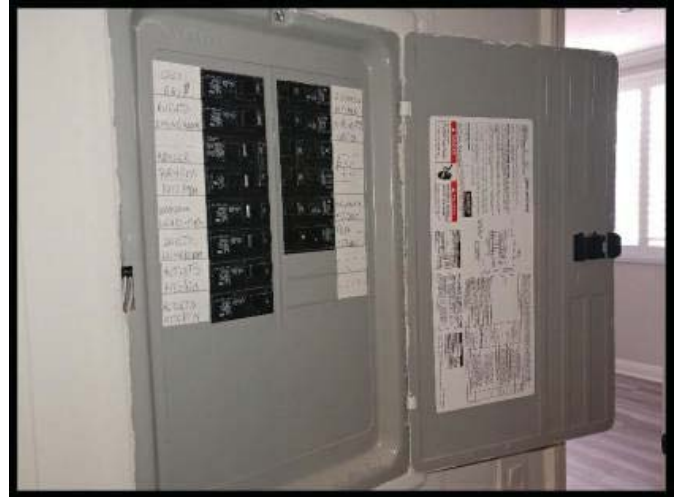
Each apartment has its own subpanel within

These are located in the hallway.

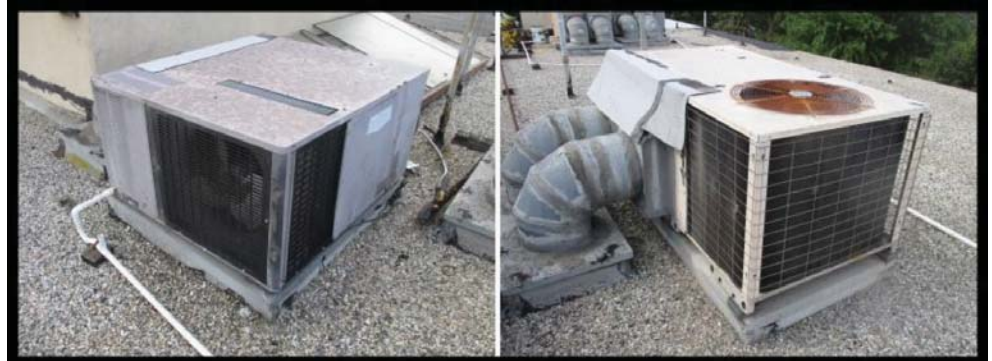
Typical HVAC views.

A total of 20 HVAC units were observed on the roof. The heating and cooling systems for the building are known as "Roof Packages". This is the type of system where the gas heating furnace and the electric air conditioning (cooling) components are packaged inside one container and perform both functions from this common location on the roof. All appear to be two ton unit with the vast majority of them approx. 22 years old or older.

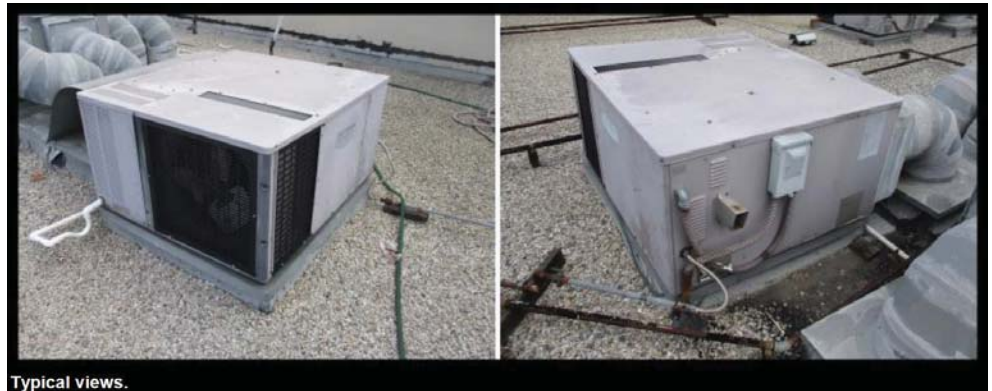
LOCATION:

The heating and cooling units are located on the roof.

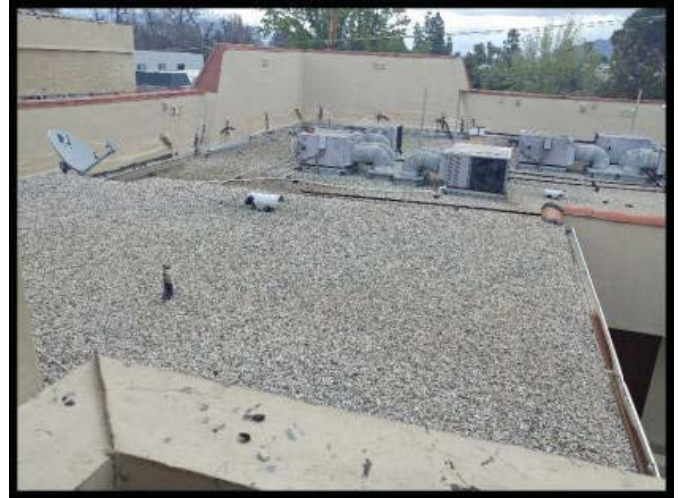
ROOF STYLE:

The roofing system has a Low Slope to it. This means that the slope of the roof appears to be no more than 2" of rise for every 12" of horizontal measurement.

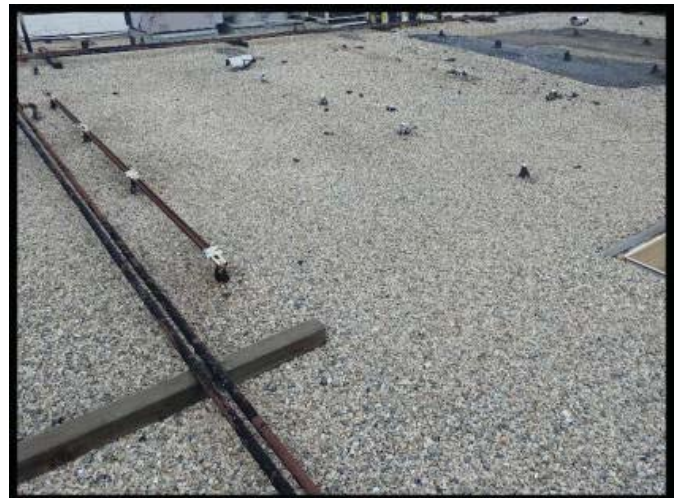
TYPE OF ROOFING MATERIAL:

The roofing material on the low sloped roof is made of tar with gravel on top of it.

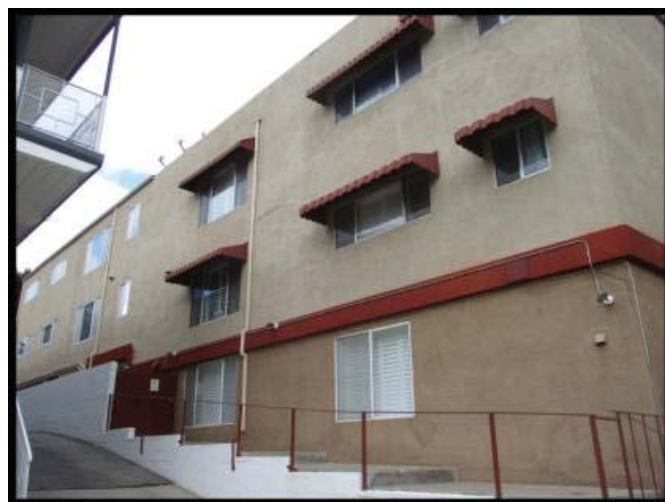
EXTERIOR WALLS
CONDITION:

Serviceable overall.

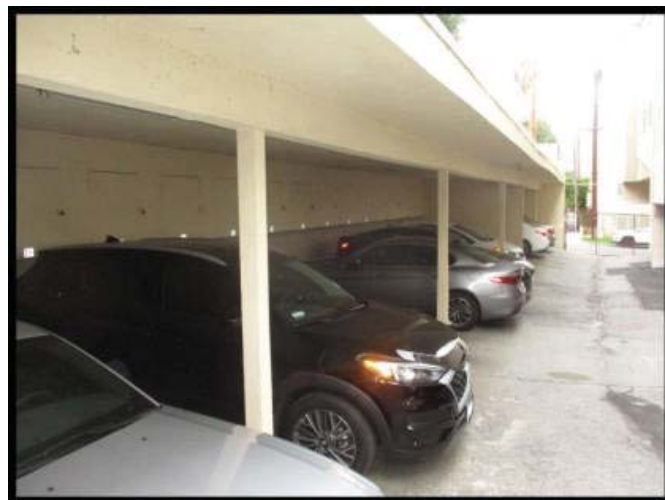
PARKING STRUCTURE
BELOW LIVING SPACE

Serviceable Overall.

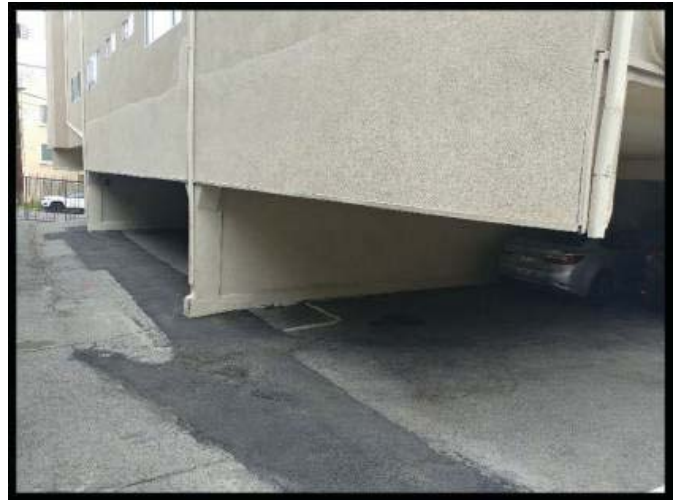
Overall the garage is generally serviceable and exhibits typical wear.

It appears there have been modifications to the support system to the parking areas below living or office space to help mitigate the possible effects of a seismic event. Full disclosure is advised.

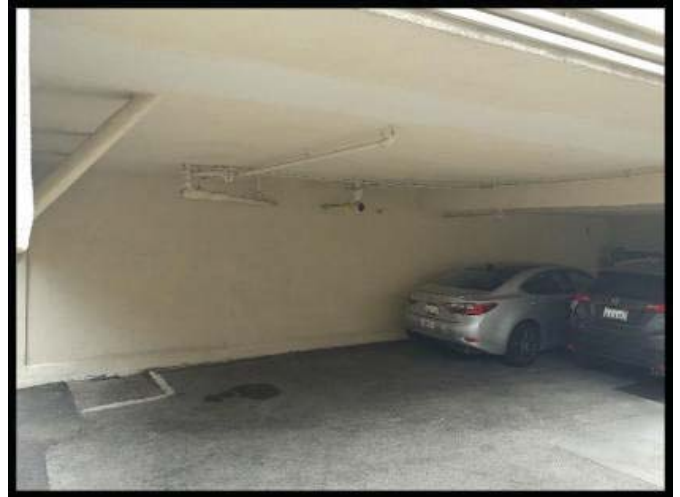
Serviceable.

Typical wear and tear is noted in areas.

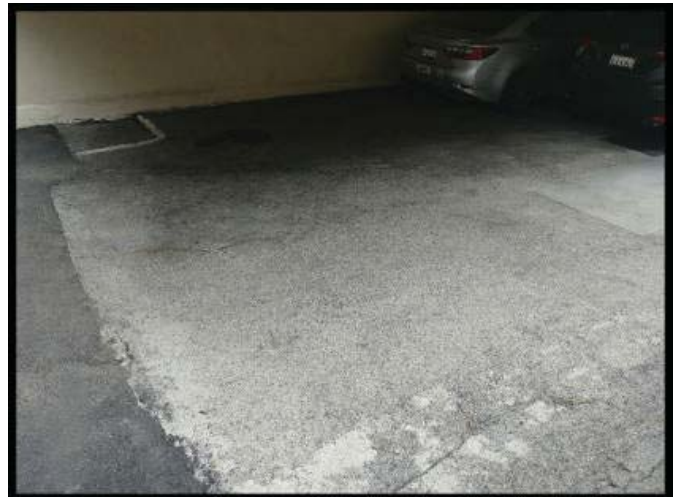
GARAGE FLOOR:

Serviceable.

with typical wear and tear in areas

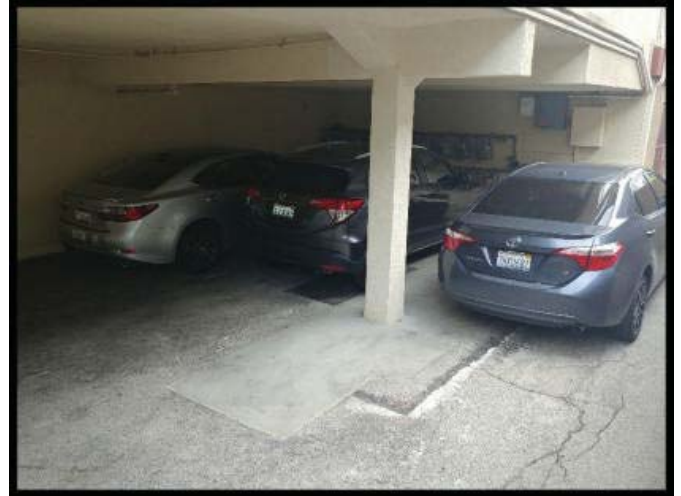
GARAGE SUMMARY:

It appears there have been modifications to the support system to the parking areas below living or office space to help mitigate the possible effects of a seismic event. Full disclosure is advised.

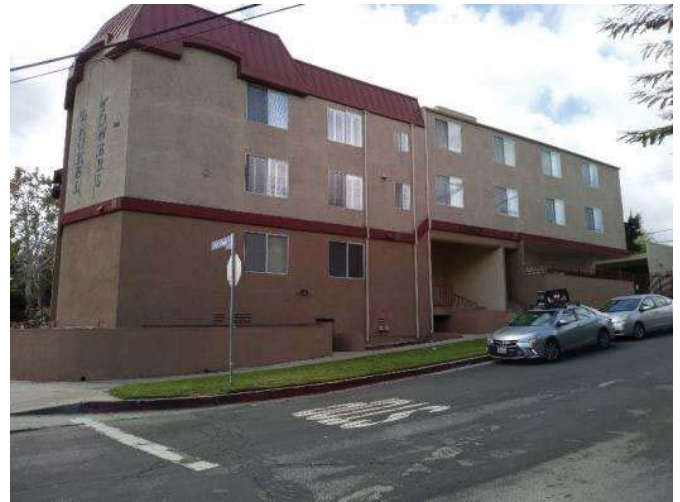
EXTERIOR OVERVIEW:

Overall the exteriors are generally serviceable exhibiting typical wear.

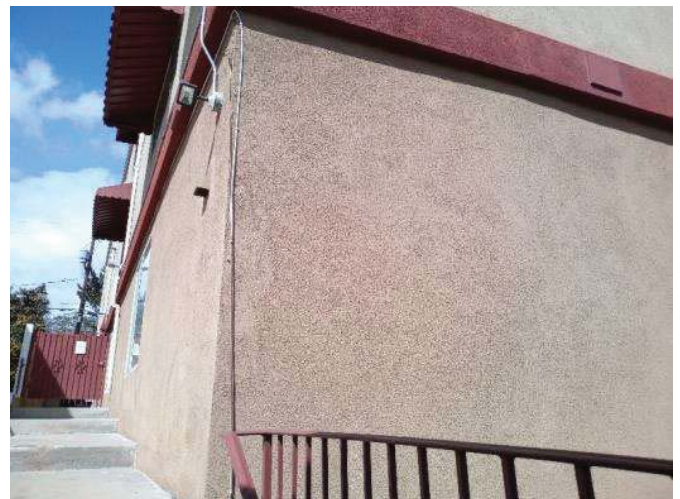
The exterior building covering is stucco.

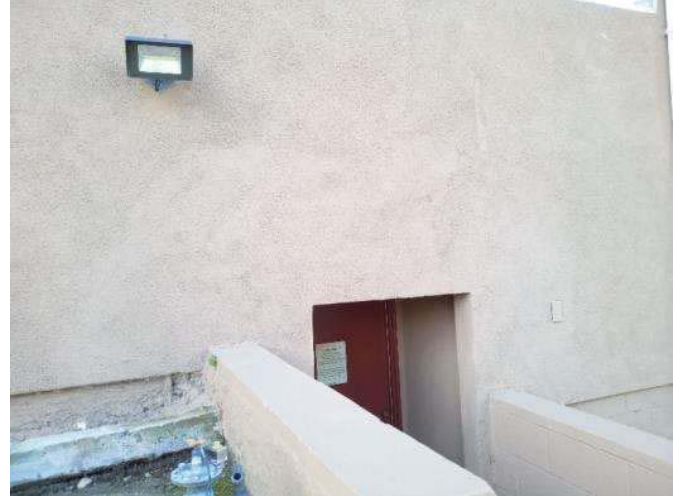
It appears the building has been recently repainted and there has been some re-stucco done in areas

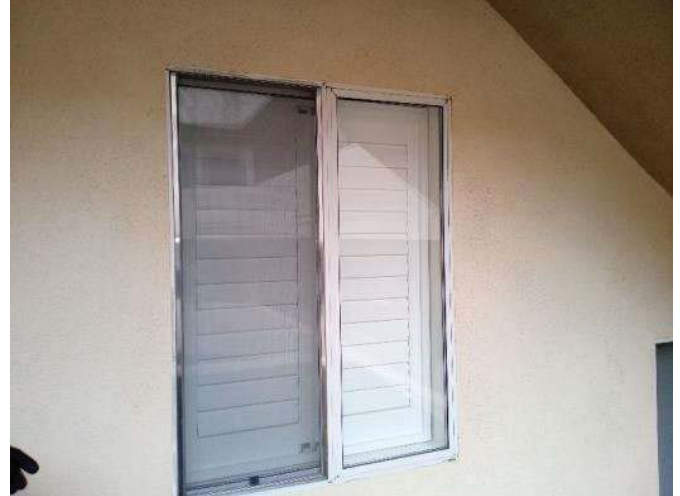
The exterior window surfaces are metal.

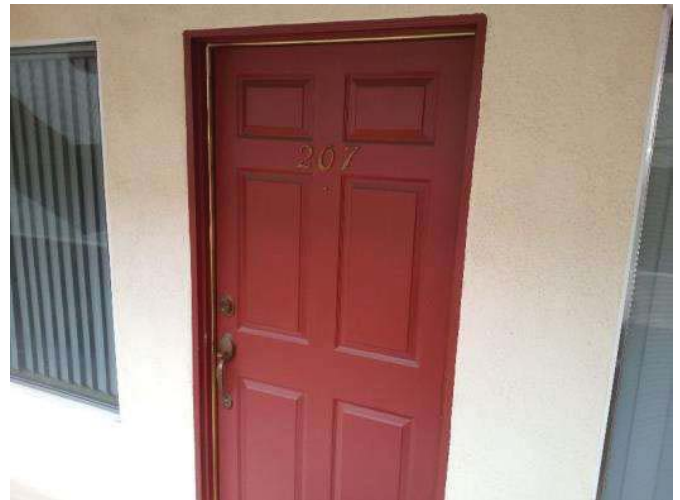
The exterior door surfaces are wood.

Damage to a door in
the basement
service room.

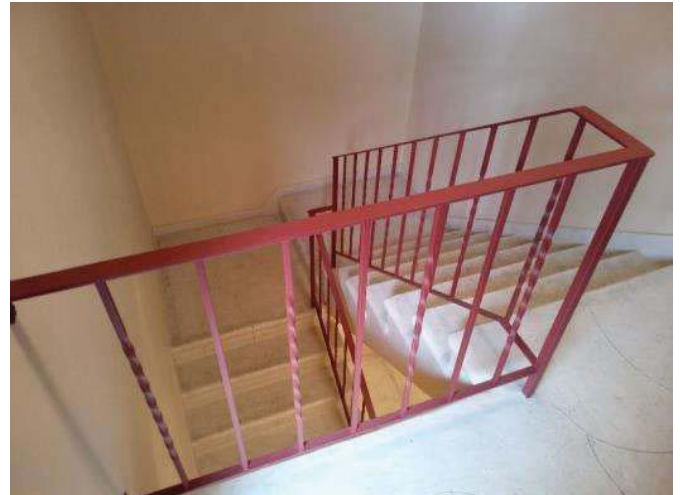
Serviceable.

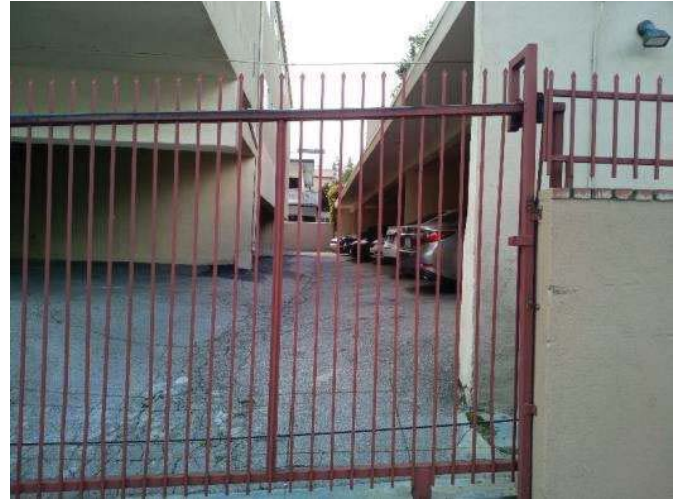
GARAGE OVERVIEW:

Overall the garage is generally serviceable and exhibits typical wear.

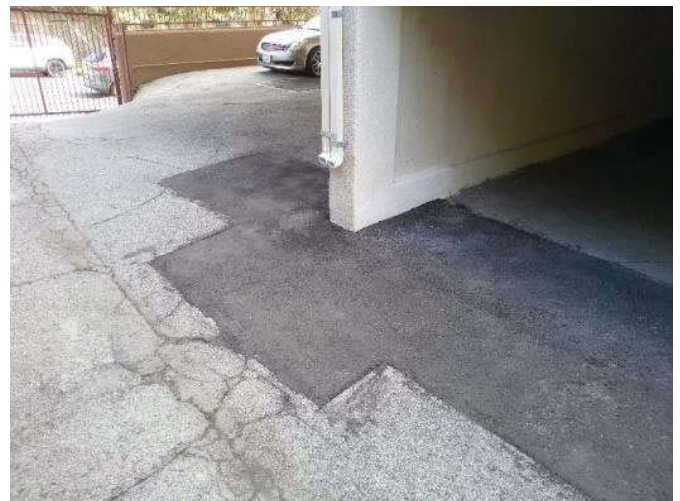
Serviceable.

though it is noted that Soft-story work has been done.

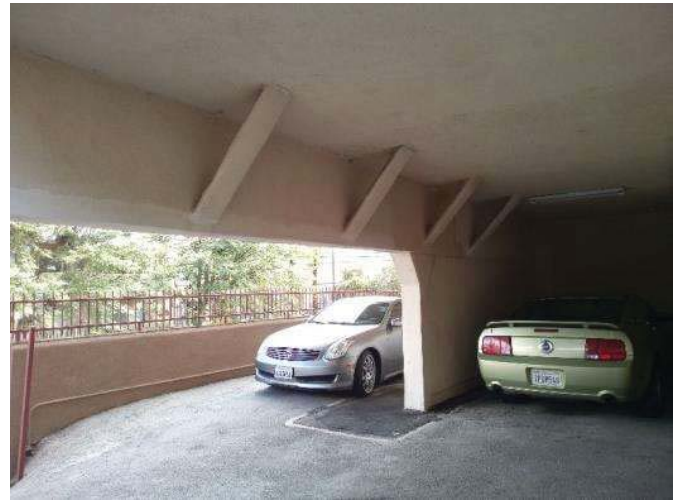
It appears that saw story work has been completed.

No repairs are recommended other than regular routine maintenance as needed.

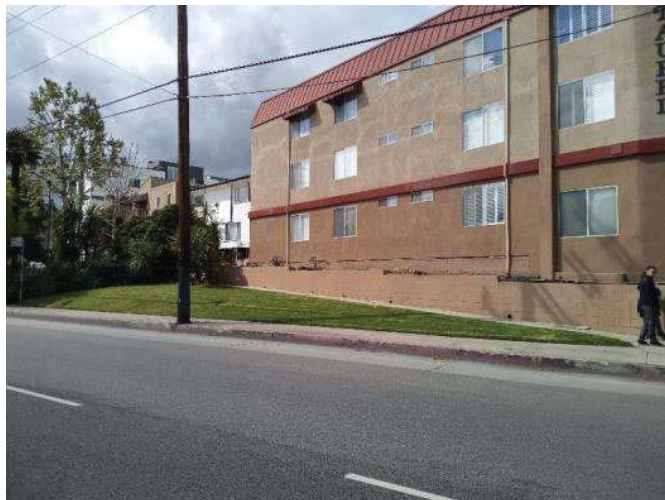
GROUNDS OVERVIEW:

Overall the grounds are generally serviceable and exhibit typical wear.

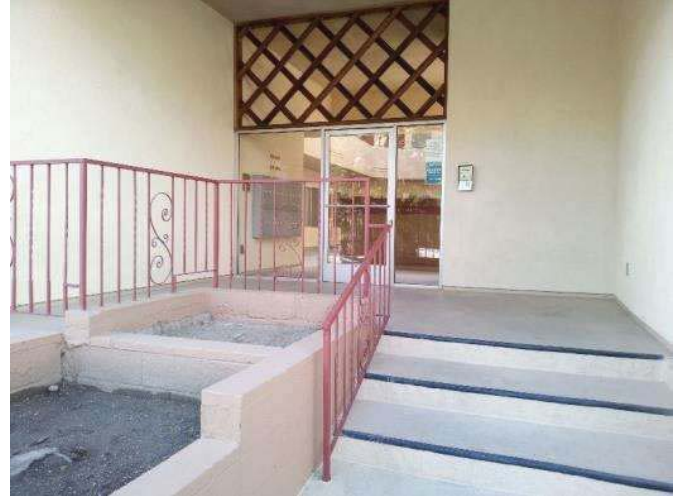
MAIN ENTRY:

Serviceable.

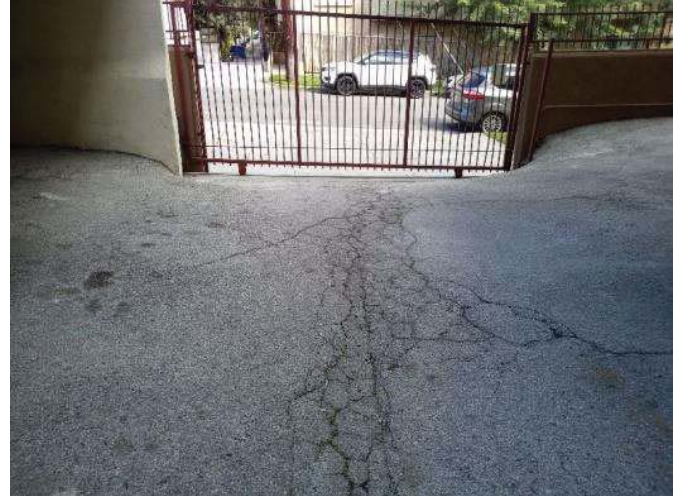
DRIVEWAY:

Serviceable.

Needs Attention:

The driveway area surfaces are deteriorated and in need of being resurfaced at this time.

The parking area is worn and aged and there are sections that are deteriorated to the point that resurfacing of the asphalt is advised at this time.

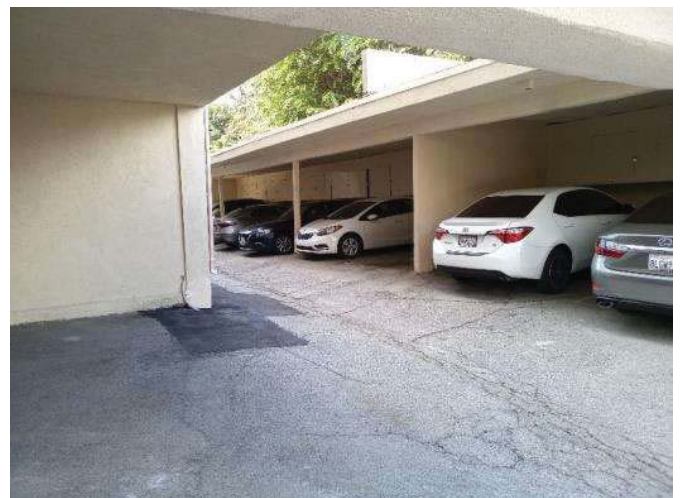
Serviceable overall.

There is a soft story and a detached carport.

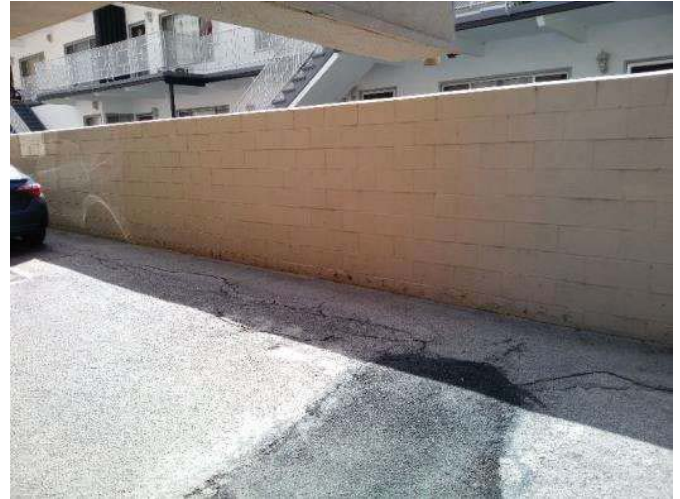
PROPERTY WALLS, FENCES & GATES:

Serviceable.

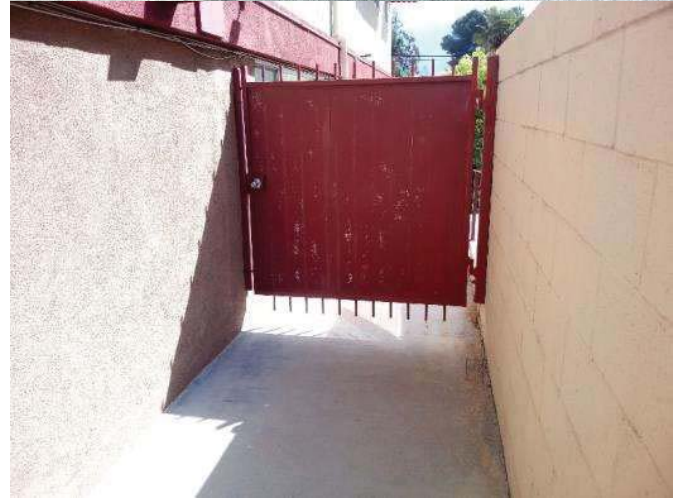
Serviceable.

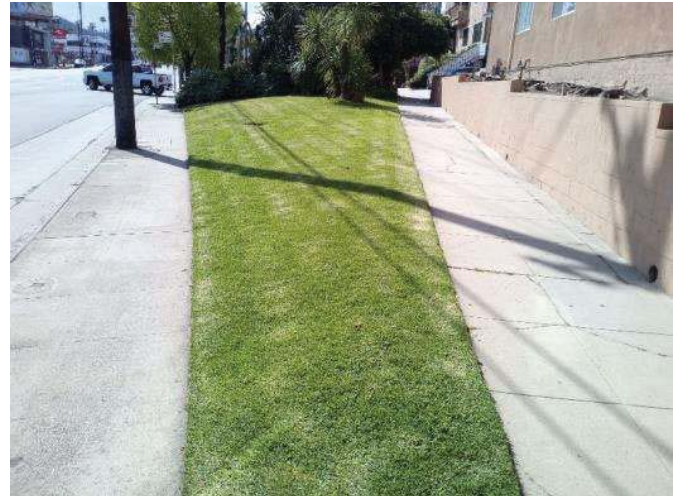
The grounds on the property need general maintenance in areas.

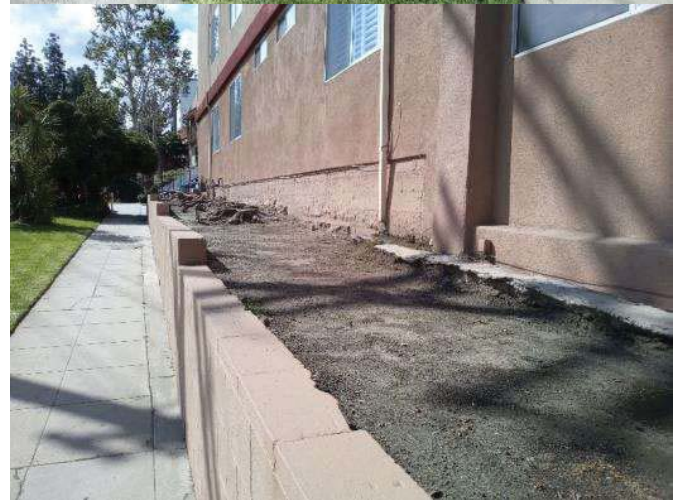
There are areas where the shrubbery has been removed.

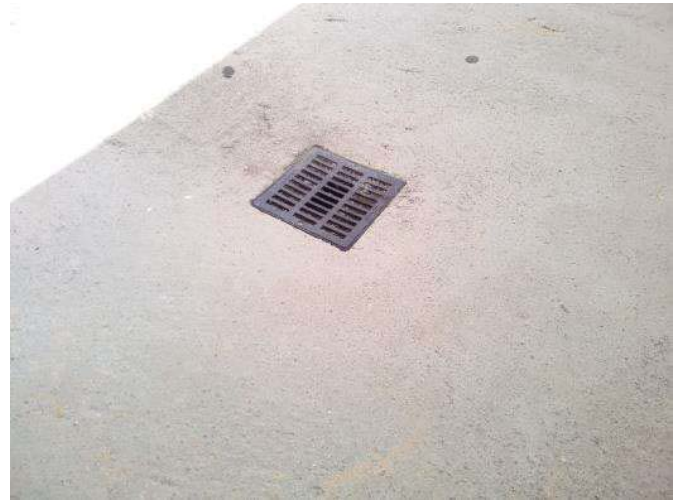
There were no significant observable defects in the grading and drainage within six feet of the building.

A camera drain line inspection can examine the interior of most drain lines and determine their condition. It is also recommended to consult with the owner for a history of the performance of all drains during periods of heavy rainfall.

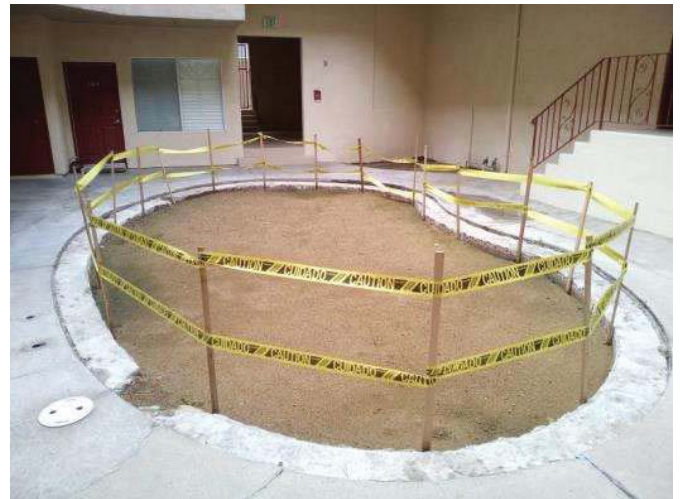
There is a pool located on the property.

This has been filled in

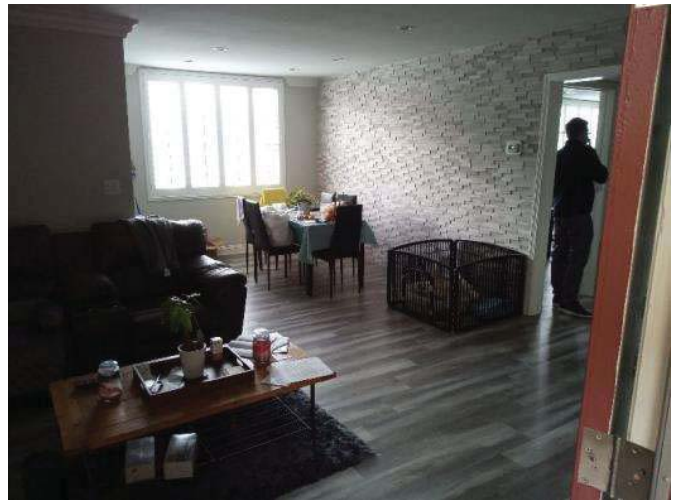
Overall the interiors of the units are serviceable with typical wear and tear noted other than those items listed below.

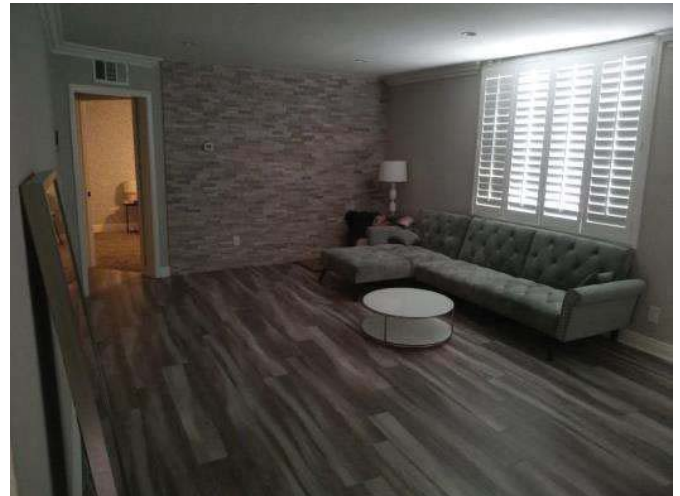
The overall interior living areas of the remodeled units were found to be serviceable.

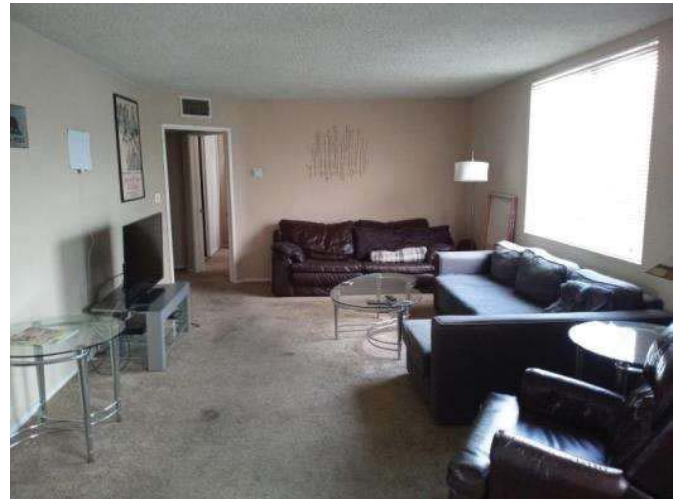
The non-renovated units are worn but remain serviceable overall.

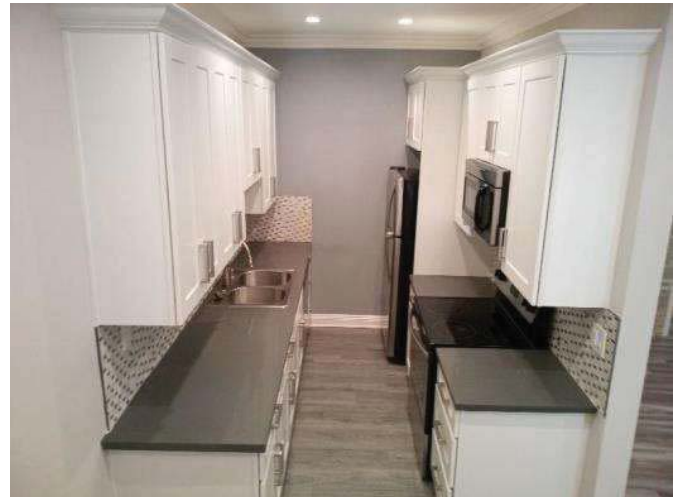
Vacant

Serviceable.

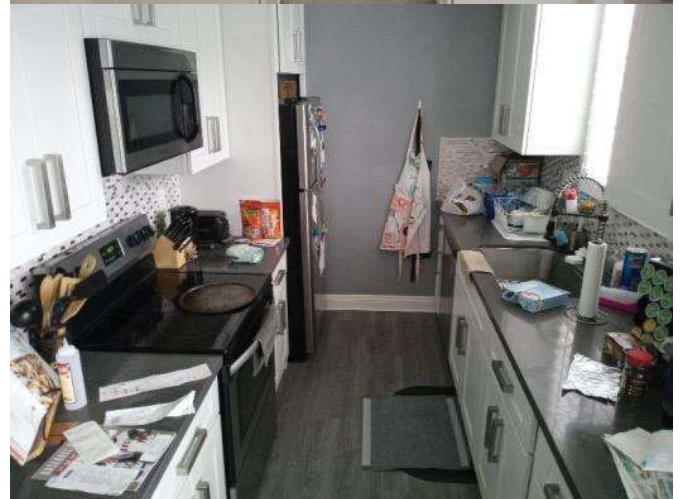
Occupied and
renoed.

Serviceable.

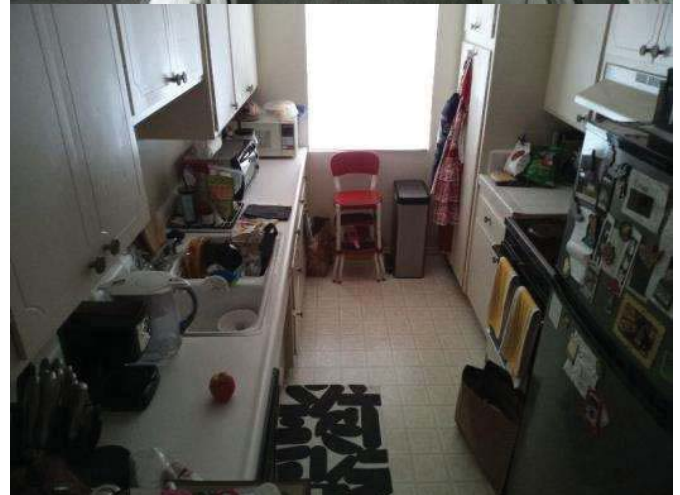
Occupied but not
renoed.

The kitchen
surfaces and
primary components
in this brief test
appeared to be in
serviceable
condition.
with typical wear.

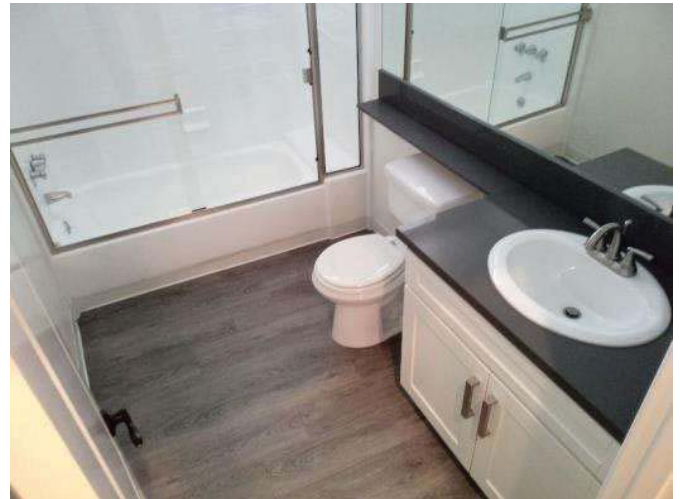
Vacant

Serviceable.

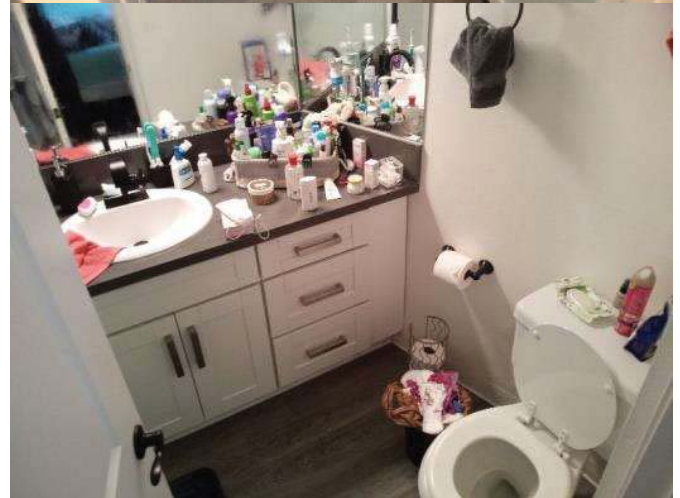
Occupied and
renoed.

Serviceable.

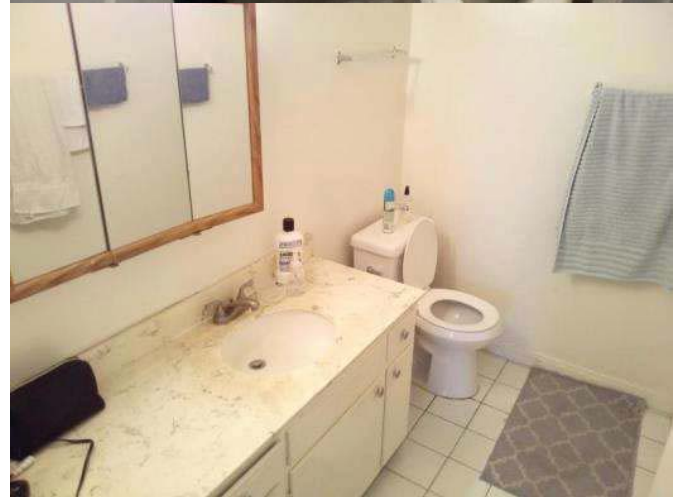
Occupied but not
renoed.

The restrooms are
generally aged but
remains serviceable.

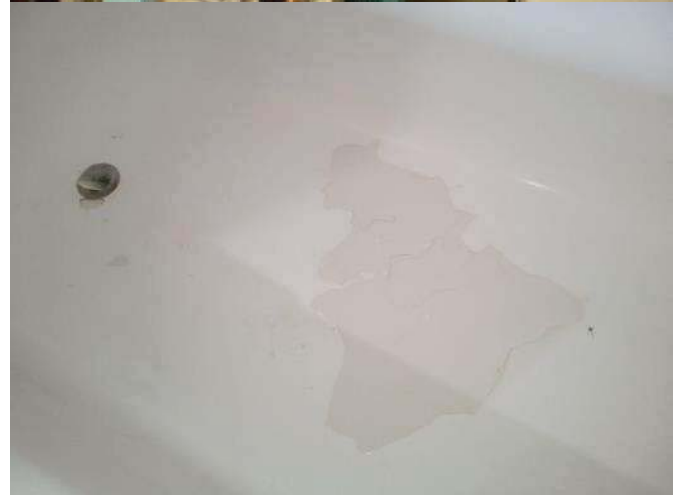
The bathtub has been resurfaced (painted) and is peeling in unit 308

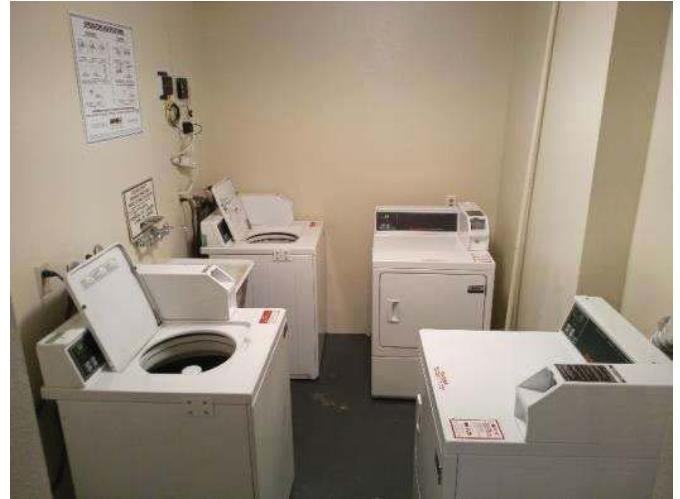
The laundry facilities are in the basement.
