RISK Assessment® Report

RISK ASSESSMENT[®]

Commercial Real Estate Inspectors

This is an assessment of the five major systems - Plumbing, Electrical, Heating and Air Conditioning, Structure and Roofing along with an assessment of any other current deferred maintenance issues for the site.

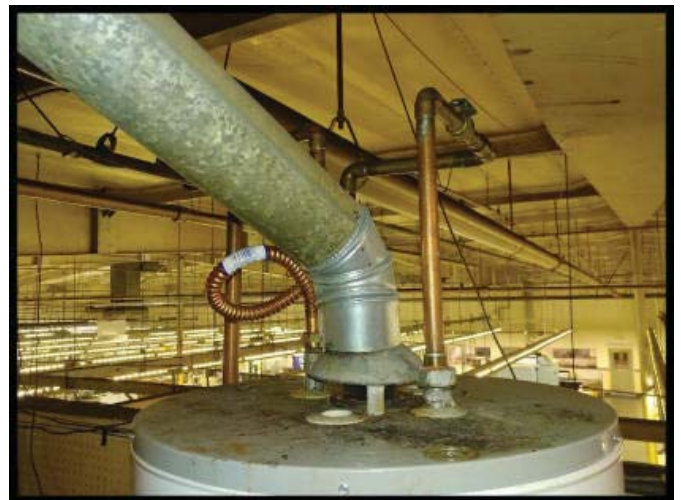
Needs Attention:

There are no flexible connections at the inlet and outlet piping. This is a requirement.

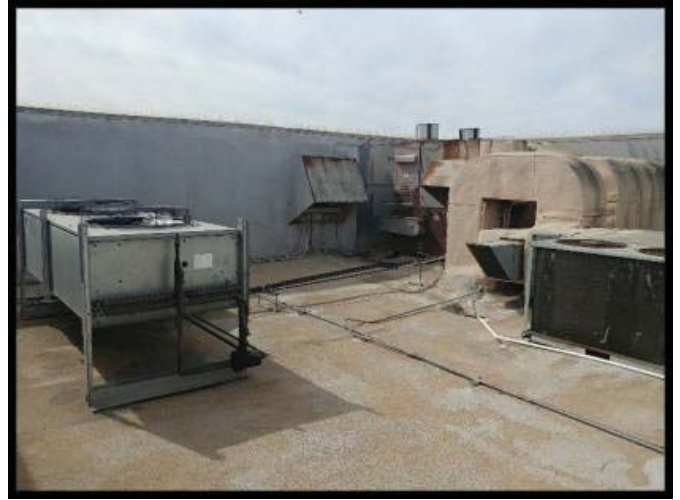
1. Roof package unit from 1984. This appears to be a 7.5 ton unit. The fins show damage and age. Also there is no condensate trap. .

2. Reznor boiler connected to a refrigerant unit. This is a large system. The Reznor component is old. The refrigerant unit appears to be from 2011. After consultation with my HVAC professional this is called a **"built up double duct system."** The Reznor portion appears at or near the end of it's expected useful life.

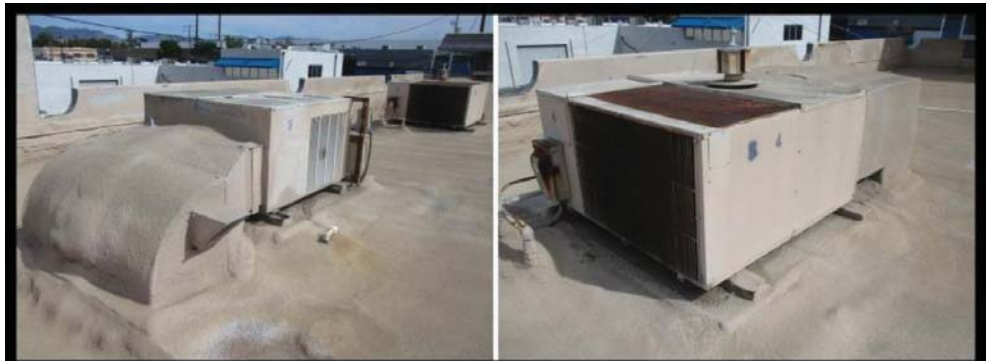
Typical views of older units.

The heating and cooling units are located on the roof.

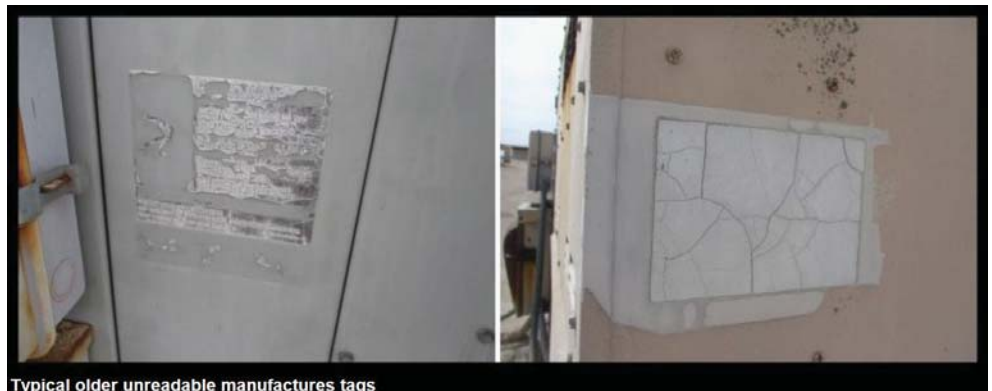
The units are various ages and conditions however for the most part these are very aged and worn and past the expected useful life.

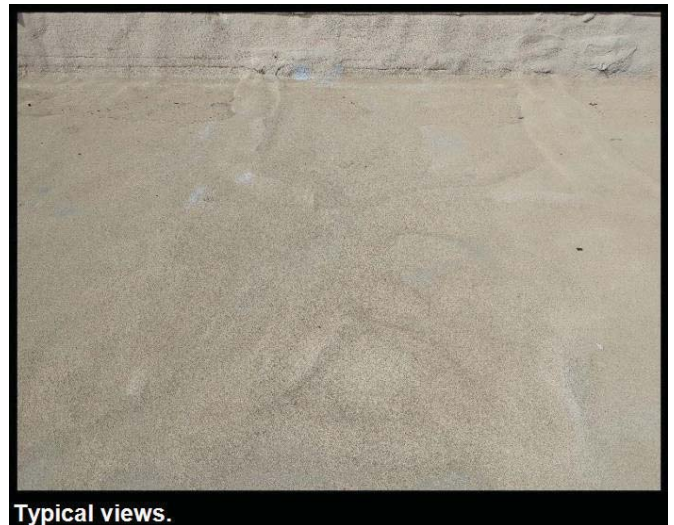
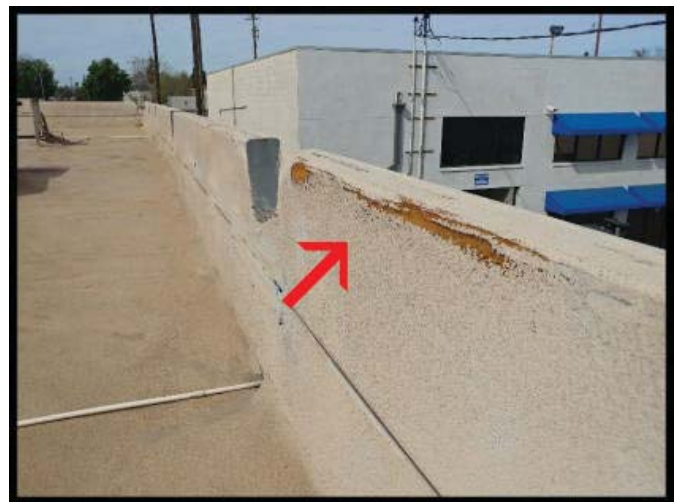
**The roofing material
along the parapets is
showing signs of
general wear and age.**

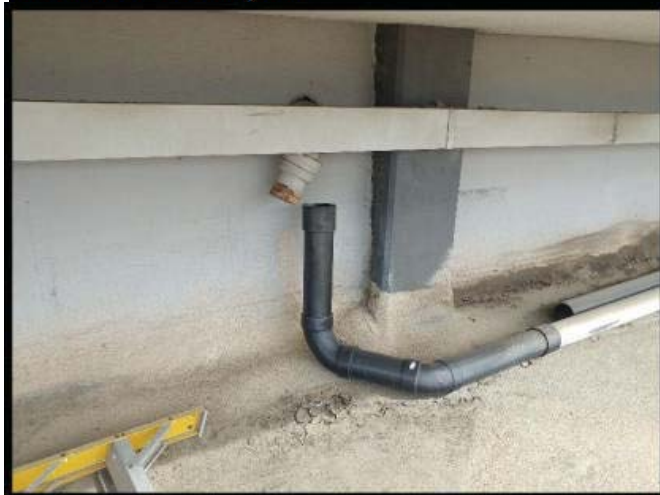
Disconnected downspout.

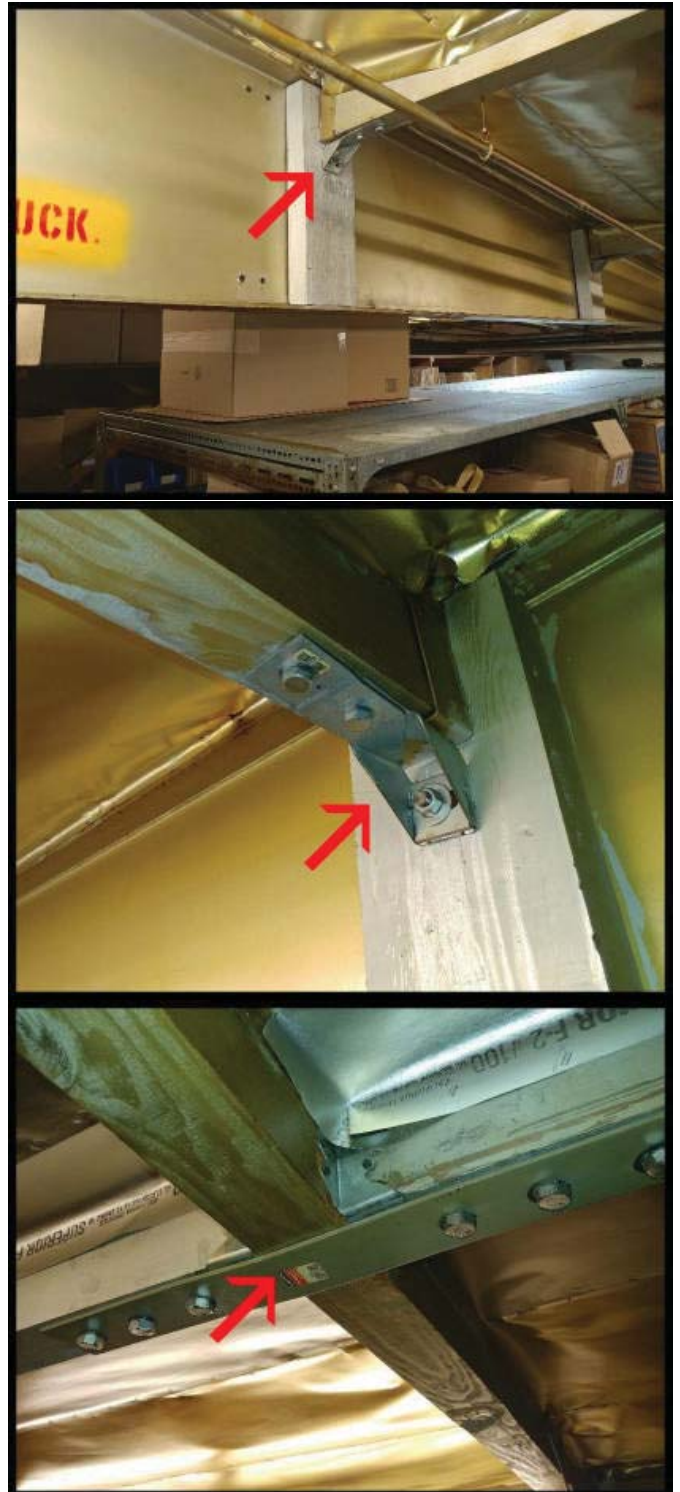
The roof framing
condition appears
serviceable overall.

Seismic upgrades were
observed.

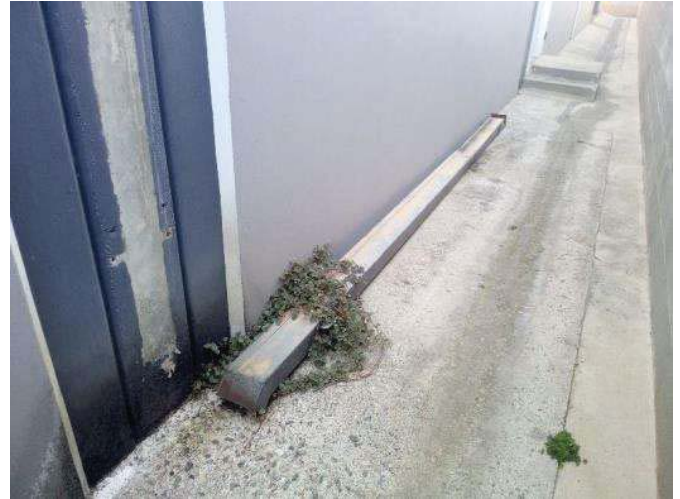
There are 2 Downspouts that need reinstalled.

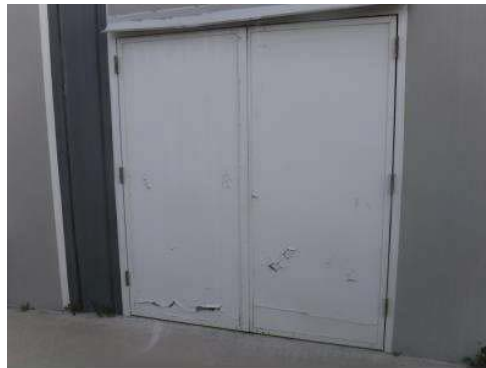
Needs Attention:

There are areas of deterioration to the exterior of the doors.

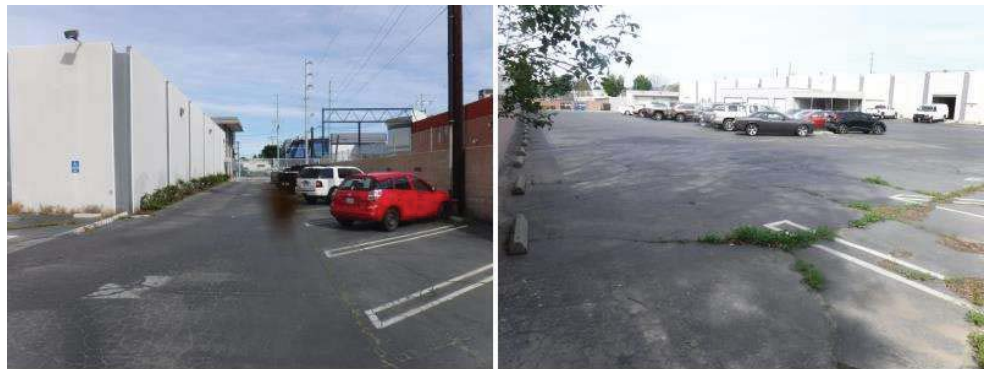
EMPLOYEE LOT:

The parking for the site is in an asphalt parking lot. There are striped spaces.

Needs Attention:

The parking area asphalt has areas of wear, weathering and

deterioration to the point that resurfacing should be strongly considered.

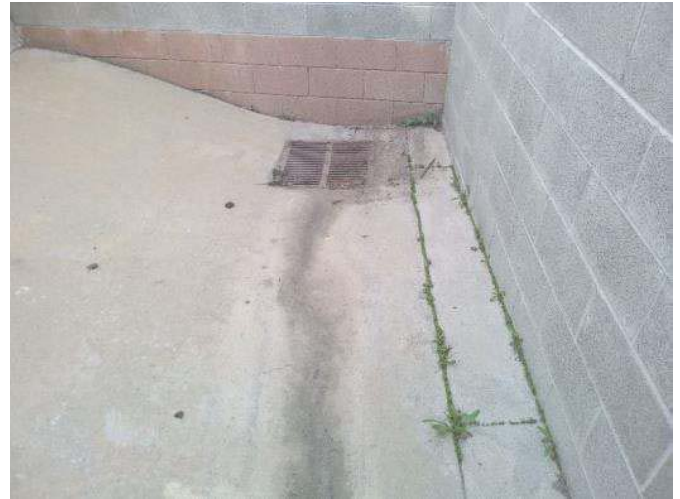
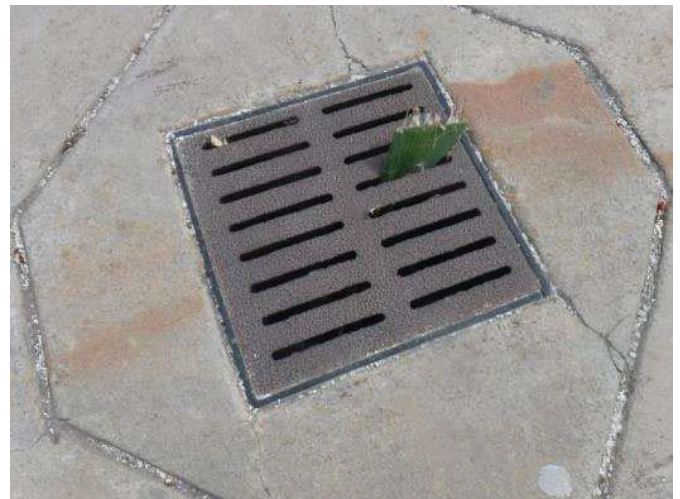
Plants are growing out of the drains.

Needs Attention:

There appears to be a pollutant in the area drain. (Located in the back near the gas main)

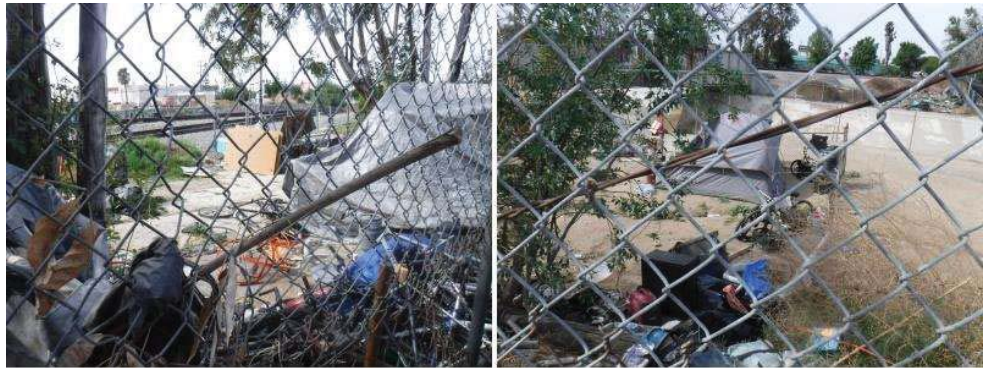
Just as a mention; The back property line is adjacent to Rail property. On which there are about a dozen or so homeless camping right up against the property wall. As this is not city property the local police may not have any real jurisdiction.

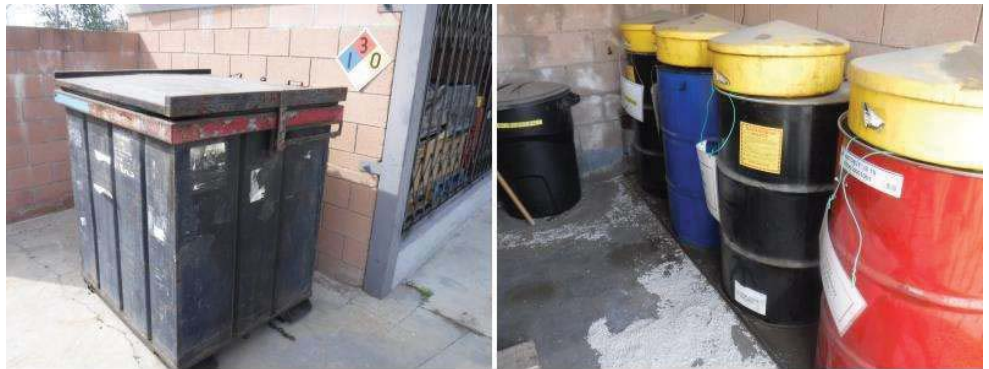
There are areas of storage noted around the property of petroleum and/or other chemical products generally deemed hazardous or of environmental concern.

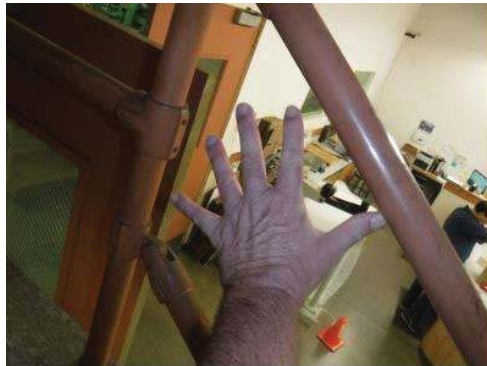
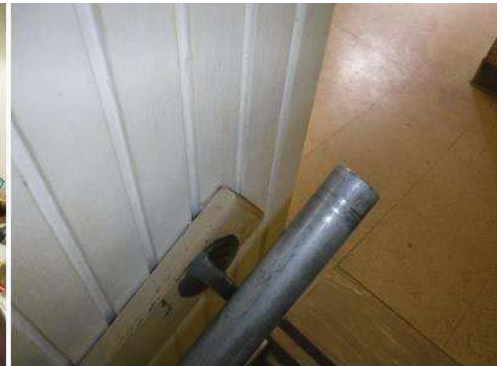
RAILING CONDITION:

Needs Attention:

The space between the rails is greater than is currently recommended for child safety. The railings should not have any space greater than four inches in any portion of them.

The railing does not return to the wall but stops with the end of it exposed. This is considered a safety hazard as the end of

it could catch a garment or handbag and cause someone to trip or fall.

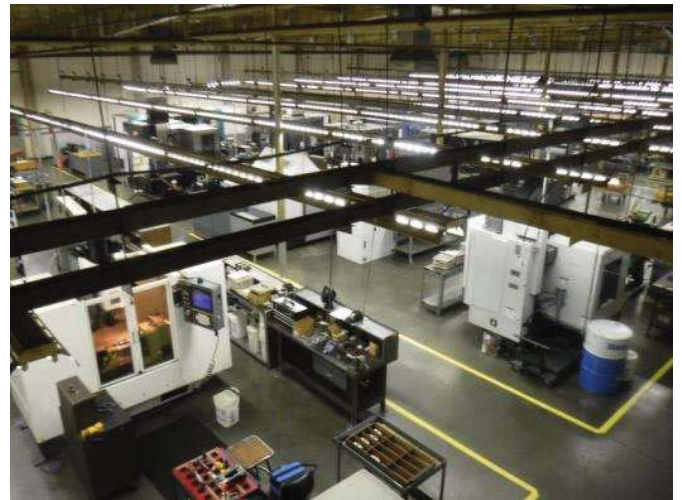
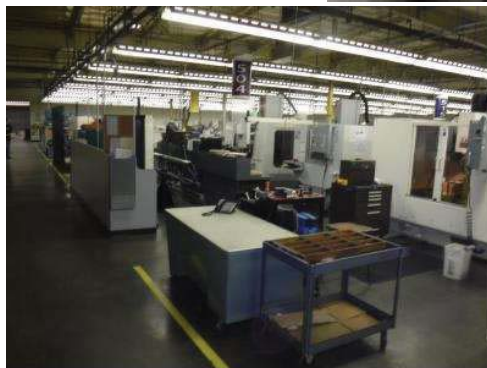
The warehouse area is generally serviceable overall with typical wear.

Such as typical cracking in the slab.

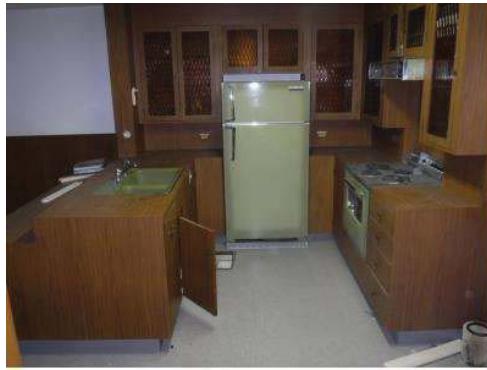
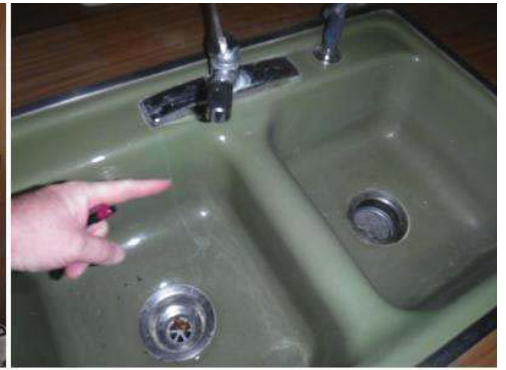
Needs Attention:

The water supply piping does not appear to provide any flow of water.

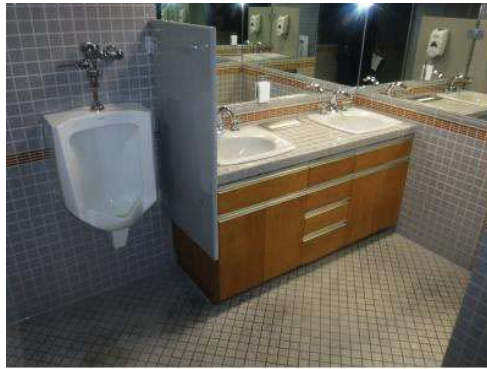
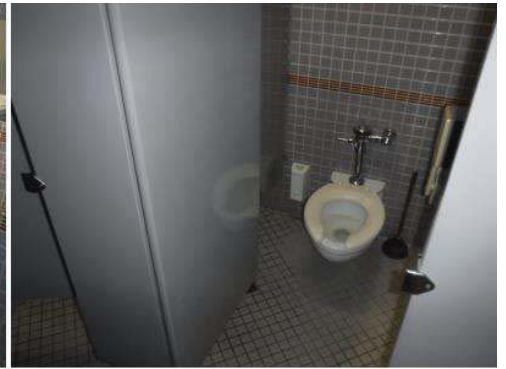
The interior surfaces, such as the walls, ceiling and such were found to be serviceable.

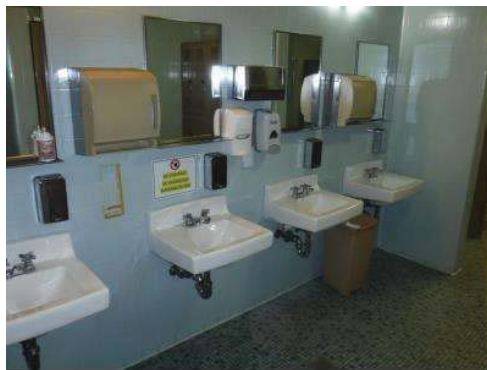
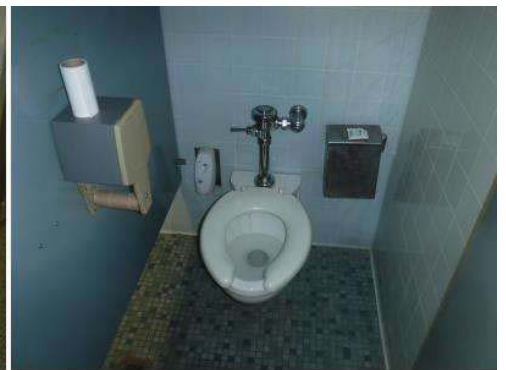
The restrooms in the production floor area is generally serviceable however there are areas with noticeable wear.

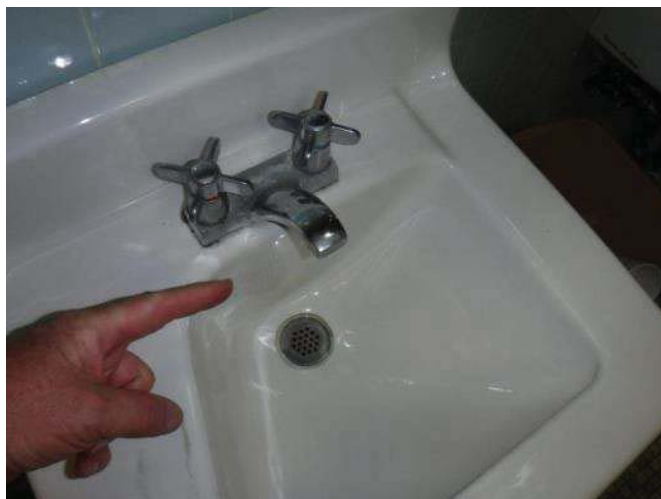
(men's room warehouse)

Needs Attention:

The sink faucet does not appear to provide an adequate flow of water.

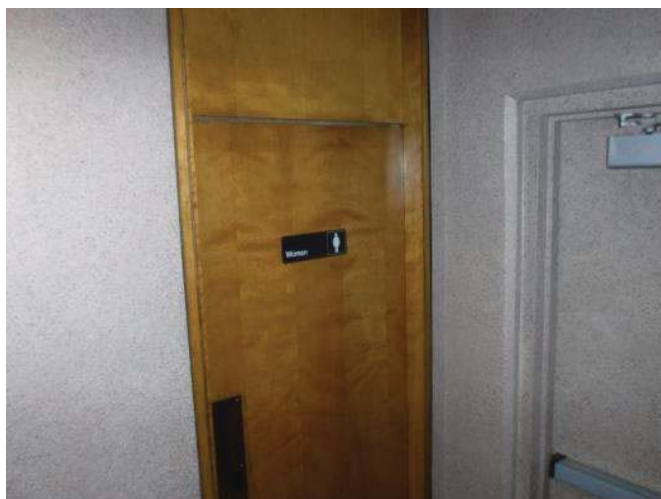
Needs Attention:

Though outside the scope of a general visual inspection the bathrooms do not appear to be up to current ADA requirements. This is mentioned as a courtesy however further review by a qualified ADA specialist is advised to determine the best course of action for this site.

The doors into the 1st & 2nd floor office area rest rooms are less than 36"

The Warehouse production area's restrooms have no ADA facilities.

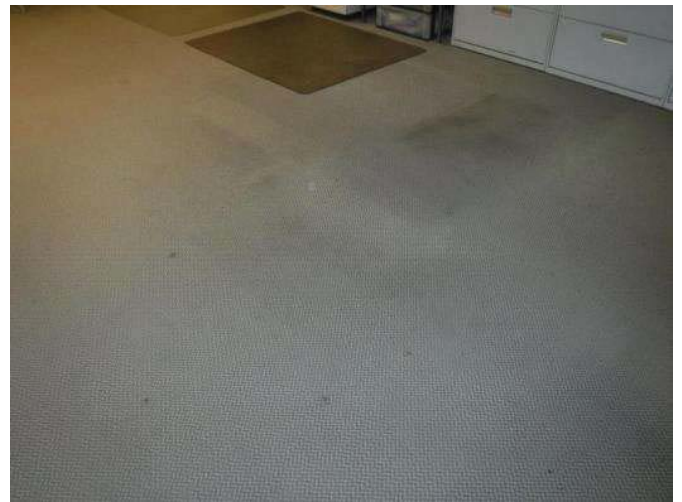
Offices were serviceable with typical wear.

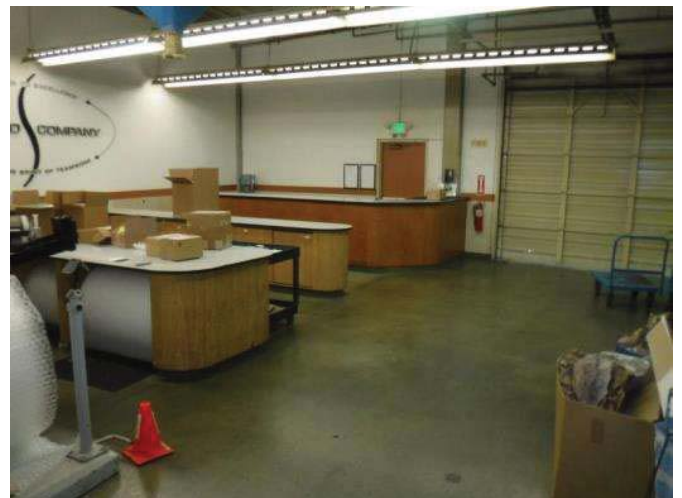
Warehouse was serviceable with typical wear.
