RISK Assessment® Report

El Monte, CA 91731

RISK ASSESSMENT[®]

Commercial Real Estate Inspectors

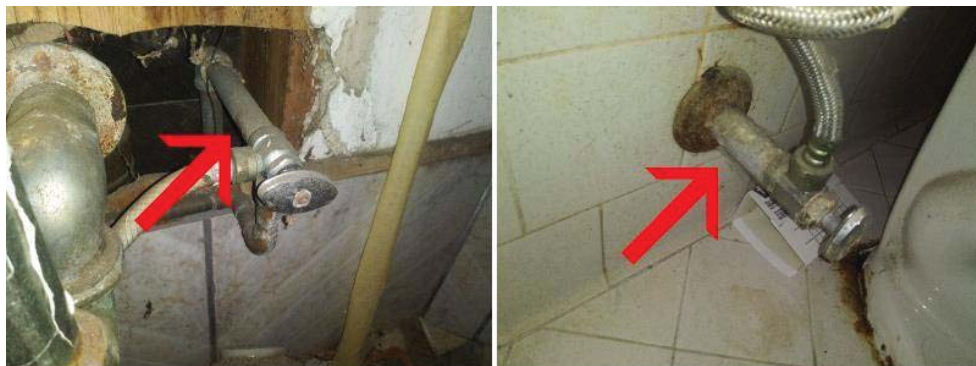
The interior piping that supplies the water throughout the building is a combination of copper and galvanized steel piping.

It appears that the majority of the supply lines are galvanized iron piping.

The original galvanized steel piping that is left in the system is aged and at the end of its expected useful life. These will need to be replaced as they continue to wear out. While the system appears generally serviceable at this time, it is recommended to upgrade the older galvanized piping to copper piping.

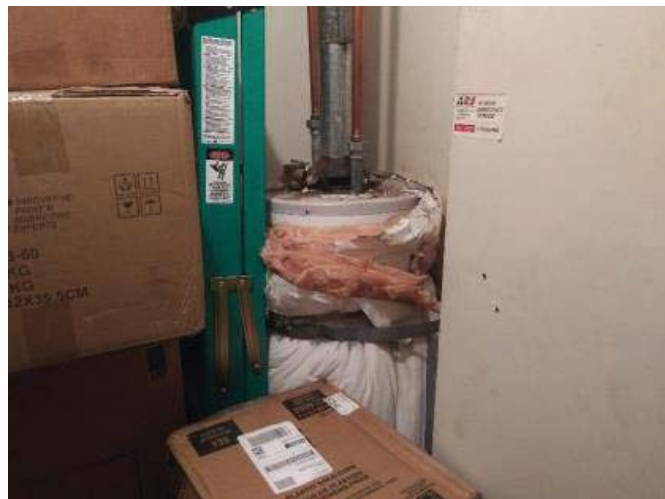
The water heater is located in the utility room/closet.

Needs Attention:

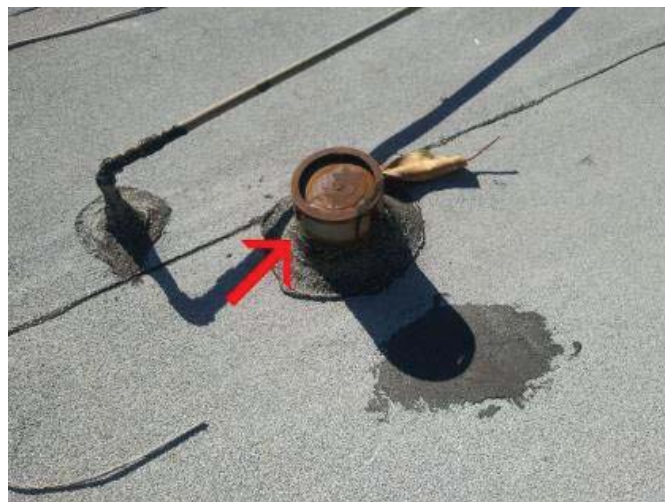
Needs Attention:

The vent (flue) is too short. It should extend to above the roof line for proper & safe operation.

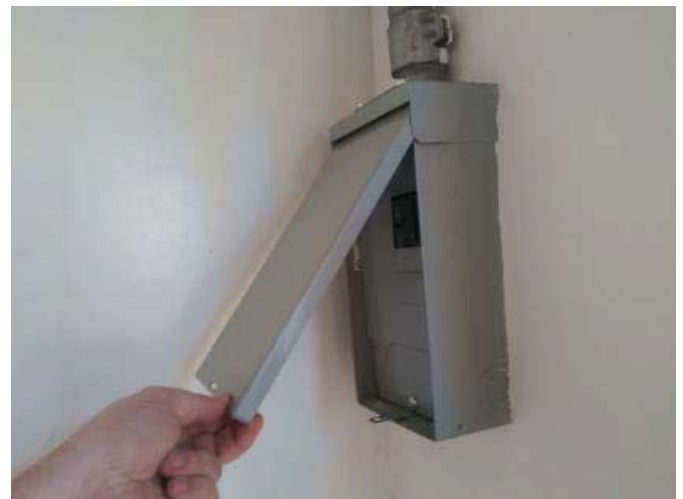
Needs Attention:

The panel cover does
not open properly.

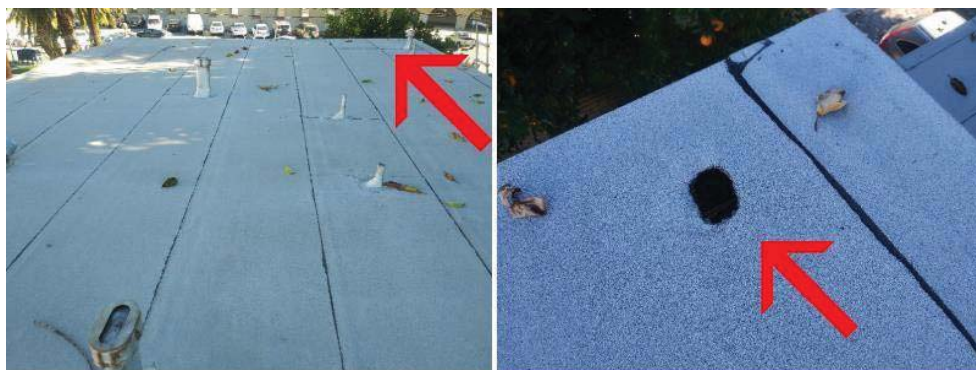
Not Acceptable:

There is a 3 inch penetration through the roof material and wood decking. Repairs by a qualified roofing specialist is advised to ensure the roof system is a reliable moisture barrier.

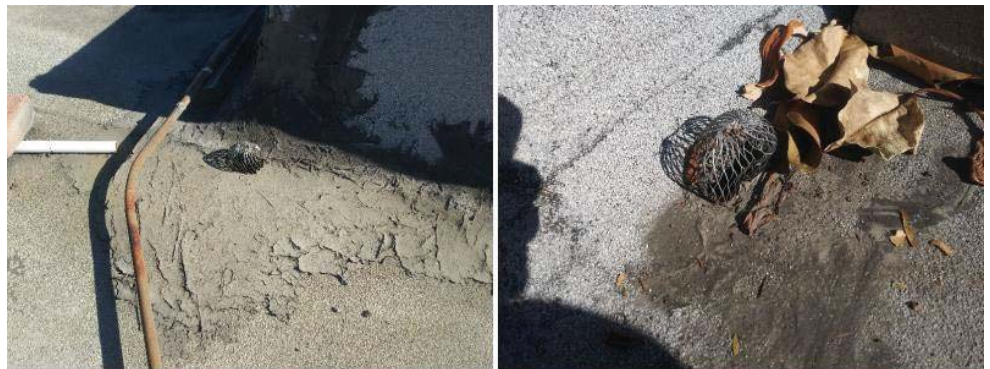
Needs Attention:

The drain screens are rusted and deteriorated. These are makeshift screens made from stucco lathe.

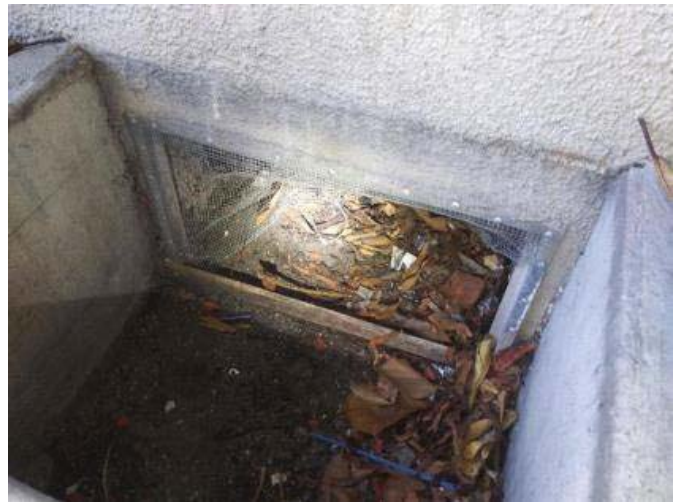
The crawl space was not tall enough to enter in areas, 18 inches of space is required for safe access and it was less than that.

It is noted that the crawl spaces were viewed from the access openings only.

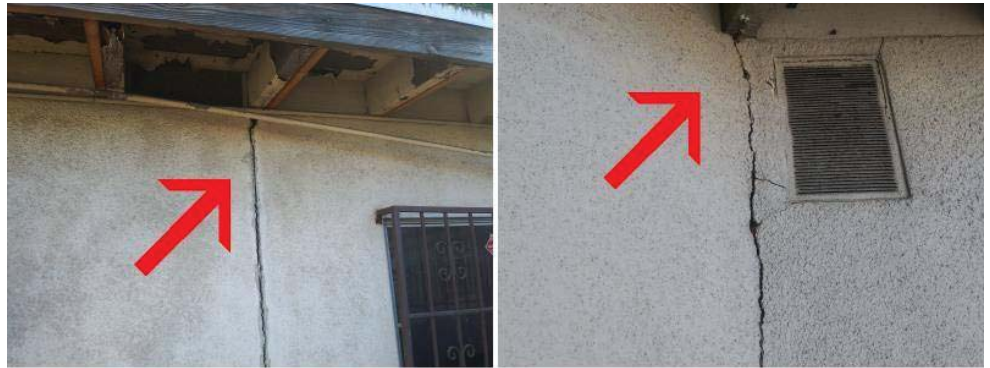
Needs Attention:

There are areas of significant crack and damage of the exterior wall of the rear building. The crack at the rear of the building appears to have been previously repaired and then re-cracked. It is recommended to consult with a structural engineer to determine if repairs are needed to improve the stability of the exterior walls.

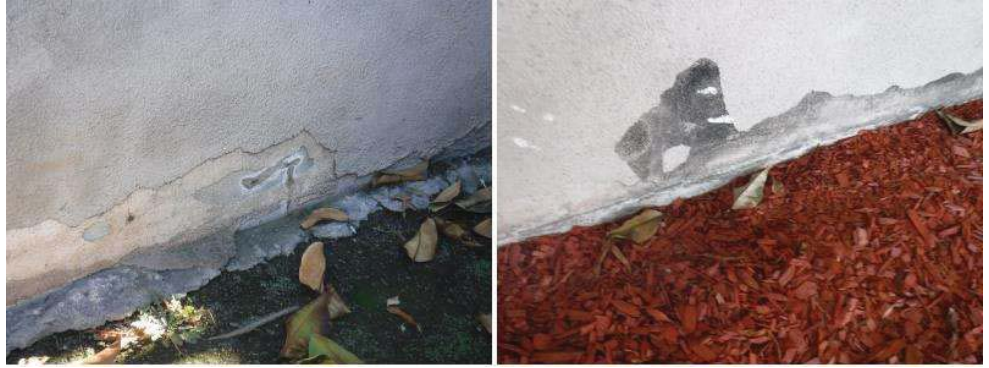
Needs Attention:

There are areas of peeling or bubbling paint to the exterior of the building.

A. It is advised to have the exterior of the building fully patched and painted to help ensure longer lasting life and help minimize moisture intrusion. Note: due to the age of the building ensuring all peeling paint is properly dealt with due to the possible presence of lead based paint is needed for health and safety.

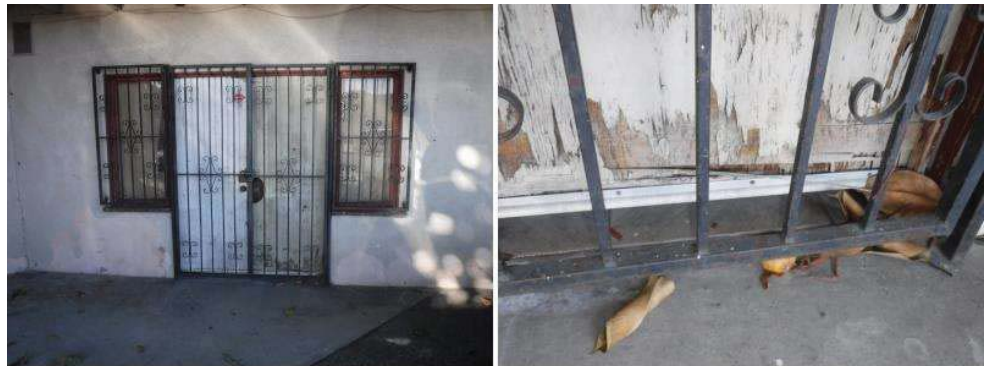
Needs Attention:

There are areas of weather beaten wood and peeling paint.

B. The Exterior Doors and Windows to rear structure are in need of some Repairs/Replacements. Full review by a qualified door specialist is advised and all needed repairs/replacements are advised.

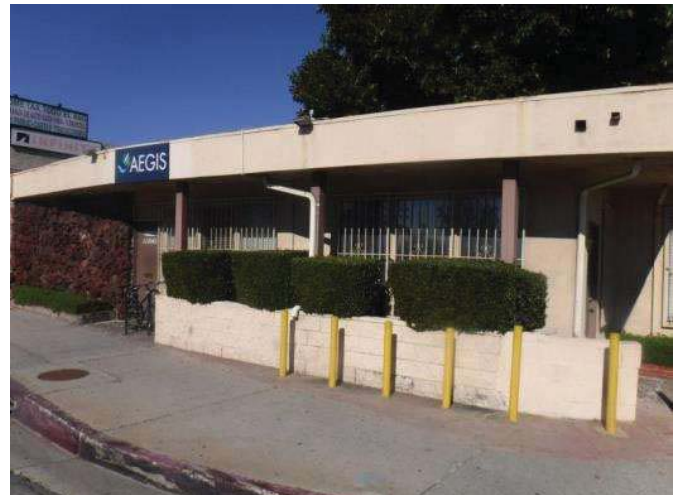
There are cracked areas of the walkways that are typical for the age and style of construction.

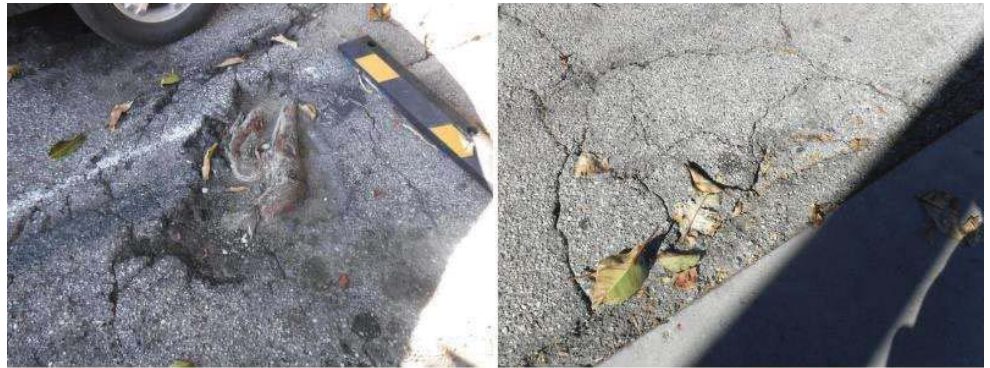
The parking for the site is in an asphalt parking lot. There are striped spaces.

Needs Attention:

C. Some repairs to the parking areas are needed then it is advised to have the parking areas fully resealed and restriped at this time.

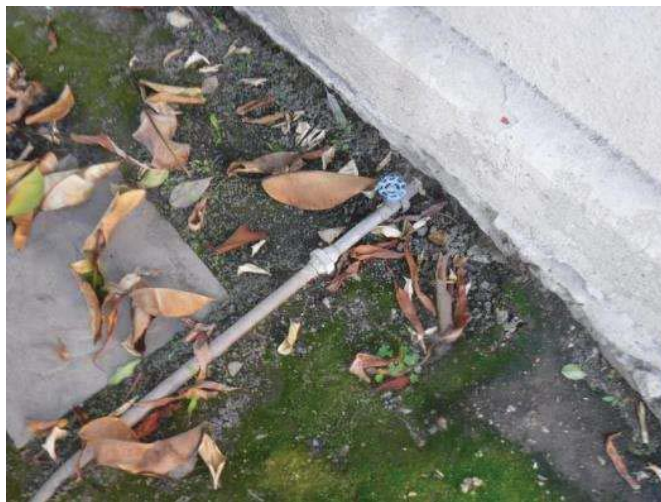
The grounds on the property need general maintenance in areas.

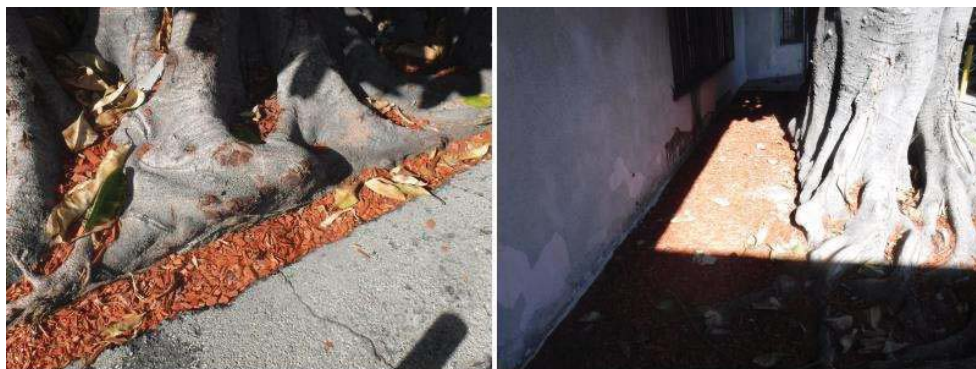
There are trees planted close to the structure. Tree roots systems may interfere with the foundation and plumbing systems over time as they continue to grow.

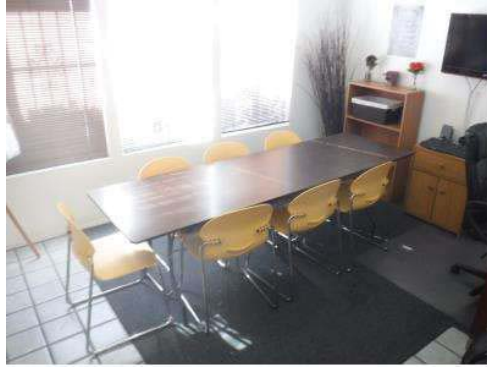
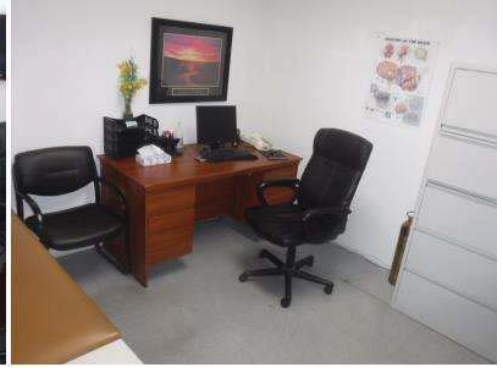
Serviceable overall with typical wear in the front offices.

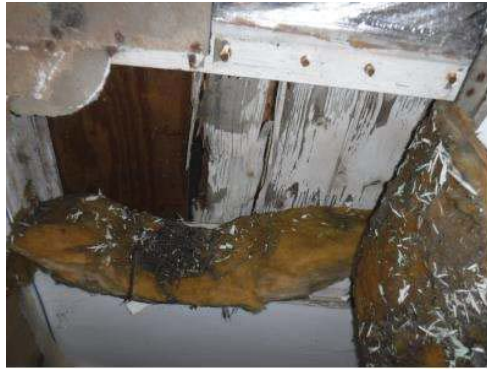
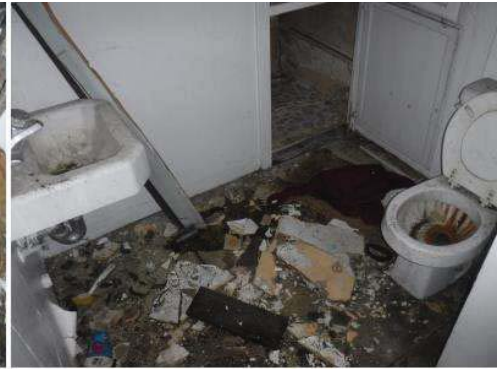
Not Acceptable in the middle building:

The office areas show excessive wear and tear. Upgrades are advised at this time.

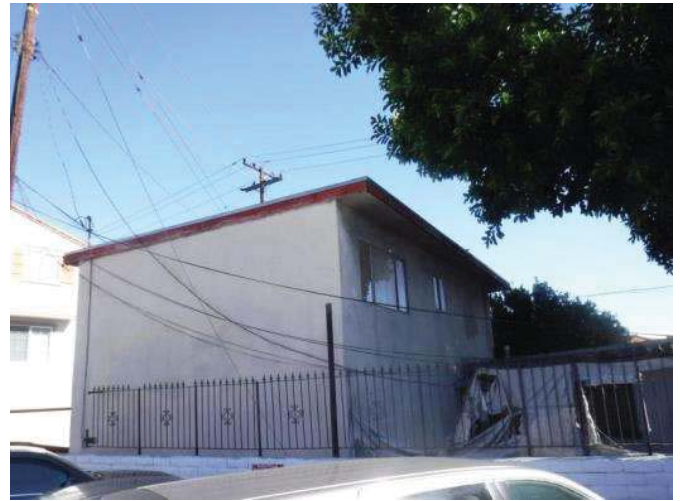
2nd Floor apartment
was not inspected

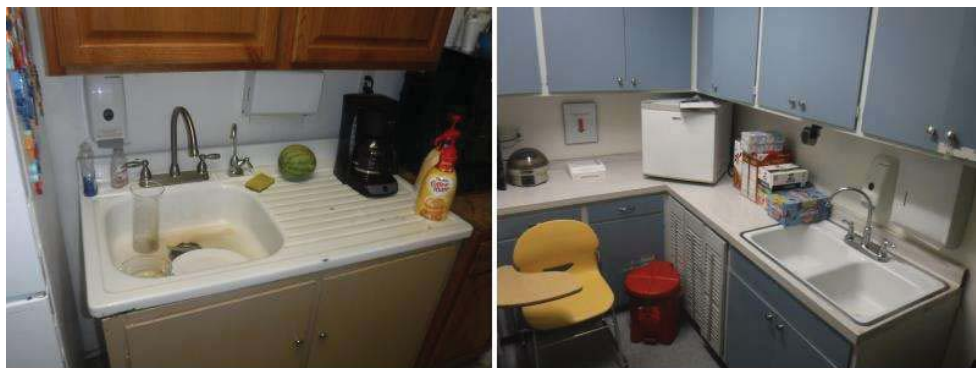
Serviceable.

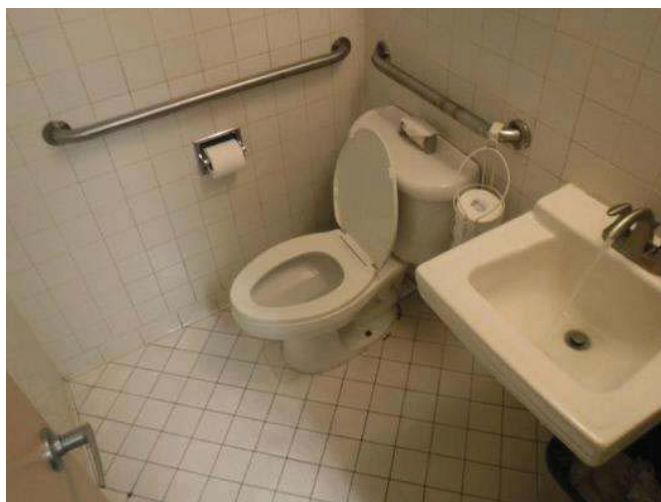
The interior surfaces, such as the walls, ceiling and such were found to be serviceable.
