RISK Assessment® Report

RISK ASSESSMENT[®]

Commercial Real Estate Inspectors

This is an assessment of the five major systems - Plumbing, Electrical, Heating and Air Conditioning, Structure and Roofing along with an assessment of any other current deferred maintenance issues for the site.

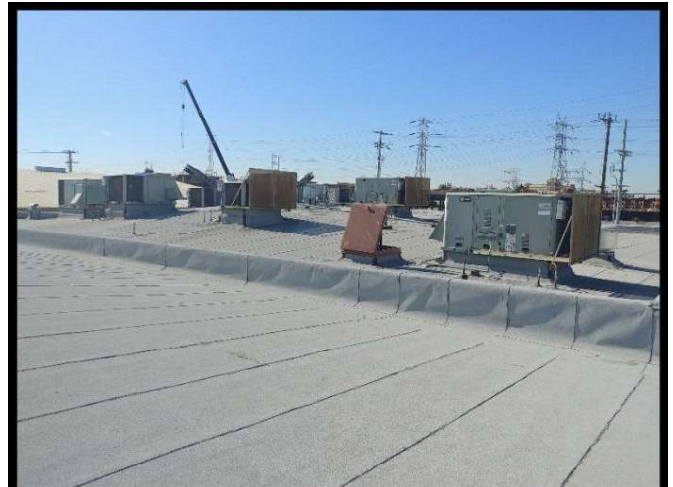
Front office areas HVAC units.

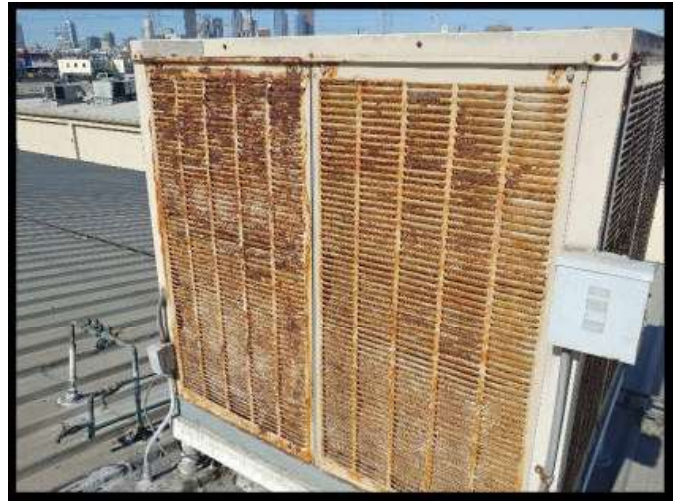
The evaporative coolers, ten of them, over the 560 warehouse area are in such poor shape for at least half of them replacement is advised now. Extensive maintenance and repairs are needed for all the evaporative cooler units.

This type of unit is called an evaporative cooler. It is a type of system where water soaks onto usually fibrous materials and then air is pulled across the material and cooled by evaporation which is then blown into the building.

Replacement of each evaporative cooler is approx. \$5,000 - \$7,500+ depending on the methods and materials used. Expect replacement of at least 5 of them in the near future to be needed along with extensive repairs to the rest.

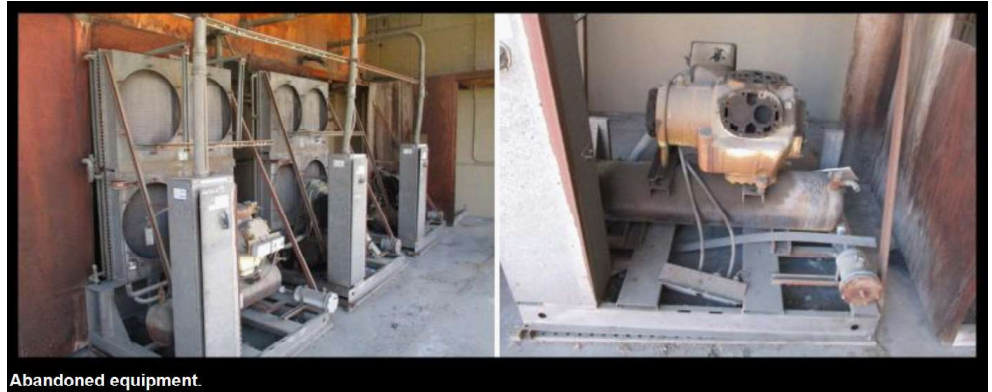
In the same enclosed area on the ground at the rear of 560 with the refrigeration equipment that is abandoned equipment that appears to be the cooling equipment from before the current equipment from 2006 was installed.

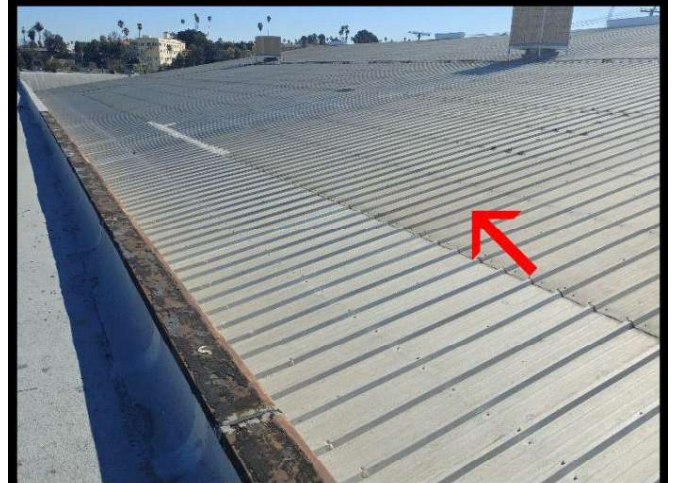
560 roofing.

Steel Roofing System for 560.

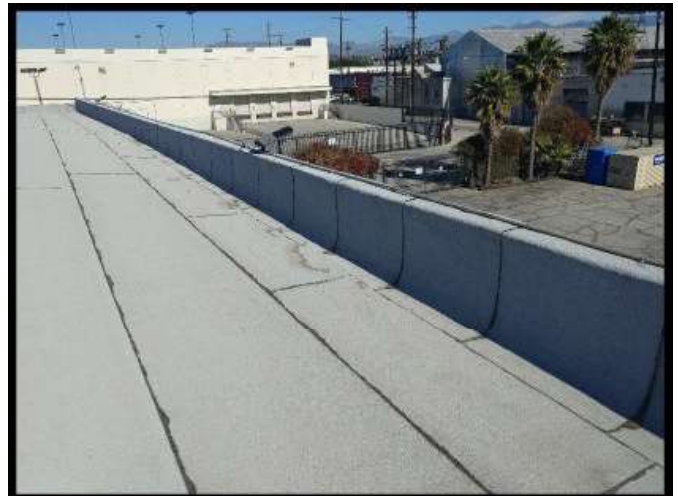
Needs Attention:

It is noted that there are areas where the seams are not fully sealed such as app the office area partition. This is a defect in installation.

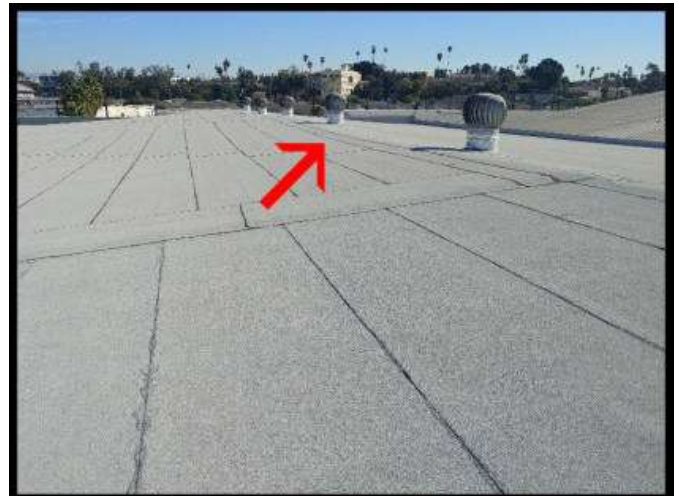
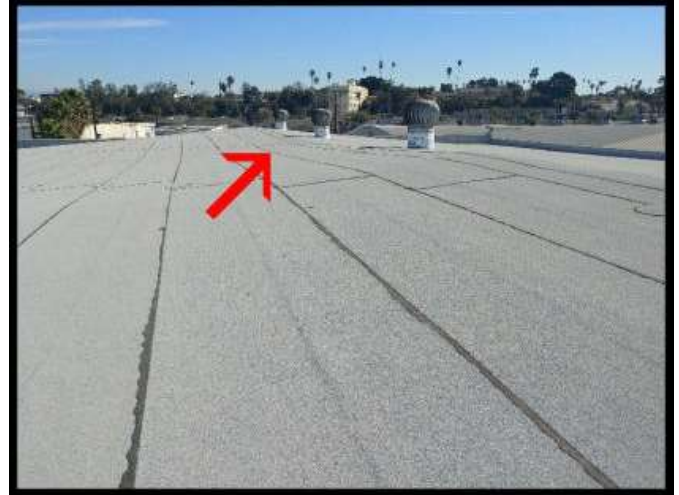
Needs Attention:

There are areas of sagging such as at the rear warehouse area of 550.

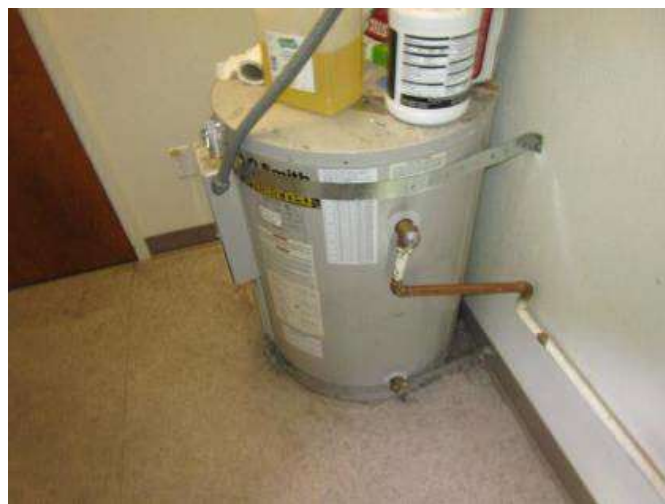
Utility closet above
restrooms of 550
building.

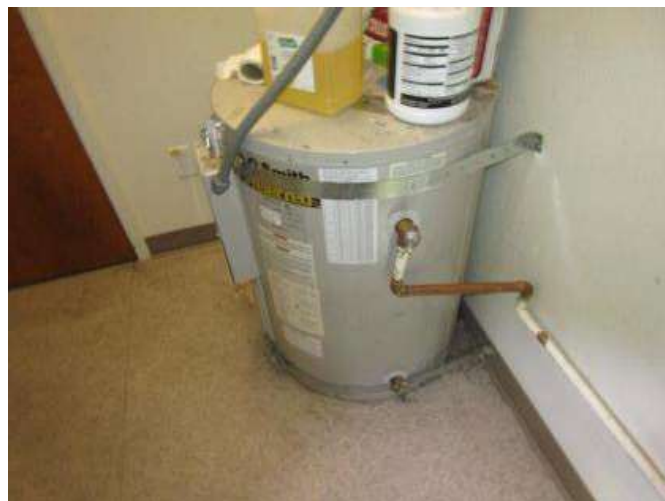
Needs Attention:

There is no catch pan under the water heater to prevent leaks from damaging the floor or structure, this is recommended in this location.

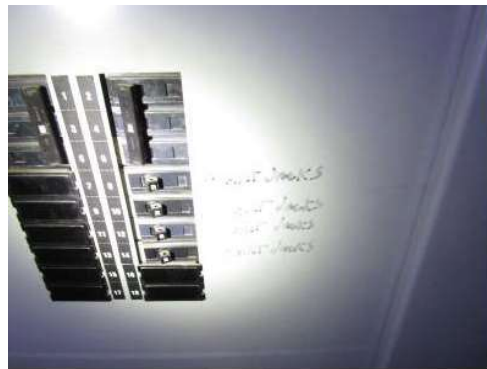
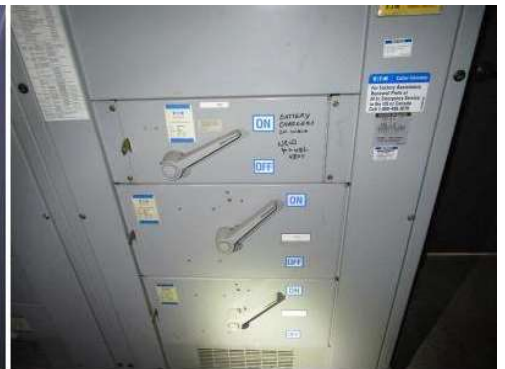
Needs Attention:

The panel is missing some required labels. This is a safety issue. Each panel and breaker is required clearly visible label as to its size and what area it serves.

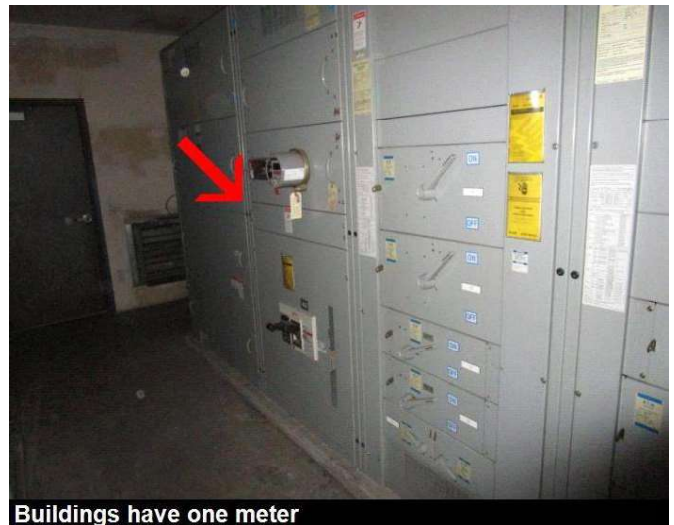
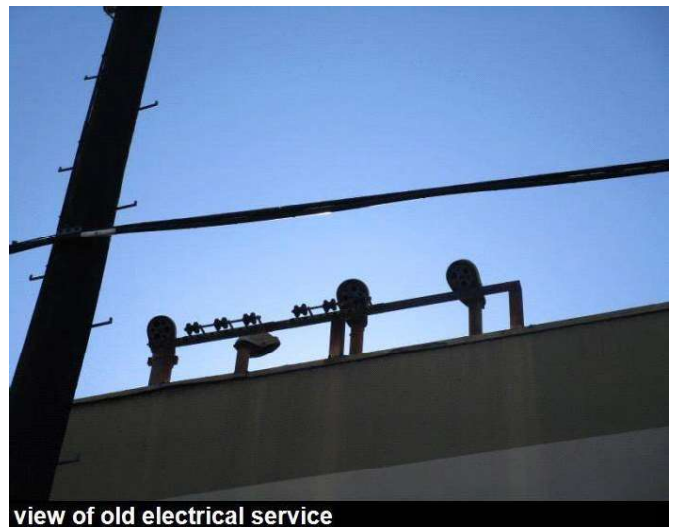
It appears that older overhead service was removed and replaced by the present underground system.

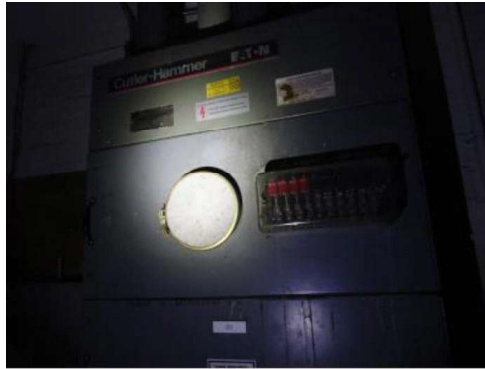
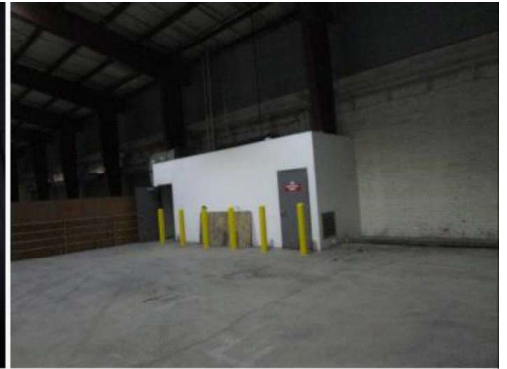
Building 560, has it's own Electrical room and has panels but has no meter of it's own.

View of electrical room 560 building

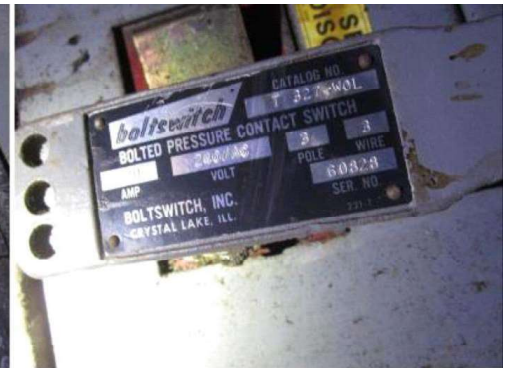
560 building has an 800 AMP system which is a 3 phase 3 wire system . It gives 120/240 volts to this building.

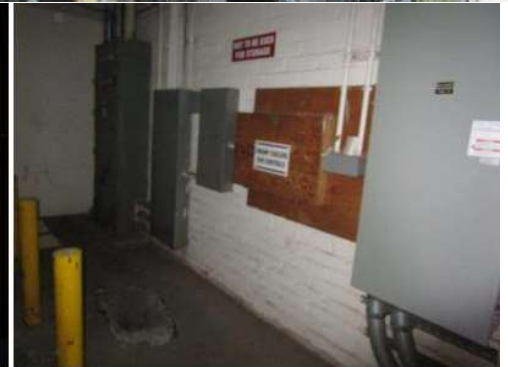
There are knock-outs missing at the panel leaving open spaces in the cover and there are exposed live electrical items as a result. This is inexpensive to correct but should be repaired for health and safety.

Due to the age and overall condition it is advised to have a complete cleaning and servicing done for health and safety for all sub panels.

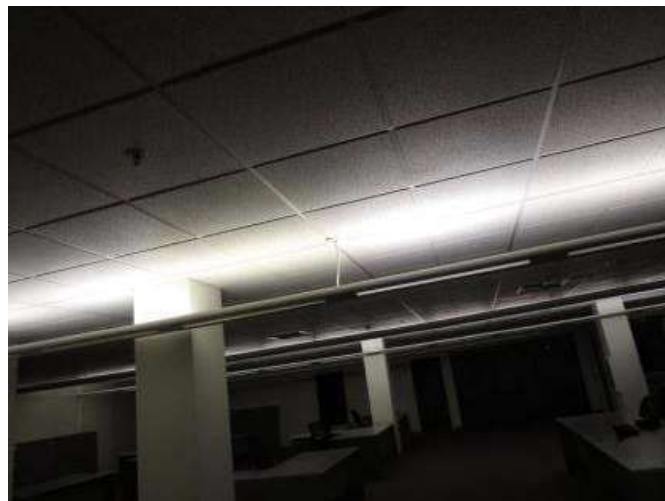
There are light fixtures that did not work when tested. This can be a burnt out bulb or deteriorated ballasts in fluorescent lights but it is not known exactly why they are not working.

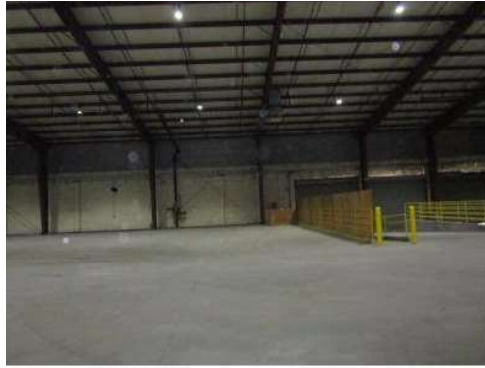
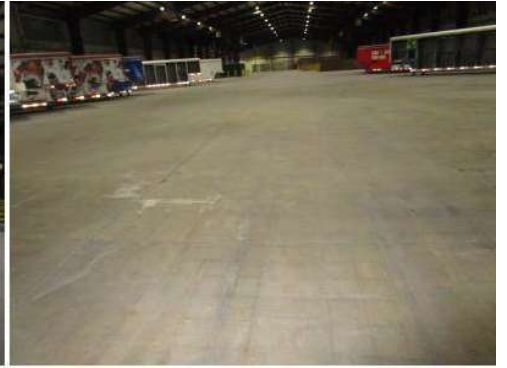
Slab foundation has cracks in areas. Most are typical. Some are larger cracks which should be repaired by an expert.

There are cracks in the slab that appear to be typical for the age and style of construction. However if you need a more detailed evaluation it is advisable to contact a structural engineer or a foundation specialist.

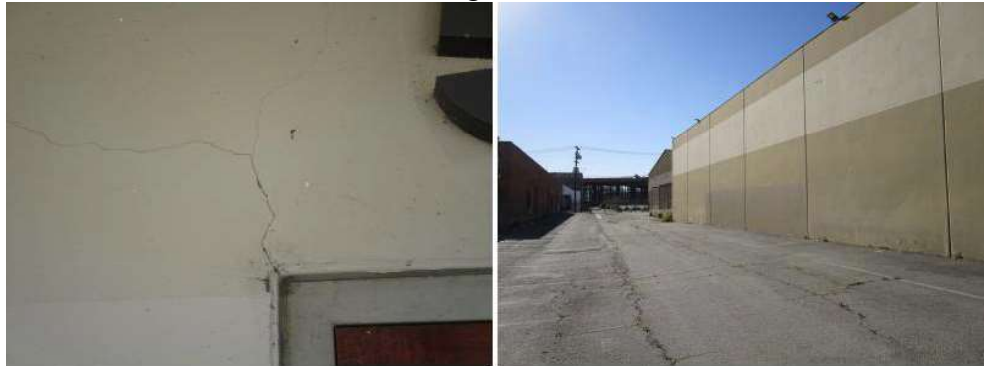
Also brick walls seen at 560 building in areas.

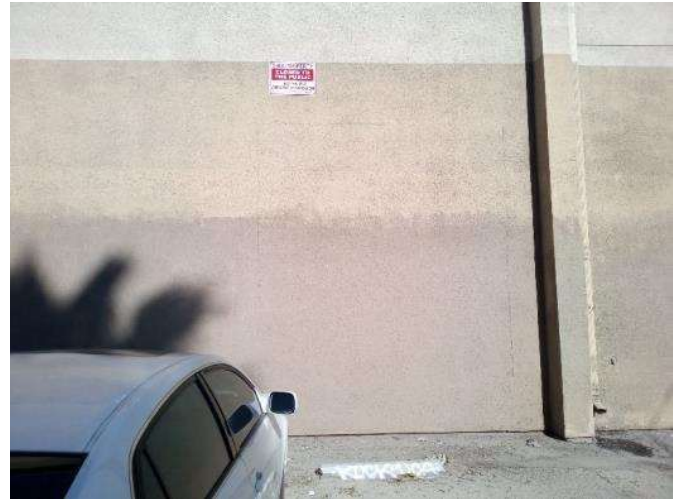
There are areas
where openings
have been filled in

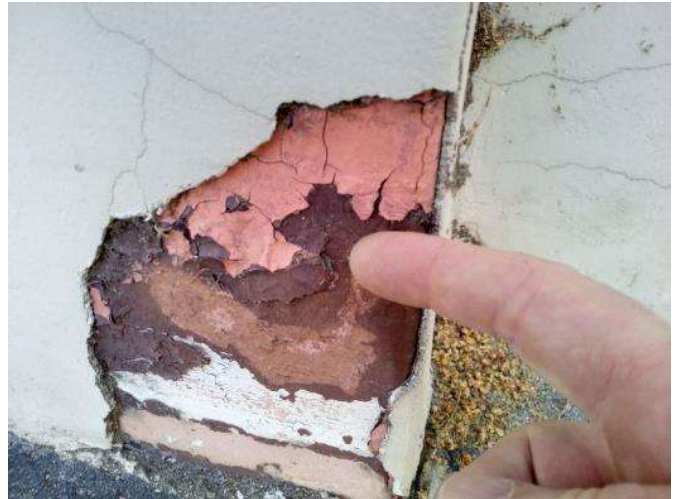
The stucco may have been applied over lead paint in the front.

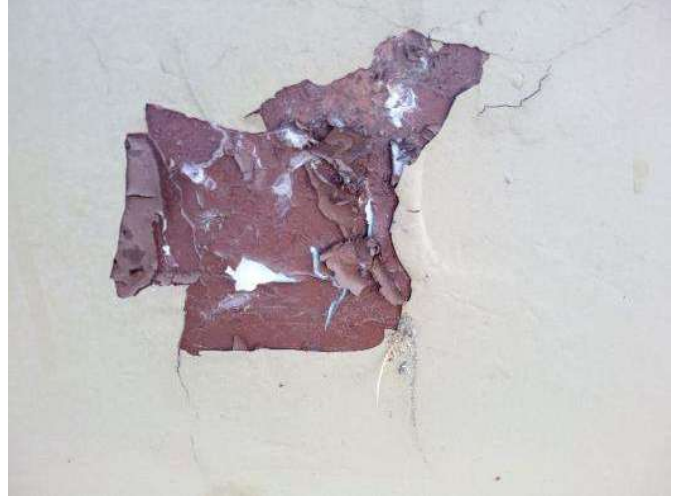
There is a peeling coat of paint over what looks like lead paint on the left side of the building.

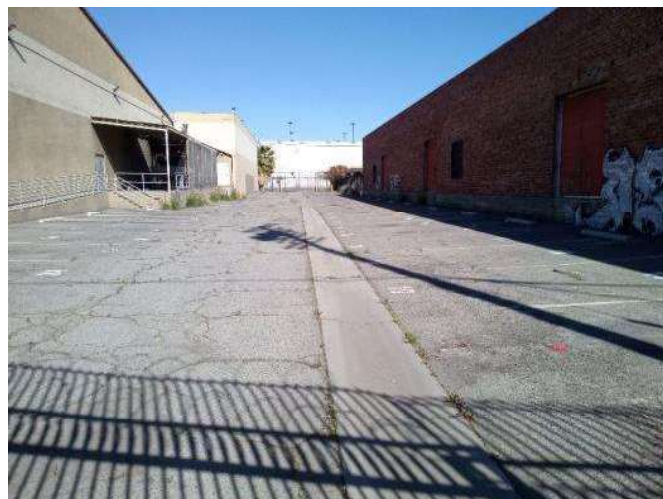
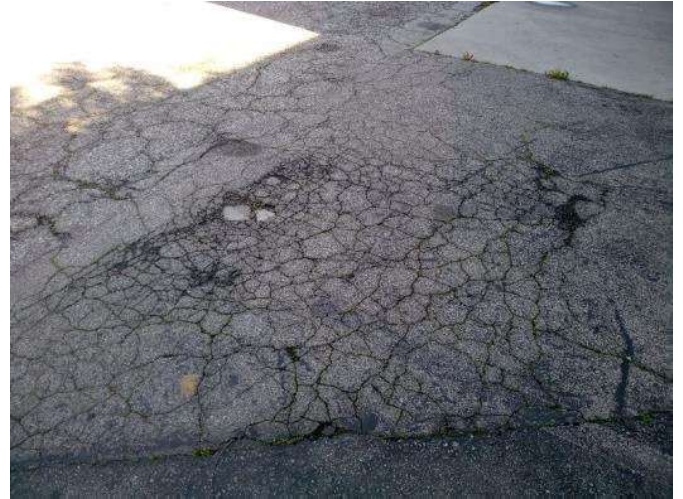
The parking area asphalt has areas of wear, weathering and deterioration to the point that resurfacing should be strongly considered.

The parking area appears to be a shared area. Full disclosure is

**advised for who's
responsibility the
upkeep and
maintenance is.**

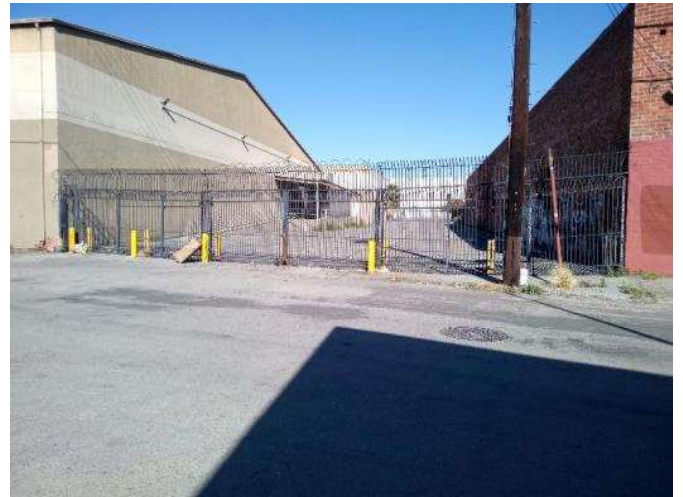
This gate was not operational

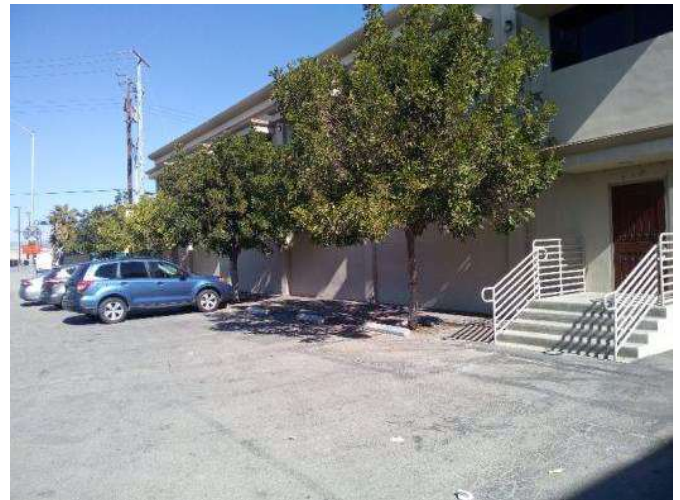
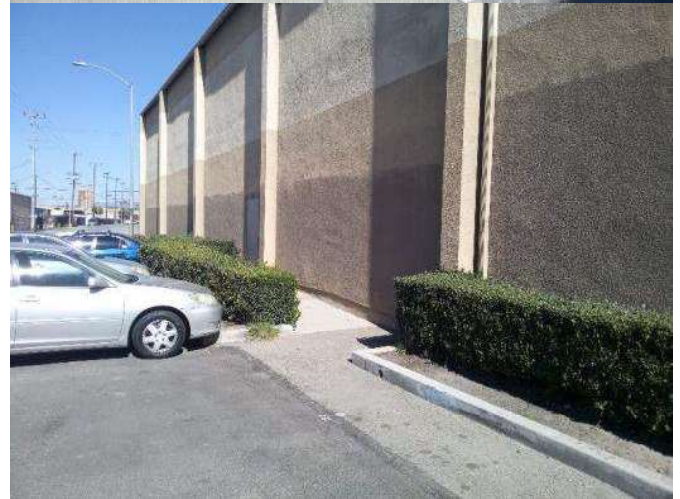
The grounds on the property need general maintenance in areas.

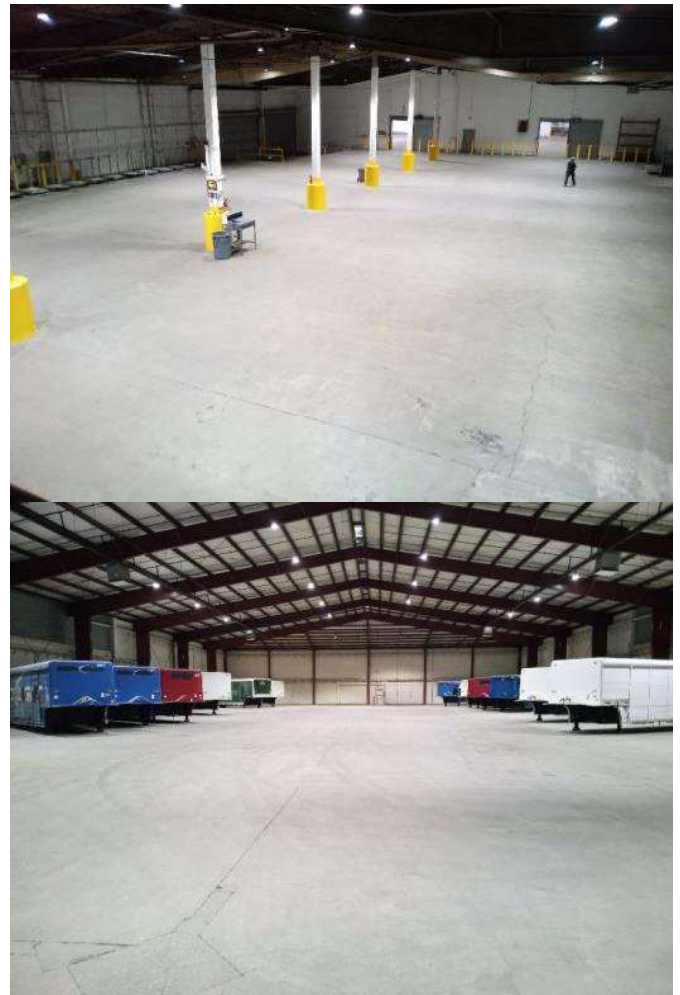
WAREHOUSE AREAS:

The warehouse area is generally serviceable overall with typical wear.

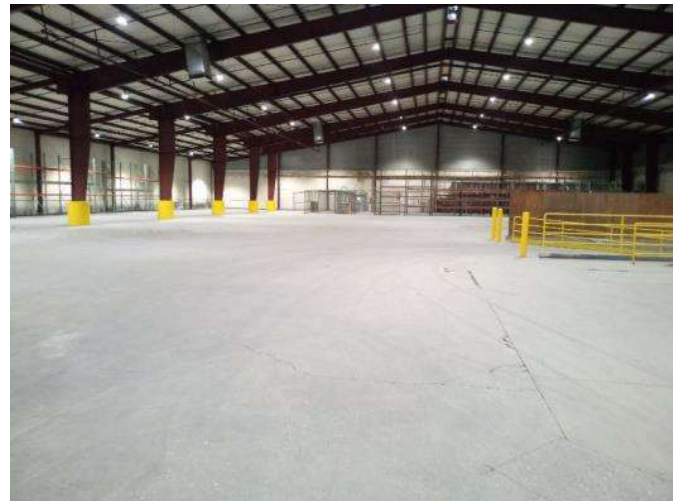
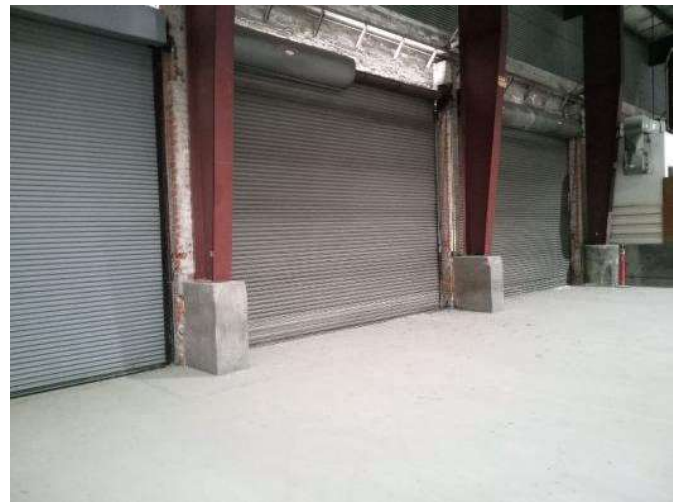
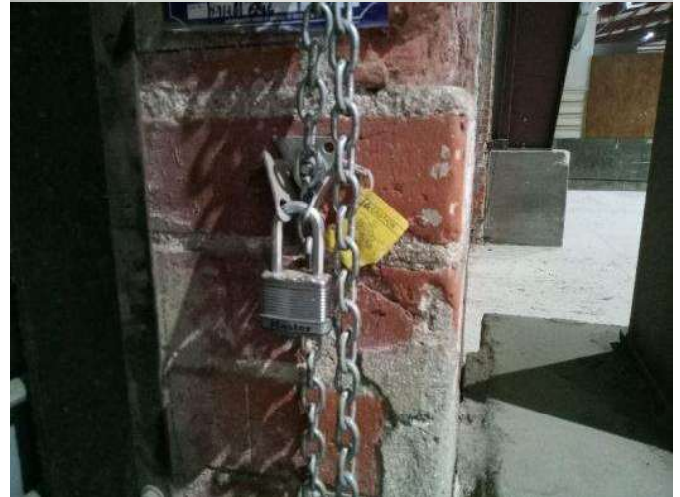
ROLL UP DOORS:

Roll up doors appear to be serviceable however each one is held fast with a padlock and we're not tested.

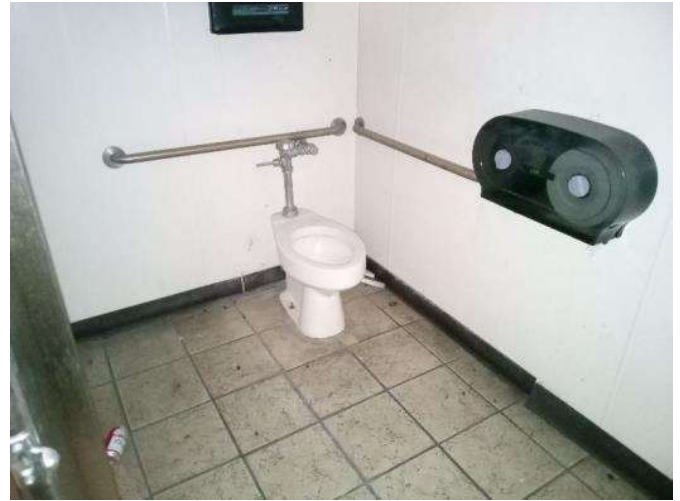
The interior surfaces, such as the walls, ceiling and cabinets are excessively worn and/or damaged.

Though outside the scope of a general visual inspection the bathroom(s) appear to be up to current ADA requirements. This is mentioned as a courtesy and exact details and measurements were not taken.

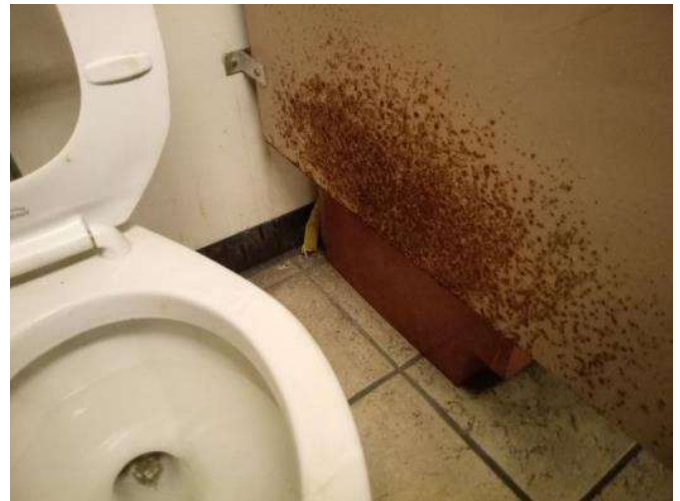
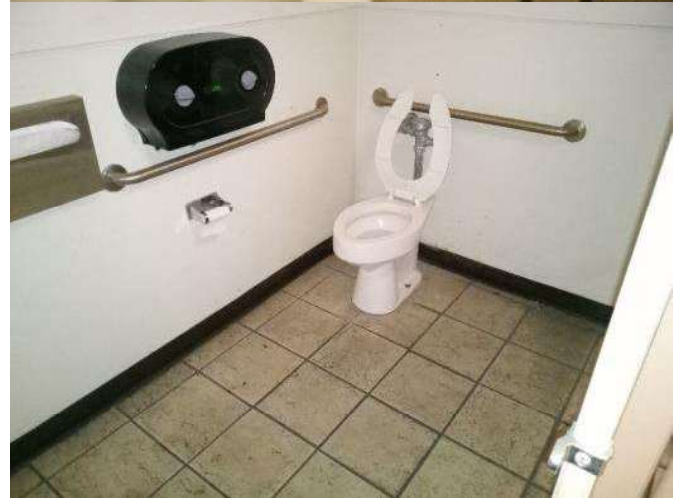
The interior surfaces, such as the walls, ceiling and cabinets are excessively worn and/or damaged.

Though outside the scope of a general visual inspection the bathroom(s) appear to be up to current ADA requirements. This is mentioned as a courtesy and exact details and measurements were not taken.

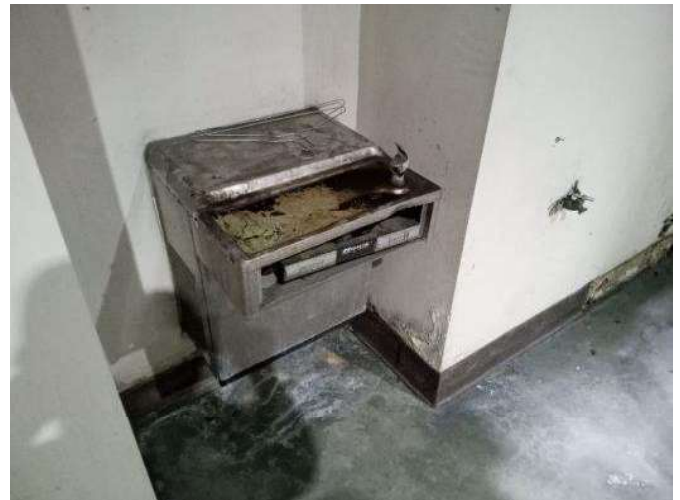
DRINKING FOUNTAIN:

Not serviceable.
